## COMMERCIAL WINDSTORM MITIGATION REPORT (OIR-B1-1802)

Shores of Long Bayou X Condominium Association, Inc.

6425 Shoreline Dr, Units 10101-10506

As of 8/17/2018

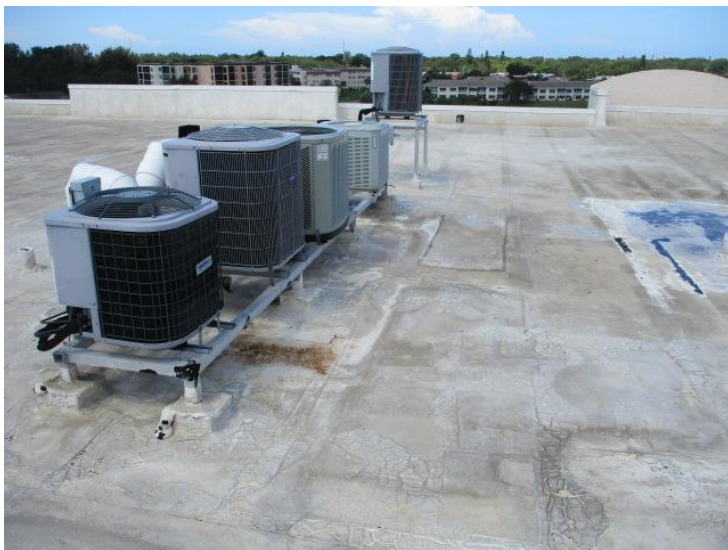
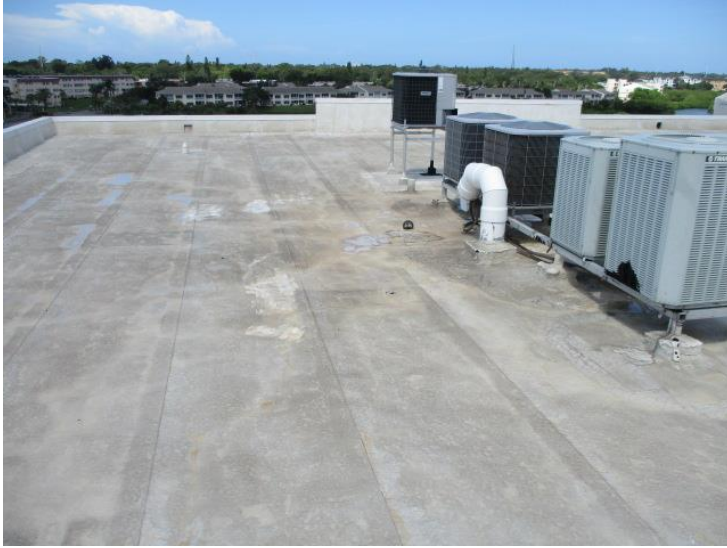
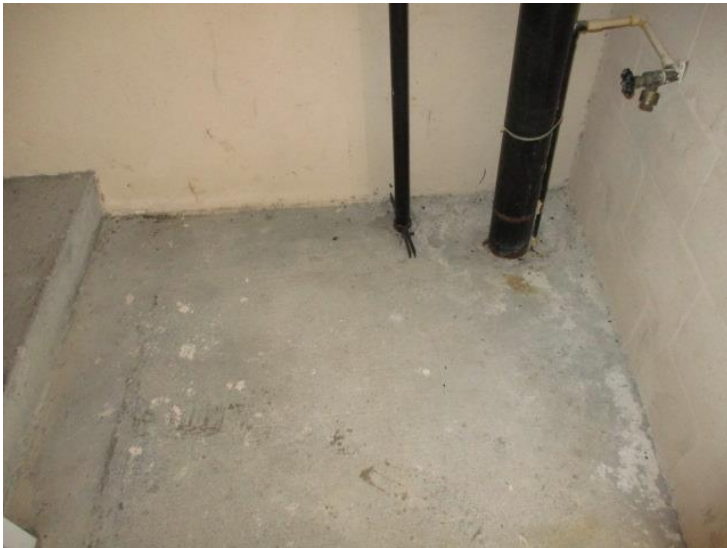
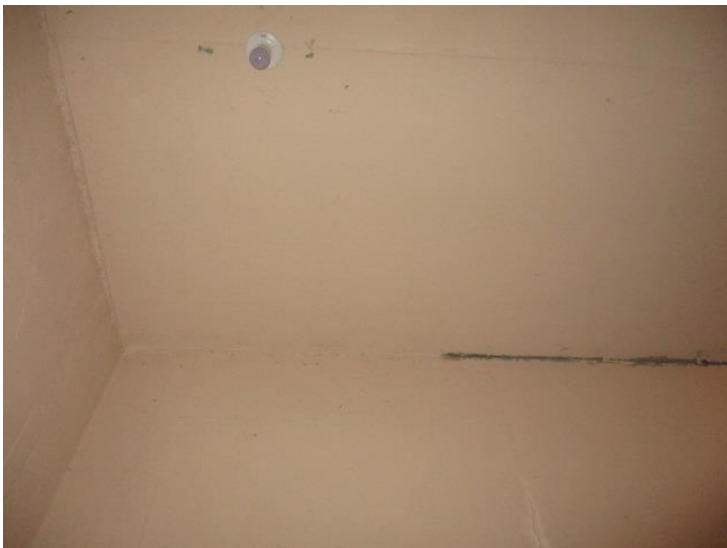
Roof Construction

- 3. Roof Deck Attachment:**        **Reinforced Concrete Roof Deck**  
Comments:                                      Inspection verified a roof structure composed of cast-in-place or pre-cast structural concrete designed to be self-supporting and integrally attached to the wall / support system.

- 4. Roof to Wall Attachment:**        **Structural**  
Comments:                                      Inspection verified a roof structure composed of cast-in-place or pre-cast structural concrete designed to be self-supporting and integrally attached to the wall / support system.

- 5. Roof Geometry:**                      **Flat Roof**  
Comments:                                      Inspection verified flat roof shape, refer to attached photographs.

- 6. SWR:**                                      **No**  
Comments:                                      SWR does not apply to reinforced concrete roof decks.
