TWA Flight 800 Evidence And Witnesses

R. Swaim

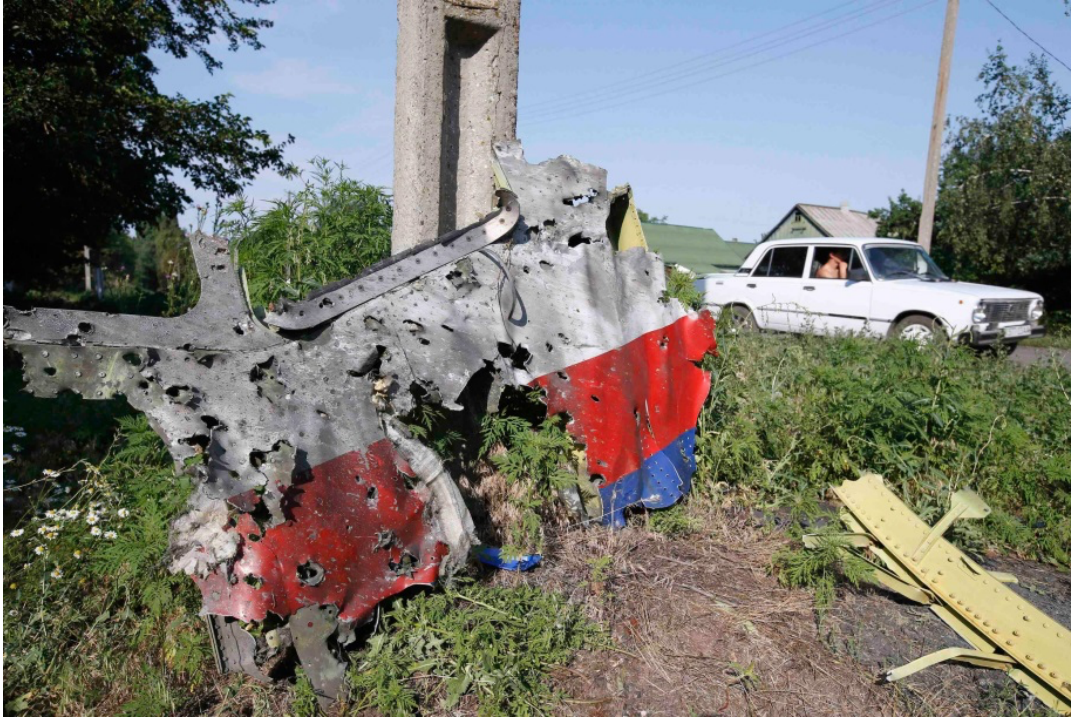
Figure 2. Shotgun type of damage inflicted on structure on a Boeing 777, operating as MH17 when shot down over Ukraine in July 2014. (Press)

TWA have clearly and repeatedly shown that the destruction caused by a missile is created by what appears as a shotgun blast and there was none in any of the TWA wreckage. (Figure 2)

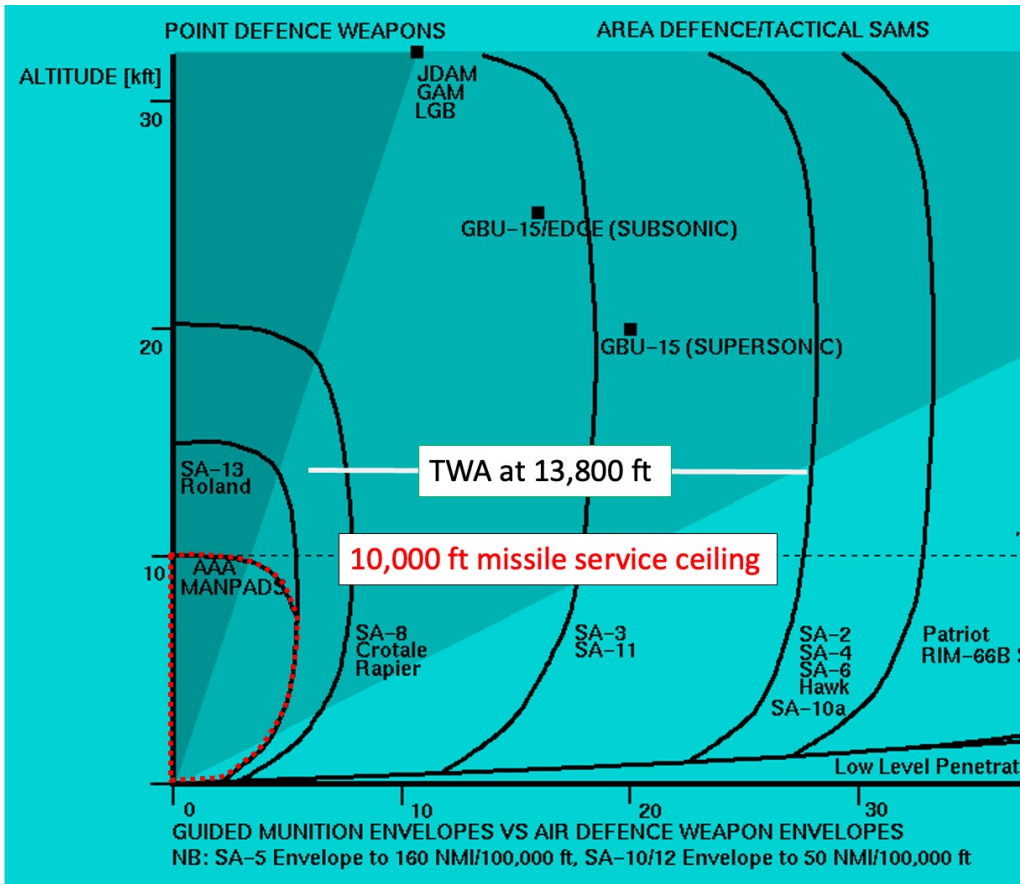
Figure 4. Range and altitude limits for many anti-aircraft missiles in 1996. Note that missiles larger than the manpad (red) should have appeared on radar.

The only way that we at the time could figure that something could come from ground level AND be too small for radar to pick it up AND have the range in altitude meant it had to have been a shoulder launched man portable launchers (manpad) such as a Stinger. Many videos of these launching have been made in the war unleashed by Russia on Ukraine. A major problem with this theory was that most manpads in service at the time could not travel more than about five miles or reach more than about 10,000 feet in altitude and the airplane was at 13,800 feet. (Figure 4)

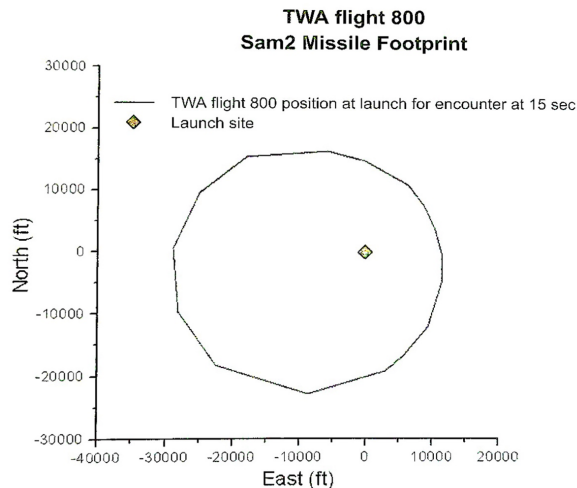
Figure 5. The required location for a missile launch to reach the TWA airplane. (NTSB Report)

Newer anti aircraft missiles with greater capabilities were coming into service so the NTSB accounted for those in the report when it determined where a potential launch point would need to be located. This created the next obstacle to the missile theory because the launch point needed to be in a very specific place on the water almost directly below the approaching airplane. (Figure 5) The exhaust of the launcher would have been down into the boat and all of the witnesses would have said it went straight up, not east or west as discussed later.

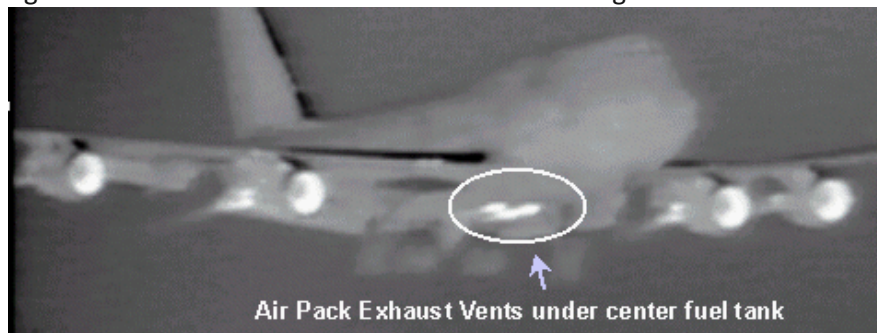
Figure 7. An infrared image shows the hottest parts of the airplane in white which missiles would target.

In missing physical evidence, the manpad and ship launched missiles in 1996 would seek the hottest parts of the airplane; the wing mounted engines and the hot machinery located beneath the fuel tank. (Figure 7) The engines were recovered and none had missile damage.

In three separate layers, the floor of the center wing fuel tank had no penetrations, there were no penetrations in any of the hot air conditioning machines beneath the tank which would have been the target of a heat sinking missile, and the entire fiberglass fairing that was the bottom of the airplane was also found to be without any external penetrations, let alone the typical missile damage resembling a shotgun blast. The tank walls and top surface were also without penetrations.

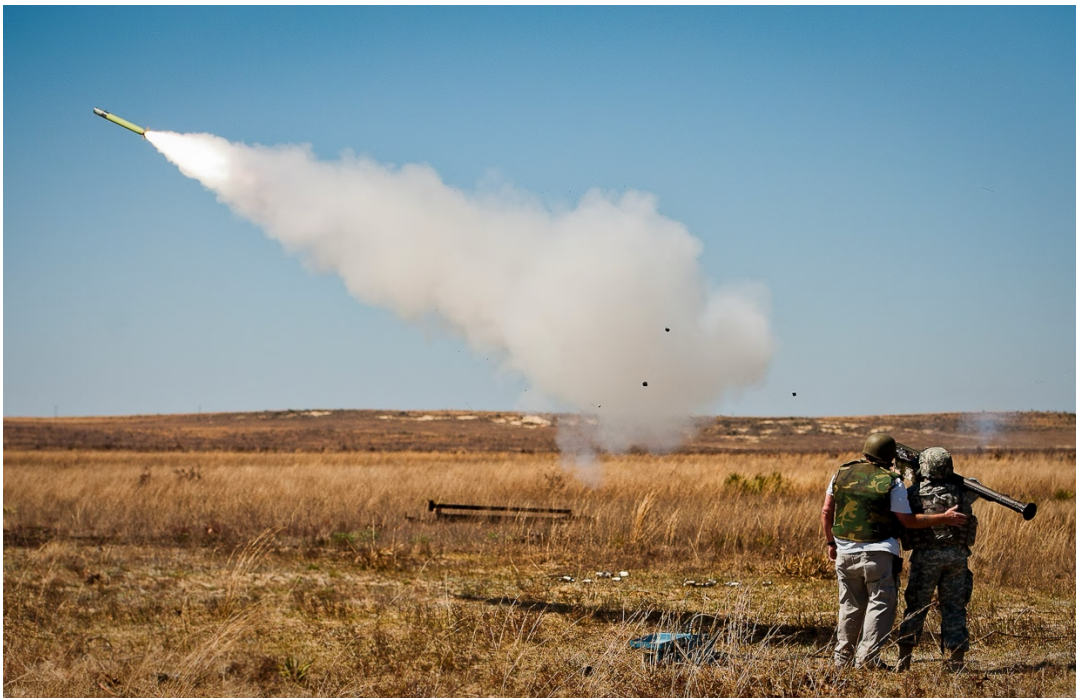
Figure 8. Launching of a man portable (manpad) missile, showing white smoke originates from the launch site on the ground. (Eglin Air Force Base)

A very conspicuous item was that many of the 56 reported a “streak of light” or flare rise. Missiles and manpads create a white trail from the ground then go into coast mode with no trail. (Figure 8)

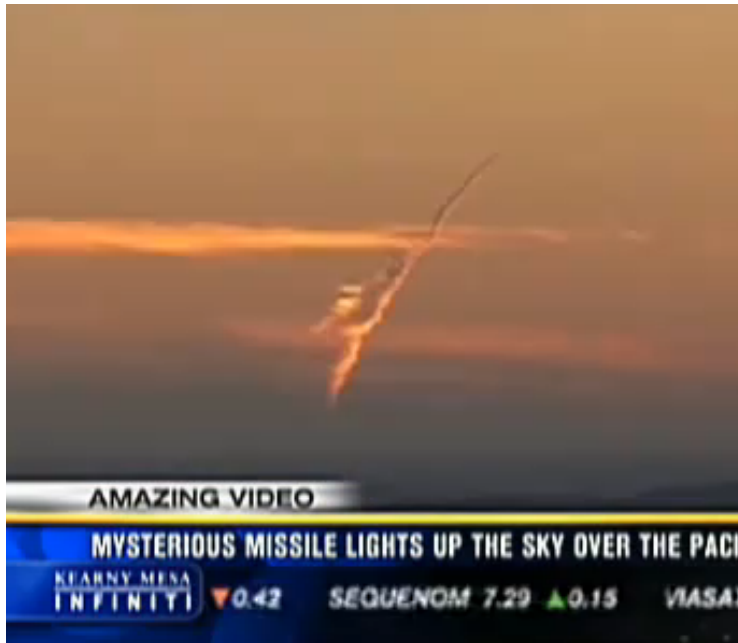
Figure 11. A 2010 Los Angeles television broadcast claiming that a missile lit up the sky, which was later found to be an arriving UPS cargo flight. (Media)

To me, the most fitting explanation for flares or streaks of light which go up like a missile but start above the ground is something which is easily mistaken mistaken for missile launches. The contrails of other airplanes. Movement of an overhead path toward a viewer makes a flight appear to be climb upward. As an example from 2010 in Los Angeles, a television news broadcast claimed that a missile lit up the evening sky over the Pacific Ocean. The purported missile was later realized to be an arriving UPS cargo flight. (Figure 11)

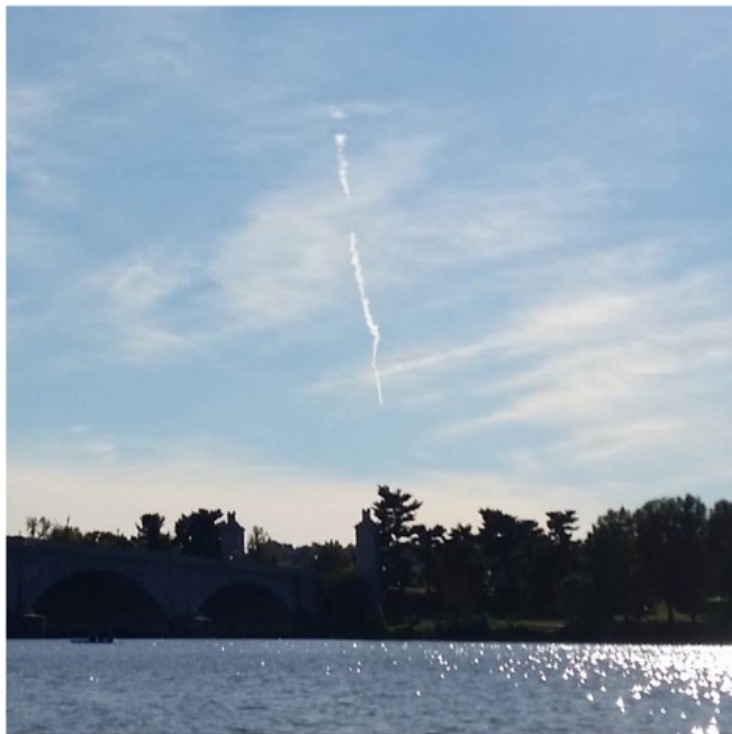
Figure 12. Airplane contrail photo taken while kayaking on the Potomac River. (Author)

Such illusions are common when recognized for what they are, such as the following airplane contrail which appears to be a missile rising from the Pentagon. (Figure 12)
