“Full” Reserve Study

The Landings Slidell, LA

Report #: 28121-0
For Period Beginning: January 1, 2015
Expires: December 31, 2015
Date Prepared: January 14, 2015

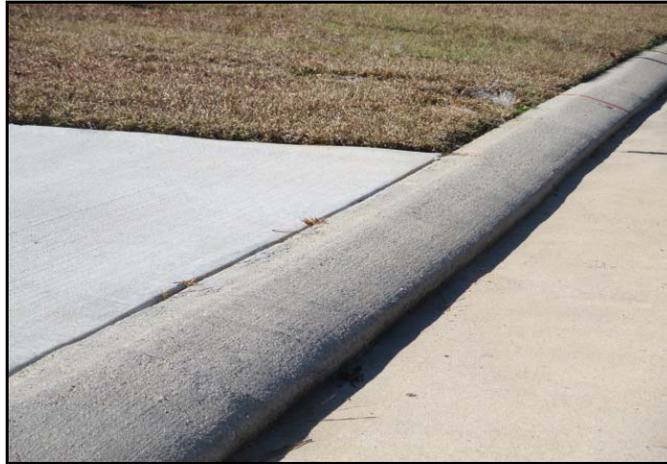
Comp #: 2109 Concrete Curbs & Gutters - Repair

Evaluation: Some damage noted during inspection, likely resulting from ongoing development within the community. Curbs and gutters are typically not life-limited components and can often be repaired as needed for relatively low cost using Operating funds. If potholes, large cracks, or other drainage impediments develop, these should be addressed to ensure proper water flow. No need for Reserve funding at this time.

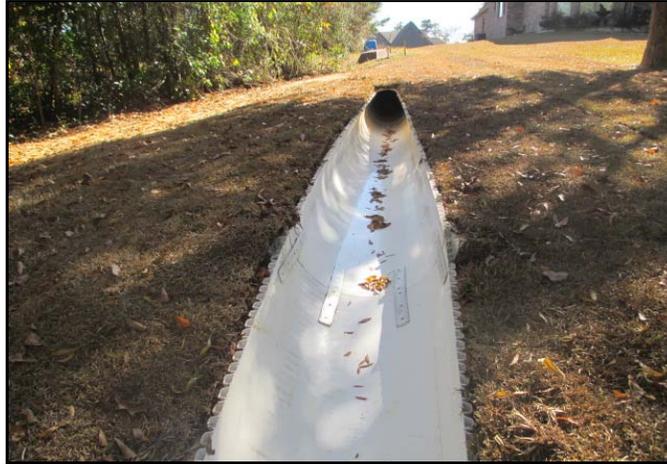
Comp #: 2113 Site Drainage System - Clean/Repair

Evaluation: According to information provided by the manager and visual observations, all surface drainage within the community drains by gravity to the North end of the development where it meets the local swamp. Drains are spaced approximately 4 houses apart. In at least one location, the drainpipe did not extend far enough to allow for water flow to reach the swamp, resulting in local erosion around the pipe. Manager reported that the pipe was extended (see photo) farther to prevent recurring issues. At this time, existing conditions at other locations may require a similar modification. This component represents an allowance for ongoing drainage repairs/refurbishment, which may include repairs to underground piping in other sections of the community.

Lower allowance to clean/repair

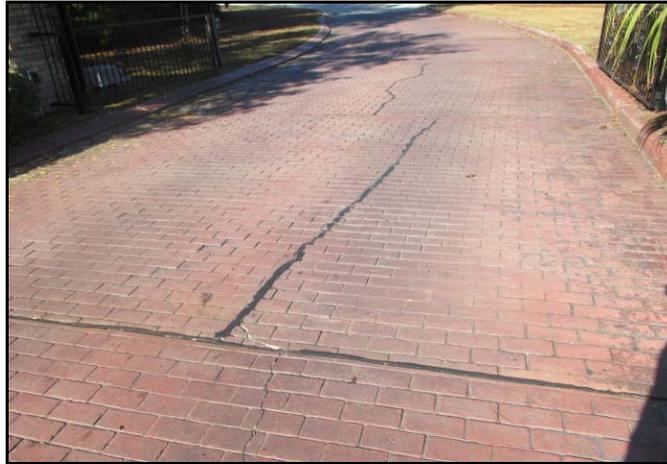
Comp #: 2119 Brick Roadways - Replace

Evaluation: Some cracking and deterioration observed. High-traffic area which may have a shorter useful life than other road sections. Also a higher aesthetic priority for curb appeal. As routine maintenance, pavers should be inspected to identify any physical issues such as lifting, cracking, and excessive surface wear. Plan to resurface/replace at the approximate interval shown here.

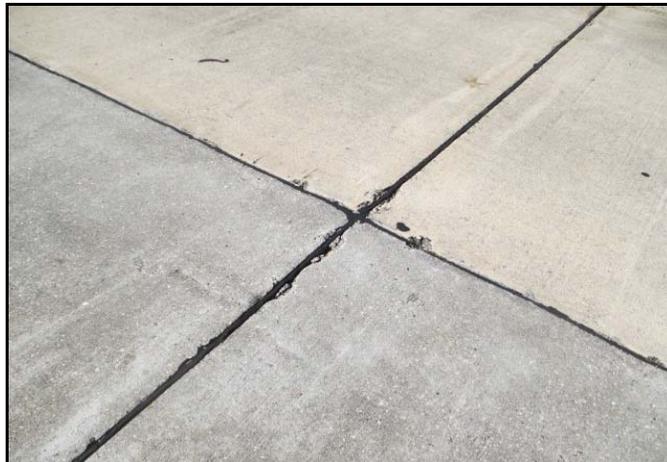
Comp #: 2123 Concrete Roads - Repair

Evaluation: Control joints run down the center of each road, and horizontally spaced at 15 foot intervals. Repairs are expected to be required on an ongoing basis. Some work was completed in 2014 according to manager. Plan for similar projects going forward.

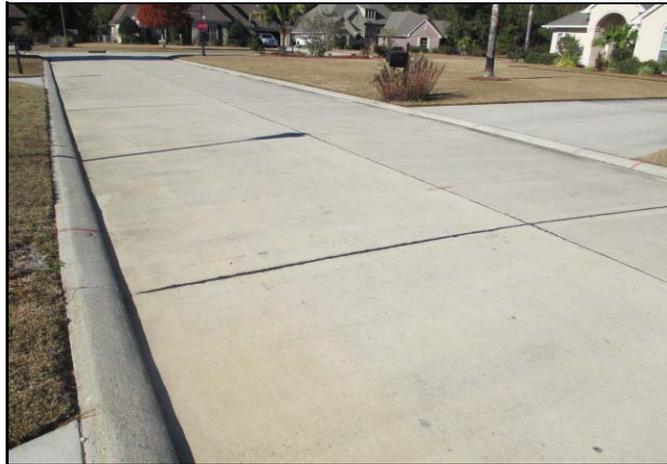
Comp #: 2125 Concrete Roads - Repair/Replace

Evaluation: Control joints run down the center of each road, and horizontally spaced at 15 foot intervals. Some cracking noted during inspection, but not severe or extreme. Conditions vary somewhat throughout development, and ongoing construction in some areas may lead to increased deterioration. Individual sections can be replaced without needing to replace the entire roadway. As routine maintenance, keep roadway clean, free of debris and well drained; fill/seal cracks to prevent water from penetrating into the sub-base and accelerating damage. Take note of any areas of ponding water or other drainage concerns, and incorporate repairs into scope of work for resurfacing. Our inspection is visual only and does not incorporate any core sampling or other testing, which may be advisable when roadways are nearing end of useful life. Some communities choose to work with independent paving consultants or engineering firms in order to identify any hidden concerns and develop scope of work prior to bidding. If more comprehensive analysis becomes available, incorporate findings into future Reserve Study updates as appropriate. Costs shown here are based on replacement of roughly 20% of the total area every 15 years.

Lower estimate to repair/replace (20%)

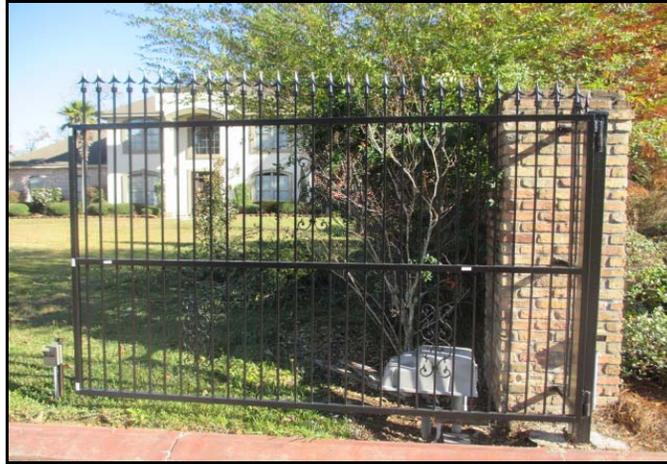
Comp #: 2145 Entry/Exit Gates - Replace

Evaluation: Painted steel gates. Each pair is approximately 24 LF across at main entry and 26 LF at secondary entry. Manager reported that the Association is considering removing the gates to save on operating costs. If gates are removed at a later date, the Reserve Study should be updated accordingly to remove all related components, including operators, entry access systems, etc. We strongly recommend regular inspections, maintenance and repairs to help extend useful life cycles. Clean for appearance and paint/touch-up as needed within general maintenance/Operating funds. Although metal gates are typically durable, we recommend setting aside funding for regular intervals of replacement due to constant wear/usage, exposure and vehicle damage. Replacement can also be warranted for aesthetic changes over time. Plan to replace at roughly the time frame shown below.

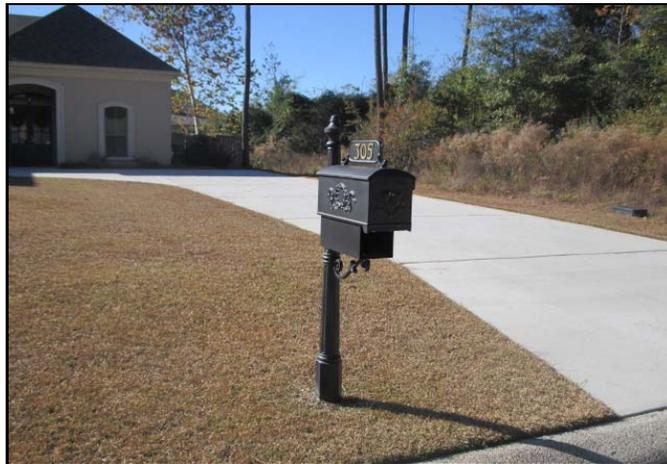
Comp #: 2166 Mailboxes - Replace

Evaluation: Individual home owners are reported to be responsible for replacement of mailboxes. No recommendation for Reserve funding at this time.

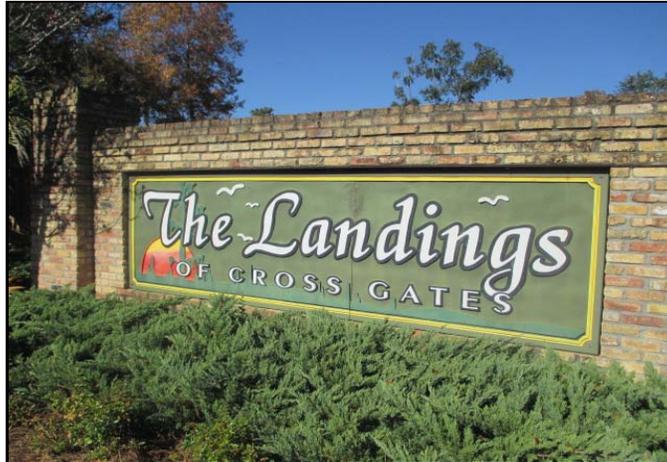
Comp #: 2169 Sign/Monuments - Refurbish/Replace

Evaluation: Sign at entry looks more faded and worn. At brick wall, with surrounding planters and lighting. Second entrance has a similar, but smaller sign. As routine maintenance, inspect regularly, clean/touch-up and repair as an Operating expense. Plan to refurbish or replace at the interval below. Timing and scope of refurbishing or replacement projects is very subjective but should always be scheduled in order to maintain good curb appeal. In our experience, most Associations choose to replace signage in order to maintain good appearance and aesthetics in keeping with local area, often before signage is in poor physical condition. If present, concrete walls are expected to be painted and repaired as part of refurbishing, but not fully replaced. Costs can vary significantly depending on style/type desired, and may include landscaping, lighting, etc. Reserve Study updates should incorporate any estimates or information collected regarding potential replacements.

Lower estimate to refurbish/replace

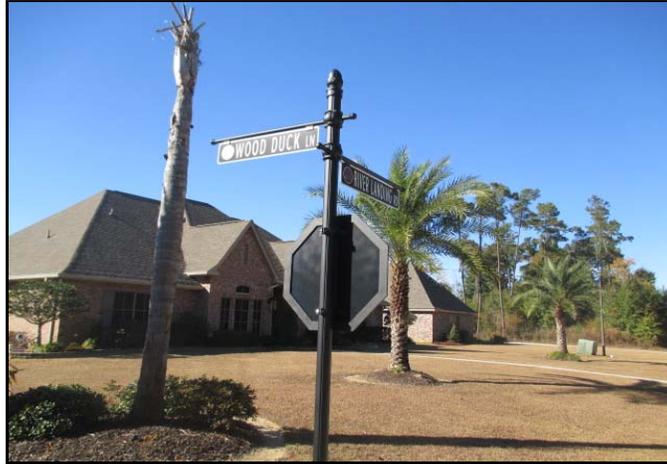
Comp #: 2170 Road Signs, Reader Boards - Replace

Evaluation: (12) MPH/stop signs and reader boards, and (9) street name signs. Some posts have combinations of signs. All were replaced in 2012 and 2013. New signs are decorative aluminum, which replaced older wood signs. Decorative street signs and posts are generally replaced at longer intervals due to weathering and deterioration or to coincide with other exterior projects such as entry signage, street lighting, etc. Signs should be inspected regularly to make sure visibility is adequate, including at night. Repair any damaged or leaning posts as needed. Costs for replacement can vary greatly depending on style selected; costs shown here are based on replacement with a comparable type as are currently in place.

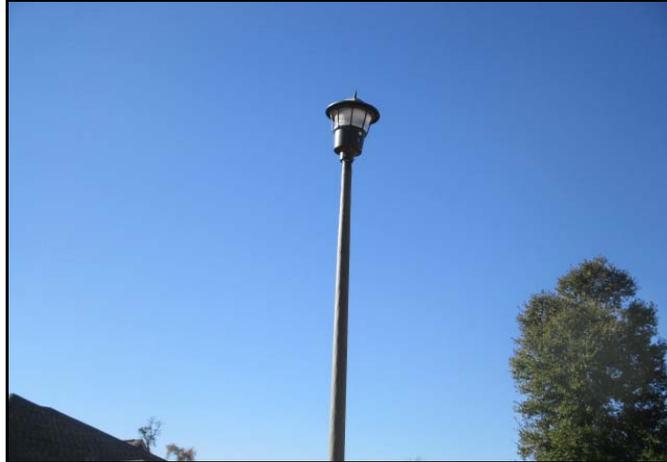
Comp #: 2173 **Street Lights - Replace**

Evaluation: Street lights are not owned by the Association. No obligation to pay for replacement, so no Reserve funding is required.

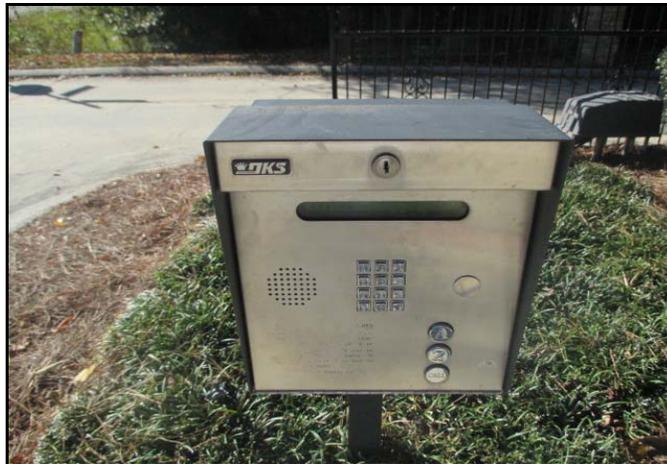
Comp #: 2501 **Intercom/Entry Systems - Replace**

Evaluation: DKS model with small digital display. Appeared to be original. Access/intercom system was not inspected internally during site inspection. Should be checked and repaired as needed by servicing vendor as routine maintenance. Individual components can often be replaced for relatively low cost as an Operating expense. Plan for complete replacement at the approximate interval shown here for functional and aesthetic considerations.

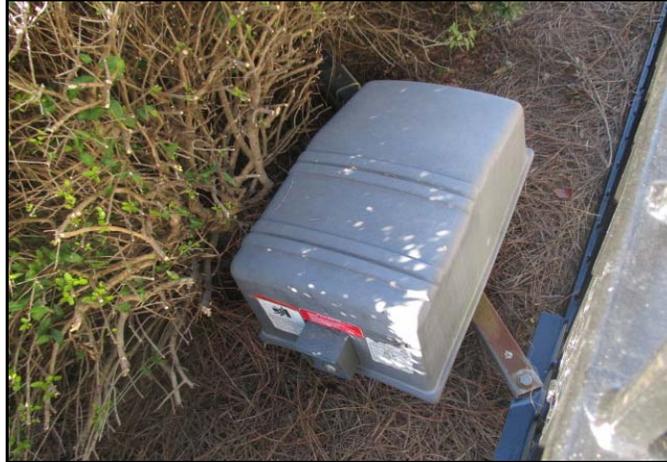
Comp #: 2509 Gate Operators - Replace

Evaluation: DKS model 6100-080 swing open operators. All appeared to be original. We recommend regular inspections (including service and repair as needed) be paid through the Operating budget. Even with ongoing maintenance, plan for replacement at typical life expectancy indicated below. Useful life can vary greatly depending on level of use, exposure to the elements, etc. Monitor actual expenses closely for future Reserve Study updates. Funding to replace with similar units.

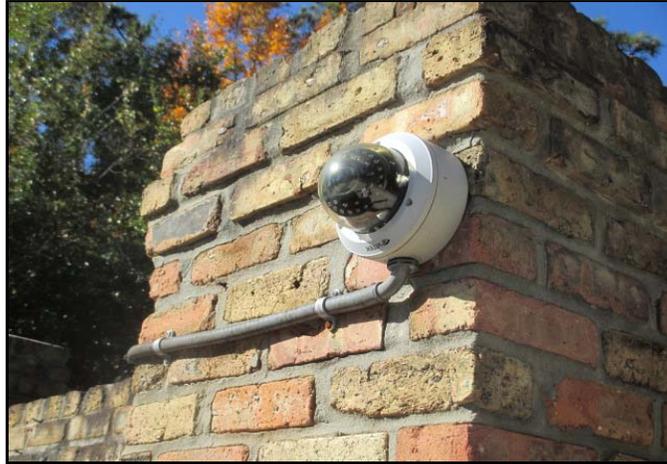
Evaluation: Camera systems were added within the last 1-2 years according to manager. Image quality is reported to be poor. Security/surveillance systems should be monitored closely to ensure proper function. Whenever possible, camera locations should be protected and isolated to prevent tampering and/or theft. Plan to replace/upgrade the system at the approximate interval shown below. Typical modernization projects may include addition and/or replacement of camera fixtures, recording equipment, monitors, software, etc. In many cases, replacement or modernization is warranted due to advancement in technology, not functional failure of the existing system. Keep track of any partial replacements and include cost history during future Reserve Study updates.
