An outbreak of Diffuse Lamellar Keratitis
(DLK) related to waste gas and an
improperly mounted air conditioner.

Mark Edmund Johnston MD FRCSC

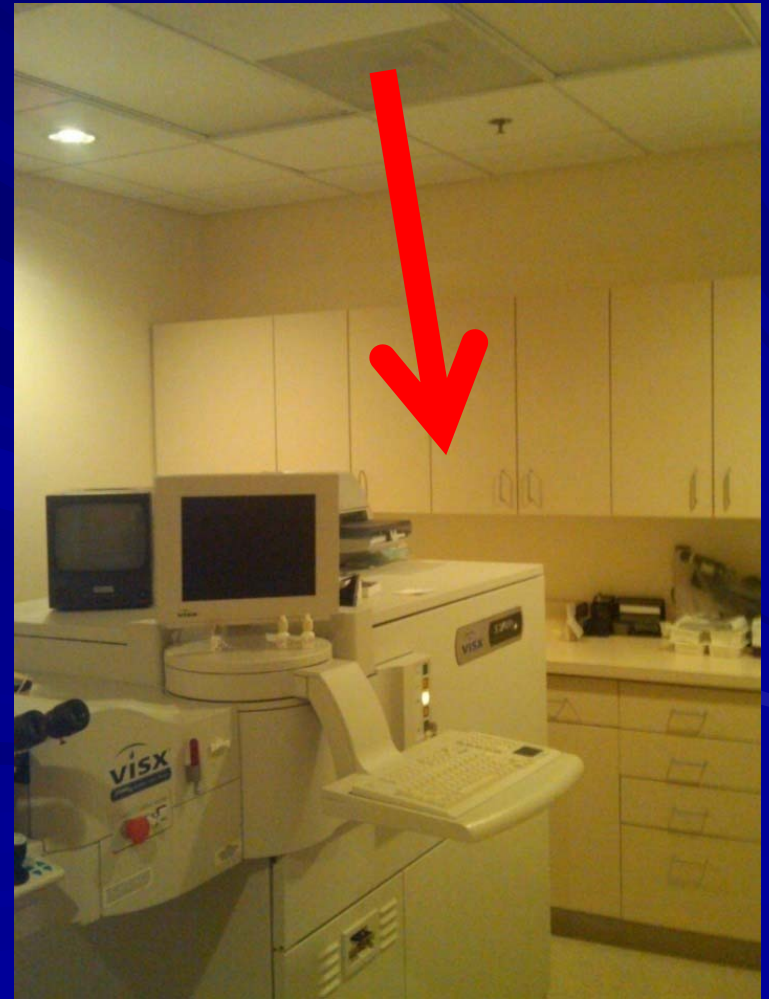
Air duct in laser room

- The laser technician had noted a “rotten egg” odor from the air ducts.

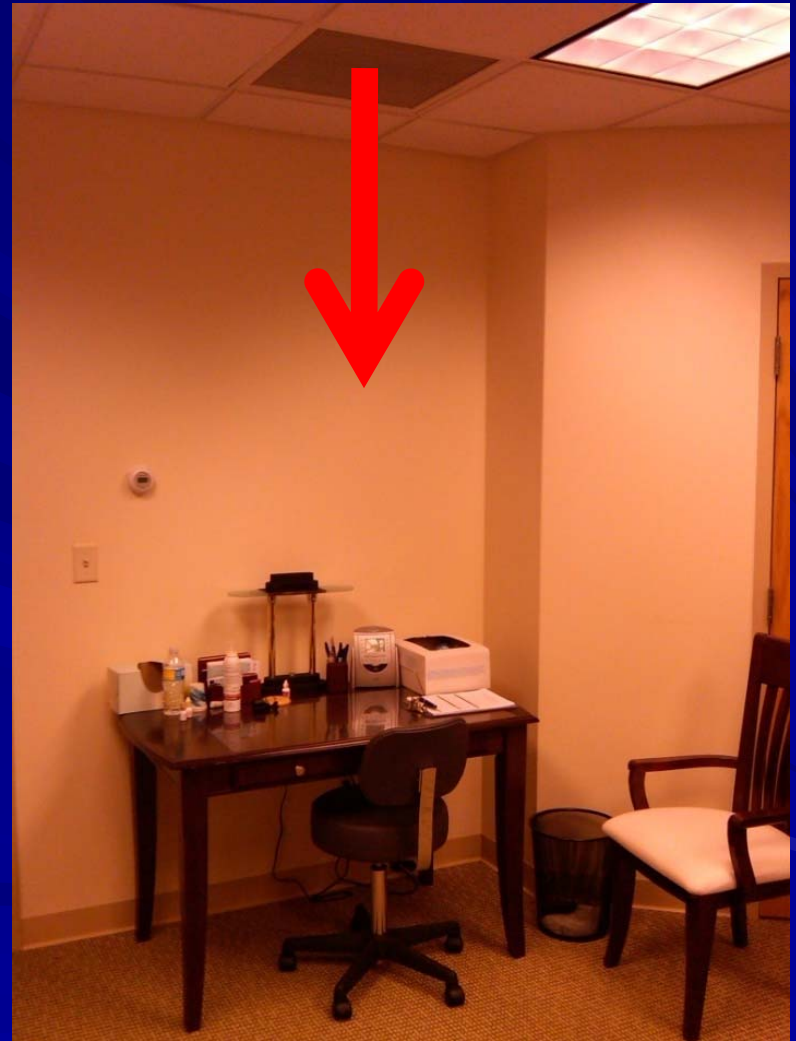
Air duct in Pre-op

- The pre-op nurse had an abnormal cough, noted by the surgeon, during the time interval in question

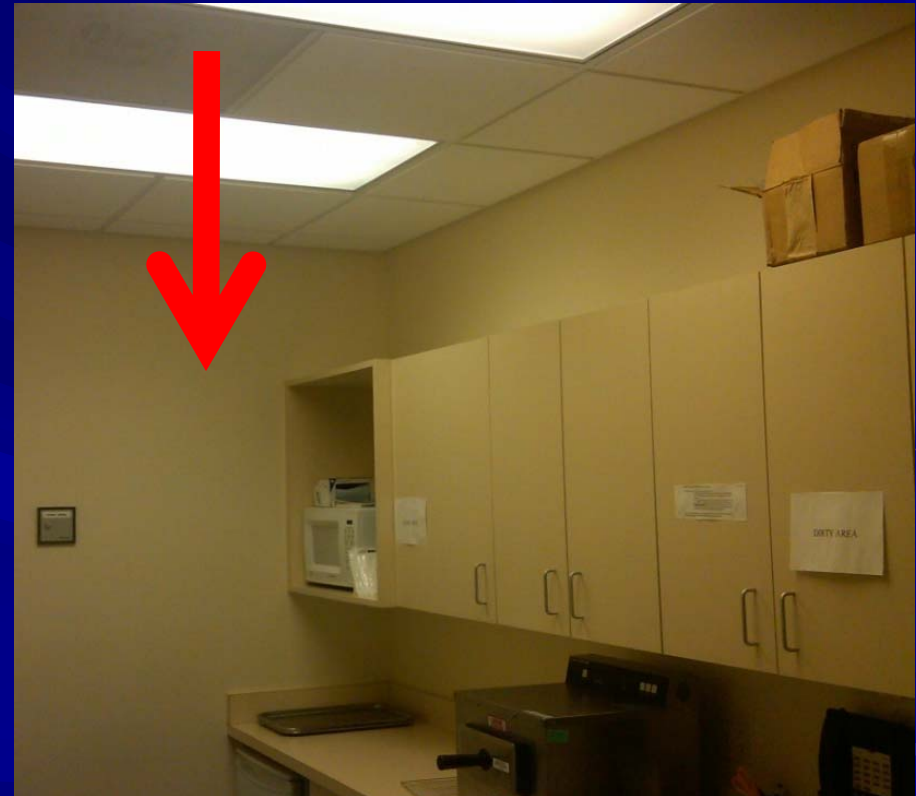
Instrument Prep Area

- One week later a single blast of a “sulfuric” odor was noted from the suspected air conditioner duct as the unit turned on.

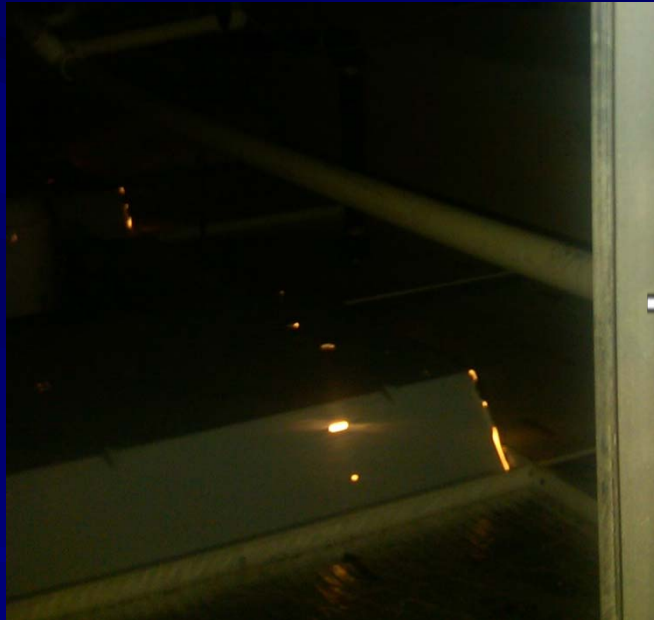
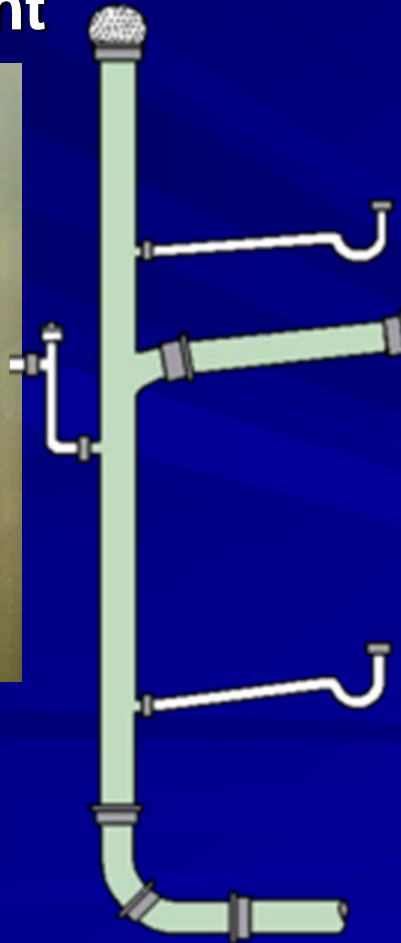
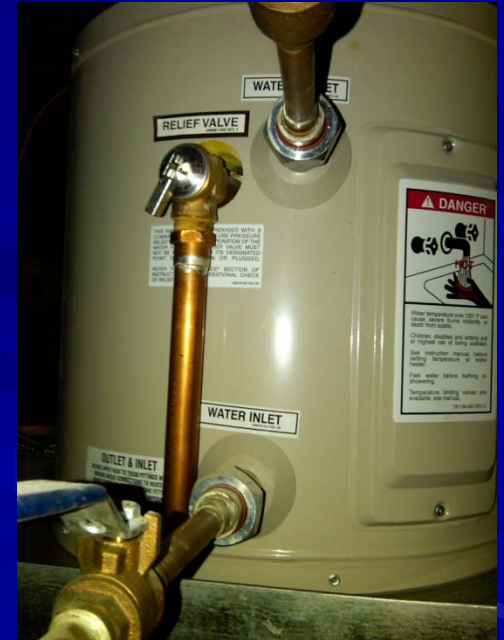
Water heater

A remote air conditioner did not meet code:

- It was more than 20 feet from the drainage waste system
- did not have a proper vent

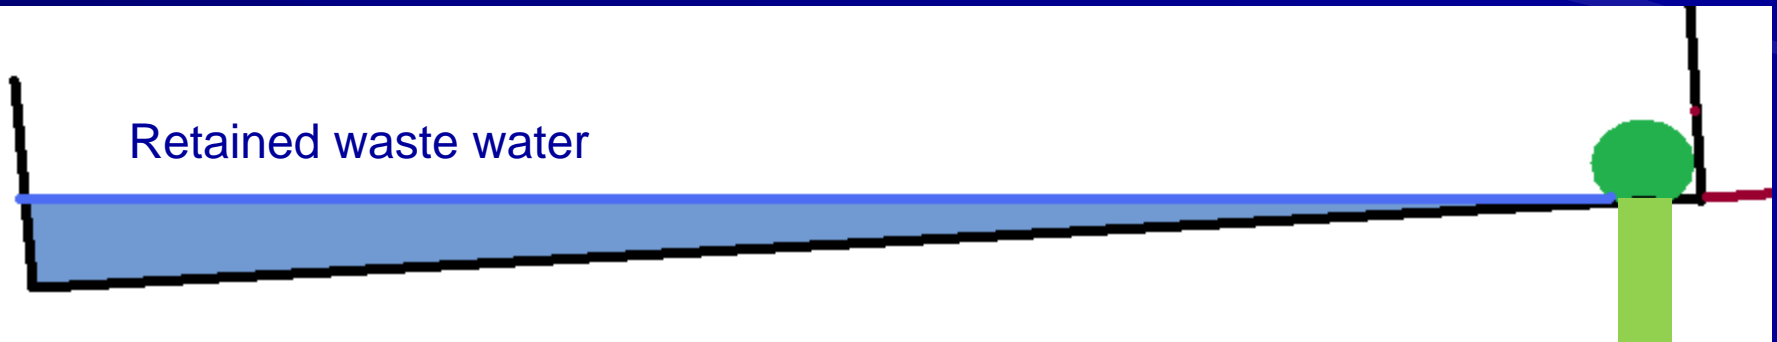
Internal inspection after the OR unit was removed showed rusting of the drainage pan consistent with an improper reverse slant, away from the water trap.

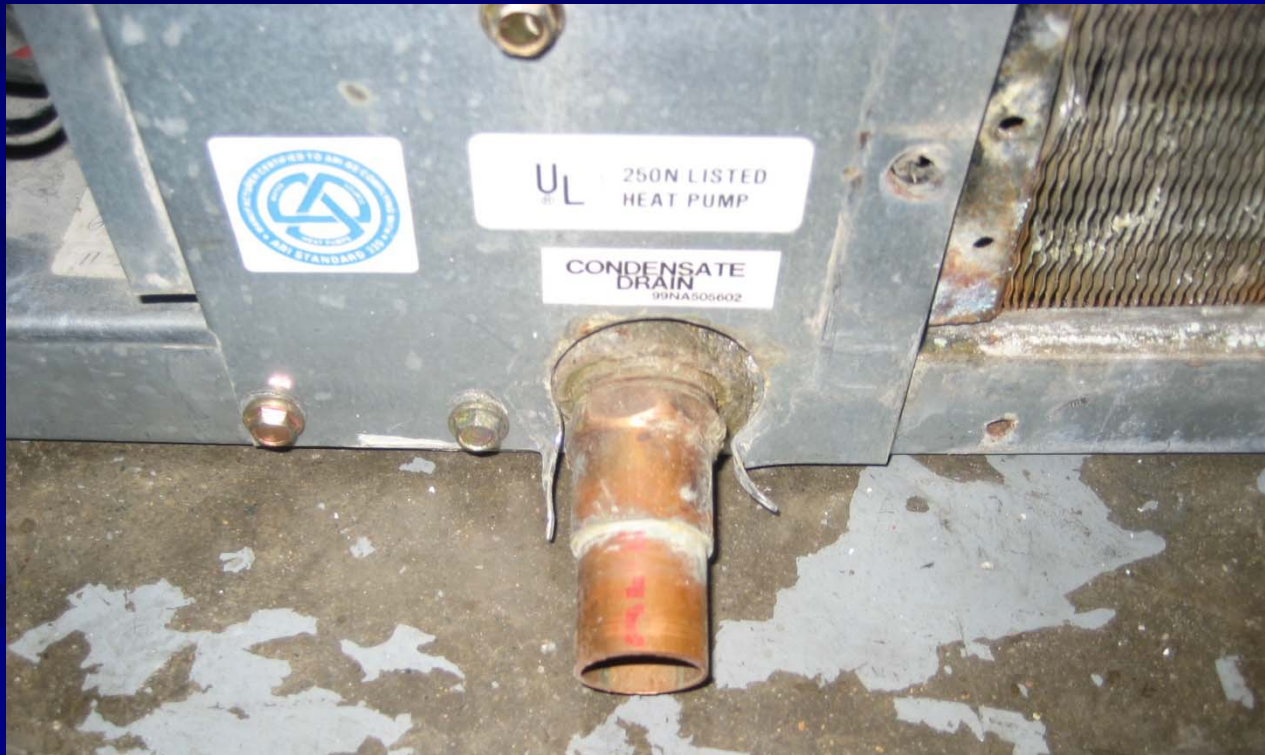
The abnormal unit drained in the middle, making it easy to tilt in the wrong direction during installation
