THE IMPACT OF OFFSHORE PIPELINE INSTALLATION AND PRE-COMMISSIONING ON FUTURE SYSTEM INTEGRITY

J. L. Grover

BJ Process and Pipeline Services, Dubai

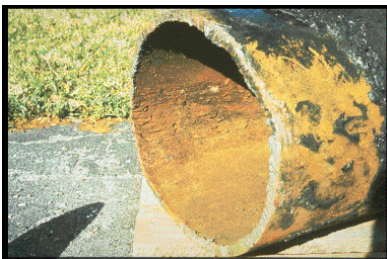
Each of the above, or a combination thereof, can cause internal corrosion (fig. 1) to occur on the pipe wall. This effect is greatly mitigated by internally coating the pipe joints prior to installation. The resulting corrosion adversely impacts the time required to dry the pipeline – in the line detailed in the first case study, drying time increased 100% due to trapped water from poor surface condition. Once the line is in service, this fine corrosion sloughs off causing operational difficulties as detailed in the second case study.

Figure 1 – Internal corrosion

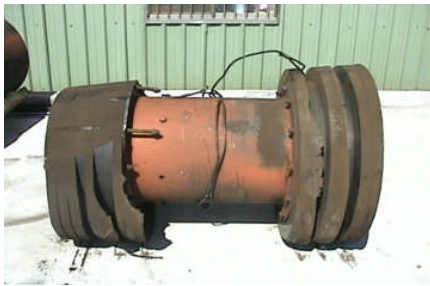
Prior to the MFL survey being performed, a number of standard cleaning pigs were run through the line by the MFL vendor to remove debris from the pipeline. Due to the internal corrosion caused by the wet buckle, and the large amount of dust formed on the pipe wall, these pigs suffered severe wear (fig. 3) and recovered very little debris from the line. It can be seen that the front of the pig is more heavily worn than the rear caused by the pig “nose diving”

Figure 3 – Worn cleaning pig

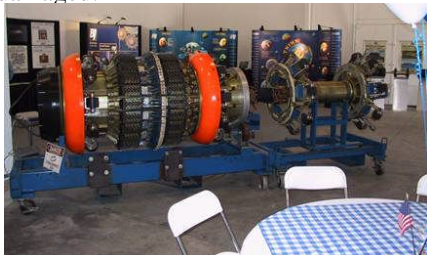
Subsequently an MFL tool was run in the line (fig. 4). Such tools are fitted with high powered magnets and strong brushes to magnetise the pipe wall – as such these tools make highly effective pipeline cleaners. During this first run nearly 20,000kg of fine powder was recovered from the pig receiver, and all external components of the MFL tool were badly worn or damaged.

Figure 4 – MFL tool

After repeated cleaning runs over 80 tonnes of ferrous debris was removed from the pipeline before a successful MFL run could be performed. This was in addition to the estimated 40 tonnes removed during pre-commissioning, and 20 to 30 tonnes removed from filters downstream of the pig receiver. The results of the MFL run endorsed the calculated corrosion rates shown previously – the deepest internal defects were greater than 35% WT with a large population of > 20% WT shown in the area immediately downstream of the wet buckle area. In total over 100,000 metal loss defects were identified.

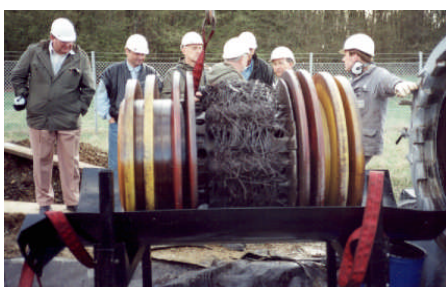
Figure 5 – Welding rods on cleaning pig

- Welding rods (fig. 5), welding bladders, hand tools, and shims used to secure bevel protectors to the pipe joint etc.
- Sand and soil introduced into the pipeline either via the onshore / landfall pipelay, or in the water used to flood and test the pipeline
- Naturally occurring seawater borne debris below the project filtration levels such as shell particles

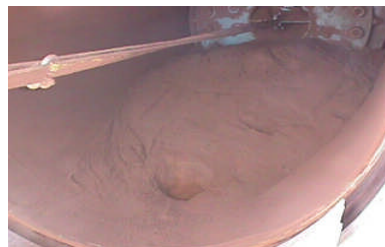
Figure 6 – Fine debris removed by cleaning pig

Fine debris, such as particles below 50 μ in size tend to settle at the bottom of the pipeline (fig. 6) during hydrotesting, and are very difficult to remove during subsequent dewatering. Once settled this debris can form a crust trapping water, which can adversely affect the drying of the line.

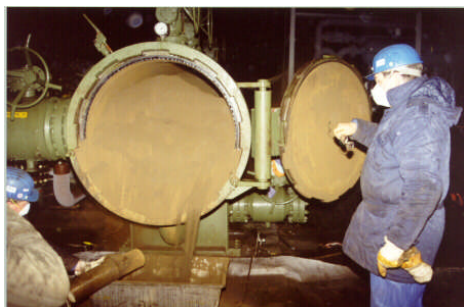
Once the line goes into production (for dry gas lines) this debris slowly dries out and sloughs off into the gas stream as powder (fig. 7) causing downstream problems with valves and filters (fig. 8).

Figure 7 – Dust removed by pigging

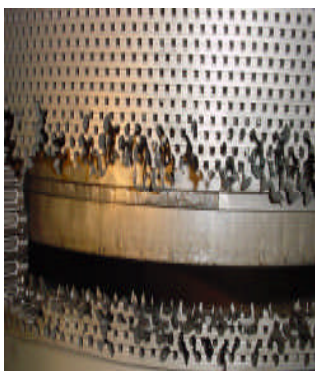
Figure 8 – Control valve cage damage
