# Structural Failure of the BioBridge Rib Prosthesis After Chest Wall Reconstruction

(Ann Thorac Surg 2022;114:e233-e235)

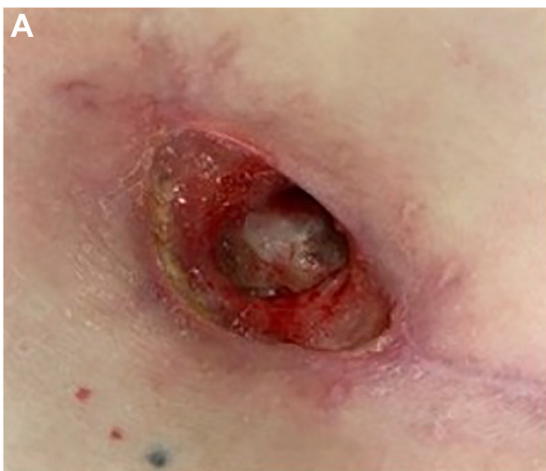
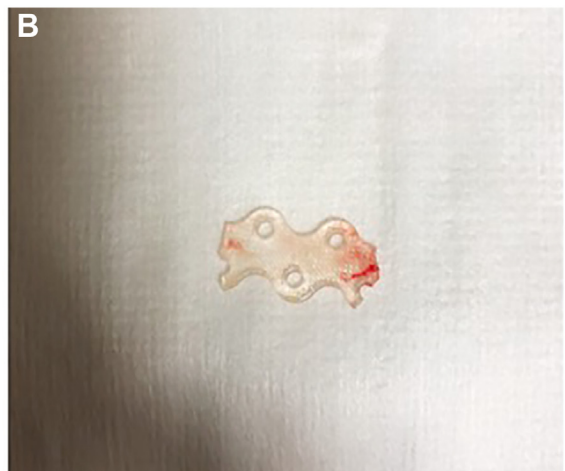
Flap and donor sites healed well after initial surgery; however, 6 months later, the patient presented with a 2.5 cm wound dehiscence at the inferomedial aspect of the flap (Figure 2). On inspection of the wound, a fractured 2 cm fragment of BioBridge plate was extracted. Chest wall magnetic resonance imaging was obtained and was suspicious for infection of the left anterior fourth costal cartilage stump.

**FIGURE 2** (A) Wound dehiscence with BioBridge fragment erosion. (B) Extruded fragment of BioBridge plate.

During surgical exploration, a 3 cm × 2 cm chest wall wound with exposed bioprosthetic material and cartilage was found. The fourth rib stump was concerning for devitalized cartilage and was resected back to the costosternal junction. BioBridge prostheses were fractured into seven separate fragments, that were completely explanted (Figure 3). Strattice matrix from the prior operation appeared to be well incorporated. Operating room cultures revealed rare growth of *Diphtheroid bacilli* with negative fungal cultures. Pathology revealed bone, cartilage, and detached fragments of fibrous tissue with

necrosis, granulation tissue, and acute and chronic inflammation, with no evidence of tumor. Wound closure was achieved with re-elevation and advancement of the myocutaneous latissimus dorsi flap without additional skeletal reconstruction.

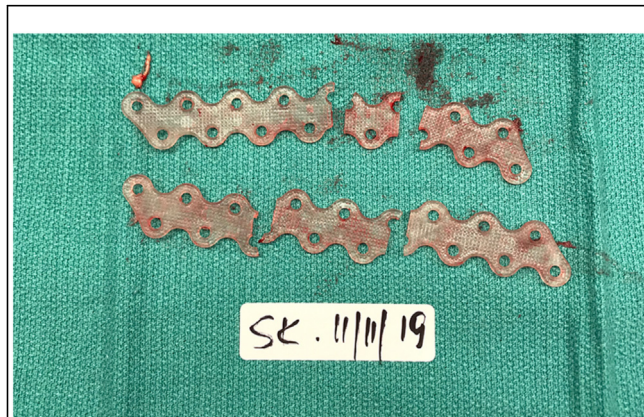
**FIGURE 3** Explanted heavily fragmented BioBridge plates. Note lack of any resorption at 6 months, indicated by preserved surface texturing.

Although unable to identify specific risk factors leading to this complication, we believe that structural failure should be considered as a possible cause in the case of delayed wound complications after chest wall reconstruction with BioBridge. Thorough wound exploration should be undertaken, and if fragmented prosthetic material is identified, explantation is required for successful wound management. This case describes a novel complication of chest wall reconstruction with BioBridge not previously reported in the literature, adding to the body of surgical knowledge in managing such a complex patient population.
