# *Big Bear Home Inspectors*

## Property Inspection Report

1215 Sample street, " Erwin Lake ", Big Bear City , CA 92314  
Inspection prepared for: Res Sample  
Real Estate Agent: Default AAA -

Date of Inspection: 7/24/2018 Time: 3:00pm  
Age of Home: Built in 1996/ 22 years old Size: 1,352 SqFt.  
Weather: Cliudy and Humid  
Inspection repoert was Paid for at the time of the Inspection7/24/2018  
Ck#181

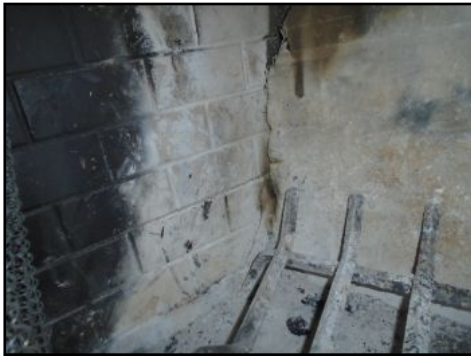
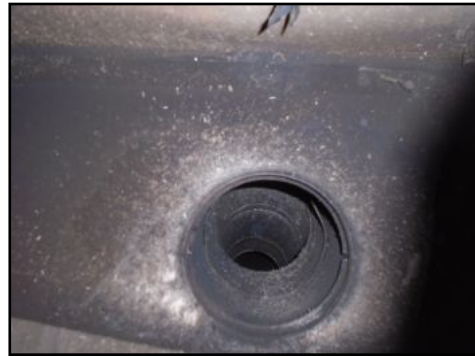
Fire Box has some big cracks in it. Recommend further evaluation by a Chimney Contractor to see if this is Okay to have the insert just put in or anything needs to be done first.

Flue appears to just be open with no Damper

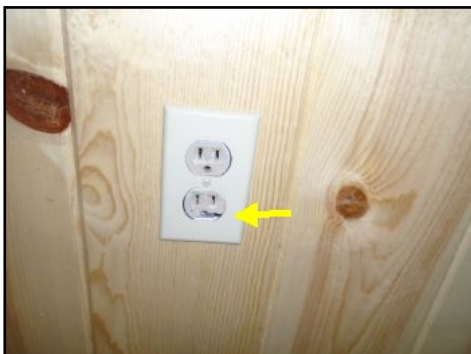
Master Bedroom Outlet Broken Recommend replacement.

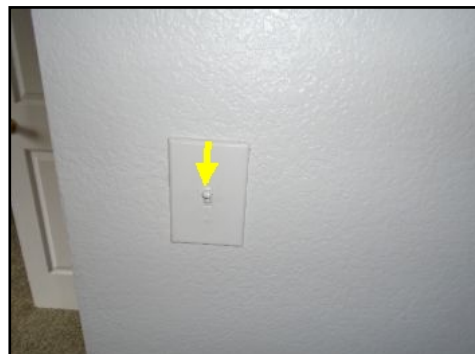
Master Bedroom Switch and Plate Covered in Paint

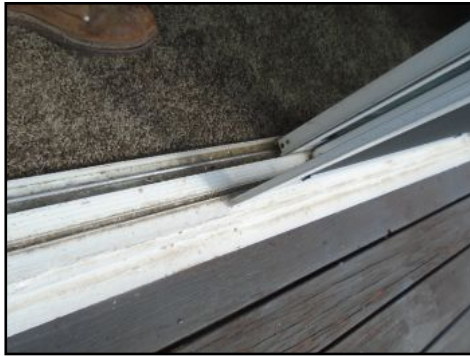
Master Bedroom Patio Door appears to be dragging when opening. Recommend blowing out debris with Canned Air and cleaning whats left and this should be resolved

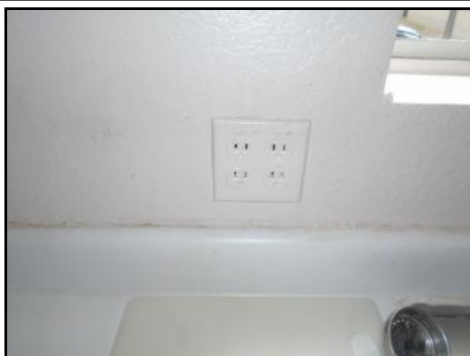
Page 18 Item: 13	Electrical	<ul style="list-style-type: none"> <li>• <b>Outlet(s) in the Kitchen are all painted over. May be not usable after that much paint was applied to them. Recommend further evaluation by a Handyman or a Licensed Electrician</b></li> </ul>
------------------	------------	---

Almost all Outlets in the home one way or another has been painted over.

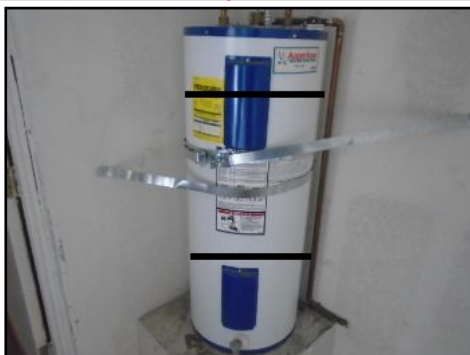
Page 26 Item: 11 Strapping

- The water heater is missing one strap. Two are required.
- Not to code, requires two 1 1/2" steel straps 16 gauge, 1/3 from the top and the bottom.

This Is One Strap and Done Incorrectly. Must 2 straps 1 at bottom 1/3 and one at top 1/3

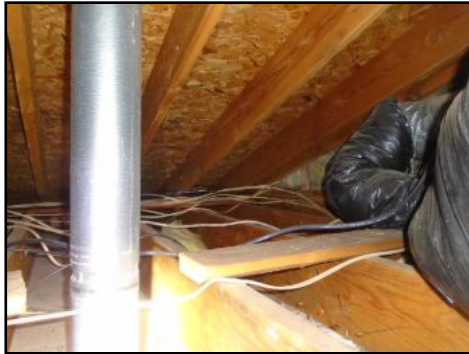
Page 27 Item: 6 Electrical

- All wired should be attached to framing

(Garage Attic) Wiring should be secured to the framing

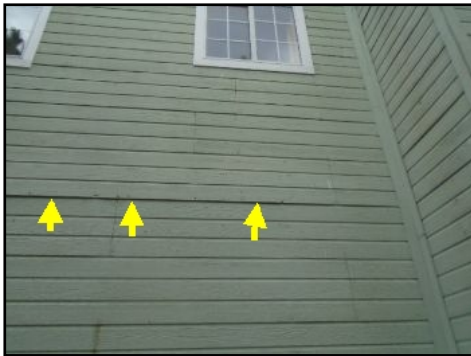
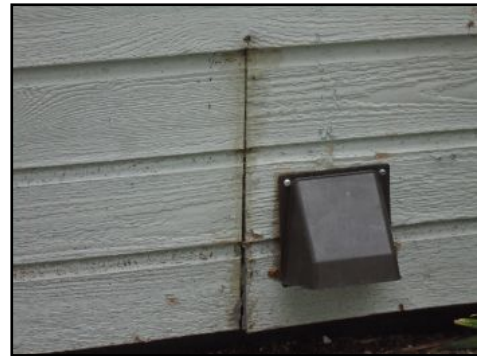
Seal all gaps and Cracks

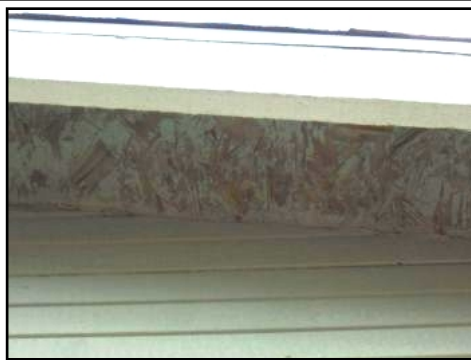
Unfinished Material up in the Eaves. Recommend Further Evaluation by a Handyman.

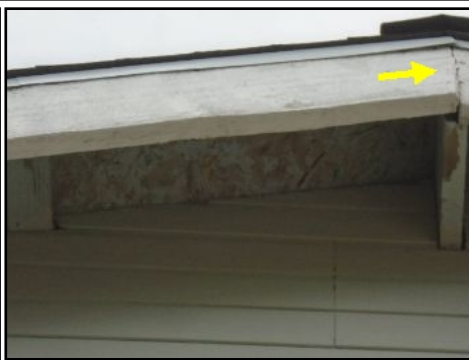
Facia Board is Twisting. Secure or replace with a new pre sealed and painted board to assure sealing.

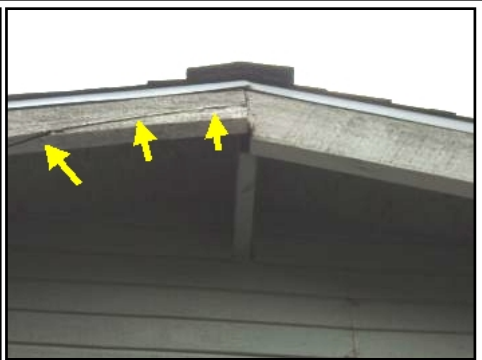
Facia Bard is Cracked and Twisted. Recommend Further Evaluation by a Handyman

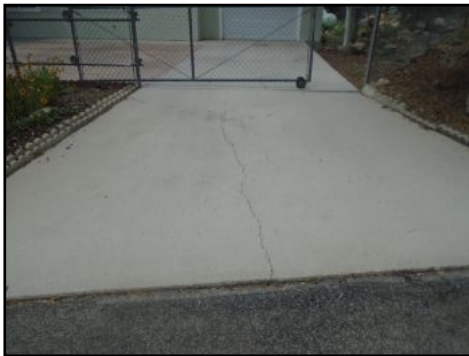
Page 35 Item: 2

• Minor settlement, or "hairline" cracks in driveways, are normal for properties of any age. They should, however, be monitored for expansion and sealed as necessary.

Small Crack

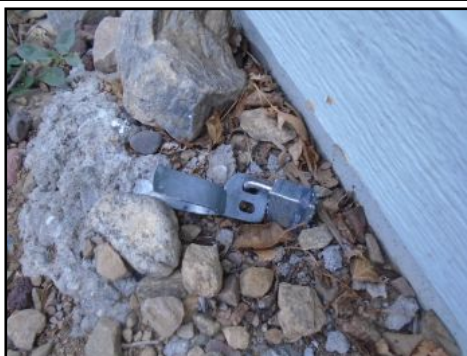
Page 36 Item: 5

• Damaged gate observed. Right of the Garage by the Electrical Panel

Gate Latch is off the Gate. (Side of the Garage By Electrical Main Panel)

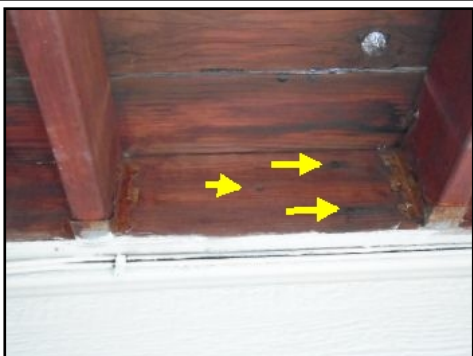
Page 36 Item: 6

No Lag Bolts or Screws. For Safety reasons you might think about added at least Lag Screws to help support.

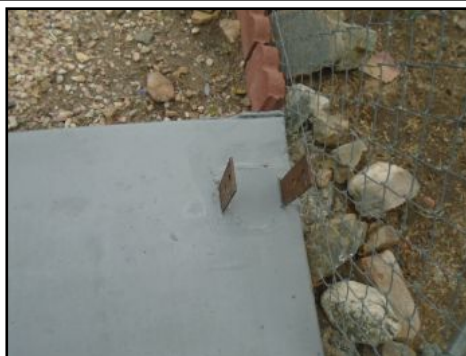
Support Bracket Could be a tripping Hazard. Recommend a Decorative Cover for Safety and Covers Eye Sore

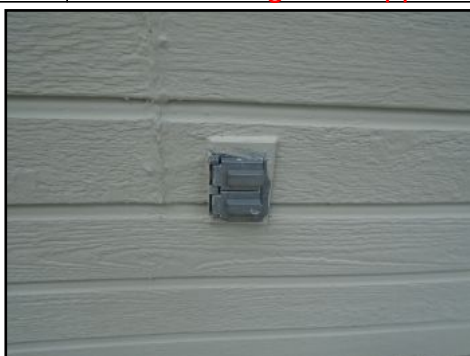
Page 37 Item: 8 | Grounds Electrical | • Outlet damaged or apparently inoperable.

Outlet is dead (No Power). Recommend Further Evaluation by a Handyman or a Licensed Electrician.

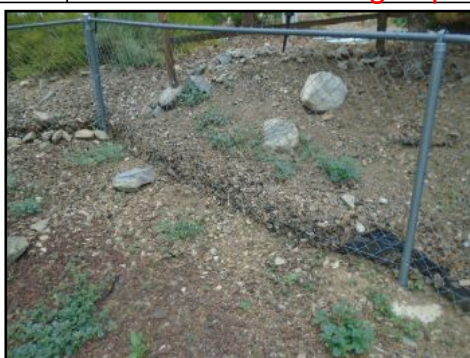
Page 39 Item: 15 | Fence Condition | • Fence being pushed out at base in areas. Hillside movement with rain fall is starting to push on the fence

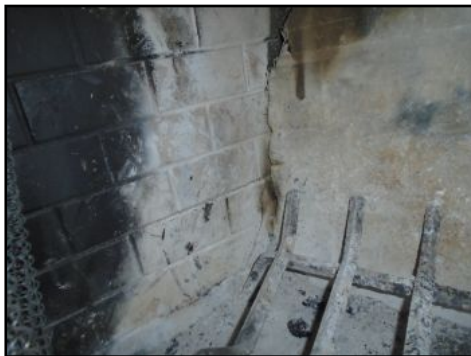
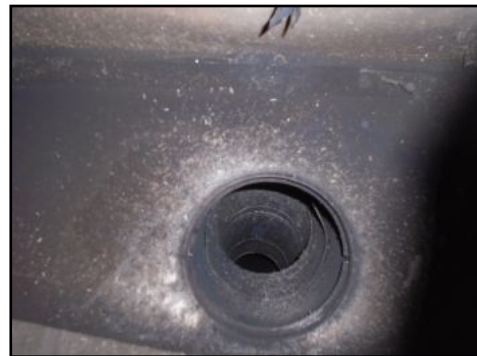
Materials: Living Room  
 Materials: Masonry fireplace noted.  
 Observations:  
 • **\*\*Wood Fireplaces\*\***  
 • **It was observed that some of the mortar around the firebox was failing; have a qualified individual evaluate and repair to avoid possible safety issue.**

Fire Box has some big cracks in it. Recommend further evaluation by a Chimney Contractor to see if this is Okay to have the insert just put in or anything needs to be done first.

Flue appears to just be open with no Damper

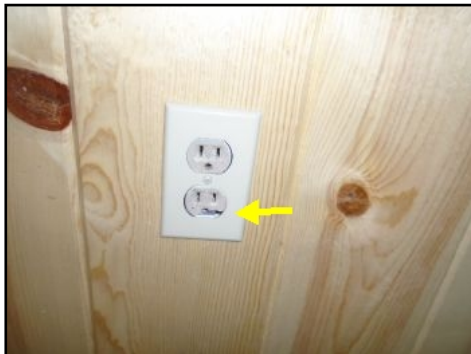
- Outlet is broken. Master Bedroom
- Switch & cover are covered think in Paint as is most of the wall Outlets and switches around the inside of the home.

Master Bedroom Outlet Broken Recommend replacement.

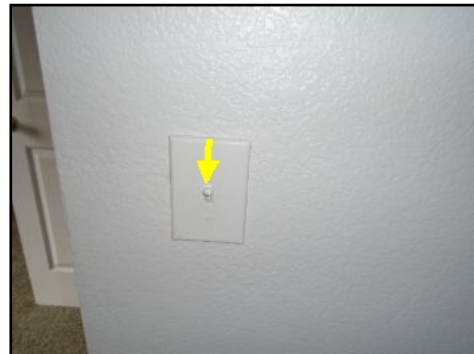
Master Bedroom Switch and Plate Covered in Paint

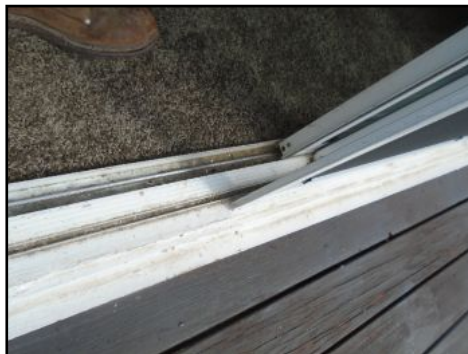
- **\*\*Sliding Patio Doors\*\***
- Door is difficult to operate, this presents a safety hazard in the event of an emergency/fire. Recommend repair/adjusting of door by a Qualified Contractor to allow easy and smooth operation. Current building standards require this second means of egress in a sleeping area for quick escape in the event of an emergency.

Master Bedroom Patio Door appears to be dragging when opening. Recommend blowing out debris with Canned Air and cleaning whats left and this should be resolved

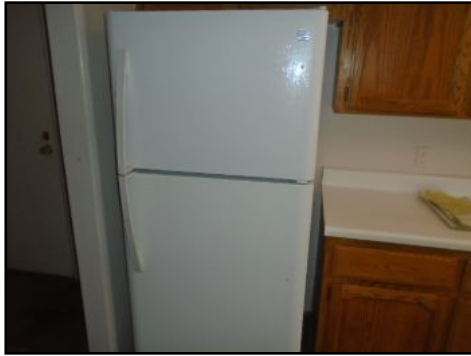
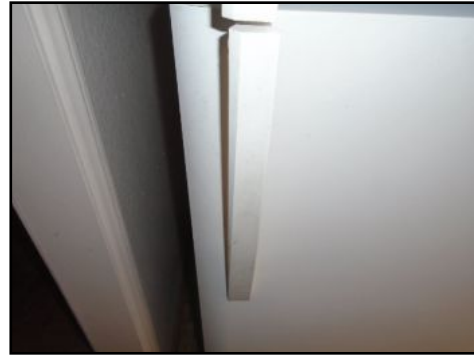
Handle Loose

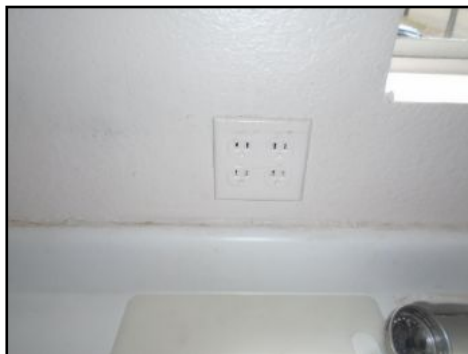
- Outlet(s) in the Kitchen are all painted over. May be not usable after that much paint was applied to them. Recommend further evaluation by a Handyman or a Licensed Electrician

Almost all Outlets in the home one way or another has been painted over.

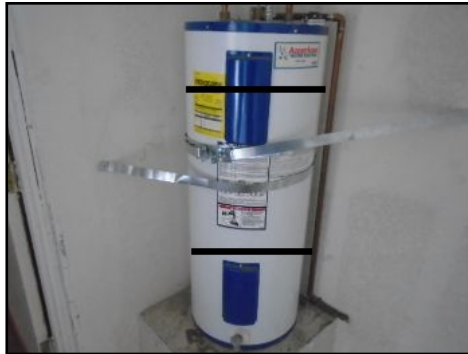
11. Strapping

- The water heater is missing one strap. Two are required.
- Not to code, requires two 1 1/2" steel straps 16 gauge, 1/3 from the top and the bottom.

This Is One Strap and Done Incorrectly. Must 2 straps 1 at bottom 1/3 and one at top 1/3

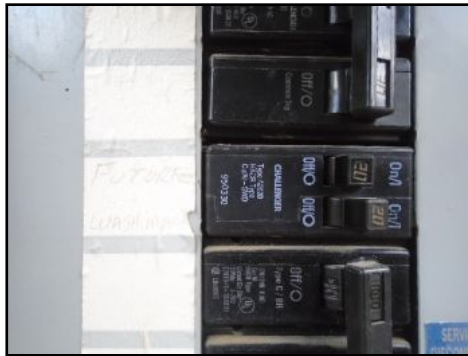
Materials: Copper non-metallic sheathed cable noted.  
 Observations:  
 • All of the circuit breakers appeared serviceable.  
 • 1 -20 Amp Breaker was Tripped when box was open due not know why but reset and all was good

1 - 20 Amp Breaker was Tripped when panel was opened.

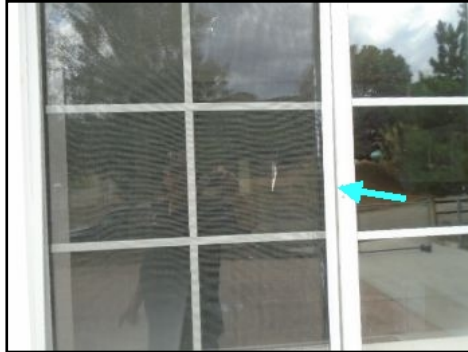
- Some window screens damaged.

Multiple Screens around the house are showing tampering (Slight Bends in the Frame) to try to get open. Only around the first floor seals the Idea of tampering. Recommend Repairing & Replacing as needed.

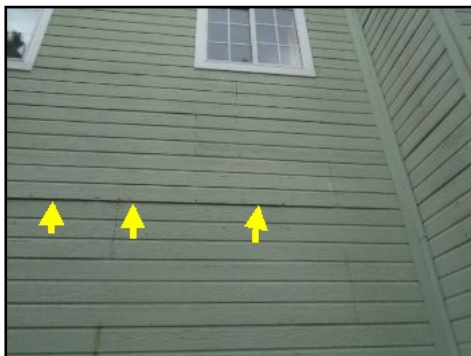
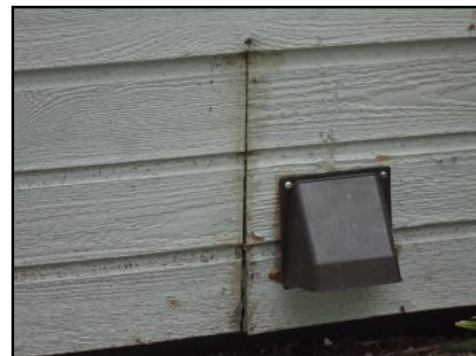
- Caulk and seal all gaps, cracks and openings.
- Some composition siding shows signs of water damage and swelling.
- Some siding deterioration noted. Have repaired as necessary.
- Warped siding present in some areas; recommend repair or replacement as necessary.

Seal all gaps and Cracks

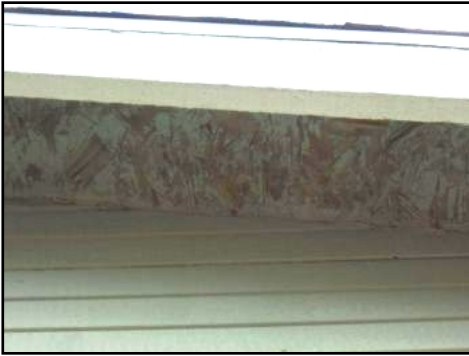
Unfinished Material up in the Eaves. Recommend Further Evaluation by a Handyman.

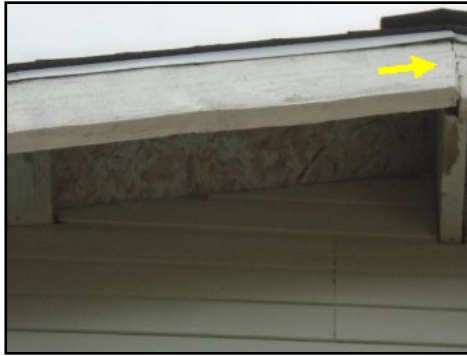
Facia Board is Twisting. Secure or replace with a new pre sealed and painted board to assure sealing.

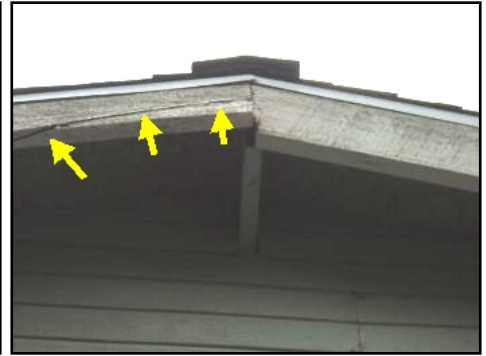
Facia Bard is Cracked and Twisted. Recommend Further Evaluation by a Handyman

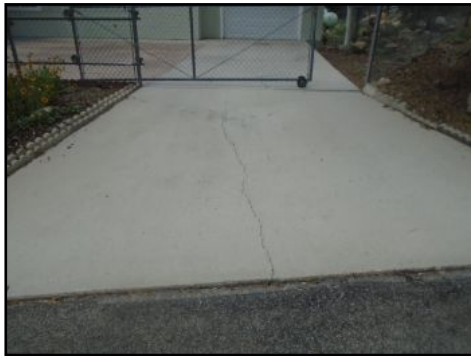
- No major system safety or function concerns noted at time of inspection.
- **Minor settlement, or "hairline" cracks in driveways, are normal for properties of any age. They should, however, be monitored for expansion and sealed as necessary.**

Small Crack

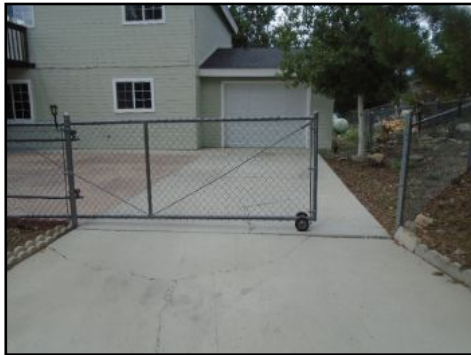
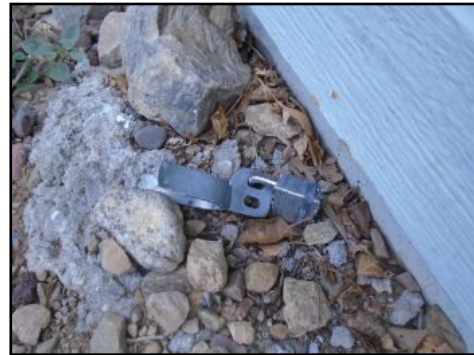
- Appears to be no Issues with the Gate at the Time Of The Inspection.
- **Damaged gate observed. Right of the Garage by the Electrical Panel**

Gate Latch is off the Gate. (Side of the Garage By Electrical Main Panel)

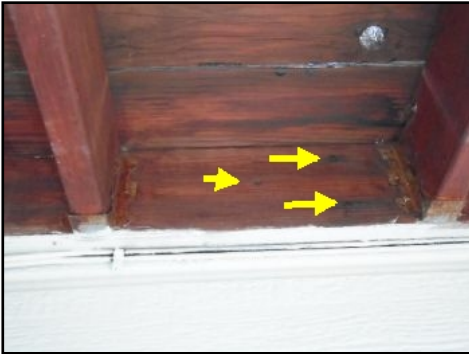
No Lag Bolts or Screws. For Safety reasons you might think about added at least Lag Screws to help support.

- No Lag Bolts Visible: The deck ledger board is nailed or screwed to the house, or is covered and not visible. Consider installing lag screws to securely attach ledger board to house, if they have not been used.
- **Support Bracket is still in Concrete Waiting to be used, But can be a Possible Tripping Hazard. Recommend covering with decorative item.**
- **Ledger Board appears to have some water damage and is starting to twist. Recommend further evaluation by a Handyman or a General Contractor**

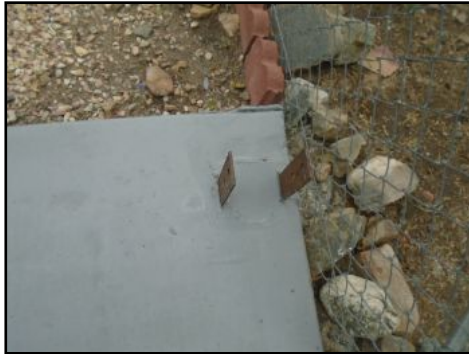
Support Bracket Could be a tripping Hazard. Recommend a Decorative Cover for Safety and Covers Eye Sore

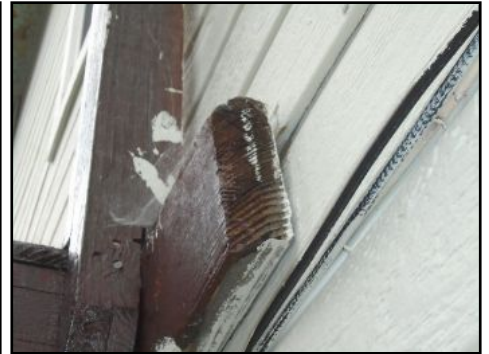
Ledger Board Twisting Pulling away from wall. Recommend further Evaluation by a Handyman or a General Contractor for Options

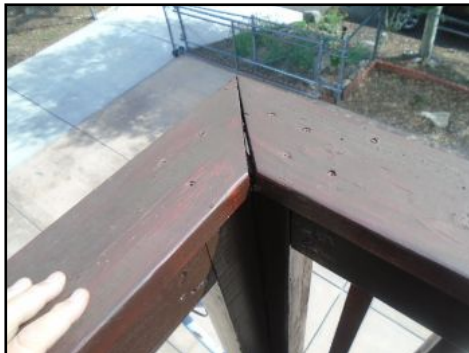
Monitor The Joint

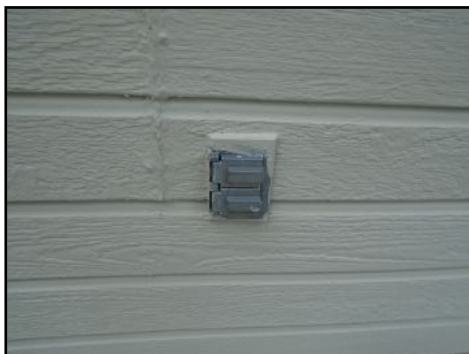
Observations:  
 • Outlet damaged or apparently inoperable.

Outlet is dead (No Power). Recommend Further Evaluation by a Handyman or a Licensed Electrician.
