Installation

Motor Cables - Specification

Power Cabling Practice

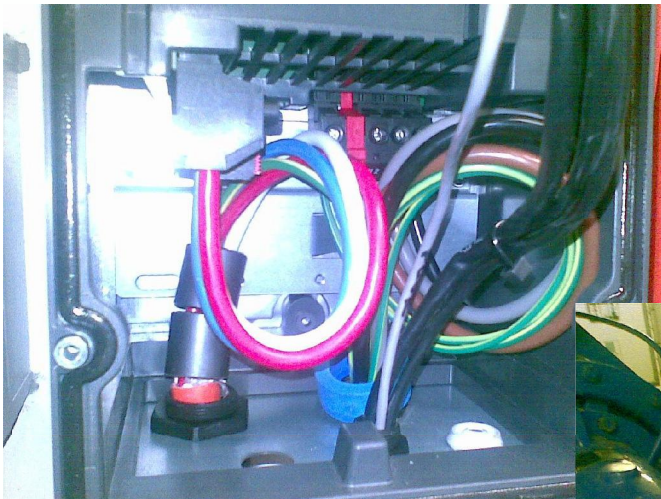
Good: Ferrite rings fitted & EMC rated glands used with shielded motor cable. Separate thermistor cabling.
Bad: Cable loops and no bonding to the backplane using the metal straps provided with the drive.

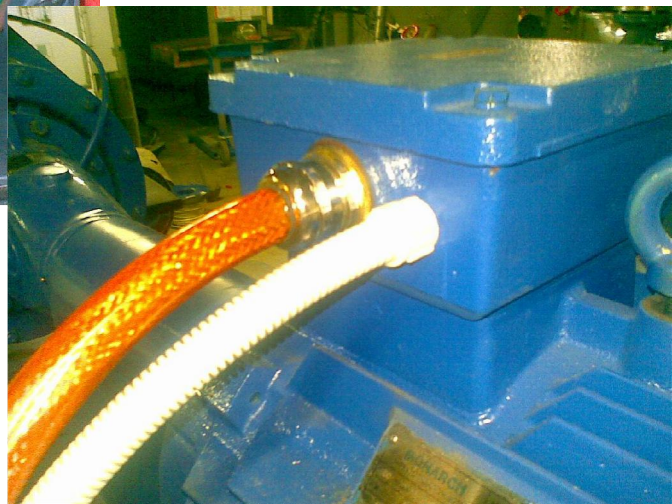
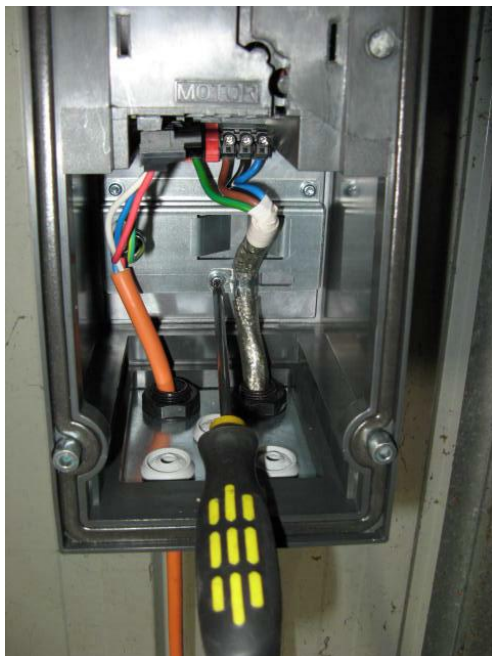
Left: This shows the minimum power wiring requirements for a Category 2 (Class A) installation. The strap is used to provide a good EMC bond between the motor cable and the drive, while the nylon glands maintain the IP55 rating. For Category 1 (Class-B) installations you must use EMC rated glands and the ferrite rings included with the drive. Note an additional earth bonding cable may be necessary.

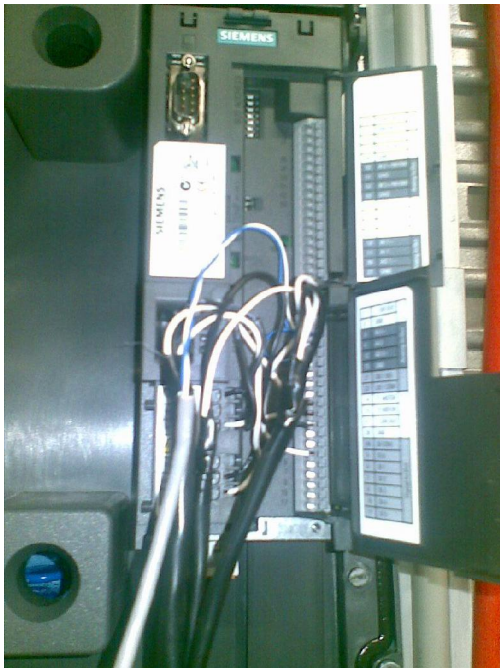
Good: individual shielded signal cabling used to separate the analog inputs, digital inputs, and the status relay outputs.

Bad: Forgot to use the included cable termination plate that is supplied with the drive.

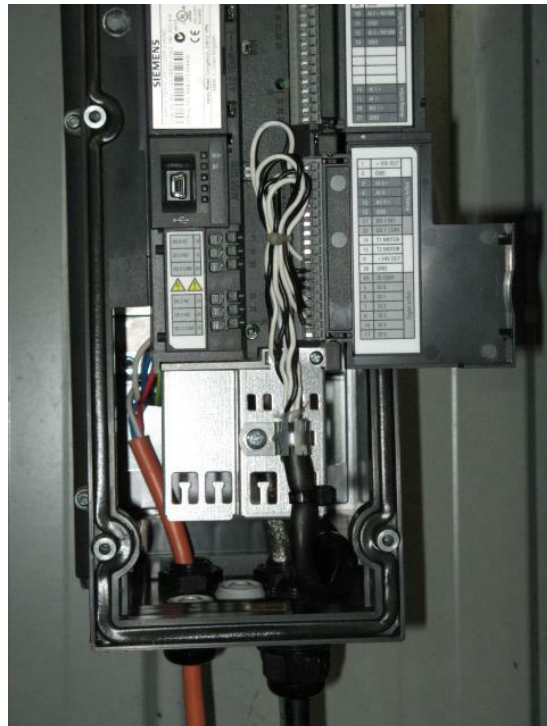
Right: Use the cable termination plate that is supplied with the drive to manage the separation of signal cables from power cables. This also allows for correct bonding of the shield when connecting sensors directly to the drive, e.g. when using the drive's internal PID loop to control cooling towers and stairwell pressurisation systems.

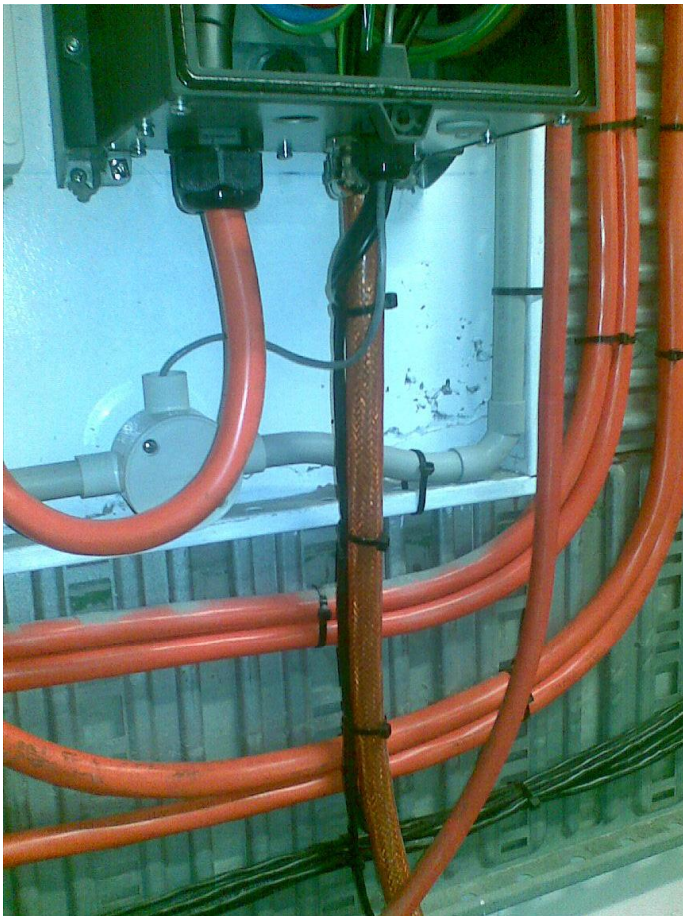
Good: A wide cable tray allows a reasonable distance to separate signal cables from power cables. Best practise is to keep 250mm clearance. Having the motor cable cross the supply cables at 90 degrees minimises any noise coupling.

Bad: Strapping the most sensitive signal cables to the motor cable – which is the worst EMF noise emitter in the area.

Even the best quality shielded cables have a leakage factor that demands a physical separation between power and low level signals be observed.

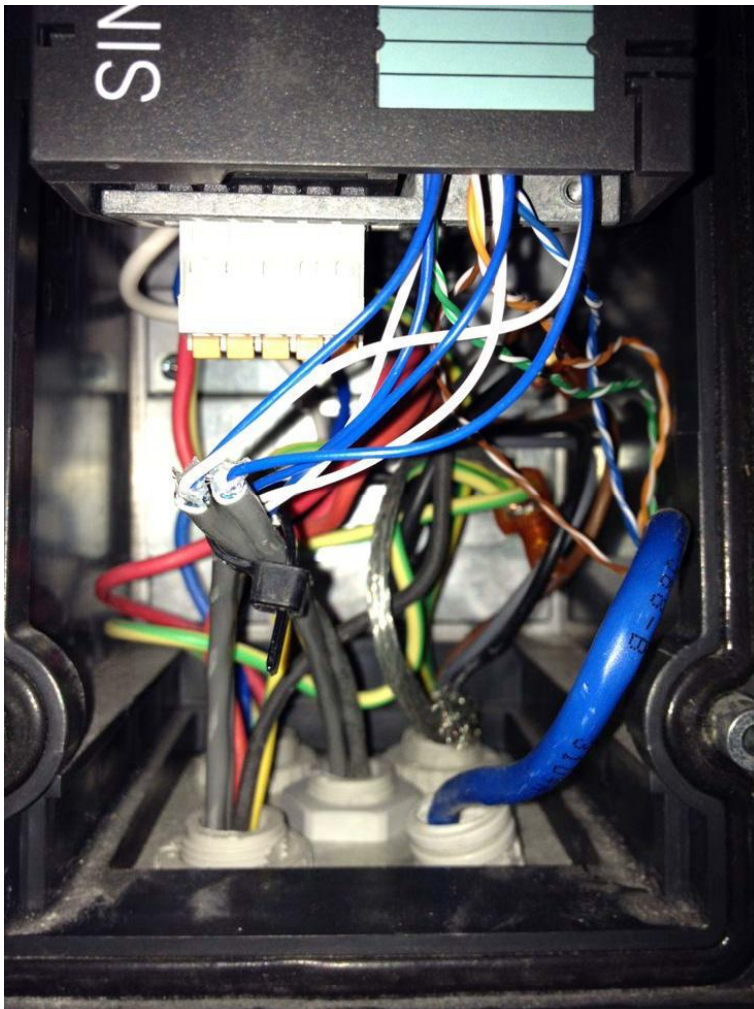
Below is an example of how not to install a drive. There are multiple problems here that could cause issues with control accuracy, EMC compliance, and perhaps even drive longevity.

Motor cable shield is terminated with a connector and earth wire, which provides very poor EMC bond. Metal straps thrown away. No sign of EMC glands. Ferrite rings thrown away.

No separation of any cabling. Signal termination plate thrown away.

Sensor signal shields not connected anywhere.

Cat-5 cable used for Fire Stop and Run modes.

No cable glands used, so IP rating reduced to that of corrugated conduits.
