## COMMERCIAL WINDSTORM MITIGATION INSPECTION REPORT (OIR-B1-1802)

**The Villas Condominiums Association, Inc.**  
18122-40 Villa Creek Dr, Building 1, 10-Unit Risk  
Tampa, FL 33647

**RECAPITULATION OF MITIGATION FEATURES**  
**For 18122-40 Villa Creek Dr, Building 1, 10-Unit Risk**

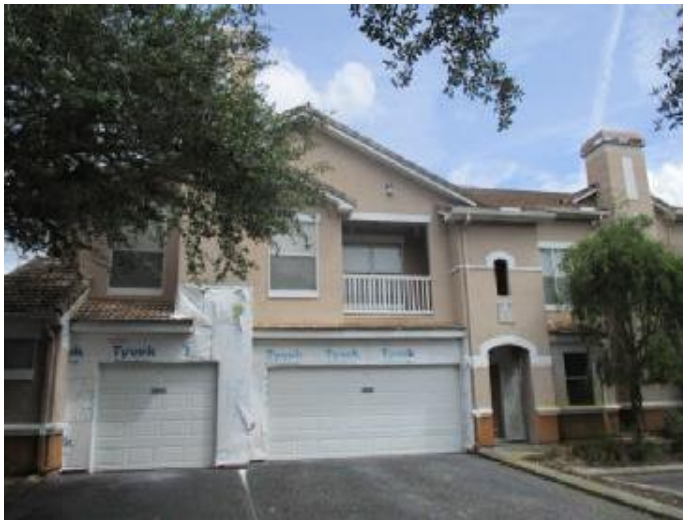
Exterior Elevation

| 7. <b><u>Opening Protection:</u></b><br>Comments: | None or Some Glazed Openings<br>No opening protection verified at the time of inspection. |

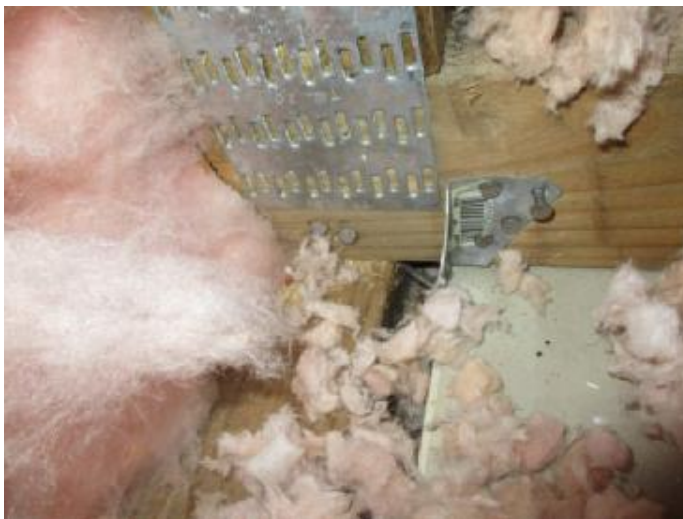
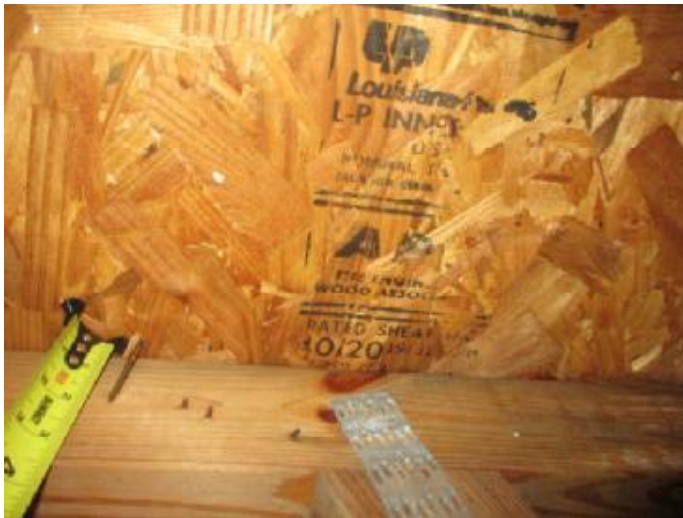
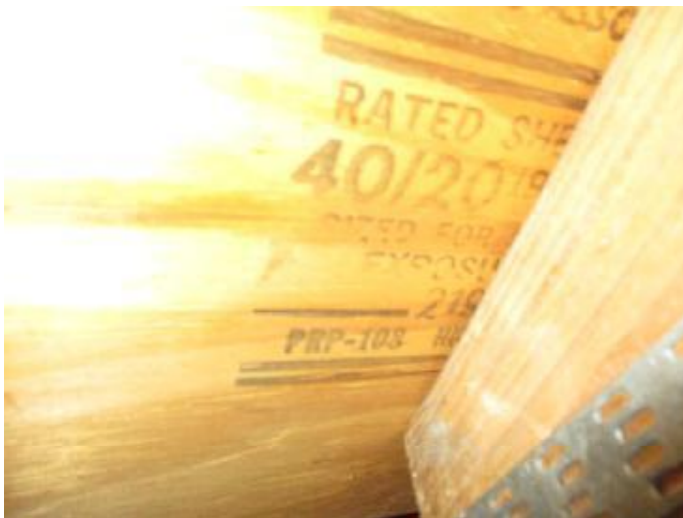
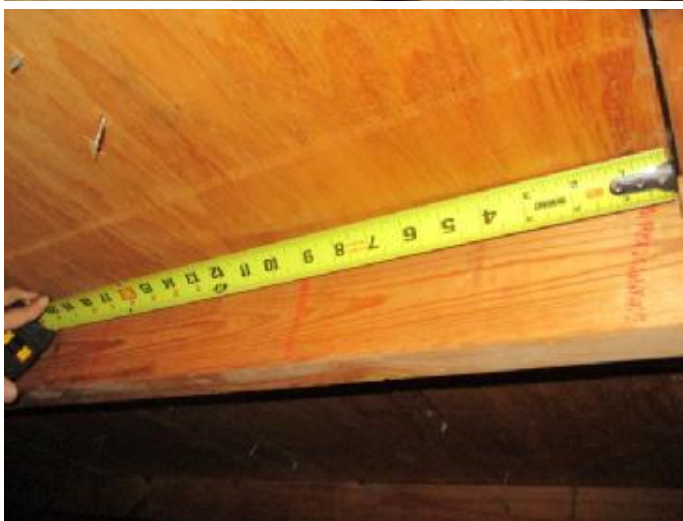
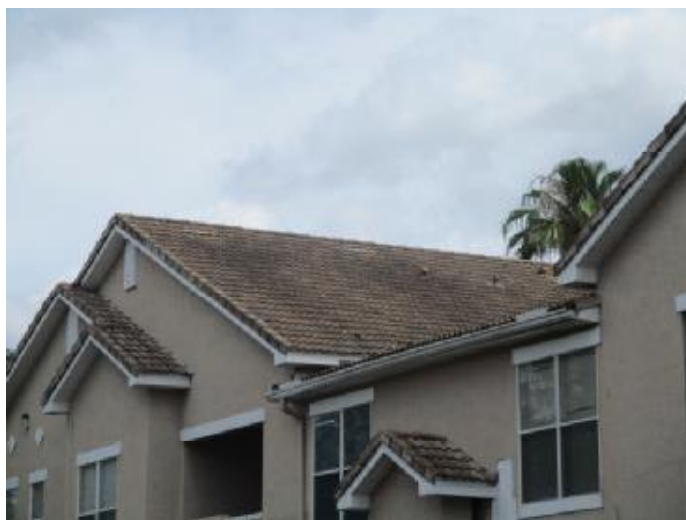
Roof Construction

| 3. <b><u>Roof Deck Attachment:</u></b><br>Comments: | Level B<br>Inspection verified 1/2" plywood and OSB roof deck attached with 8d nails at a minimum of 6" on the edge & 12" in the field. |
| 4. <b><u>Roof to Wall Attachment:</u></b><br>Comments: | Clips<br>Inspection verified hurricane clips fastened with a minimum of three nails. |
| 5. <b><u>Roof Geometry:</u></b><br>Comments: | Other Roof<br>Inspection verified a gable roof shape. |
| 6. <b><u>SWR:</u></b><br>Comments: | No<br>No SWR verified. |

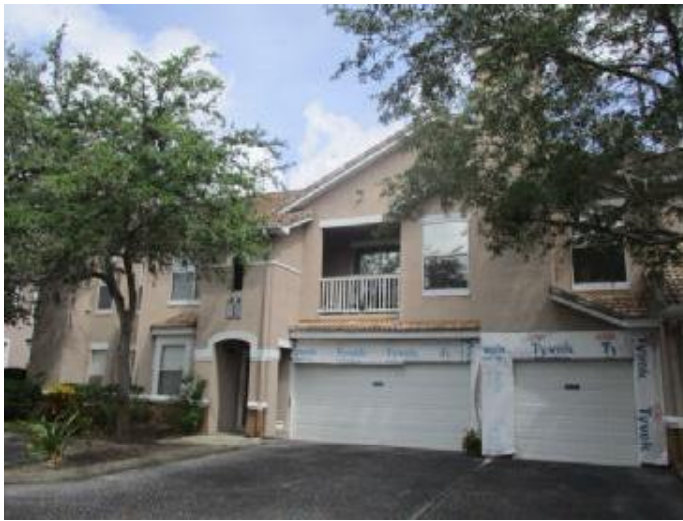
Exterior Elevation

| 7. <b><u>Opening Protection:</u></b><br>Comments: | None or Some Glazed Openings<br>No opening protection verified at the time of inspection. |

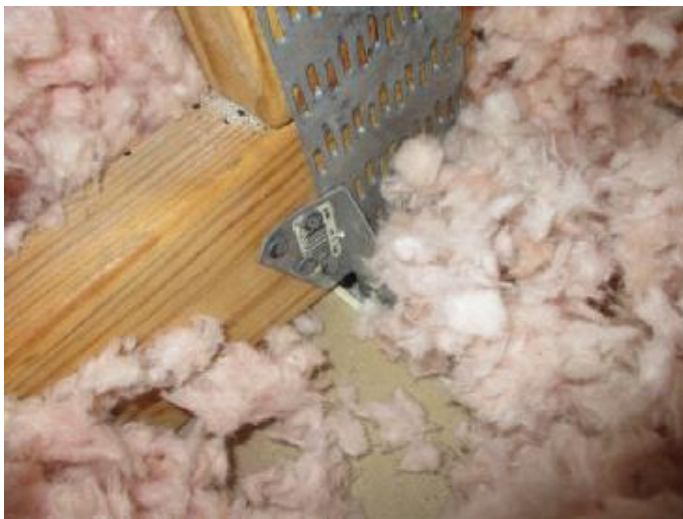
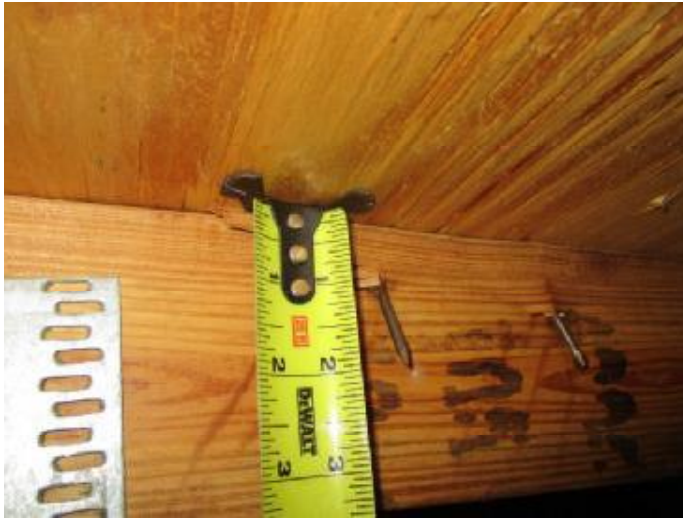
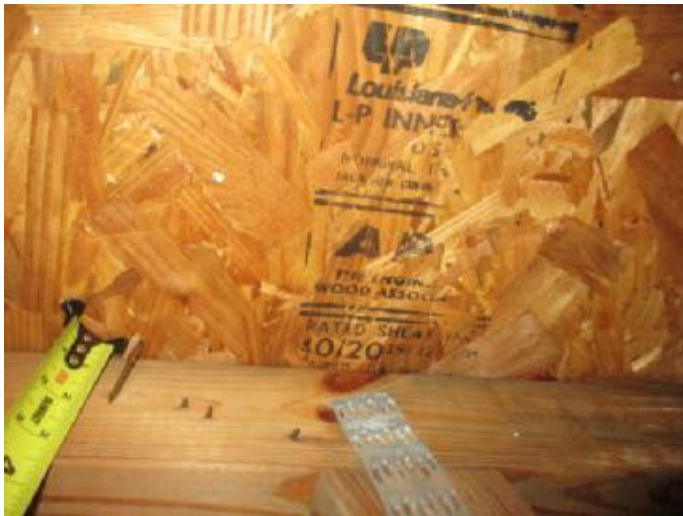
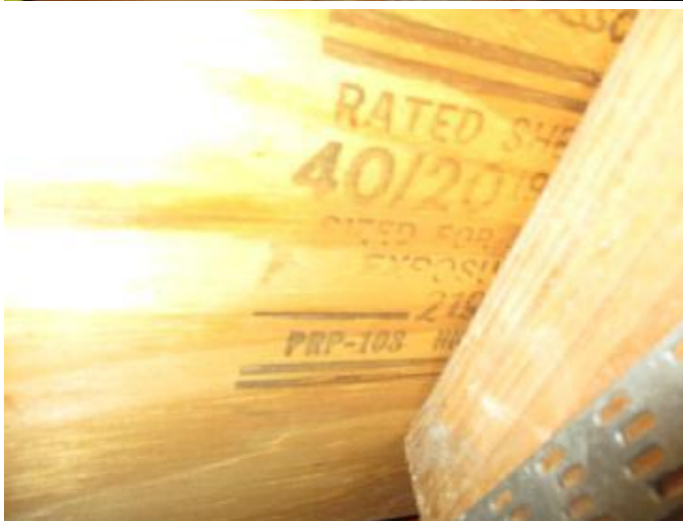
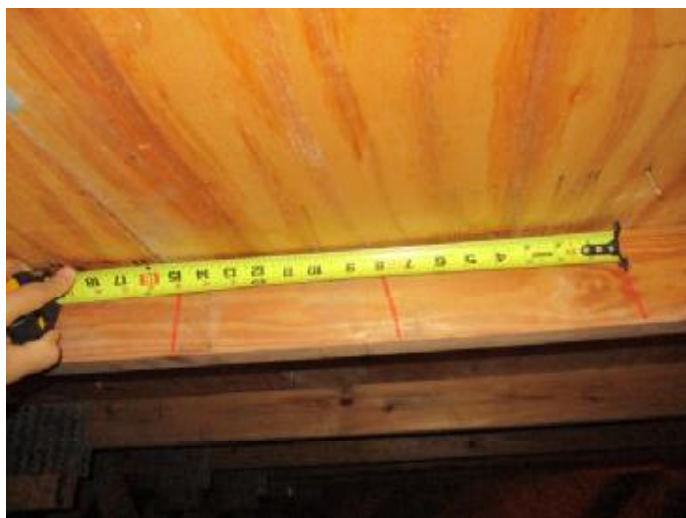
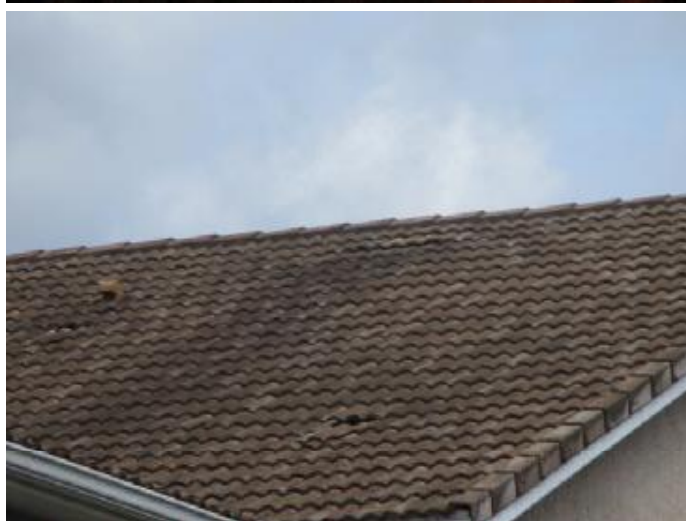
Roof Construction

| 3. <b><u>Roof Deck Attachment:</u></b><br>Comments: | Level B<br>Inspection verified 1/2" plywood and OSB roof deck attached with 8d nails at a minimum of 6" on the edge & 12" in the field. |
| 4. <b><u>Roof to Wall Attachment:</u></b><br>Comments: | Clips<br>Inspection verified hurricane clips fastened with a minimum of three nails. |
| 5. <b><u>Roof Geometry:</u></b><br>Comments: | Other Roof<br>Inspection verified a gable roof shape. |
| 6. <b><u>SWR:</u></b><br>Comments: | No<br>No SWR verified. |

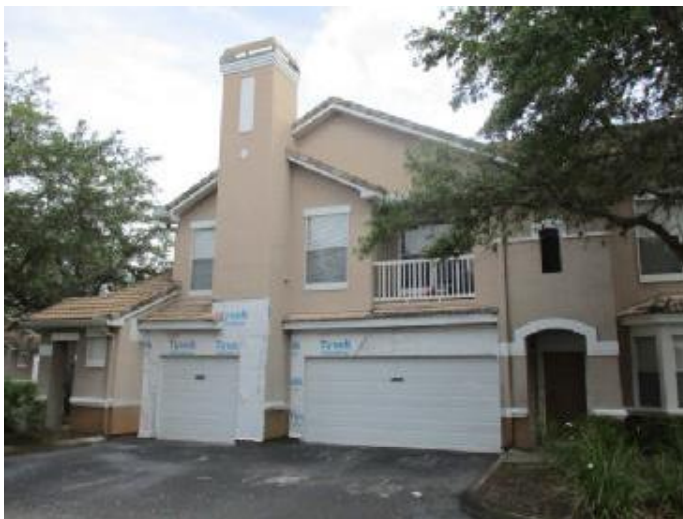
Exterior Elevation

| 7. <b><u>Opening Protection:</u></b><br>Comments: | None or Some Glazed Openings<br>No opening protection verified at the time of inspection. |

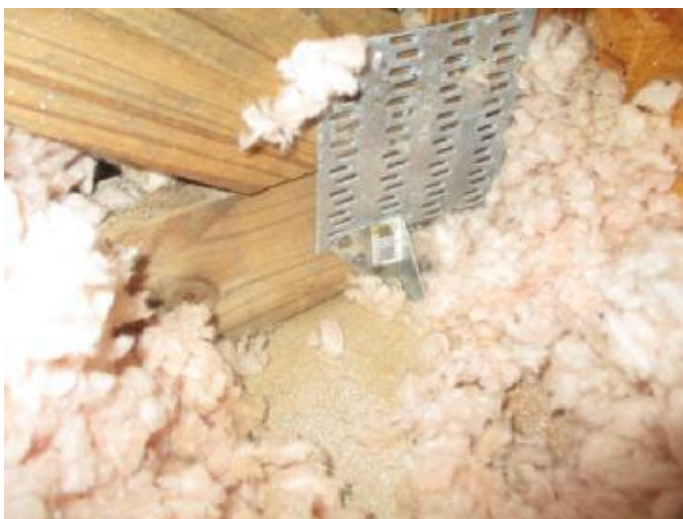
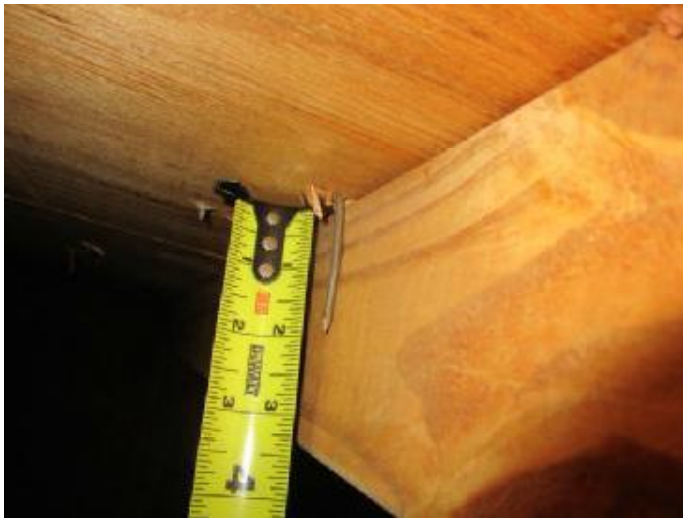
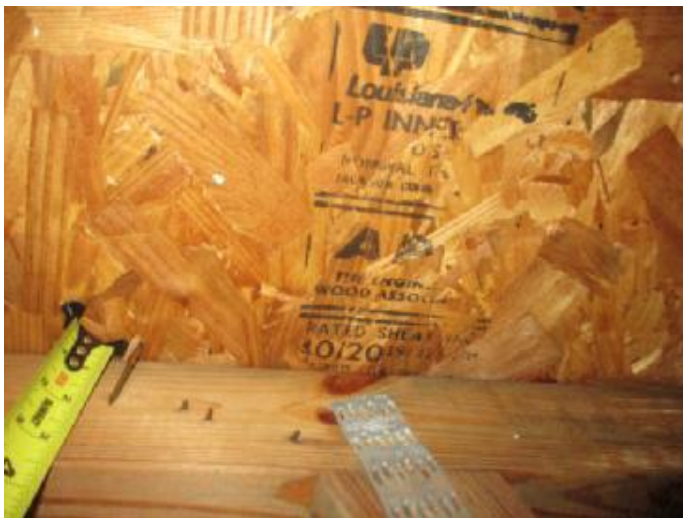
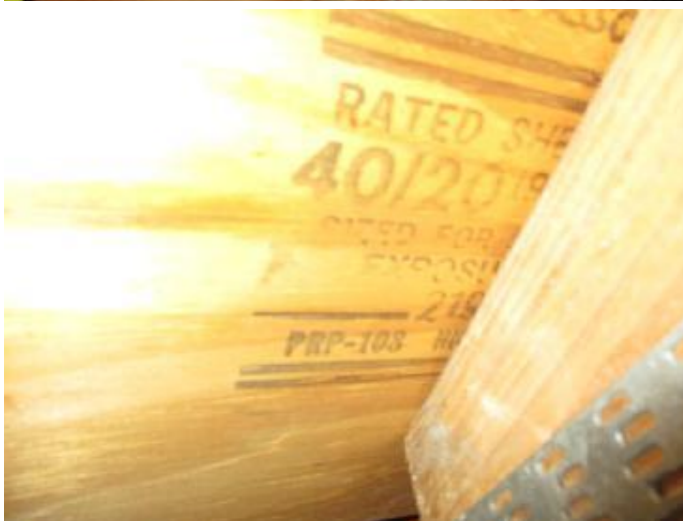
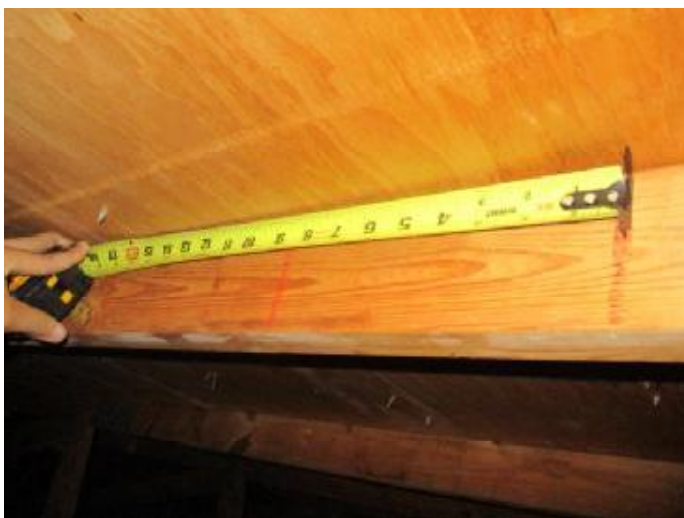
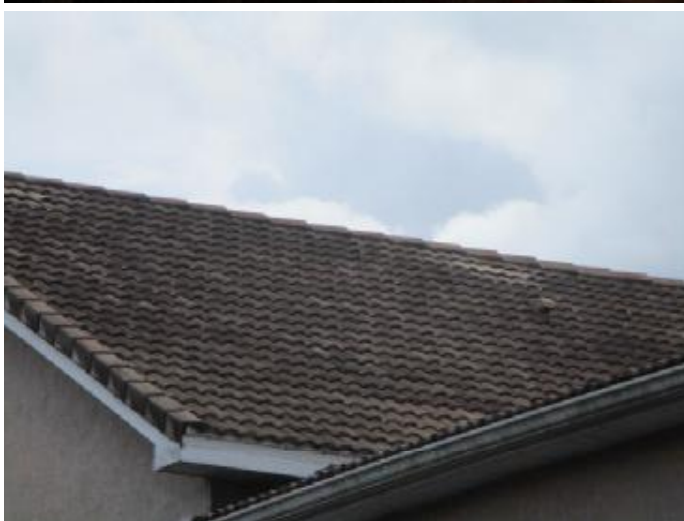
Roof Construction

| 2. <b><u>Roof Covering:</u></b><br>Comments: | No roof coverings meet the minimum requirements<br>The roof covering is original to the construction of the building in 2001. There was a major repair due to water damage in 2007. Only repairs have been made since original construction. This roof covering does not meet FBC requirements as stated in the mitigation affidavit. |
| 6. <b><u>SWR:</u></b><br>Comments: | No<br>No SWR verified. |
