SUMMARY  
330 Sycamore St, Georgetown, TX  
78633  
William Rockwell  
August 29, 2022

Shaun Schroeder  
TREC# 25684  
Looking Glass Inspections, LLC  
(512) 948-6867  
shaun@lginspect.com

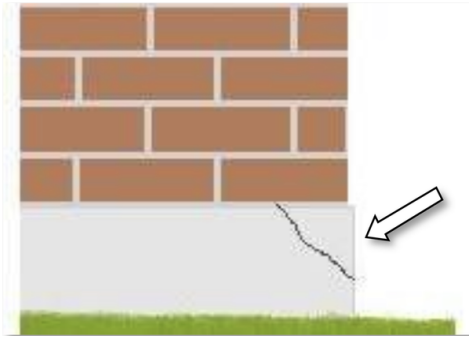
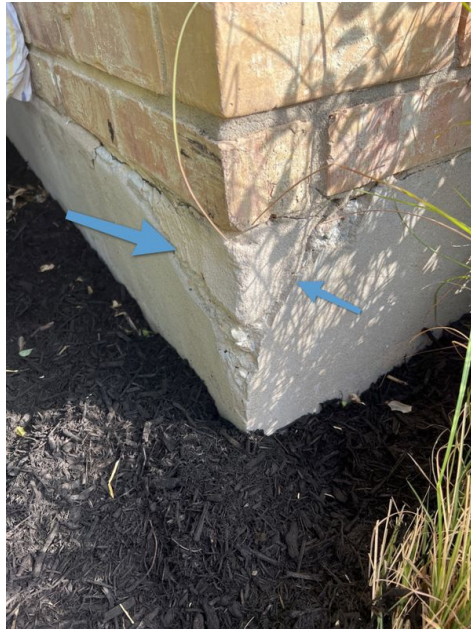
##### WEDGE CRACK

Cracking to outside corner of concrete foundation, commonly referred to as a wedge crack or 'corner pop'. This cracking is caused by curved corner reinforcement and differential material movement and does not appear to adversely affect the structure nor does it transfer to the supported masonry. These areas can be repaired for cosmetic reasons if desired but are not structural issues.

Recommended DIY Project

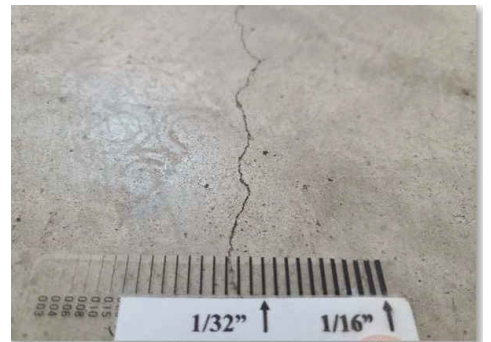
##### FOUNDATION CRACKS - MINOR

Minor cracking was noted at the foundation. This is common as concrete ages and shrinkage surface cracks are normal. Recommend monitoring for more serious shifting/displacement.

Recommend monitoring.

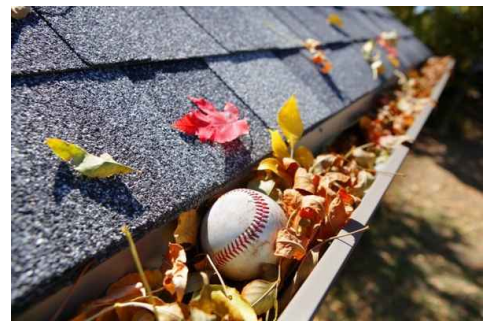
##### DEBRIS IN GUTTERS

I observed debris in the gutter. Cleaning and maintenance is recommended.

Recommendation  
Contact a qualified gutter contractor

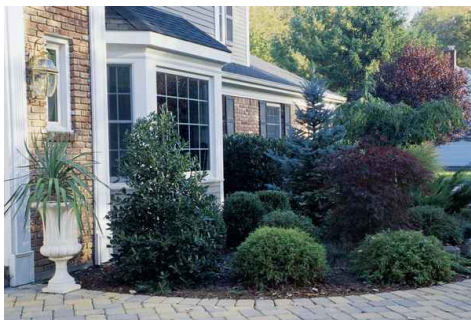
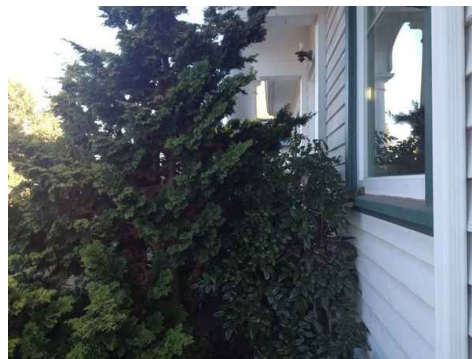
#### **DENSE VEGETATION**

I observed dense vegetation around the house in areas. This condition limited and restricted my visual inspection. Dense vegetation and landscaping up against or near the house foundation and exterior walls may be prone to water penetration and insect infestation.

Trimming, pruning and some landscaping is recommended.

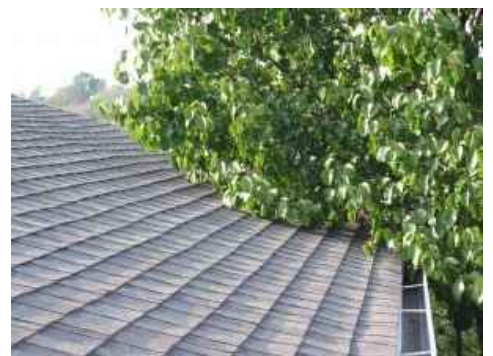
#### **FOLIAGE TOUCHING ROOF COVERING**

Foliage appears to be in contact with roof covering, or contact is imminent. Over time this contact can wear and damage the roof covering. Recommend a qualified professional inspect and make corrections as needed.

Recommendation  
Contact a qualified tree service company.

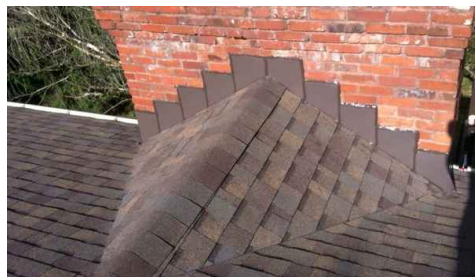
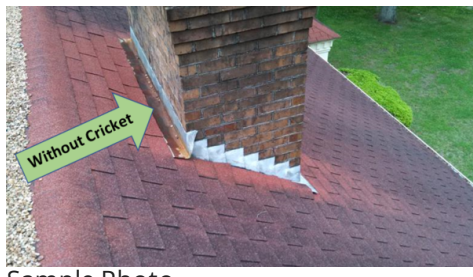
### 2.3.3 C. Roof Covering Materials **MISSING CHIMNEY CRICKET**

I observed the chimney cricket was missing. Not installed. This chimney/roof junction is prone to water penetration. A cricket is installed to provide protection against roof leaks and to divert water away from the chimney. Recommend a roofing professional inspect further for water penetration, repair as needed.

Contact a qualified roofing professional.

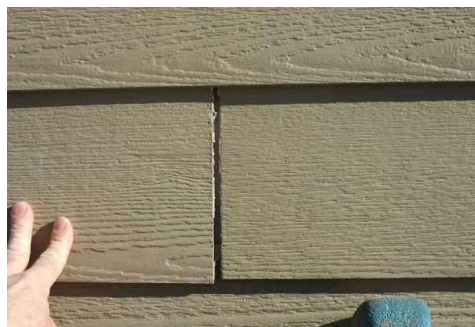
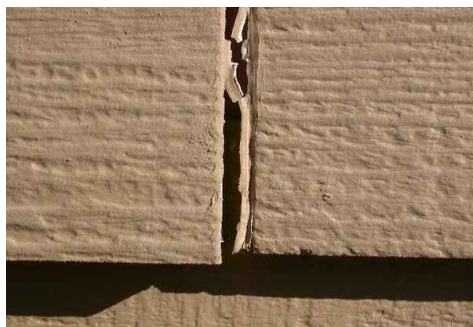
### 2.5.1 E. Walls (Interior and Exterior) **MINOR CRACKS/GAPS - EXTERIOR WALL**

Minor cracking and/or gaps were observed in wall structure. This is common in homes this age. Improperly sealed siding and cladding can allow moisture to come into contact with structural components of the house. Recommend sealing and monitoring. This is a DIY, handyman or Siding Professional project.

Contact a handyman or DIY project

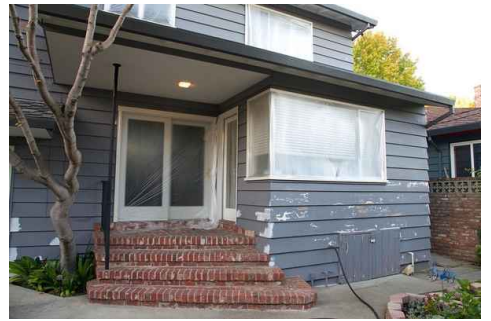
### 2.5.2 E. Walls (Interior and Exterior) **DEFECT/DAMAGE - EXTERIOR WALL**

I observed indications of a defect/damage at the exterior wall covering material. Exposed wood should not be exposed to the elements. Recommend a qualified siding contractor repair and replace as needed.

Recommendation  
Contact a qualified professional.

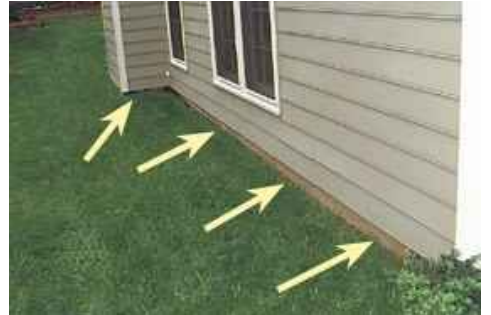
### INADEQUATE GROUND CLEARANCE - EXTERIOR WALL

I checked the distance between the bottom of wood or siding components and the ground surface (or grade). In locations that have little or no snow, the distance should be no less than 8 inches. In locations with significant lasting snow, the bottom of wood elements should be no less than 8 inches above the average snow depth.

Correction and further evaluation is recommended.

Recommendation  
Contact a qualified siding specialist.

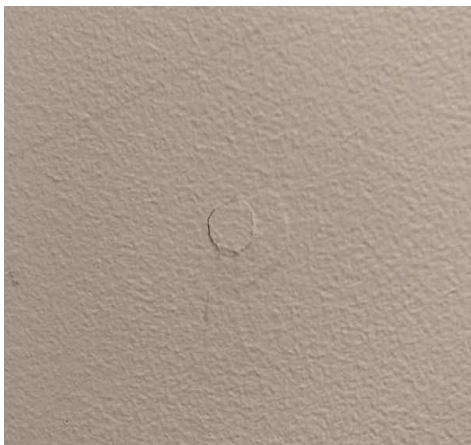
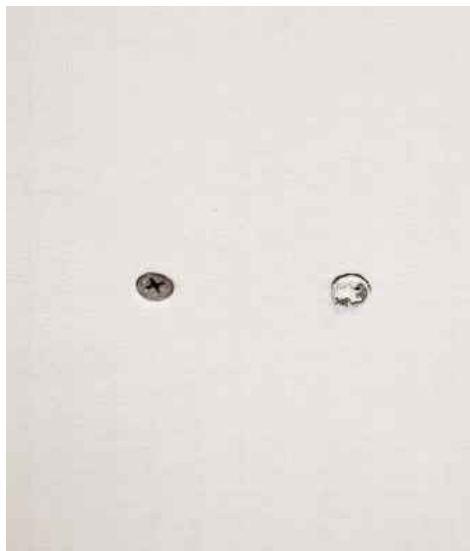
### NAIL POPS - INTERIOR WALL

Protruding nail heads visible at the time of the inspection appeared to be the result of contact with moisture. After the source of moisture is located and corrected, protruding nails should be removed, drywall re-fastened and the drywall finished to match the existing wall surfaces. All work should be performed by a qualified drywall or painting contractor.

Recommendation  
Contact a qualified drywall contractor.

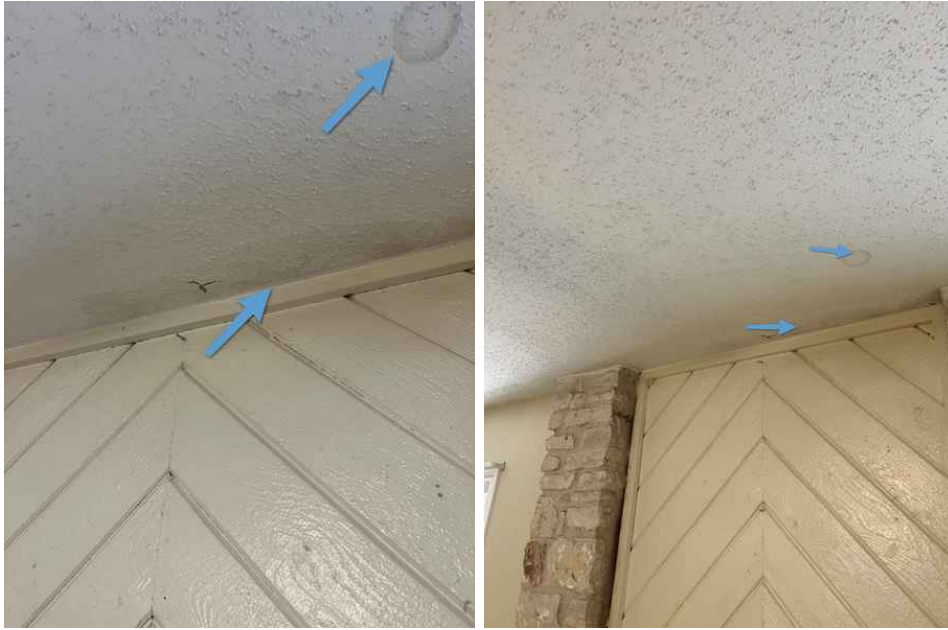
### CEILING - STAIN(S)

There is a stain on ceiling/wall that requires repair and paint. Source of staining should be determined.

Recommendation  
Contact a qualified professional.

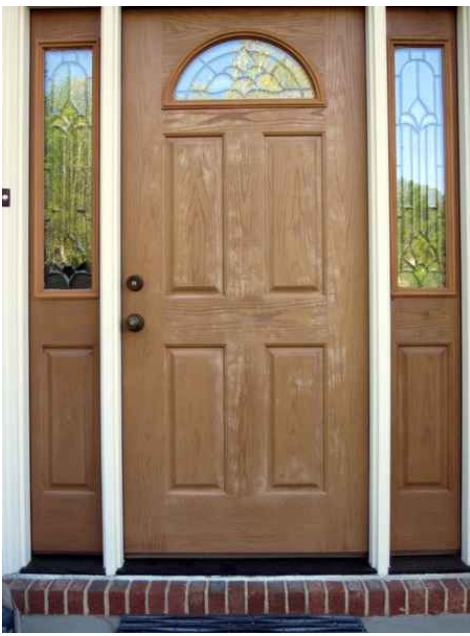
### EXTERIOR DOOR SURFACE IN POOR CONDITION

I observed that the surface of the exterior door was in poor condition.

Correction and further evaluation is recommended. This is a DIY or Handyman project.

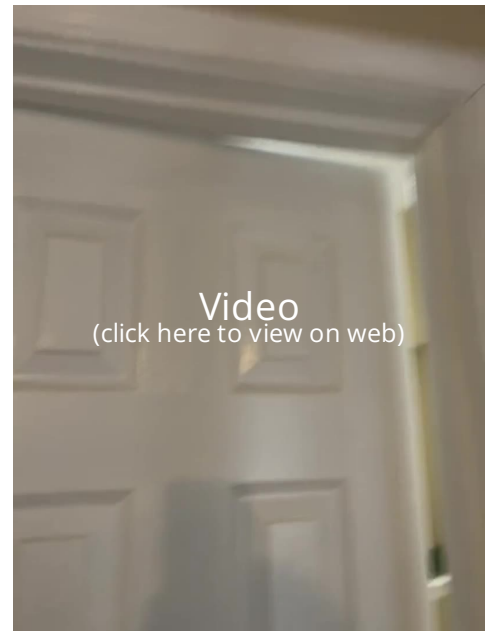
**DOOR STICKS**

I observed that the door sticks. Recommend a qualified professional inspect and repair as needed. Possible DIY project.

Recommendation  
Contact a qualified handyman.

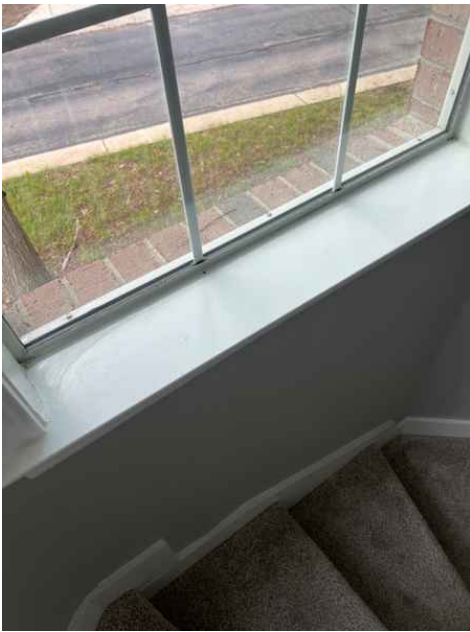
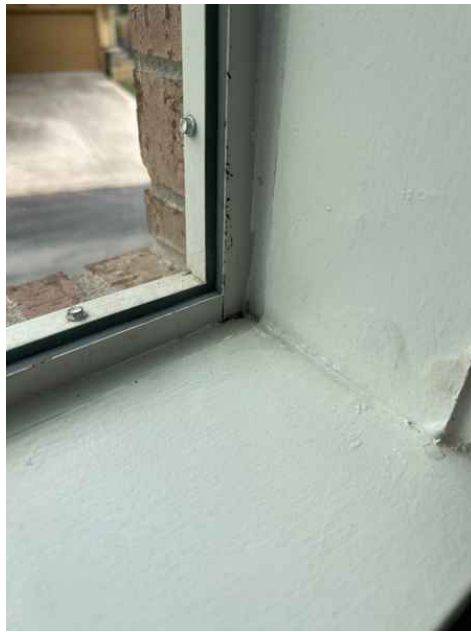
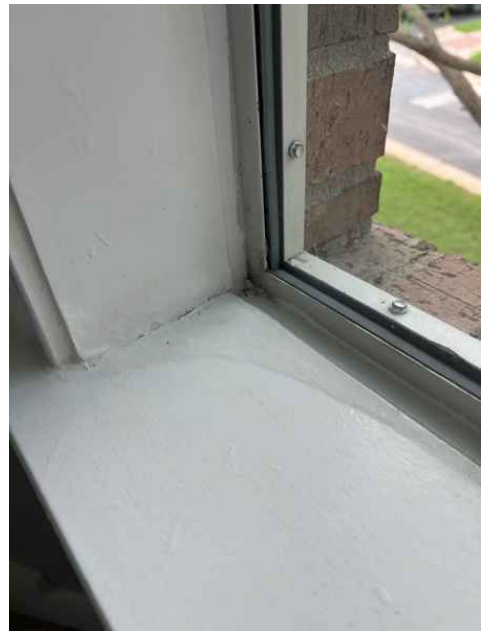
**MOISTURE AT WINDOW**

I observed indications of excessive moisture or water intrusion at a window. Aluminum windows often cause condensation which runs down to the window sill. Damage is often the result. Further monitoring and evaluation is recommended. Recommend a window repair professional inspect and repair as needed.

Recommendation  
Contact a qualified window repair/installation contractor.

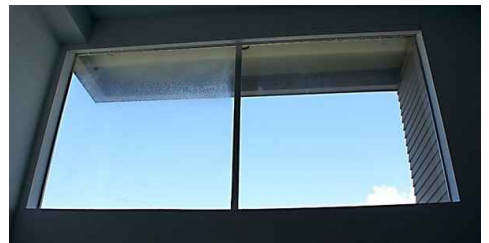
### 2.8.2 H. Windows **FAILED SEAL**

Condensation observed between window panes, which indicates a possible failed seal. Recommend a qualified window contractor evaluate and repair as needed.

If multiple-pane windows appear misty or foggy, it means that the seal protecting the window assembly has possibly failed, and condensation has formed in between the two panes of glass.

Condensation in double-paned windows indicates that the glazing assembly has failed and needs repair or replacement. Visible condensation can damage glazing and is the main indication of sealant failure. Condensation is not always visible. If the failure is recent, a failed window may not be obvious, since condensation doesn't usually form until the window is heated by direct sunlight. Windows in the shade may show no evidence of failure, so it is nearly impossible to observe and report all failed double-paned windows.

Contact a qualified window repair/installation contractor.

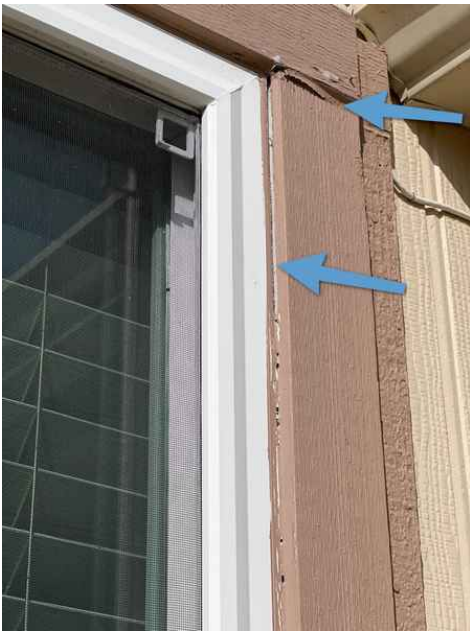
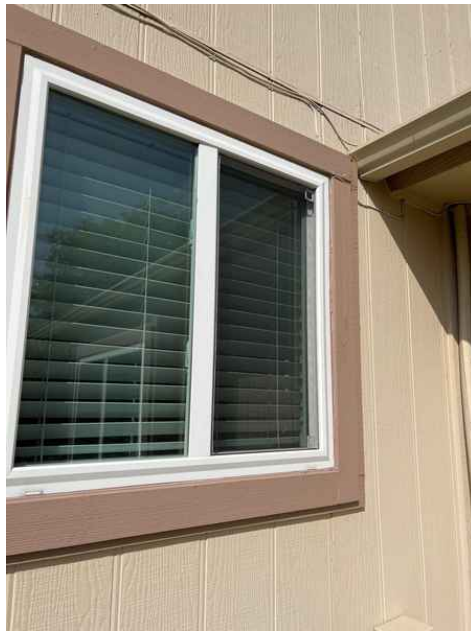
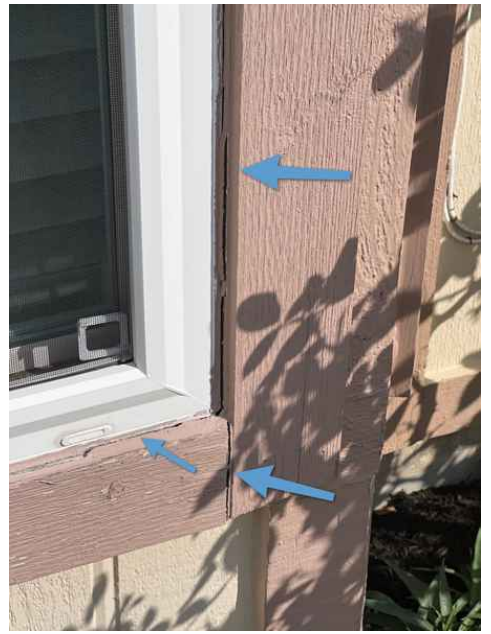
### 2.8.3 H. Windows **FAILING CAULK**

Failing or cracking caulk at windows exterior, multiple locations. Recommend re-caulking. This is a DIY or Handyman project.

Contact a handyman or DIY project

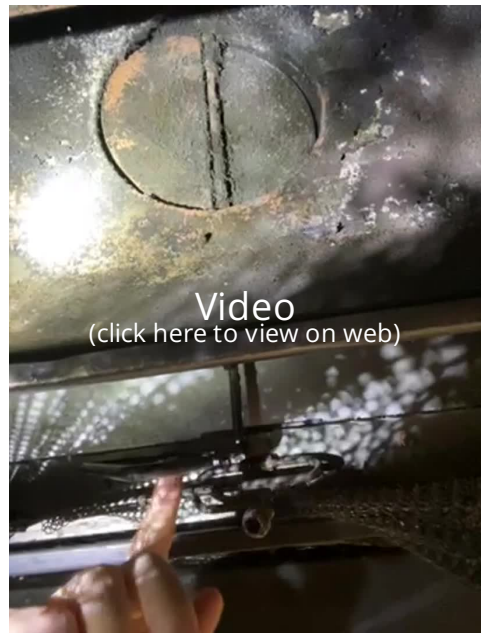
#### **DAMPER INOPERABLE**

I observed indications of a defect related to the Damper. The Damper appears to be inoperable. I recommend a Fireplace Contractor further inspect and repair as deemed necessary.

An inoperable damper is a condition that could allow toxic fumes into the home. In this case, the damper doesn't reliably stay shut, which allows air to draft in and out of the house.

Contact a qualified fireplace contractor.

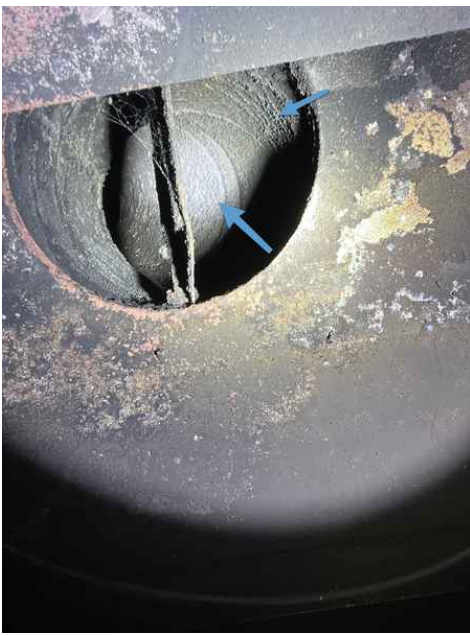
#### **CREOSOTE BUILDUP**

Observed creosote buildup. Recommend a chimney sweep service upon taking ownership, and annually going forward.

Contact a qualified chimney contractor.

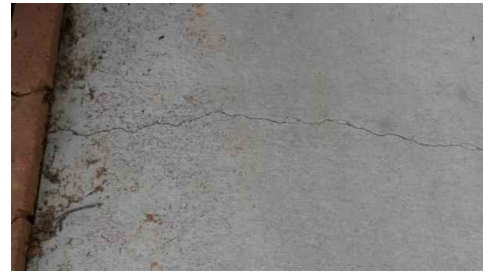
### WALKWAY - MINOR CRACKING

I observed minor cracking and no major damage at the walkway. Monitoring is recommended.

Recommendation  
Recommend monitoring.

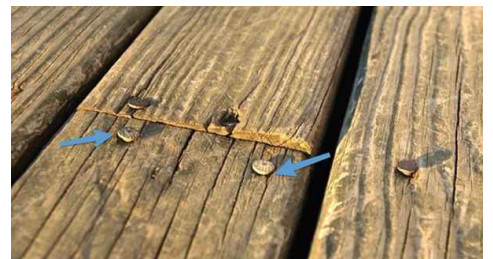
### DECK - NAILS EXPOSED

One or more nails were observed to be exposed. Recommend nails be reset. This is a DIY or Handyman project.

Recommendation  
Contact a handyman or DIY project

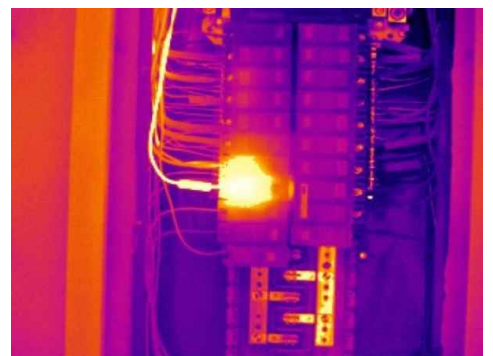
### ARCING OR EXCESSIVE HEAT

I observed indications of arcing or excessive heat. Hazard. Recommend a qualified electrician inspect further and make any necessary repairs.

Recommendation  
Contact a qualified electrical contractor.

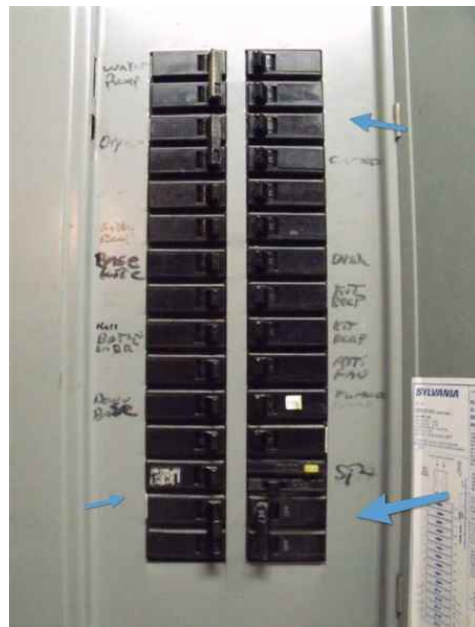
### PANEL MISSING LABELS

Electrical panel does not have labels. Recommend a qualified electrician test and properly label all switches.

Contact a qualified electrical contractor.

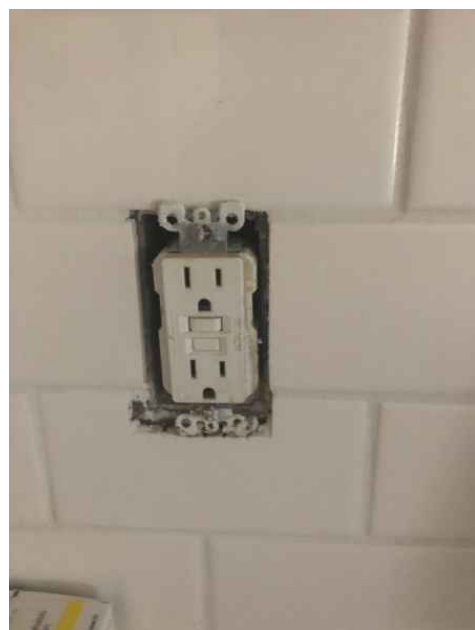
#### **COVER PLATES MISSING OR DAMAGED**

I observed indications that there was one or more missing or damaged receptacle cover plates. All receptacles are required to be covered so that no object can be inserted, causing an electric shock hazard. Recommend installing cover plates. This is a DIY / Handyman project.

Contact a handyman or DIY project

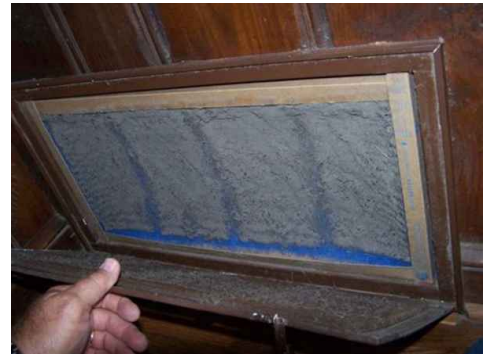
#### FILTER DIRTY

I observed a dirty air filter at the furnace filter.

Recommended DIY Project

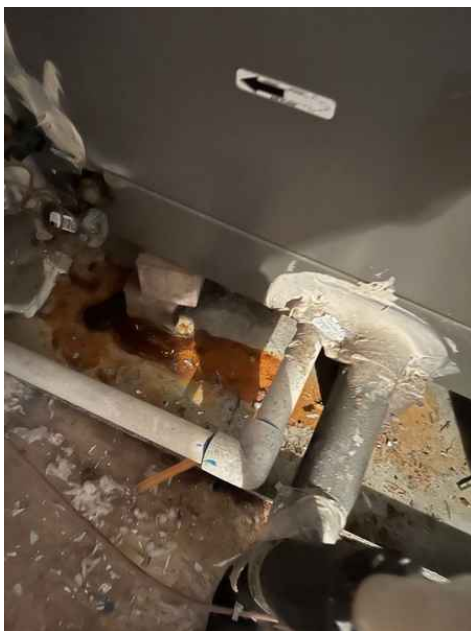
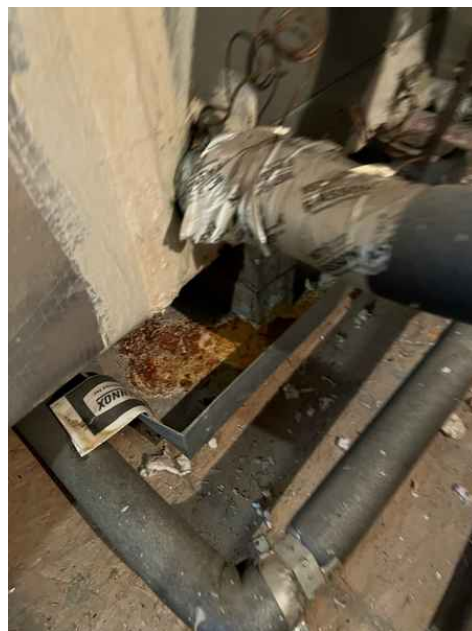
#### CORROSION IN CATCH PAN - UNIT 1 & 2

Condensate catch pan was corroded in one or more areas. It appears adding insulation to the refrigerant lines could help reduce condensation. Although this is a common finding, the cause cannot be 100% determined by a visual inspection. Along with a general servicing of the systems, I recommend a HVAC contractor evaluate this issue and repair as needed.

Contact a qualified HVAC professional.

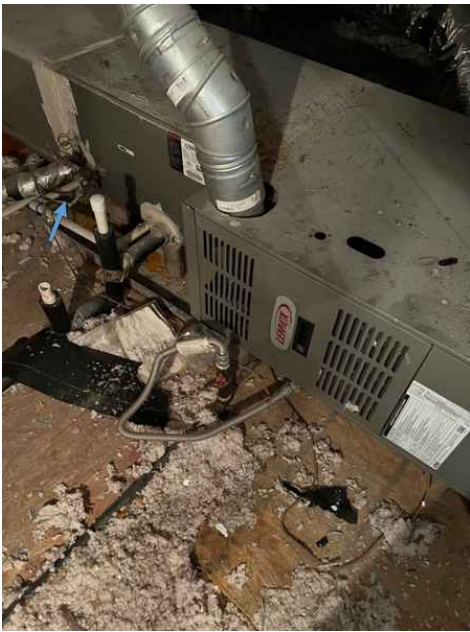
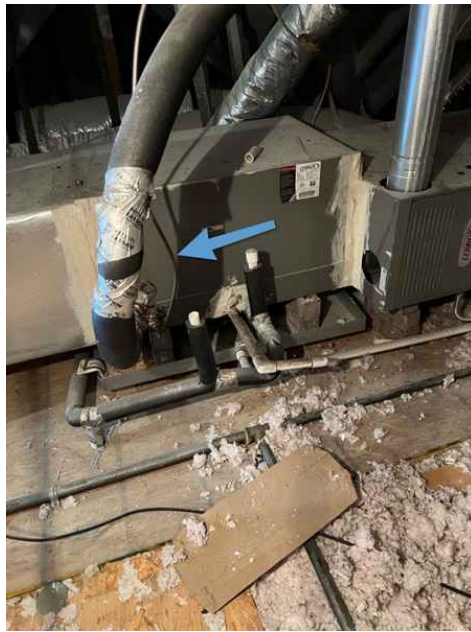
### **INSULATION MISSING OR DAMAGED**

Missing or damaged insulation on refrigerant line can cause energy loss and condensation.

Unit 2

Unit 1

Contact a qualified HVAC professional.

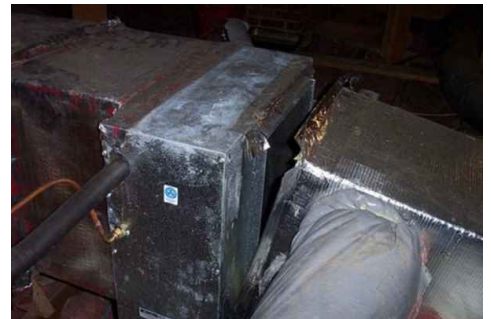
Air supply ducts were not properly sealed. Recommend a qualified HVAC contractor seal supply and return ducts for maximum efficiency.

Contact a qualified HVAC professional.

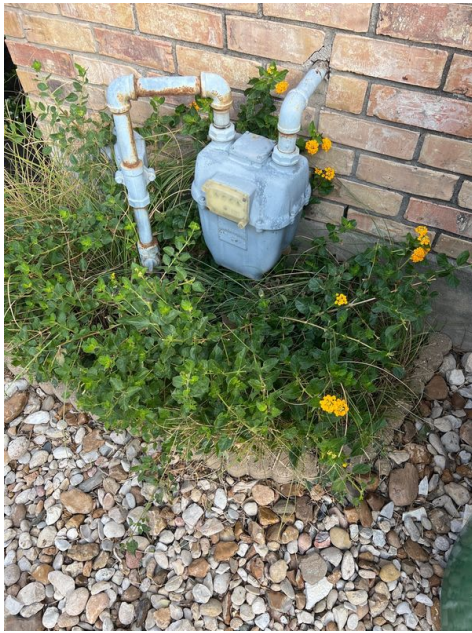
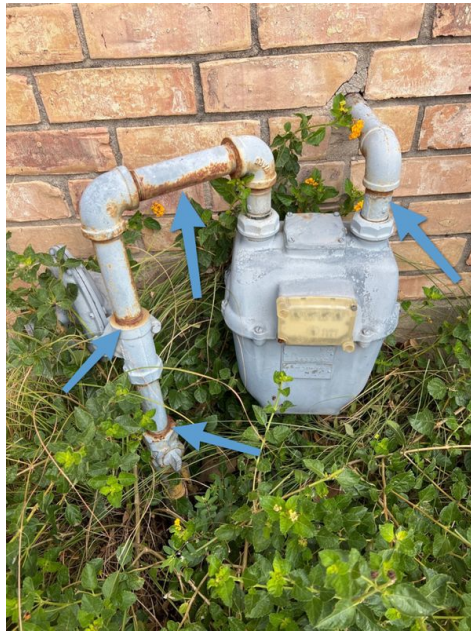
**MINOR RUST AT METER**

I observed some minor surface rust at the gas meter components. Monitoring recommended.

Contact your local utility company

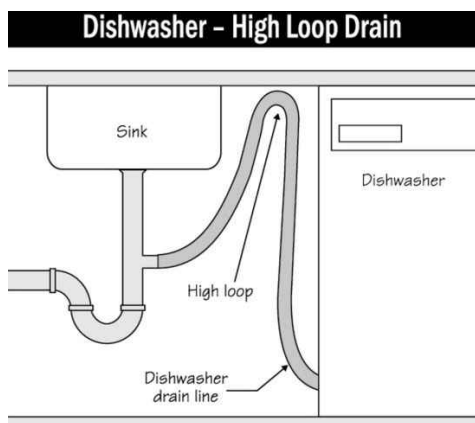
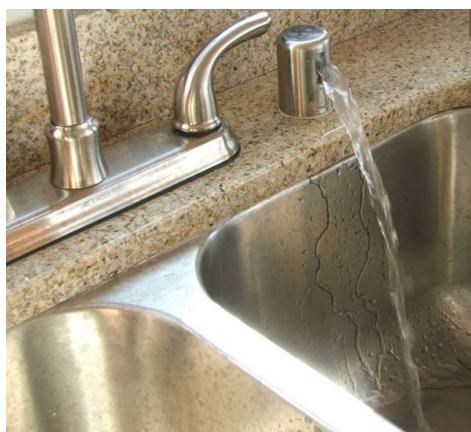
**MISSING AIR GAP / HIGH LOOP**

I observed indications of a defect at the dishwasher drain line. There needs to be a countertop air gap component installed in the drain system. Recommend a licensed and qualified appliance repair contractor further inspect and repair.

Sample - Air Gap

A "high loop" on a dishwasher drain prevents dirty water from backing up into the dishwasher. Check local code requirements.

Contact a qualified appliance repair professional.

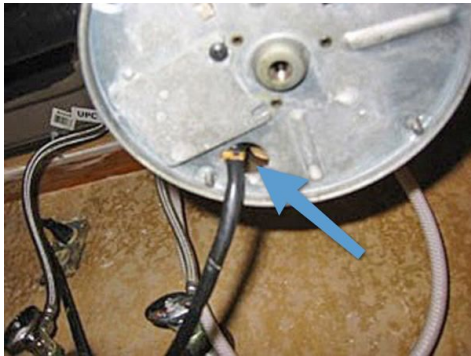
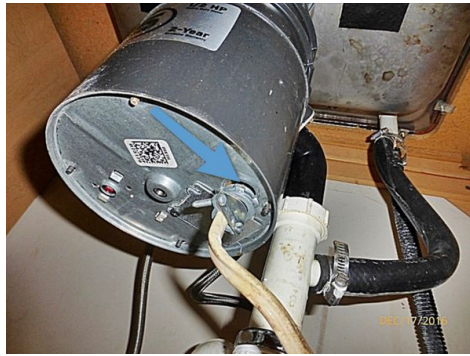
### 6.2.1 B. Food Waste Disposers **MISSING ELECTRICAL WIRE CLAMP**

I observed indications of a missing electrical wire clamp at the garbage disposal. Recommend a licensed and qualified electrical contractor further inspect and repair or replace.

Missing Clamp

Sample Photo

Recommendation  
Contact a qualified electrical contractor.

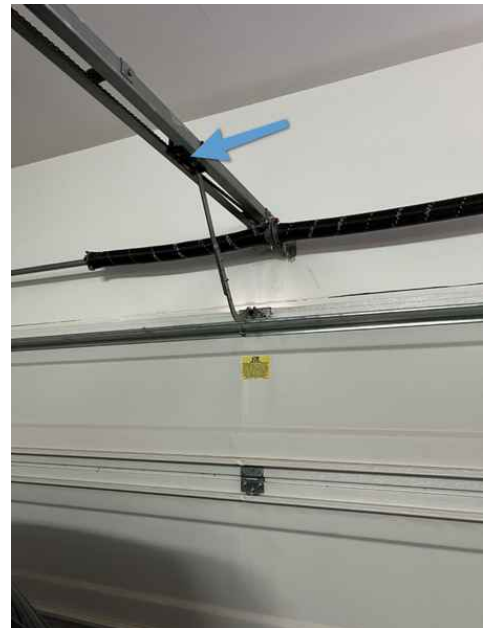
I observed that the manual release was not easily accessible and more than 6 feet above the garage floor. Missing handle and rope entirely. Defect. Recommend installing handle and rope. This is a DIY or Handyman project.

Recommendation  
Contact a qualified garage door contractor.

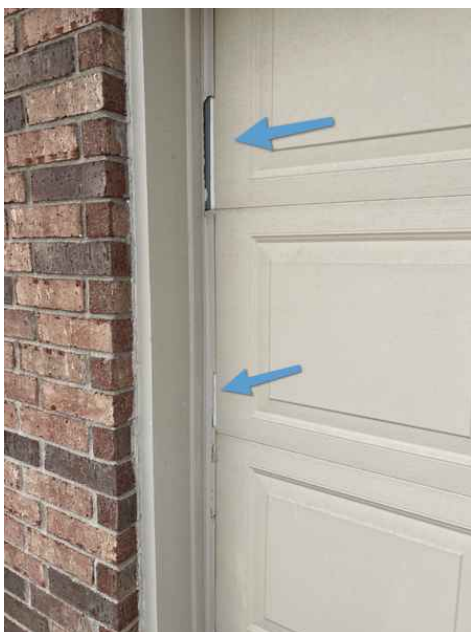
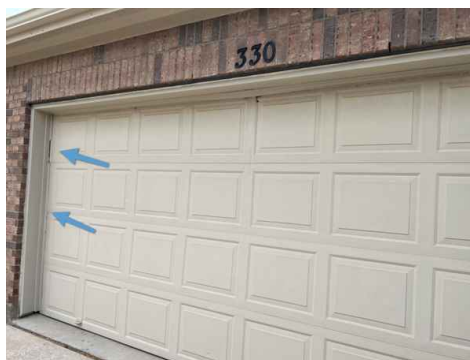
#### WEATHER STRIPPING AT GARAGE DOOR IN POOR CONDITION

I observed indications that the weather stripping at the garage door is in poor condition.

Recommendation  
Contact a qualified garage door contractor.

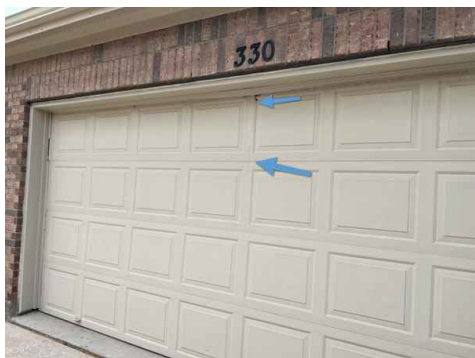
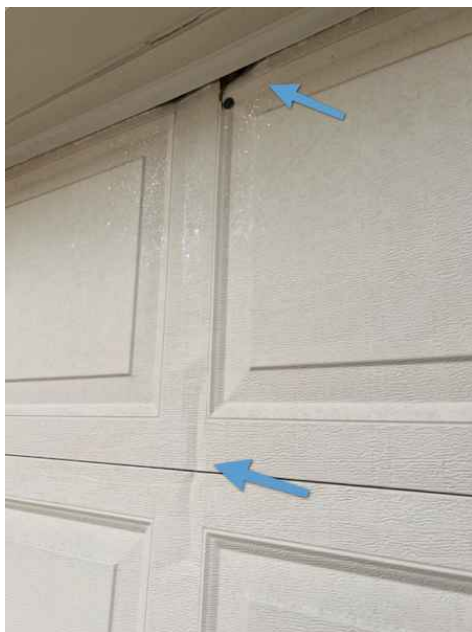
6.7.3 G. Garage Door Operators  
**DAMAGE TO GARAGE DOOR**

I observed indications of damage to the garage door itself.

Contact a qualified garage door contractor.

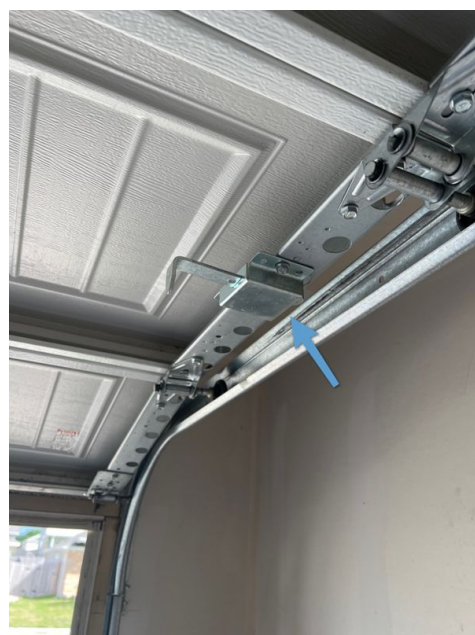
This is a deficiency. Risk of damage to door and mechanical opener. Recommend removing or bolting the lock open.

Recommended DIY Project

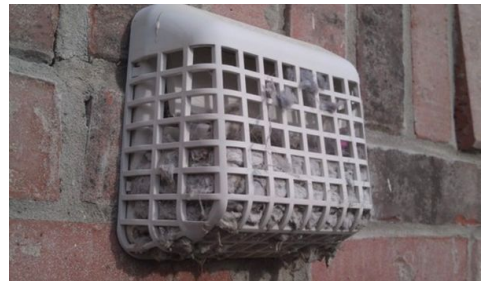
I observed that the clothes dryer exhaust hood has a screen. This will clog and create a fire hazard. Recommend replacing vent hood with a "damper" style hood. This is a Handyman or HVAC Professional project.

Contact a qualified HVAC professional.
