LOOKING GLASS INSPECTIONS, LLC

TEXAS HOME INSPECTION

330 Sycamore St
Georgetown, TX 78633

PROPERTY INSPECTION REPORT FORM

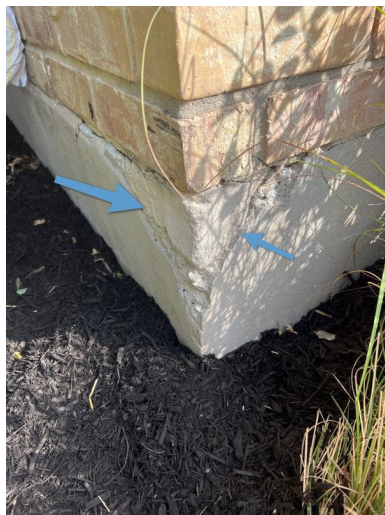
2: Foundation Cracks - Minor

Minor cracking was noted at the foundation. This is common as concrete ages and shrinkage surface cracks are normal. Recommend monitoring for more serious shifting/displacement.

Recommendation: Recommend monitoring.

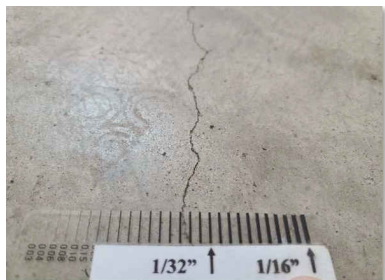
Garage

[Here is an informational article](#) on foundation cracks.

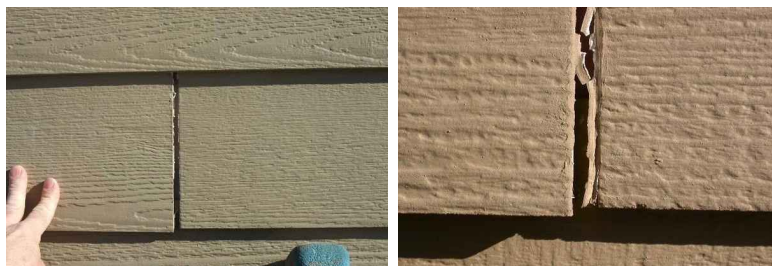
2: Defect/Damage - Exterior Wall

I observed indications of a defect/damage at the exterior wall covering material. Exposed wood should not be exposed to the elements. Recommend a qualified siding contractor repair and replace as needed.

Recommendation: Contact a qualified professional.

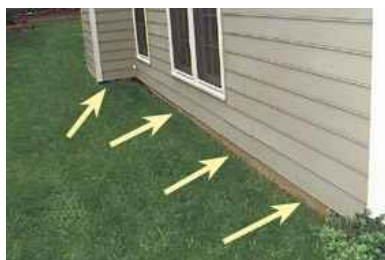
3: Inadequate Ground Clearance - Exterior Wall

Correction and further evaluation is recommended.

Recommendation: Contact a qualified siding specialist.

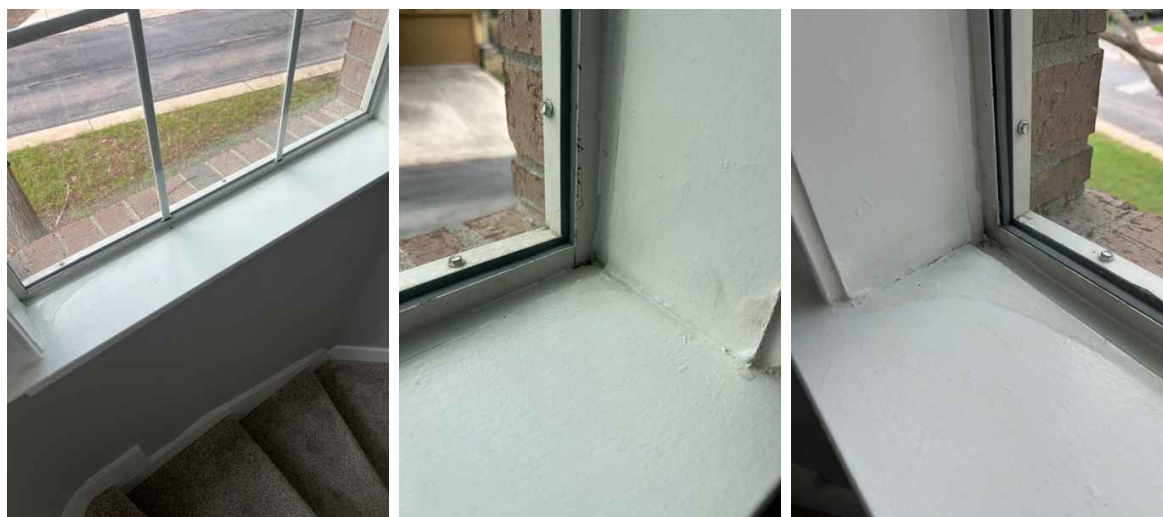
I observed indications of excessive moisture or water intrusion at a window. Aluminum windows often cause condensation which runs down to the window sill. Damage is often the result. Further monitoring and evaluation is recommended. Recommend a window repair professional inspect and repair as needed.

Recommendation: Contact a qualified window repair/installation contractor.

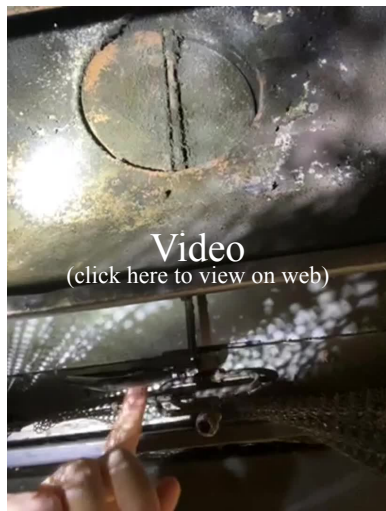
An inoperable damper is a condition that could allow toxic fumes into the home. In this case, the damper doesn't reliably stay shut, which allows air to draft in and out of the house.

Recommendation: Contact a qualified fireplace contractor.

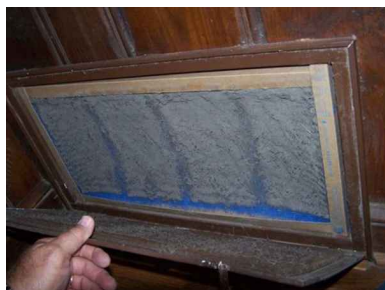
2: Corrosion in Catch Pan - Unit 1 & 2

Condensate catch pan was corroded in one or more areas. It appears adding insulation to the refrigerant lines could help reduce condensation. Although this is a common finding, the cause cannot be 100% determined by a visual inspection. Along with a general servicing of the systems, I recommend a HVAC contractor evaluate this issue and repair as needed.

Recommendation: Contact a qualified HVAC professional.

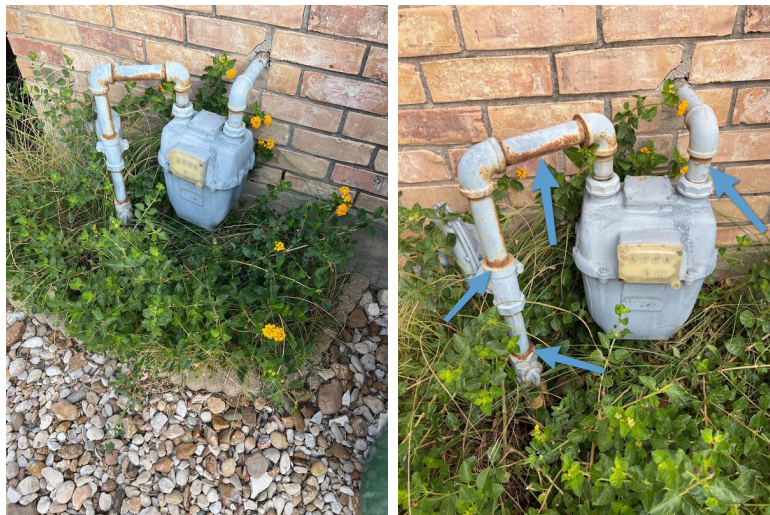
I observed some minor surface rust at the gas meter components. Monitoring recommended.

Recommendation: Contact your local utility company

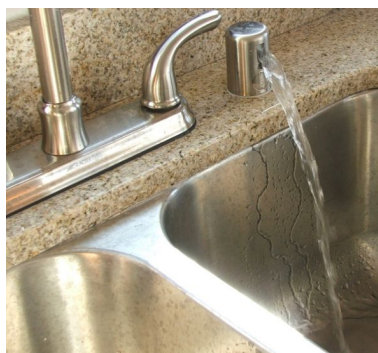
Sample - Air Gap

The alternative solution to the air gap component is the high loop. The air gap is a device that is actually mounted above the counter top surface. The high loop is when the drain hose is looped up and securely fastened to the underside of the counter.

A "high loop" on a dishwasher drain prevents dirty water from backing up into the dishwasher. Check local code requirements.

Recommendation: Contact a qualified appliance repair professional.

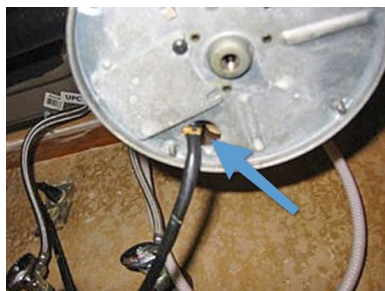
I observed indications of a missing electrical wire clamp at the garbage disposal. Recommend a licensed and qualified electrical contractor further inspect and repair or replace.

Missing Clamp

Recommendation: Contact a qualified electrical contractor.

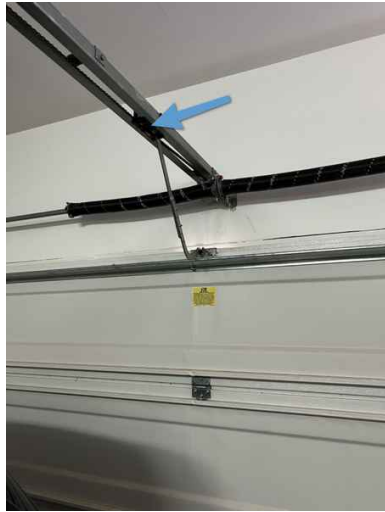
2: Weather Stripping at Garage Door in Poor Condition

I observed indications that the weather stripping at the garage door is in poor condition.

Recommendation: Contact a qualified garage door contractor.

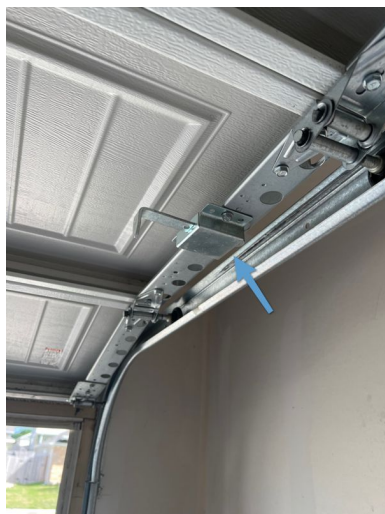
4: Door Locking Mechanism Present

This is a deficiency. Risk of damage to door and mechanical opener. Recommend removing or bolting the lock open.

Recommendation: Recommended DIY Project
