Inspection Report

Beach House In Galveston

PROPERTY INSPECTION REPORT FORM

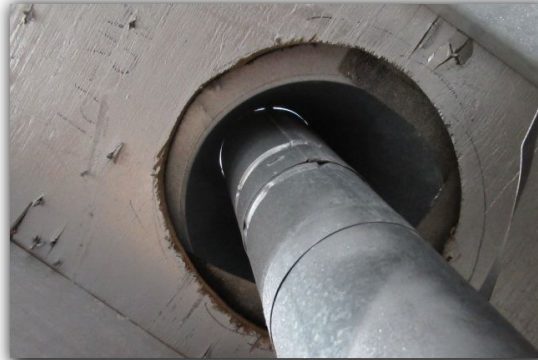
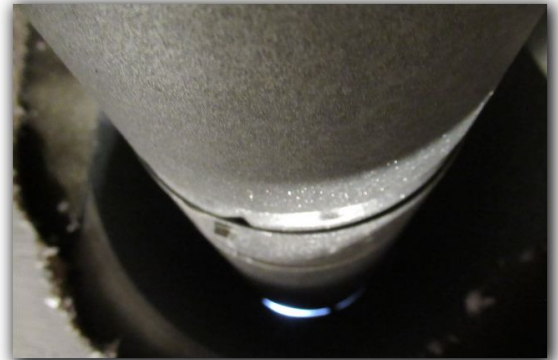
C. Roof Covering Materials

Comments: Both of the furnace flue pipes are not completely sealed at the rain collars on the roof as daylight can be seen around these pipes in the attic area.

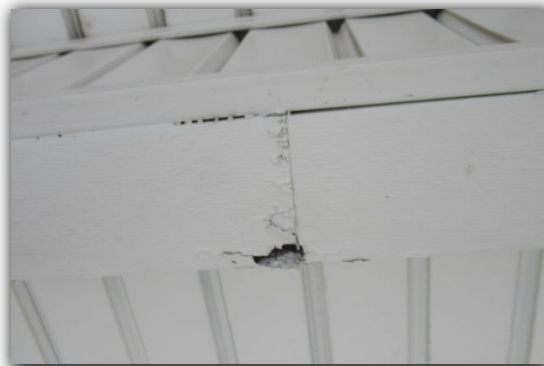
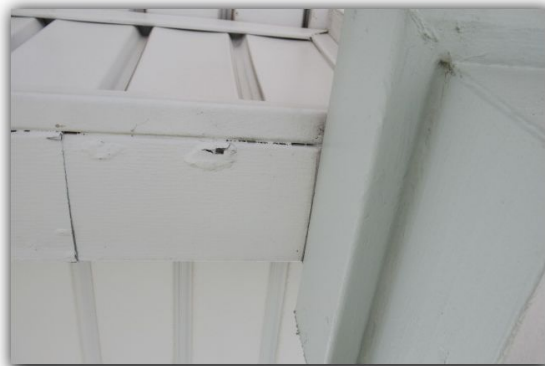
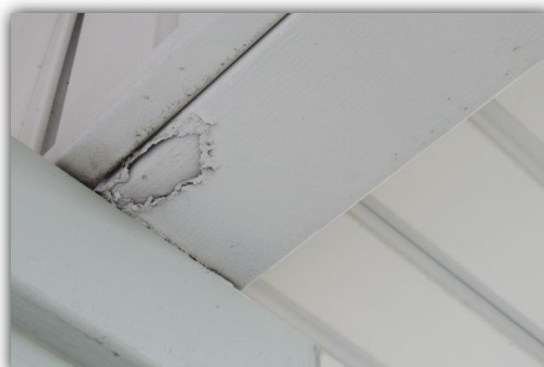
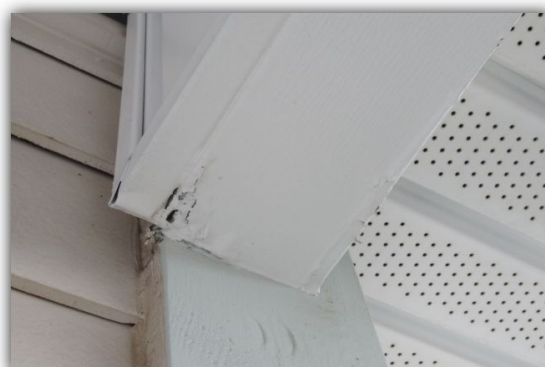
D. Roof Structures and Attics

Comments: There is a small amount of water damage and corrosion to the metal wrap over the supporting beams at the third level deck areas. All damaged elements should be repaired or replaced.

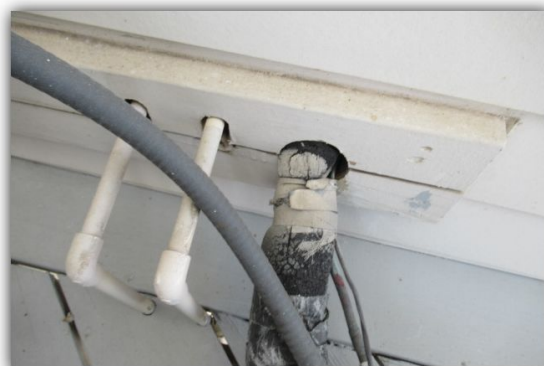
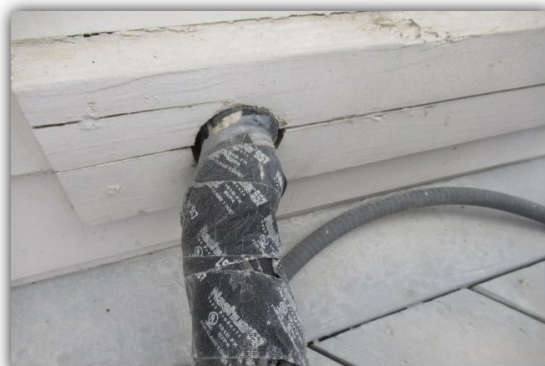
E. Walls (Interior and Exterior)

Comments: It is necessary to seal around where the air conditioning refrigerant lines and plumbing lines enter the home to prevent water/moisture intrusion.

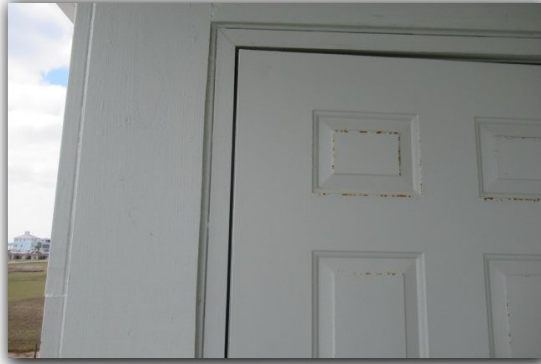
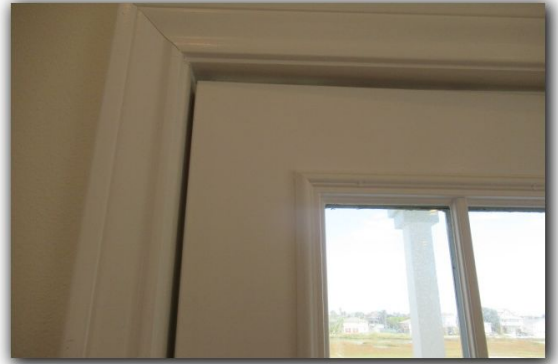
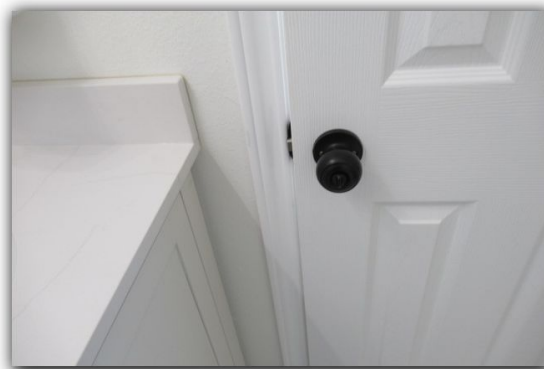
G. Doors (Interior and Exterior)

Comments: The exterior storage closet door off the third level deck, the exterior door to the third level deck, and the master bathroom door stick when operated. All doors should be present and in working order. Doors that stick or do not latch properly can usually be adjusted.

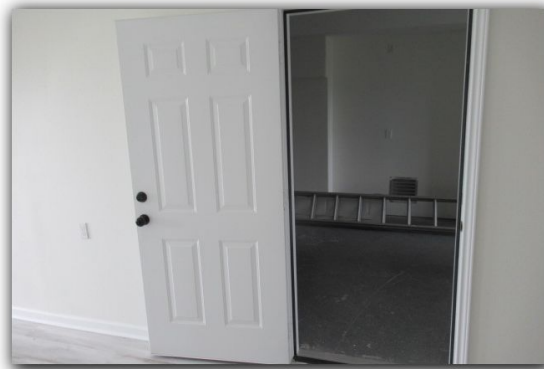
There is no self closing device installed on the door from the house to the garage.

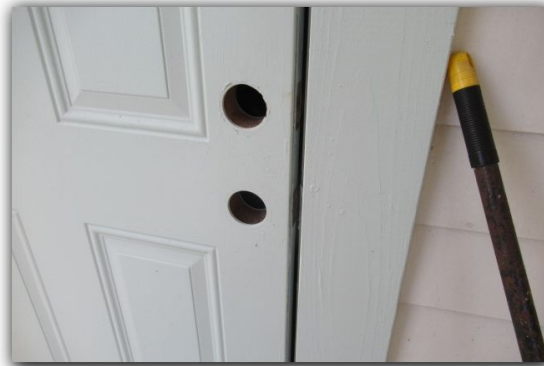
The door hardware is incomplete at the exterior closet ground floor door.

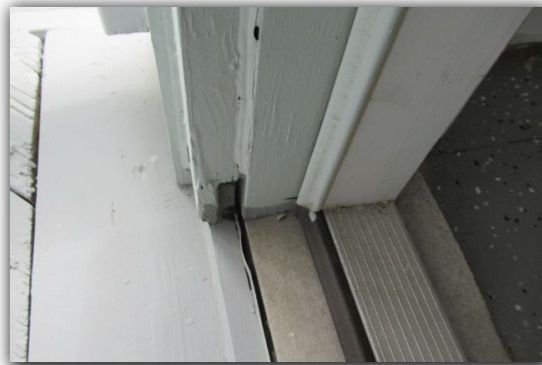
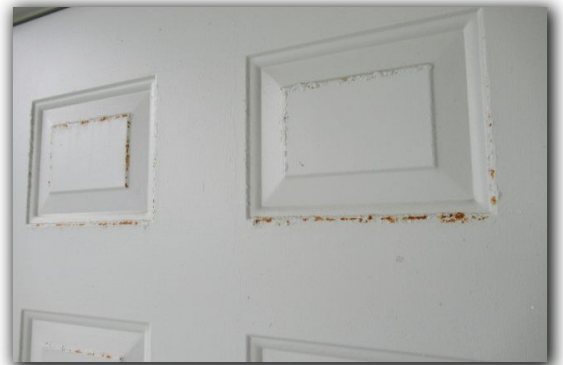
The exterior trim has been water damaged and there is corrosion at the exterior storage closet door off the third level deck. All damaged elements should be repaired/replaced.

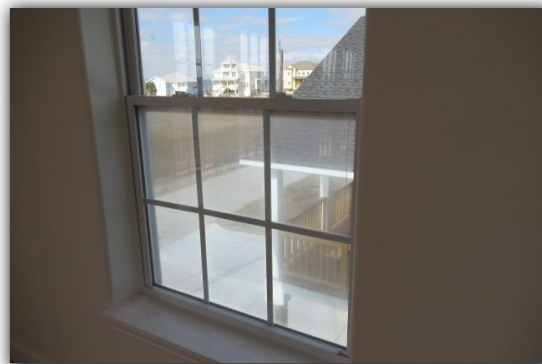
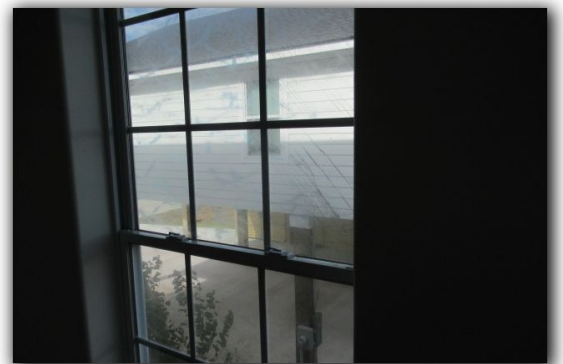
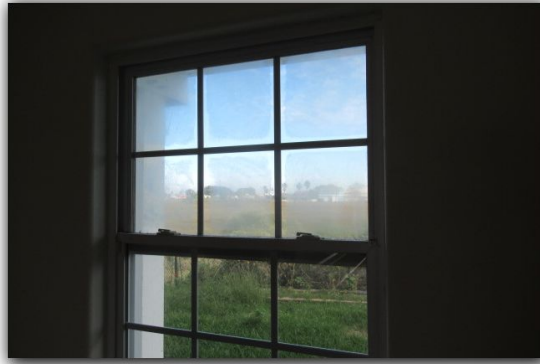
H. Windows

Comments: The thermo pane window on the northwest side of the living room, the window on the northwest side of the rear north guest bedroom, and the window in the back of the garage appear to have lost their seal as there is discoloration between the glass panes.

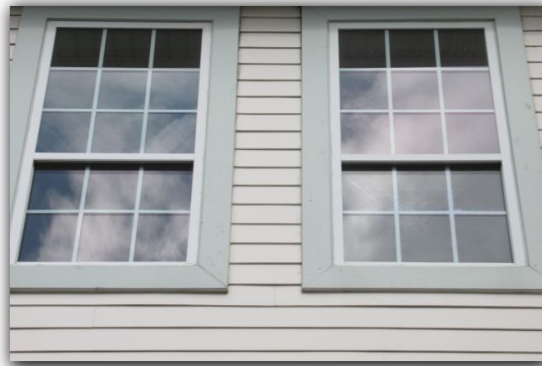
Window screens were not installed. Screens are mentioned in this part of the report as they are a specific item in the T.R.E.C. Guidelines. All windows that have channels for screens should have them installed.

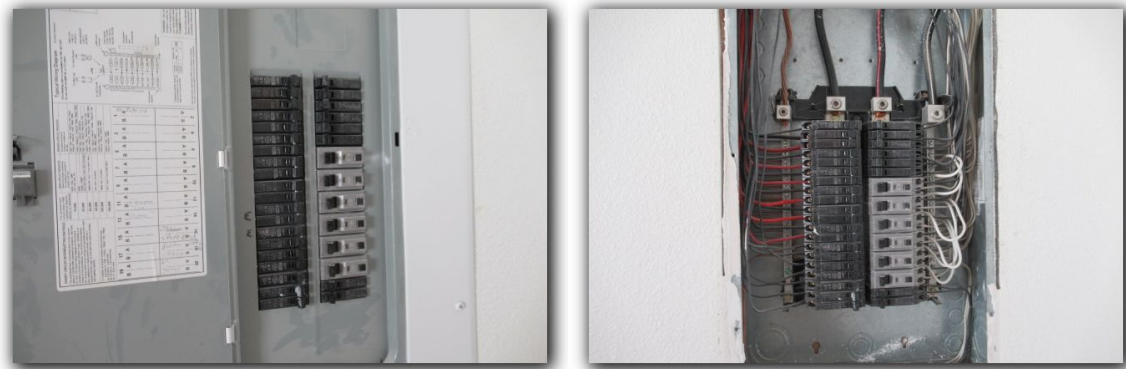
A. Service Entrance and Panels

Location of Breaker Box: Northwest side of garage (Main disconnect) with breaker box inside the 2nd floor middle guest bedroom

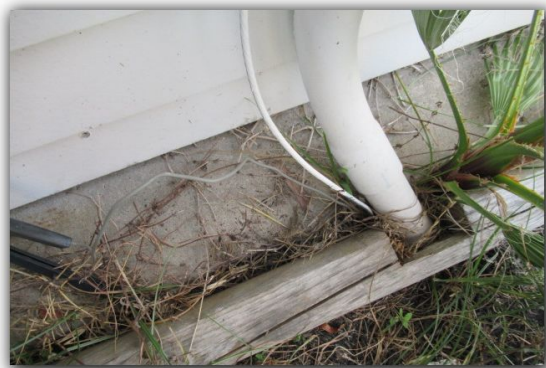
Comments: The grounding cable connection was not visible. The dedicated ground wire should be fastened or secured to the grounding rod with an approved grounding electrode (clamp). This connection should be made above the finish grade. A typical grounding rod in this area should be seven to eight feet in length.

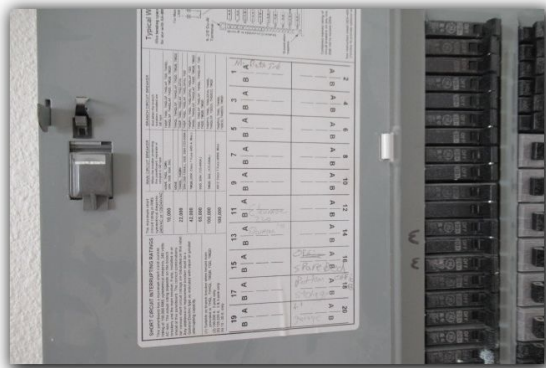
The breakers were not labeled completely at the service box as required.

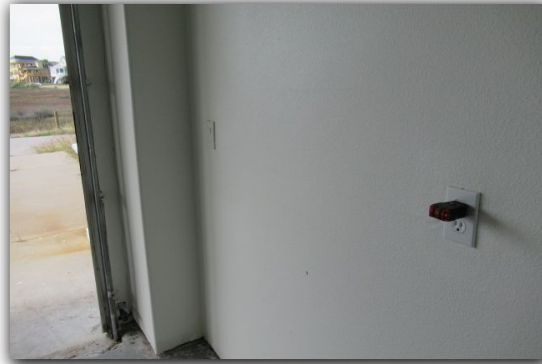
B. Branch Circuits, Connected Devices, and Fixtures

Comments: The outlets in the garage are not protected by a G.F.C.I. (Ground Fault circuit interrupt) breaker. This is required statement by the T.R.E.C.. G.F.C.I. Breakers are required for all outlets within 6' of any water source inside the house, bathrooms, wet bars, or utility room sinks, all exterior outlets, all outlets in the kitchen and all outlets in the garage.

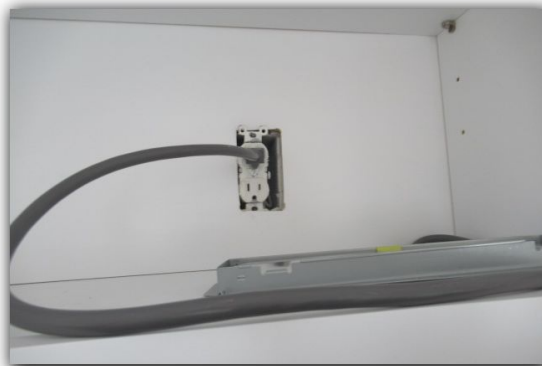
An electrical fixture face plate was missing inside the cabinet above the microwave. Face plates that are missing for either light switches or electrical outlets are considered a safety concern and is an item that is specifically checked in a real estate inspection.

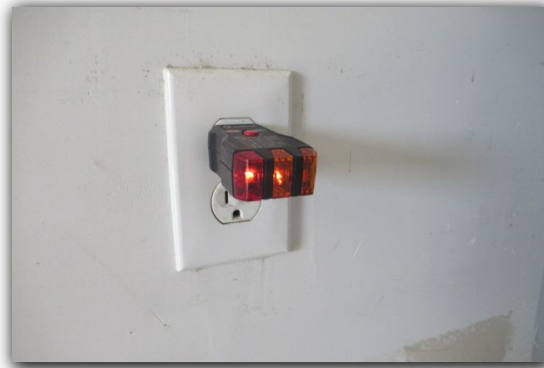
A polarity problem was detected as the hot and neutral wires appear to be reversed at the outlet inside the first level storage closet in the back of the home. Outlets are checked using a circuit tester. As fixing one outlet may cause other outlets down the line to have problems, I recommend that the system in this/these areas be serviced by a licensed electrician.

A licensed electrician should be consulted regarding the repair of the above items as well as check the entire electrical system for any other possible defects.

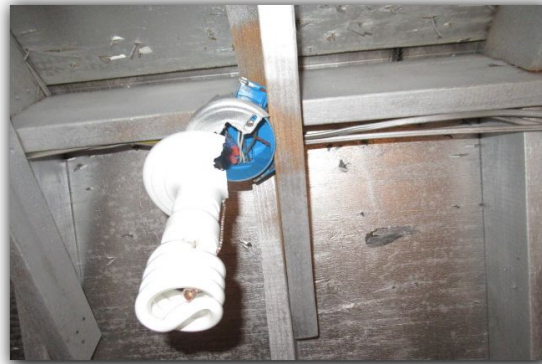
There is a damaged/incomplete light fixture in the attic.

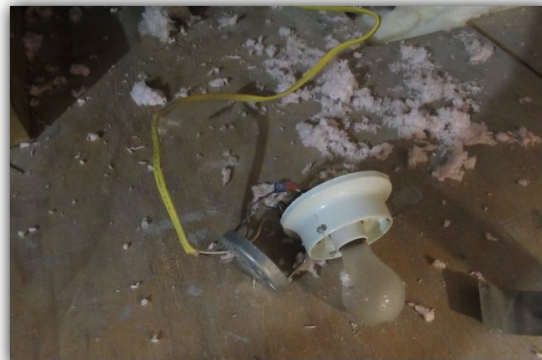
Wires were improperly spliced terminated at the light fixture in the attic at the water heater/elevator equipment area. Wire ends or splices should be in junction boxes that are properly mounted. This condition is considered an electrocution/fire concern and should be serviced by a licensed electrician.

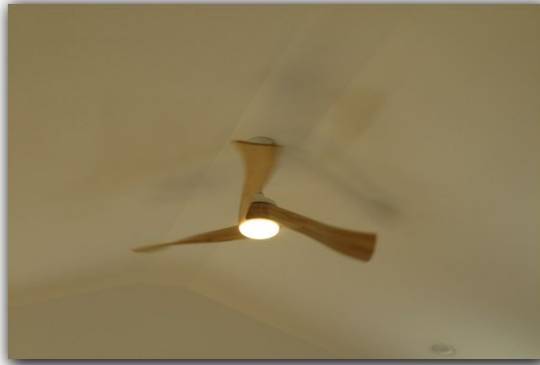
The ceiling fan in the living room is out of balance.

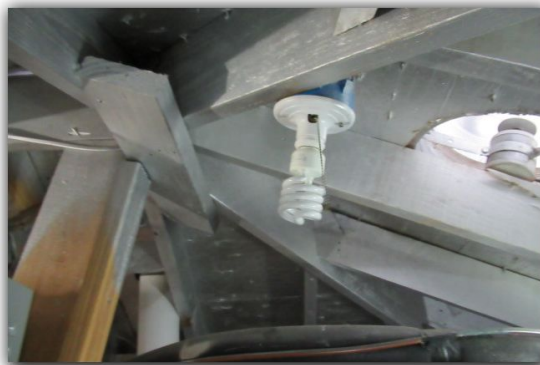
One of the lights in the attic near the water heater was not working. This condition may be a result of a need for light bulb replacement.

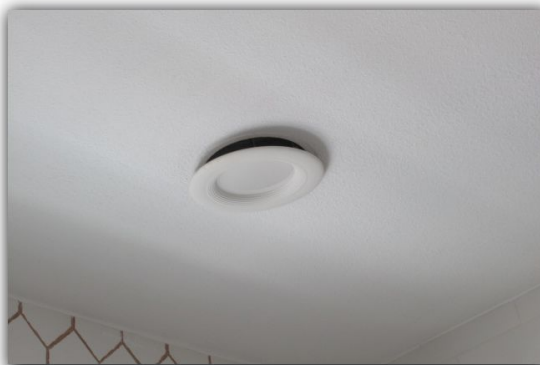
The light fixture in the master bathroom shower area is not flush with the ceiling.

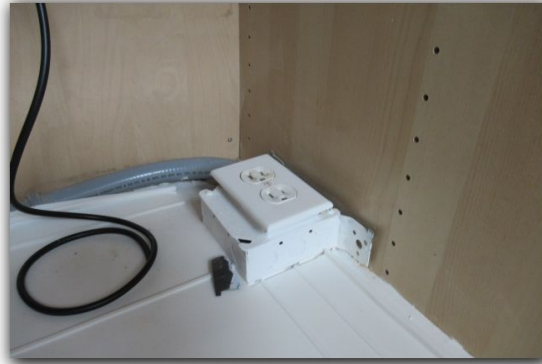
The outlet for the garbage disposal under the kitchen sink mounted on the cabinet floor should be mounted on the side or back of the cabinet to avoid possible water intrusion.

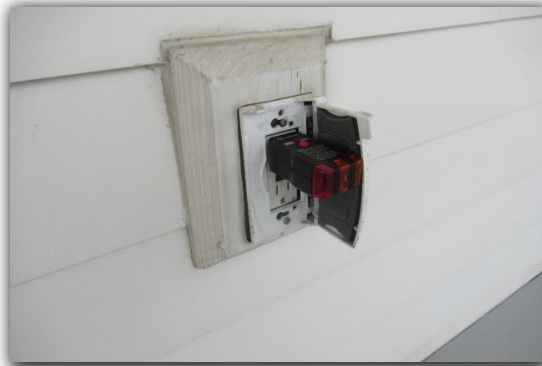
There was no power to the exterior outlet at the third floor back balcony.

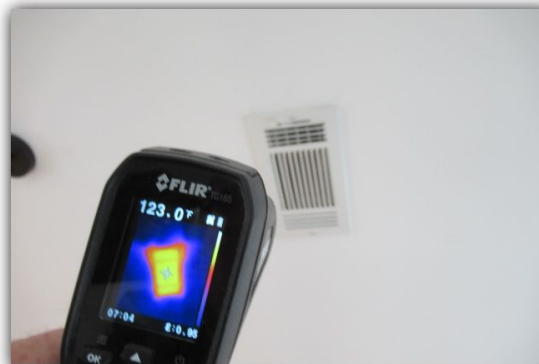
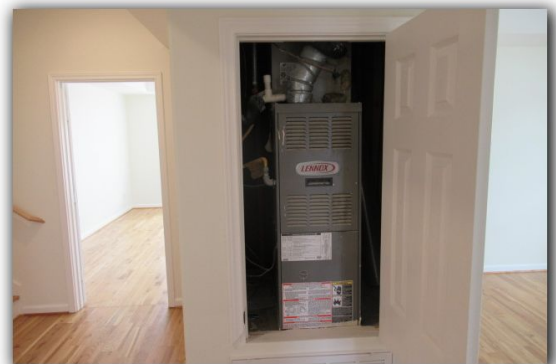
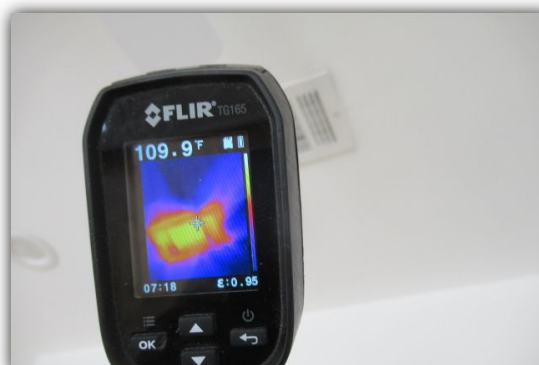
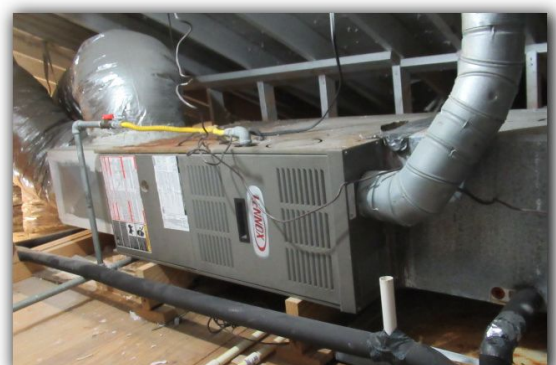
Comments: The second floor zone furnace flue pipe is in contact with the AC refrigerant line insulation. Gas appliance flue pipes must have a minimum of 1" clearance from any combustible materials.

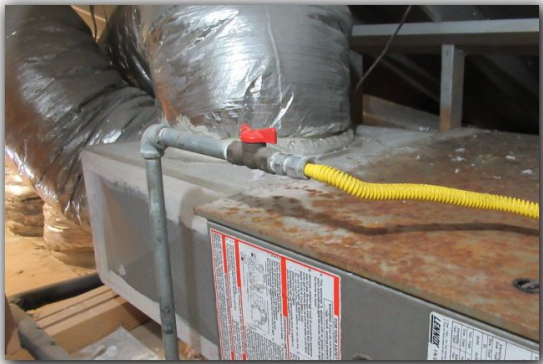
There are no condensate drip legs/sediment traps installed on both of the furnace gas supply lines as is now required.

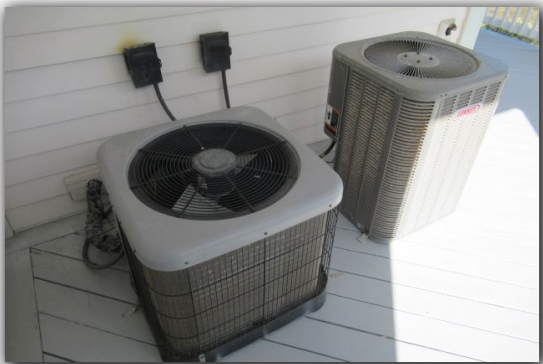
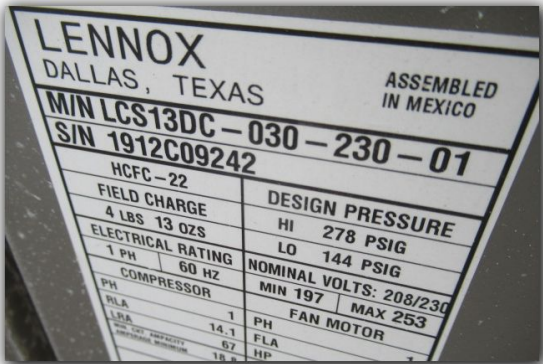
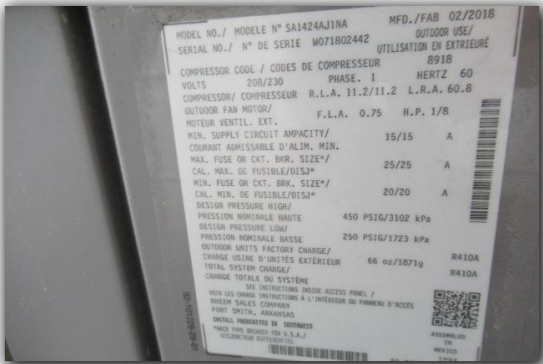
B. Cooling Equipment
Type of Systems: Central - Air Conditioner
Exterior Compressor: 2.5 and 2 ton units

Differential Air Temperature Drop During Operation:
2nd Floor Zone Air Going Into System: 70 f Returned Air: 52 f

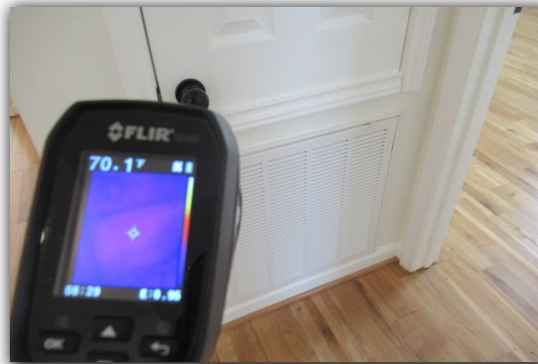
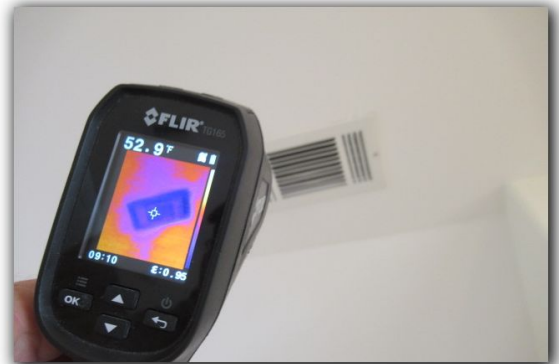
The air coming out of the vents should be 14 to 21 degrees cooler than where it goes into the cold air return. These readings are within the recommended tolerances for proper operation.

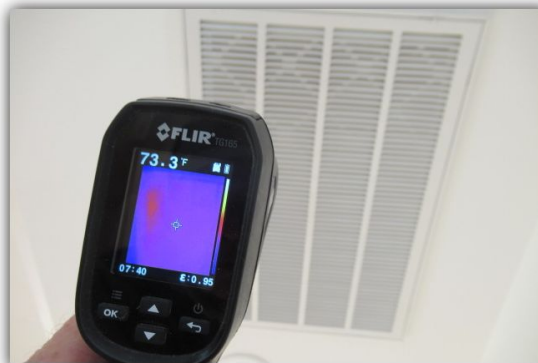
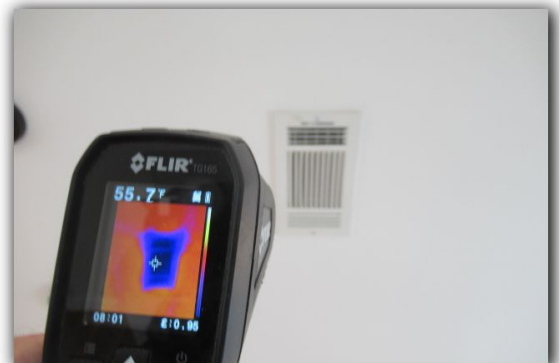
3rd Floor Zone Air Going Into System: 73 f Returned Air: 55 f

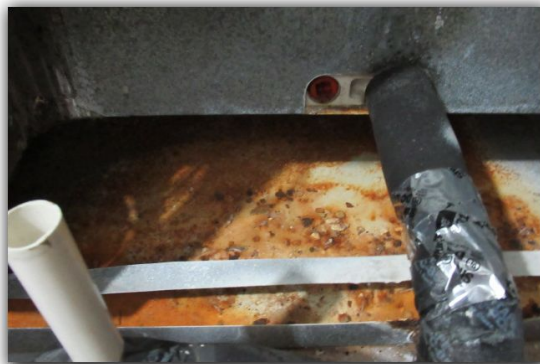
Comments: There was corrosion in the safety pan under the third floor coil box. This condition is an indication that the unit has leaked in the past or leaks during heavy use.

A qualified HVAC technician should be consulted regarding the repair of the above items as well as check the entire cooling system for any other possible defects.

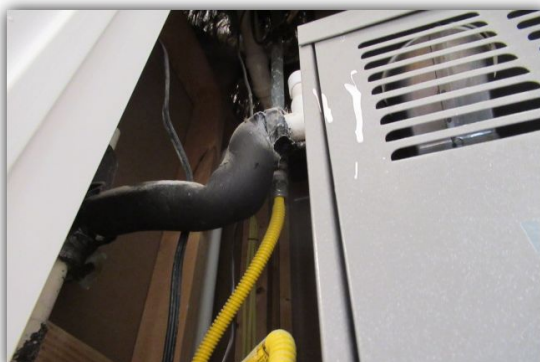
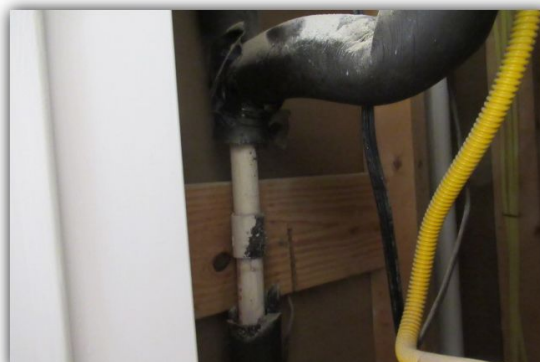
The main drain line from the second floor zone coil box is not fully insulated. This line should be insulated for at least 10' from the coil box unit. This condition causes the lines to sweat and may also cause water damage because they are located in the attic area. Applying foam tubes and taping them will remedy this condition.

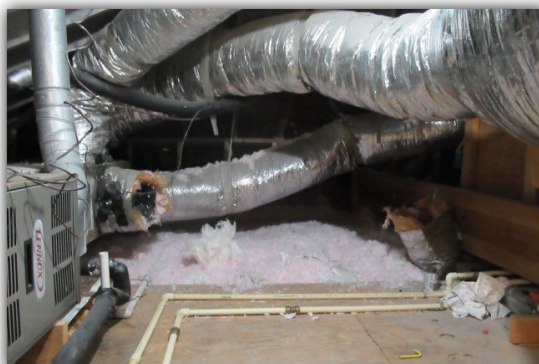
C. Duct Systems, Chases, and Vents

Comments: A section of the duct has been removed in the attic above the dining area. A qualified HVAC contractor should be consulted regarding the repair of this condition.

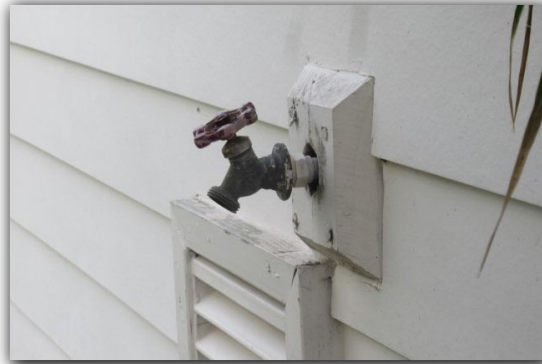
A. Plumbing Supply, Distribution Systems and Fixtures

Comments: All exterior faucets should have back flow protectors installed. Anti-siphon devices keep contaminated water from entering the potable water of the house plumbing. These devices are inexpensive, easy to install, and can be found in most home improvement stores.

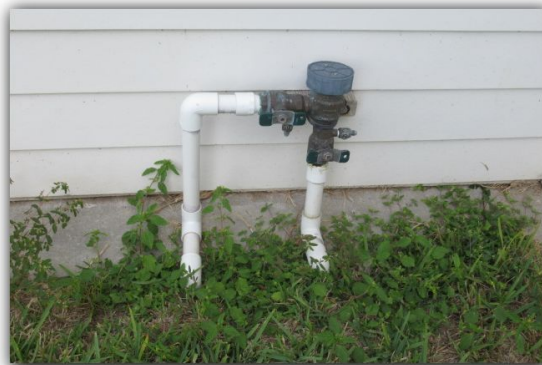
It is recommended that all of the exterior water lines be insulated from the weather in order to prevent freezing.

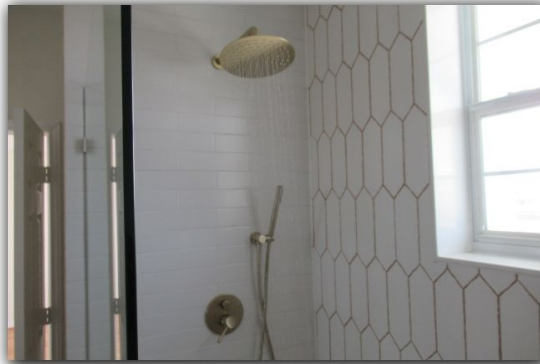
It is recommended that there be an inspection port provided on the back side of the plumbing wall of the walk in shower in the master bathroom so that it is possible to check for leaks.

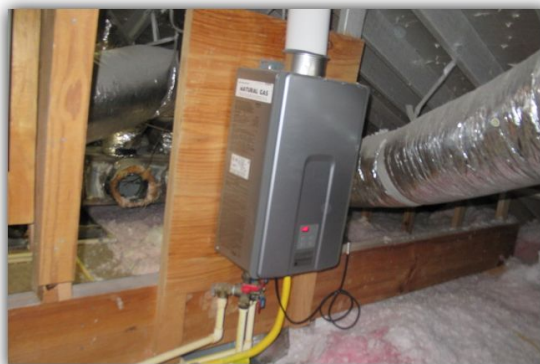
Comments: There was no condensate drip leg/sediment trap installed on the water heater gas supply line as is now required.

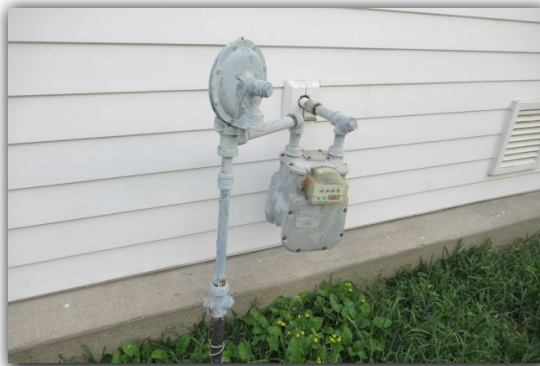
Location of gas meter: Northwest side of the home

Type of gas distribution piping material: Black Pipe

Comments: Performing properly

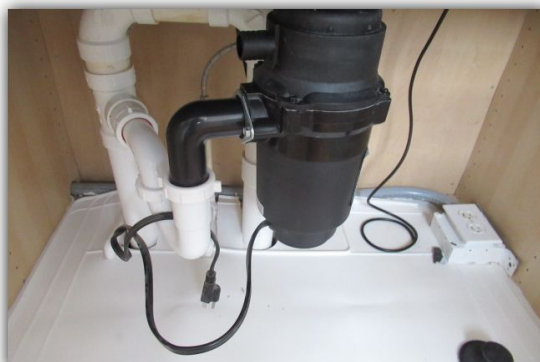
B. Food Waste Disposers

Comments: The garbage disposal is not connected to the electrical power supply.

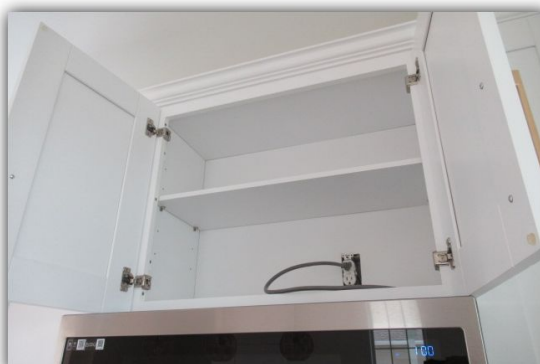
C. Range Hood and Exhaust Systems

Comments: The range top has a re-circulating vent hood. The air is filtered, and then it is re-deposited in the kitchen. Most vent-hood appliances, especially ones that use gas, will have a flue which is terminated outside of the house to remove combustion products, moisture, grease, and heat.

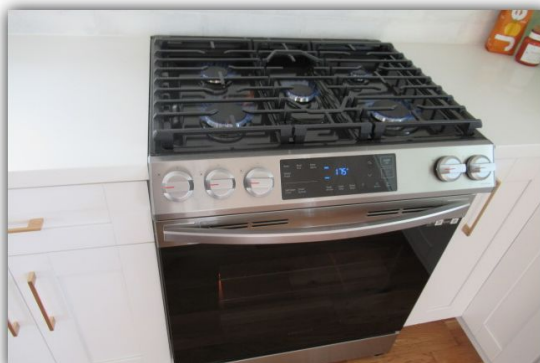
D. Ranges, Cooktops, and Ovens

Comments: The range appears to be performing properly at this time.

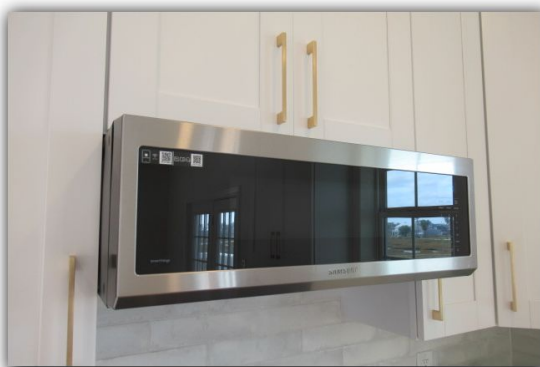
E. Microwave Ovens

Comments: Appears to be performing properly at this time.
