# Inspection Report

Houston Inspection Report

Sunday, October 19, 2025

# PROPERTY INSPECTION REPORT FORM

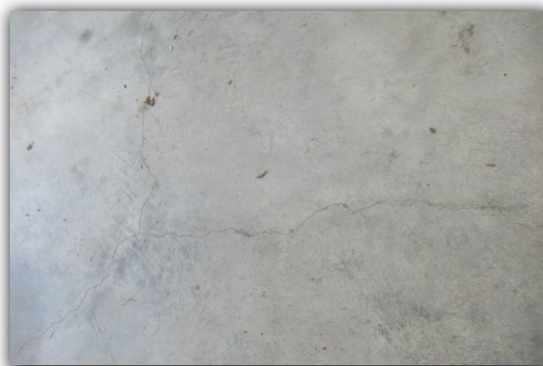
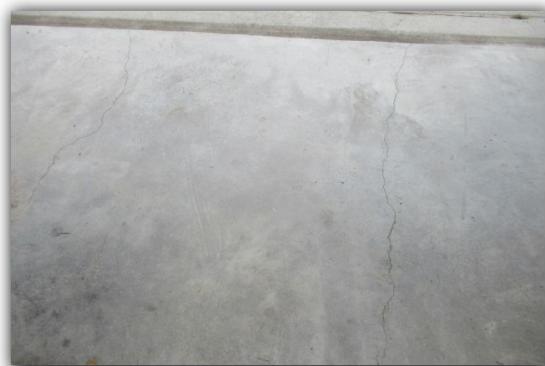
There were small cracks in the finished concrete surface of the garage. These cracks should be monitored for further activity.

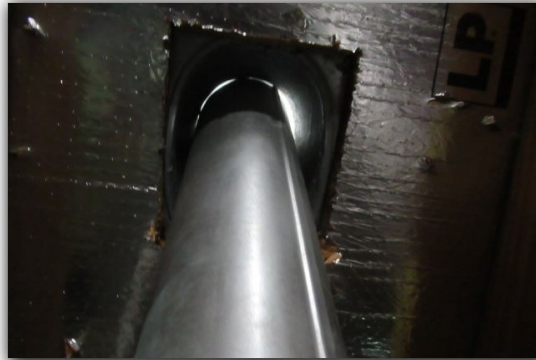
**Comments:** The water heater flue pipes are not completely sealed at the rain collars on the roof as daylight can be seen around these pipes in the attic area. A qualified roofing contractor should be consulted regarding this condition as well as check the entire roof covering for any other possible defects.

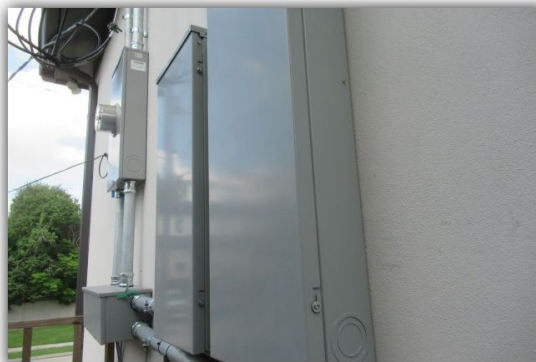
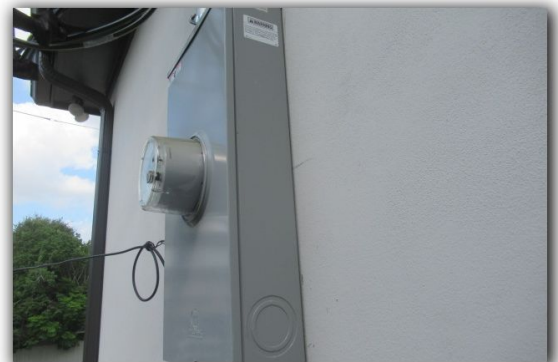
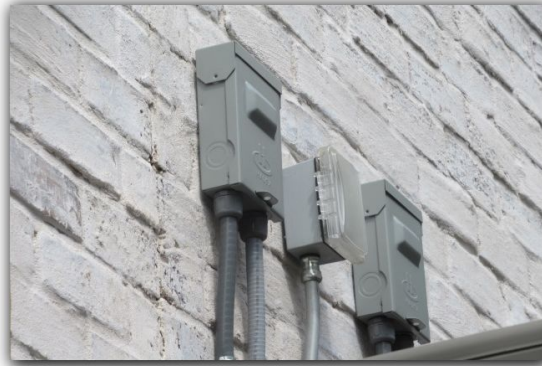
**Comments:** It is necessary to seal around the electric breaker box, the electric meter box and the air conditioning compressor quick disconnect boxes to prevent water/moisture intrusion and corrosion to the metal boxes.

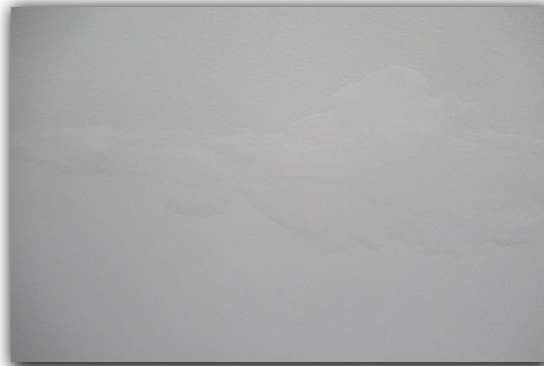
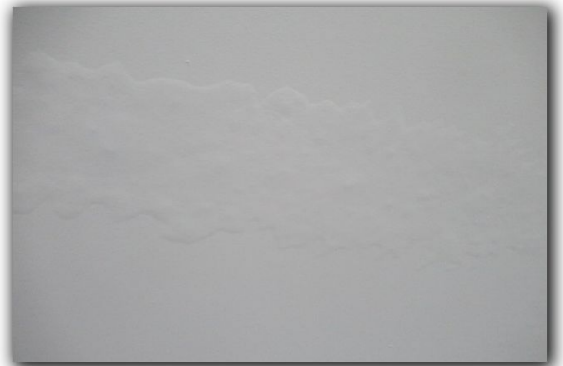
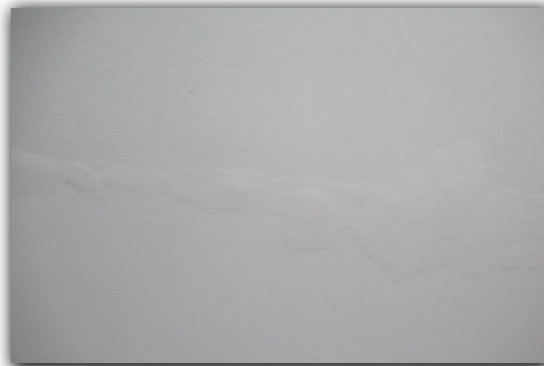
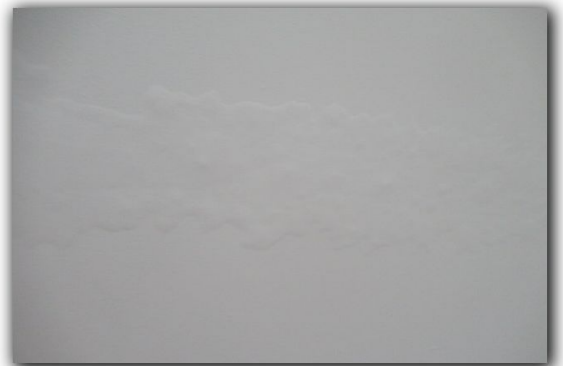
**Comments:** Damaged sheetrock was observed on the ceiling in the bonus room above the garage that may have been caused by water/moisture in this area. This area was dry when tested. Leaks inside the ceilings can cause hidden or concealed damage. All damaged elements should be repaired or replaced. The reason for the condition was not determined. A qualified contractor should be consulted regarding this condition.

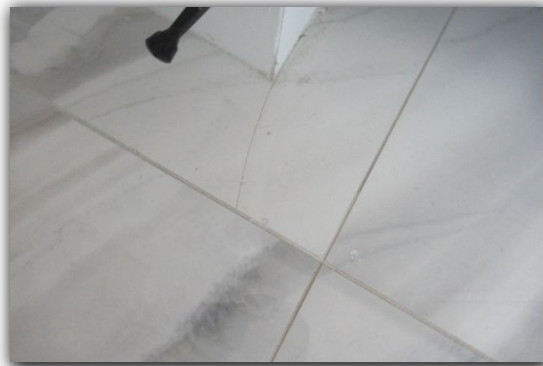
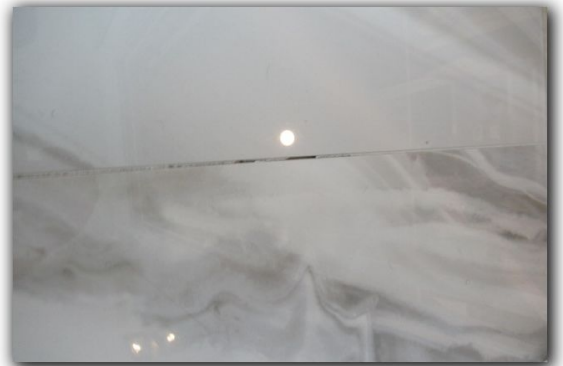
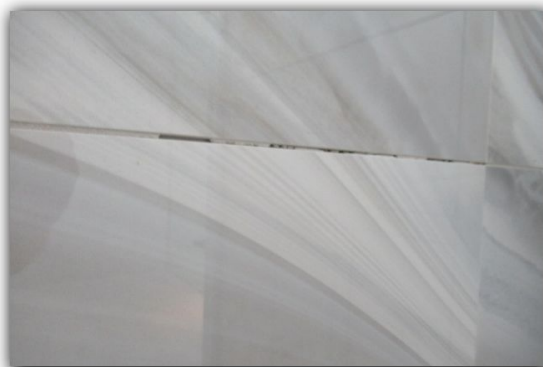
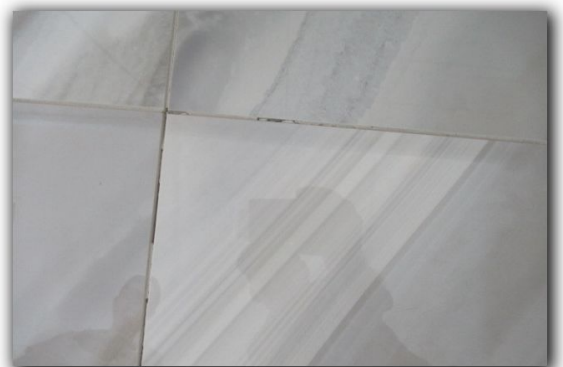
There is cracked marble floor tile and some incomplete grout in the master bathroom. It was also noted that some of the marble floor tiles are not well secured and move when stepped on. A qualified tile contractor should be consulted regarding this condition.

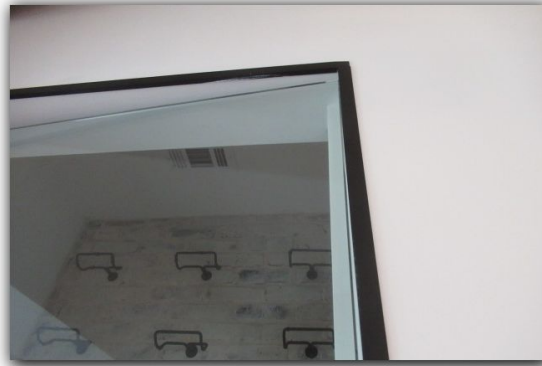
The front wine room door in the entry hallway hits the trim before it can be opened.

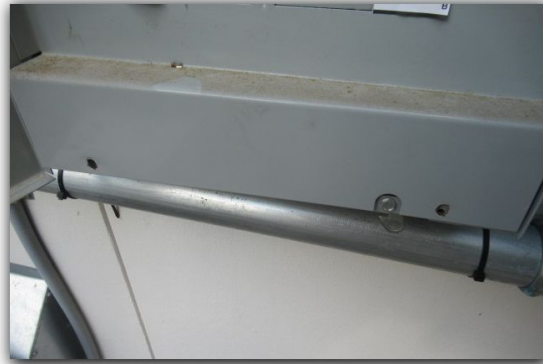
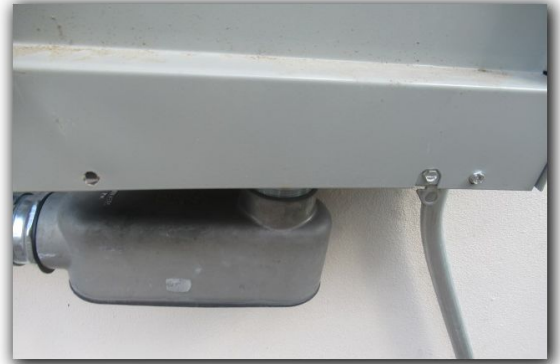
**Comments:** Three of the dead front barrier screws were missing.

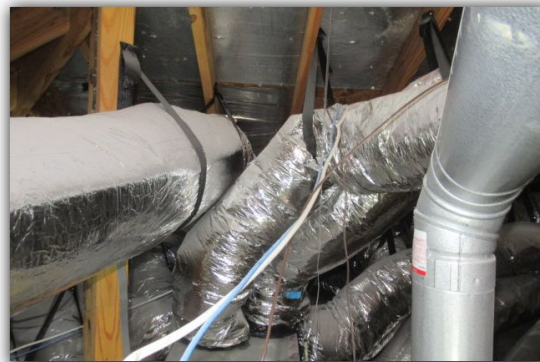
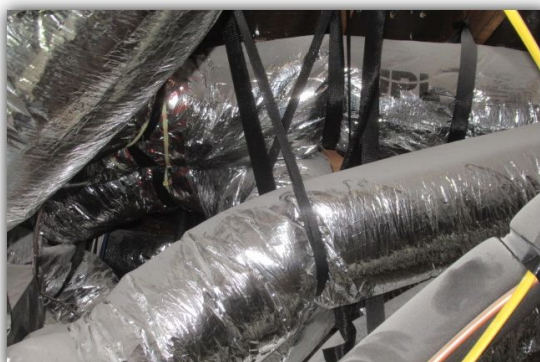
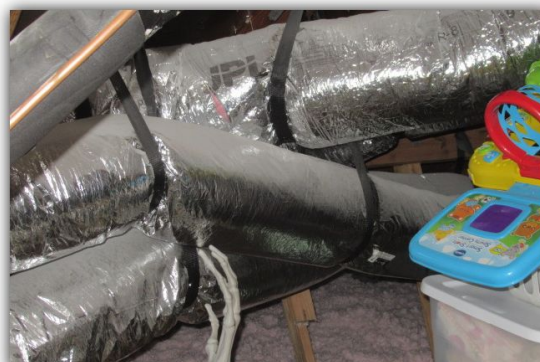
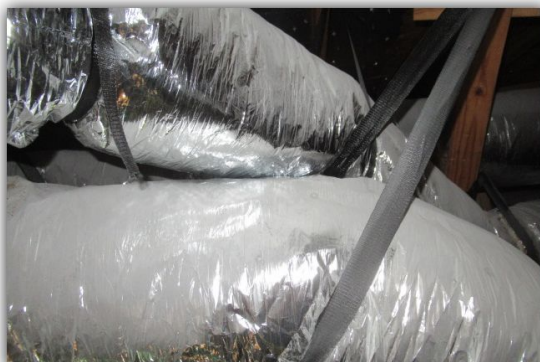
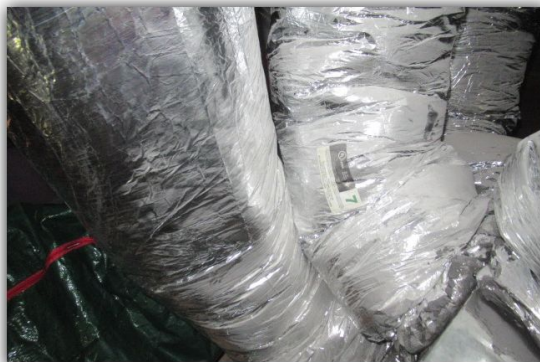
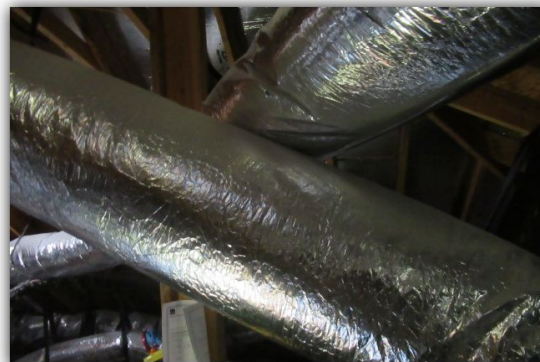
**Comments:** Ducts in the attic area are in contact with each other which may cause condensation and damage to the outer coating. These ducts should be separated a minimum of one inch or unfaced insulation placed between them.

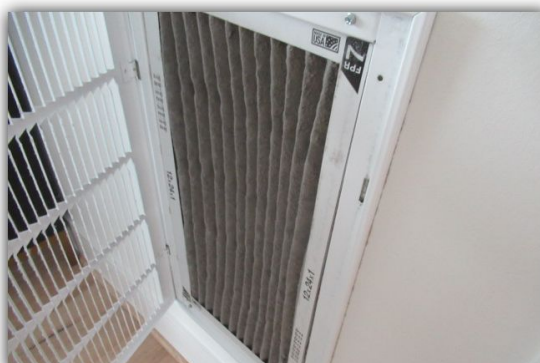
The filter/filters in the return air chase/chases were dirty. Proper filtering of the air is important. A defective filtering system can lead to dirty evaporative coils and allergy problems. It is a good idea to change these filters every month or as suggested by the manufacturer.

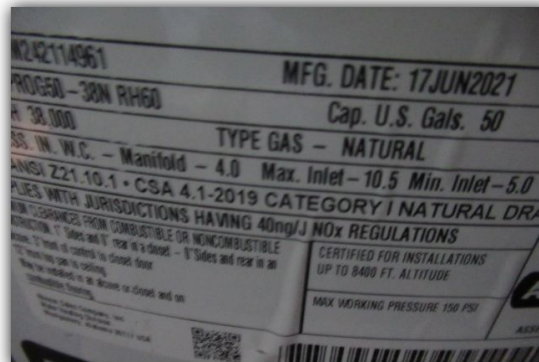
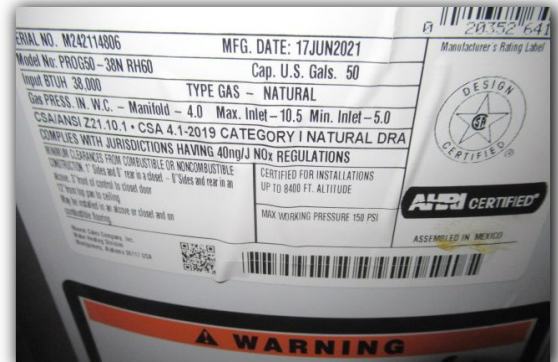
**Comments:** The flue pipe is not attached and centered over the exhaust orifice for one of the water heaters as intended.

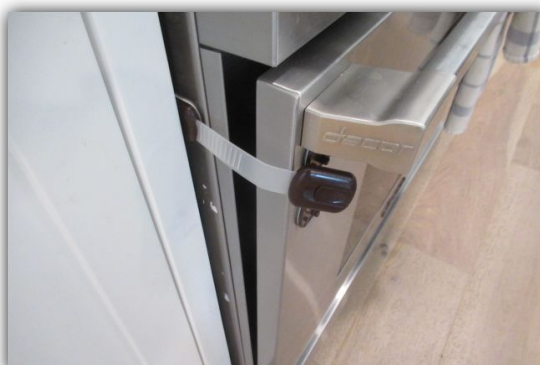
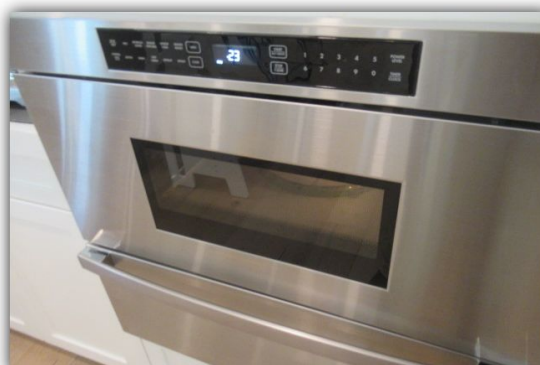
**Comments:** The oven door on the range would not stay all of the way closed.

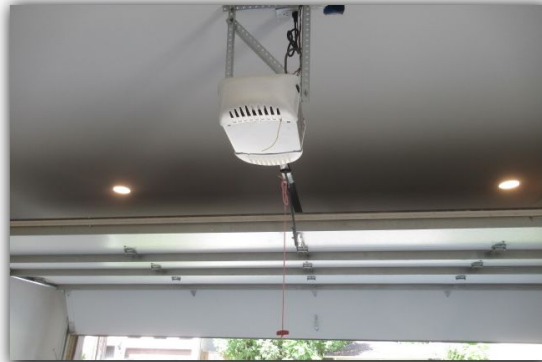
**Comments:** The safety reversing mechanism did not operate. When the inspector tests the safety reversing mechanism of the overhead garage door, the motor should reverse itself. (5 lbs of pressure over a 2 second period should be sufficient to reverse most doors) Failure to reverse is considered a recognized safety concern by the Texas Real Estate Commission (T.R.E.C.) These motors can usually be adjusted.
