The project consisted of a new 6-story office building located in Lehi, Utah. As a cost savings measure Aggregate Piers were proposed in conjunction with the project Geotechnical Engineer as a value engineer alternate to over-excavation of weak sandy clay fill material. Not only did the piers save on project cost but also on overall schedule.

Project Details:

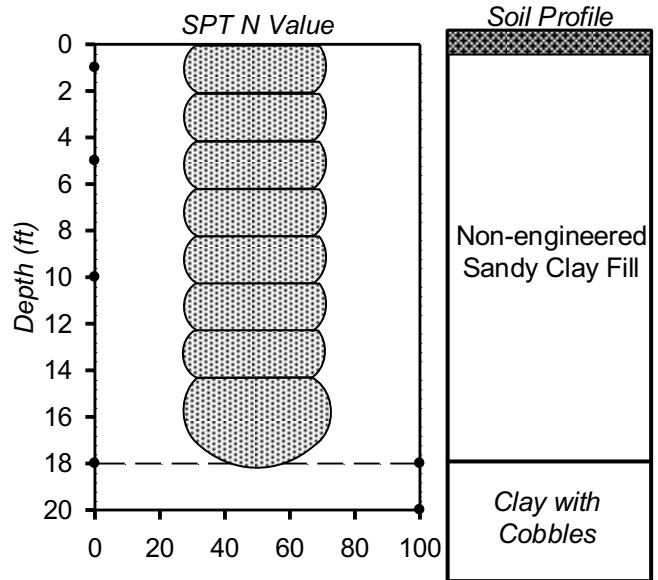
Soil Profile:

The soil profile showed an 18’ thick layer of non-engineered sandy clay fill. Below, a hard clay with cobbles layer with SPT N values of 50 or more was encountered.

The aggregate pier design was made considering that all the aggregate piers were going to penetrate into the hard clay with cobbles layer.

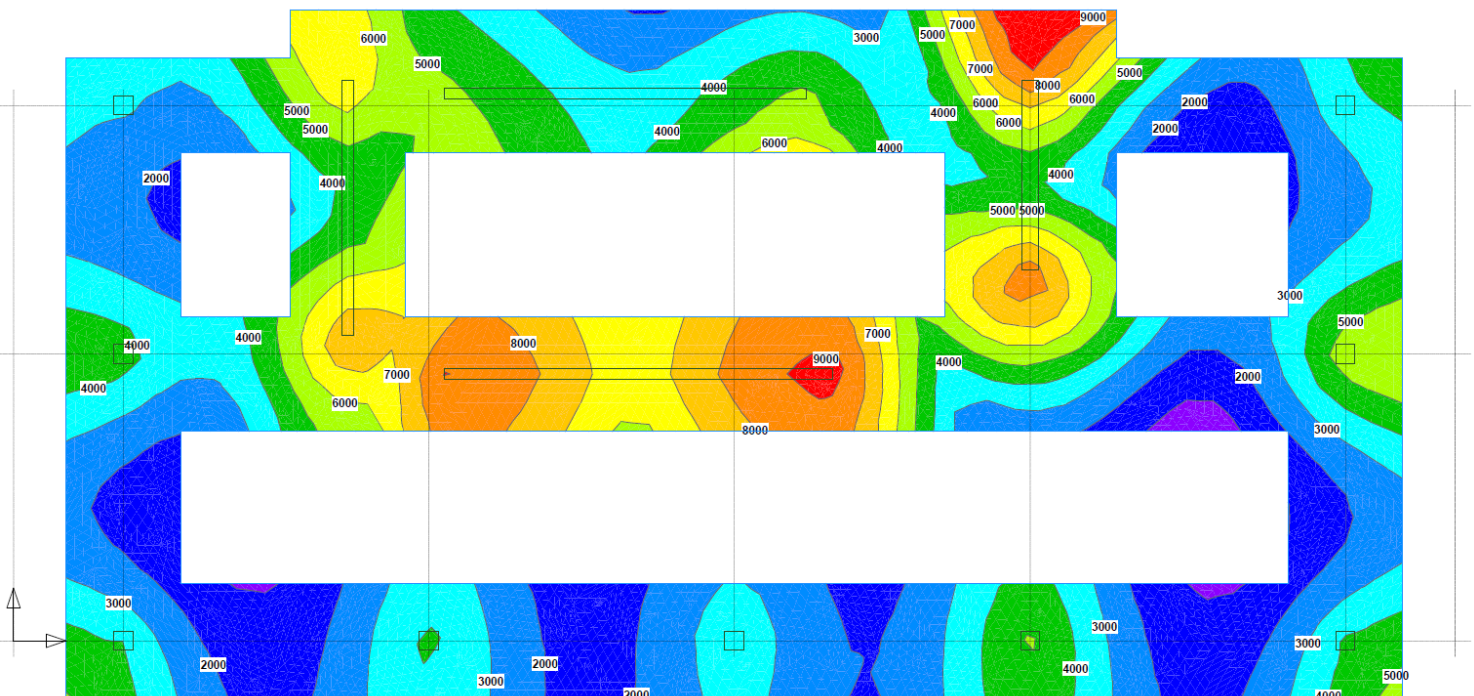
Bearing Capacity Heat Map

Due to seismic loads and overturning moments, the soil bearing capacity needed was not uniform. In some areas it was as low as 2,000psf but in others it was up to 10,000psf. To ensure uniform settlement through the entire footprint of the building, the aggregate pier distribution was adjusted to match the varying pressure. Areas of high applied load required closer pier spacing than that of lower applied loads.

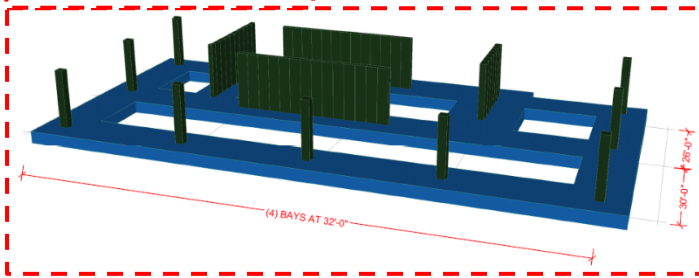
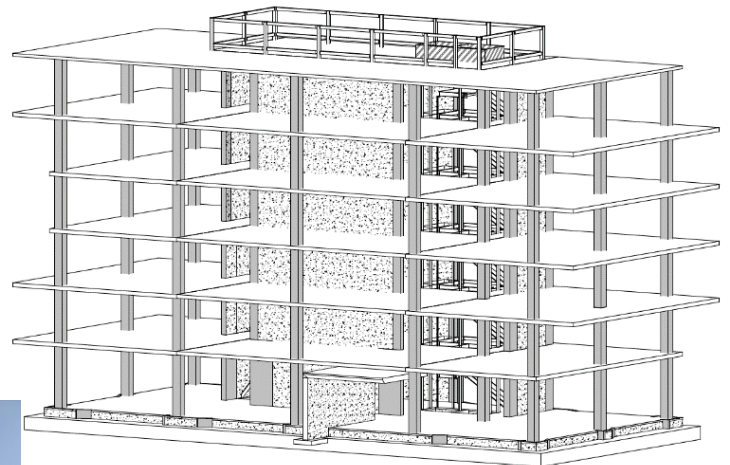
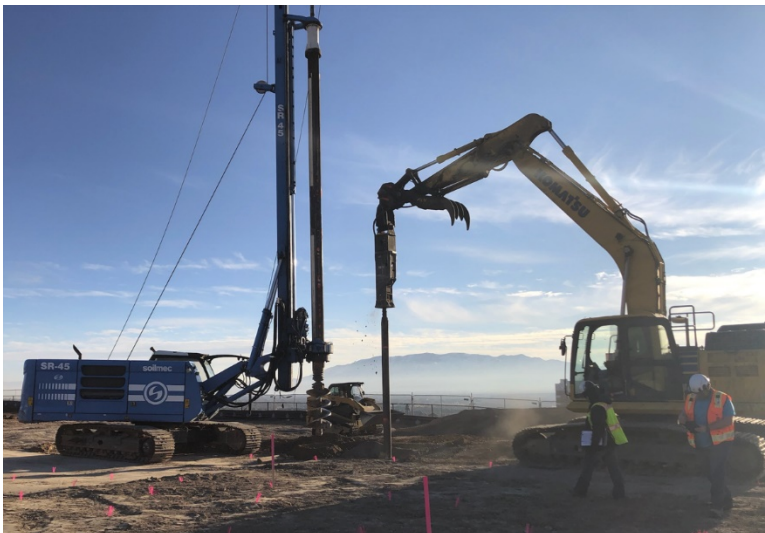
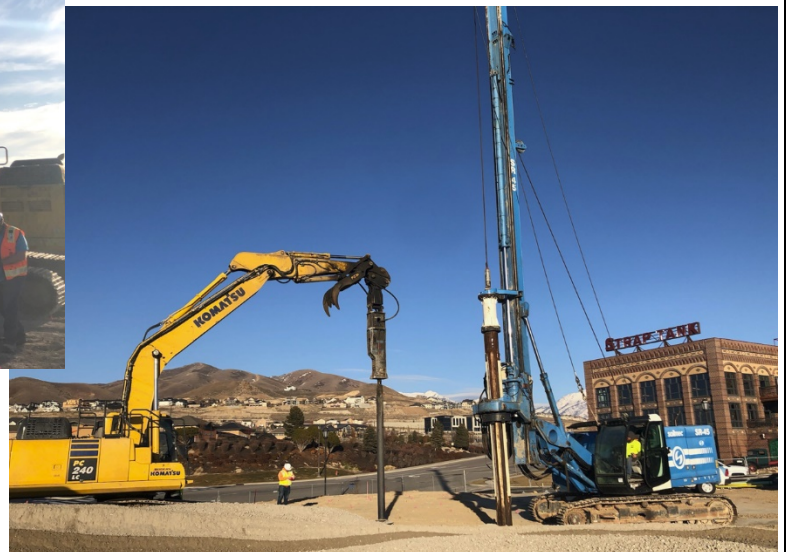
3D Foundation Model

- 220 Aggregate Piers installed.
- The Aggregate Piers were designed to mitigate compressibility of a non-engineered sandy clay fill overlying a hard clay with cobbles layer and to increase the bearing capacity up to 10,000 psf.
