BACKGROUND:

SCOPE OF WORK

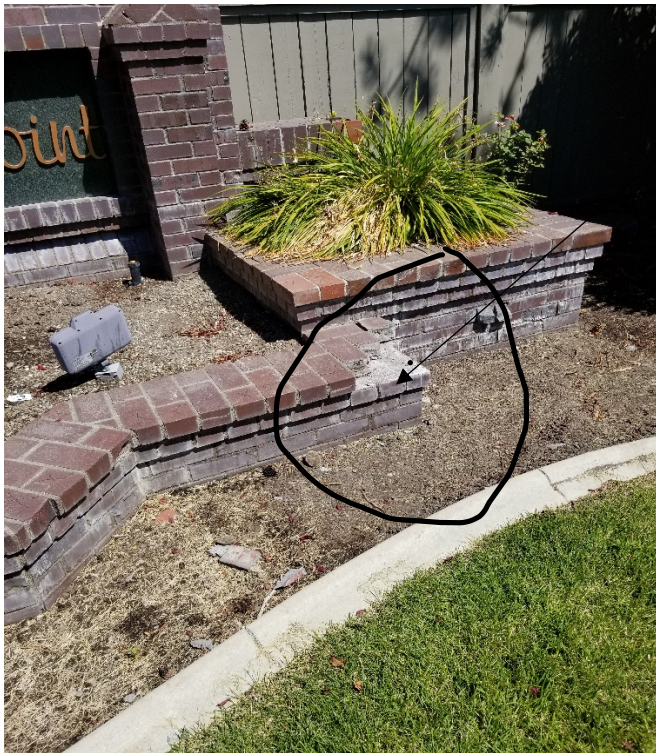
The planters have an 11 "wide brick cap around the perimeter. Remove the top row **only** from all of the planters and **salvage the good bricks.**

Use the salvaged bricks for repairs in other areas. Save and store any remaining salvaged bricks on a pallet behind the Center Street monument out of sight.

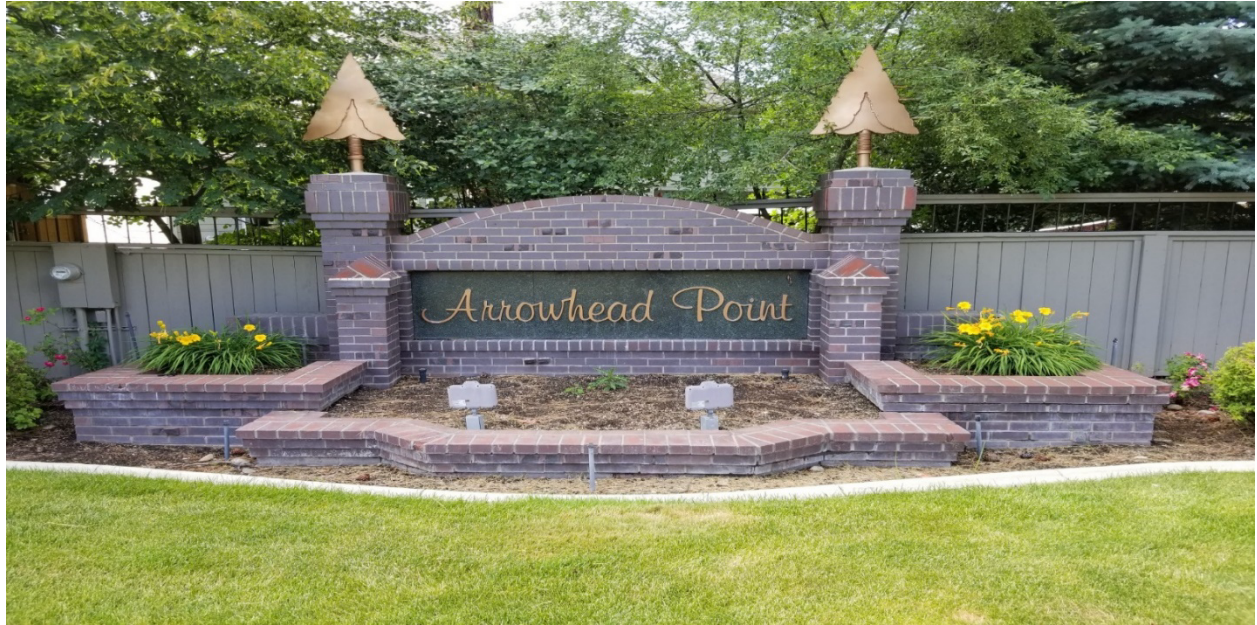
Remove top course of bricks from planters and salvage good brick for use in other areas with spalled or damaged brick.

Install precast coping cut from 12"x48" units.

See plan view for more dimensions

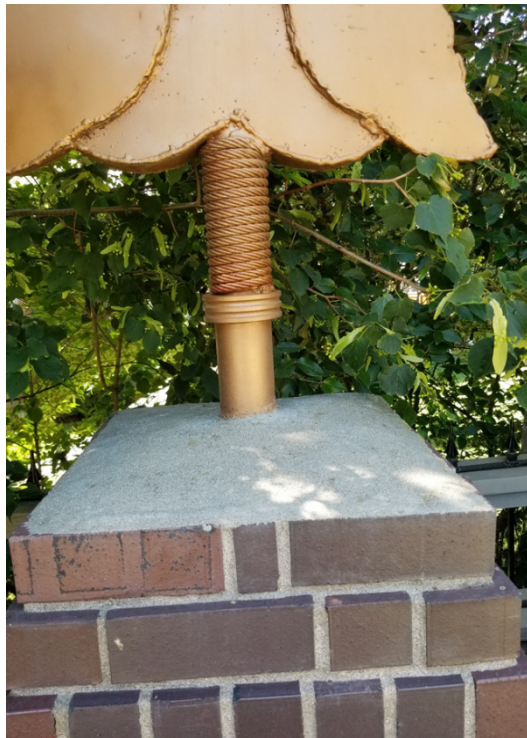
This arrowhead is from Wilson Street and is correctly mortared with a slope. However, the design is poor because the concrete cap does not overhang the brick column

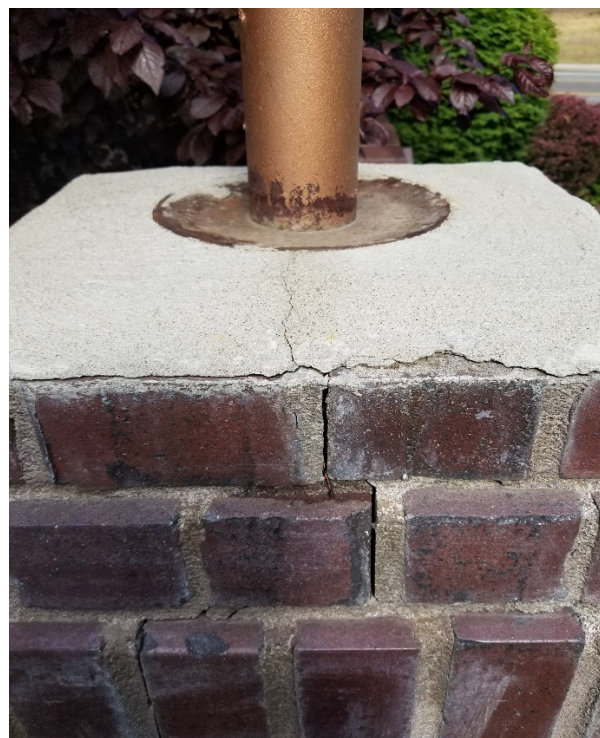
This arrowhead is from Center Street and is poorly installed in just about every way. The mortar cap allows water to enter the brick column from the uncovered metallic cup and through the crack in the mortar cap. This allows freezing water to enter the brick column and split the brick joints

A pier cap similar to this cap is to be installed under the arrowheads to keep freezing water out of the brick column. The cap will be split in half with a cut-out for the metal cup surrounding the bottom of arrow head.

Take off 2 courses of brick to make room for the new pier cap design. Add back 1 course of brick with a $\frac{1}{2}$ inch overhang on all sides. Set the new pier cap and fill the cut-out with mortar. Slope the mortar to match the concrete pier cap
