VPS Hot Rod Build Blog

Volume 1 – The Infant Years - 2018

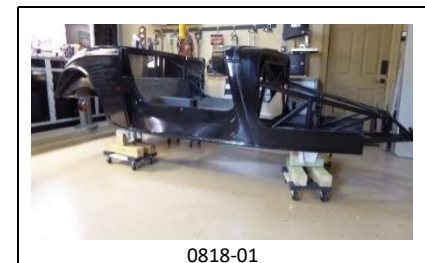
I needed to be able to move the chassis on the furniture dollies so that I could manipulate the body and chassis independently. From Build School, I was pretty sure I could lift the body by myself and I knew the chassis was way too heavy to lift/move without mechanical assistance. In anticipation of this, I had previously made 4 chassis support stands out of 4x4's that would be placed on top of the dollies (0818-01). I set the engine crate on some 2x4's and used the furniture dollies with the chassis stands to support the chassis/body. These worked great.

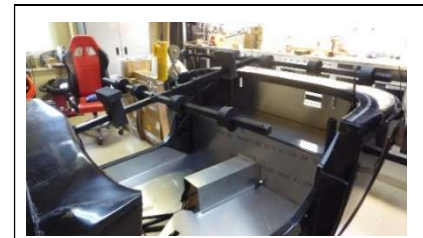
0818-02

The next step was to be able to lift the body off the chassis utilizing my overhead hoist. Now, having taken the top off my jeep many times, I was practiced in the concept and had a jeep top lifting frame hanging on the wall, how convenient. I fitted it to the body, had to relocate the 2 aft hooks by 6" inboard, and placed it into position. There were some aluminum trunk panels that needed removal and I removed the temporary screws holding the body to the chassis. I was ready to lift (0818-02). However, again from build school, I knew I had a CG issue for the first lift.

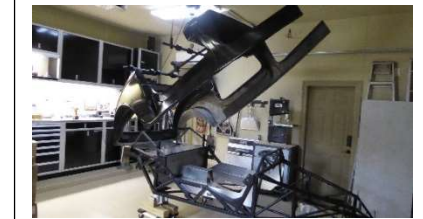
0818-03

Up it went and yes, for the initial lift, there was a CG issue but it was actually very light in handling (0818-03). I raised the body above the chassis, moved the chassis out of the way, and lowered the body to the floor. I went very slow and corrected for body/chassis interface issues, but all in all, it was actually very easy. With the body on the floor, I resolved the CG issue and located the lift point on the lifting frame (0818-04) Will not be an issue in the future.

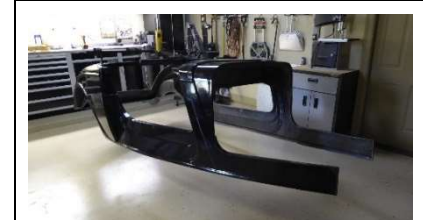
0818-04

Then I manipulated the chassis and body to position them as I wanted in the shop. Grabbing the lifting frame by hand, I could pick up the body and move it wherever I wanted. It is actually lighter than the jeep hardtop.

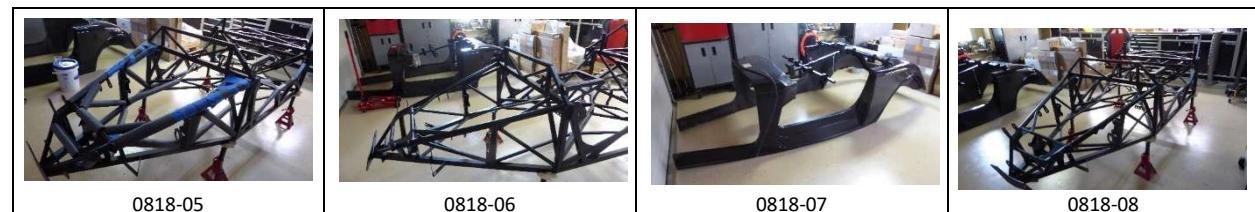
Next, I removed the furniture dolly stands and placed the chassis on my jack stands (0818-05 to 0818-08). In order to protect the chassis powder coat during the build, I attached some pipe insulation foam in strategic places on the chassis. We will see how this works out. Here is how I ended the day, of course with a glass of fine wine.

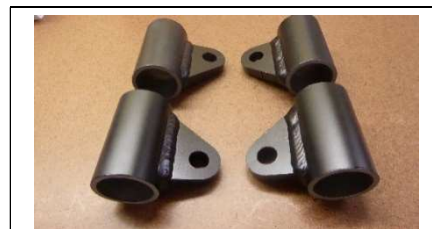
08/13/18: My overall plan is to powder coat as much as I can but both the upper and lower suspension arms have the spindle bearings permanently installed. Hence, these parts cannot go into an oven and painting them is the only solution. Off to the stores I went. I am going to try the VHT Chassis/Roll-Bar Matte Black paint on a couple of parts to see how well it matches the F5R chassis powder coat color.

Pictures 0818-09 to 0818-14 illustrate the painting process.

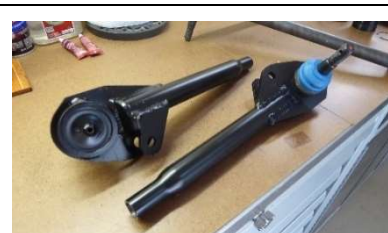
0818-12

08/14/18: Sandblasted and painted the front suspension lower swing arms. Started to blast the upper arms. Ordered some matte black powder coat, once received, I will test it to see if it matches.

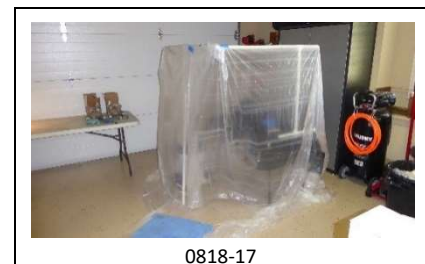
I decided to try out a new paint shack design that incorporates one of my tables. Smaller and hopefully a bit more space efficient (0818-17).

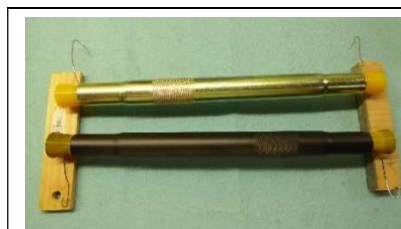
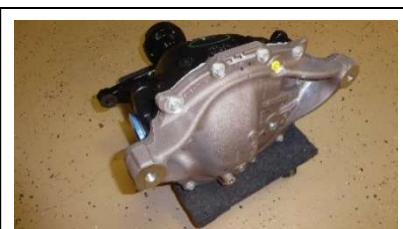
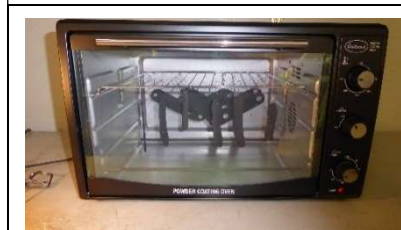
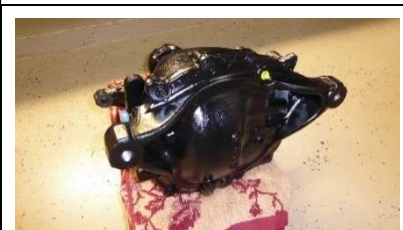
08/23/18: A day of powder coating. Shown is a before and after shot of the powder coated front toe adjuster link (0818-18). I can now assemble the lower front suspension arms but still waiting on the back ordered bushings, so installation remain on hold.

Also shown are all the brackets for the rear brake mount powdered coated and curing in the oven (0818-19). The center section was also prepped and painted (0818-20 and 0818-21). The day also included cleaning up the shop and paint shack. Some of the over spray powder was recovered and the drop cloths were trashed. I have the paint shack down to just

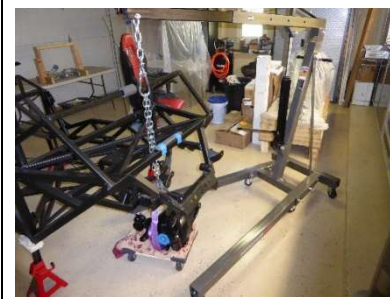
0818-22

08/25/18: Spent the day going very slow. Prepped the center section for installation and drained all of the fluid out of it. Used the shop crane and jack to adjust the position and place the center section into the chassis. The two rear bolts were installed with ease. The right front bolt

was installed fairly easily with some help of a dead blow hammer. However, the last bolt, the left front bolt, was out of alignment horizontally by about 1/8" and vertically by about 1/16". After much experimentation and frustration on attempting to align the chase bushing mount hole and the center section hole, I took a break, sat back just looking at it.

Finally I decided to back out the bushing metal sleeve out of the aft bushing allowing a little more freedom angle for the bolt to get forced into the center section hole. Then I took a really heavy mallet with an extender to the head of the bolt and let loose a good old fashion wallop. Sure enough the bolt started its journey down the center section hole. I was able to seat all 4 bolts and torque them up. The center section is now installed (0818-22 to 0818-24).

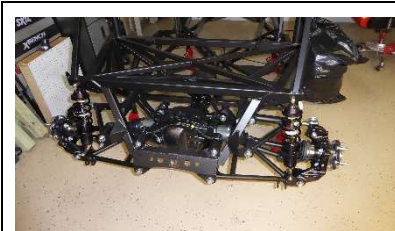
- 0818-25: The Center Section Installed.
- 0818-26: Toe Adjustment Arms Installed.
- 0818-27: Lower Control Arms Installed.
- 0818-28: Upper Control Arms Installed.
- 0818-29: CV Axles Installed.
- 0818-30: Spindles and Hubs Installed.
- 0818-31: Rear Shocks Installed.

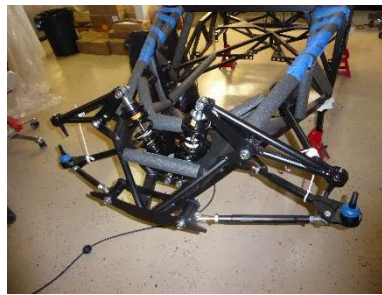
0818-32

08/29/18: The F5R box I received included the front suspension bushings and the coil-over-shocks spring hats. This allowed me to install the rear-coil-over the shocks, the lower front suspension arms, and front coil-over-shocks (0818-32). In addition, I assembled the front brake calipers (0818-33).

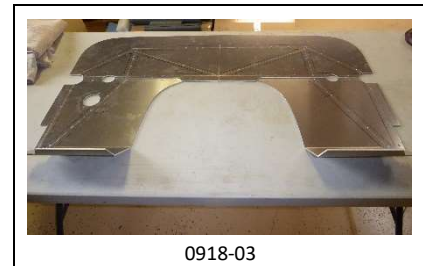
09/02/18: The last couple of days were devoted to the firewall installation. I decided that the lower foot box panels will be “permanently” installed and the upper panel will be removable. Hence, I will be using ¼”-20 button heads as the fastener of choice. The firewall was temporarily installed, the chassis frame was outlined on the back side, and removed to the bench. At the bench I spaced out the fastening pattern and drilled the ¼” holes (0918-03 and 0918-04).

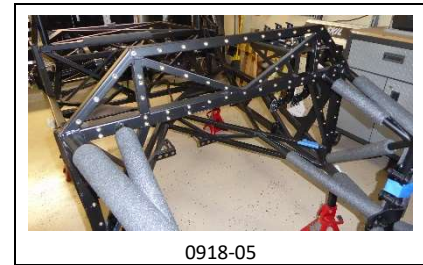
09/06/18 to 09/08/18: I found a great powder coat company in Spicewood just up the road a bit and dropped off the firewall parts to be powder coated with a super chrome finish. I also installed all of the firewall rivnuts into the chassis (0918-05) and installed the main steering arm onto the chassis. I cleaned up the shop and I am getting ready to build a sanding booth for the body.

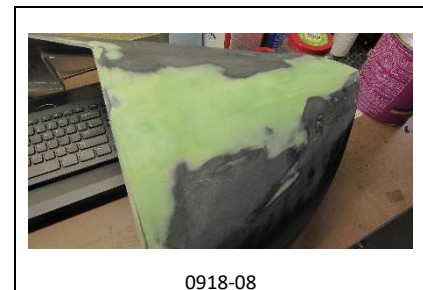
he next step is to fill in and level out the seams with body filler. I started with the nose cone using Evercoat Everglass for the base layer and sanded this smooth. Then I topped it with Evercoat Rage Gold to fill in the small imperfections and sanded it smooth. This is a very time consuming and tedious process but, so far, I like the results (0918-08).

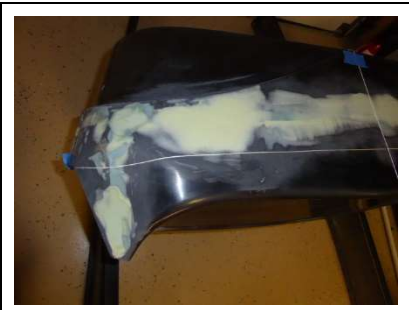
0918-13

The strings taped to the body (0918-12 and 0918-13) was used to find and mark the body centerline in order to facilitate body to chassis mounting.

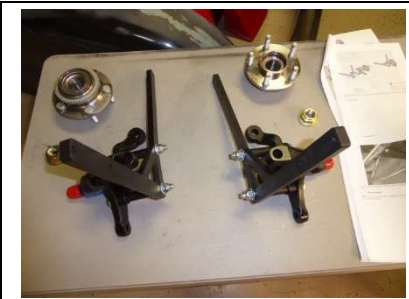
0918-14

09/30/18: Rear suspension jam nuts and missing front suspension parts were included in the box but no rear brake pads yet. The rear suspension is complete (except for the brakes) and I worked front suspension spindles, hubs, and brakes (0918-14).

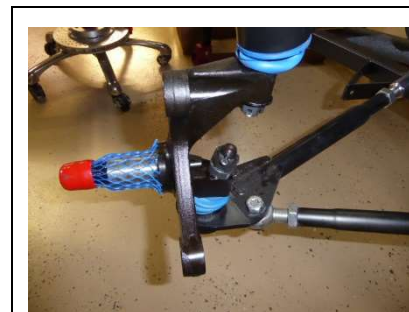
1018-01

10/01/18 to 10/07/18: With the spindles reassembled, I installed the hubs, rotors, and front brakes (1018-01 to 1018-03).

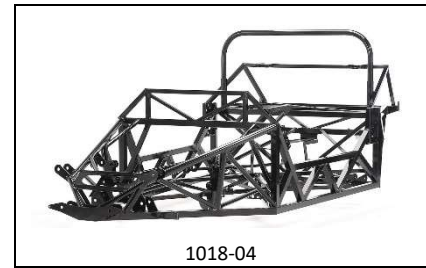
1018-04

While I am waiting for the firewall, I started to re-think the roll bar issue. The kit comes with a single roll bar that spans across the chassis (1018-04). Everyone agrees that it is only a show piece and not really a true safety roll bar because of its simplistic design and because it has no real fore-aft support structure. Also, in my opinion, it is not very eye appealing. So much so that the roll bar is not even installed on any of the hot rods pictured on Factory Five's website.

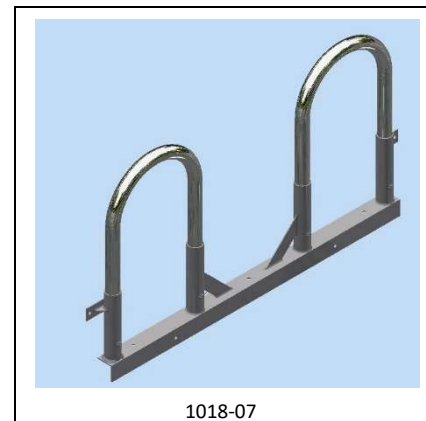
1018-07

So using Tim's design as a basis, I put together my own design and I am considering getting this made up (1018-07). I will finish the design drawing, obtain a cost, and then decide if I want to install it or just eliminate the roll bar altogether.

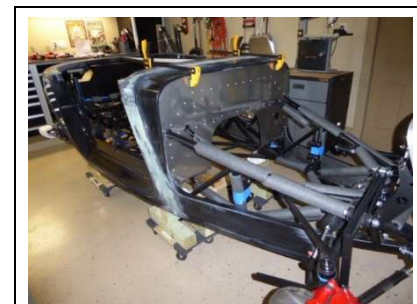
1018-09

10/12/18 to 10/14/18: Body Preliminary Fitment. I decided to proceed with the body mounting process and start the body preliminary fitment work. The first step was to put the chassis back onto the roller stands. I moved the chassis out of the way, lifted the body with my hoist, returned the chassis to a position under the body, and then lowered the body onto the chassis. Slow going to watch for interferences. In order to facilitate the mounting, I had to remove the top portion of the firewall. Once the body was sitting on the chassis, I re-installed the firewall, squared the body to the chassis, and used clamps to hold it in place (1018-09).

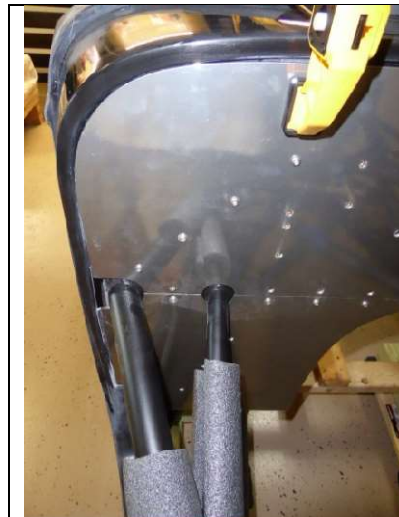
The body fit onto the chassis fairly well but there were some interference issues such as the top radius of the body at the firewall 1018-10 and 1018-11). It took a bit of work to reshape the radius so that it fit correctly. The driver side has the opposite issue where the body radius is larger than the firewall radius. My choices are leave it as it is or fill it in, either way it will be noticeable.

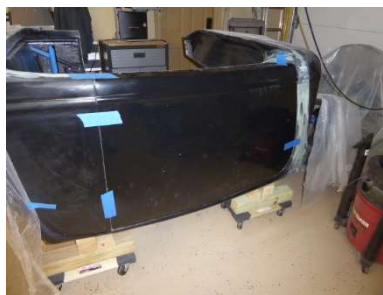
1018-12

Passenger Side Door Install. I actually installed the door hinge standoff bracket prior to mounting the body. I continued with the hinge cutouts on the body. With that done, I spent the next day and a half sanding the door edges to obtain the initial fitment onto the body (1018-12). Next came the door hinge cutouts and the frame installation. In mounting the striker bracket, I discovered a 3/8" gap between the plate and the body (1018-13 and 1018-14). I plan on adding some washers to take up the gap. I also mounted the striker bracket on the driver side which fit next to the body.

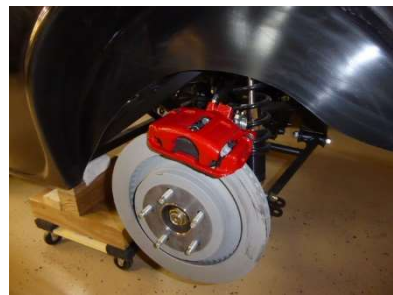
1018-15

10/18/18: I just received most of the remaining back-order items from F5R. Since I received the rear brake pads, I installed the rear rotors and brakes just so I could finish that work (1018-15).

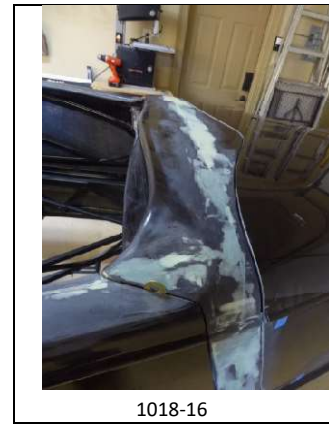
installed via the build school method, the door would have to be fitted farther aft and the gap at the top of the door/body interface would be exceedingly large. Picture 1018-16, which was taken after the door fitment, illustrates the critical gap for the position of the door. Note the washer which indicates the critical gap.

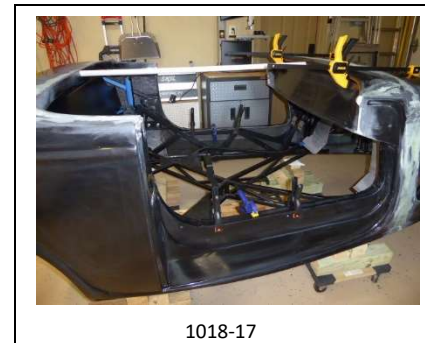
1018-17

Prior to starting the door installation, the body needs to be aligned and centered onto the chassis and mounted using the rear wheel mounts and the door sill mounts. Ensure you have the 45.5" cockpit gap (1018-17). I used a length of $\frac{3}{4}$ " PVC pipe cut to exactly 45.5" length (a good straight piece of wood will accomplish the same thing). The firewall was installed and secured to the body. I elected to have a removable top half of the firewall which made installing the striker mount bracket and the striker much easier.

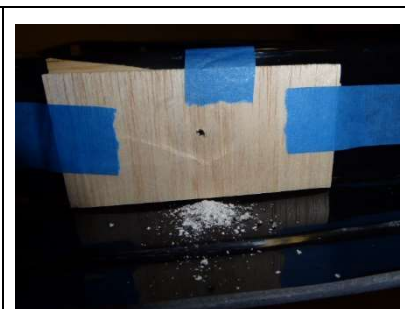
1018-19

7. Use a drill to mark the center of the striker (1018-19). Use the template in the manual to make the latch cutouts in the door. Mount the latch onto the door with the frame door latch mount bracket in place (1018-20 to 1018-22).

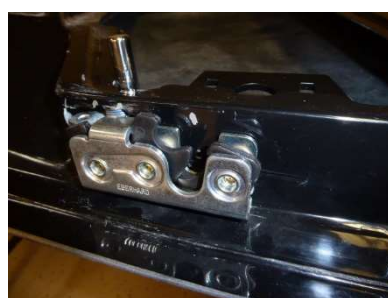
1018-22

8. Install the door to ensure proper alignment of the striker and latch. I needed to add some washers as spacers between the striker mounted washer and the striker bracket to move the striker head slightly aft to fit into the latch.
9. Install the door frame. I drilled two new holes on the frame door latch mount bracket as it was easier to fit up the attachment bolts. Bolt the door frame to the hinges and confirm the striker head is centered into the latch.

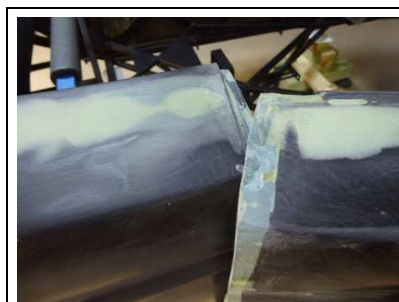
1018-25

That concludes the door installation procedure I used. As a result, the driver door opens easily and without interference. However, right now the passenger door has an interference issue at the top of the door/body interface above the hinges (1018-25).

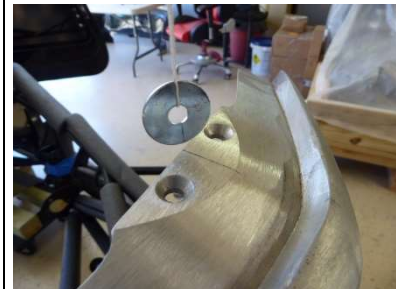
1118-02

chassis and body. I knew where the centerline of the body was and had to extend that line to the grill location. Using a couple pieces of wood nailed together and a couple of screws at each end, I attached a very tight string line at the ends of the screws, hence my straight line (1118-01). I centered the string line on my known locations, hung a washer weight over the grill and determined where grill centerline was (1118-02). I tightened the grill in the centerline location, which is not to be moved during the fitment process.

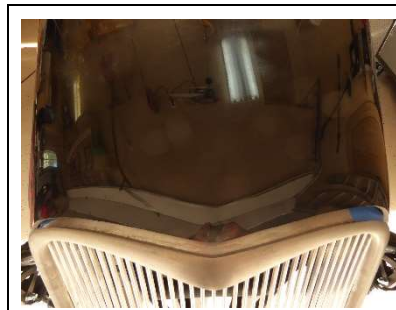
1118-03

Placing the hood back onto the body/grill, I determined about 5/8" of material was required on the side panels and hood (1118-03). For the side panels, I taped some poster board to the panel, pressed it to the grill to determine grill curve, and cut off the excess. I placed some wax paper along the front edge

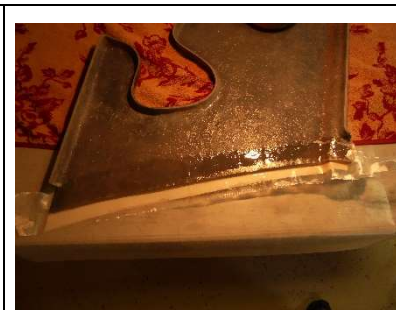
1118-04

between the poster board and the panel to act as a release agent for the fiberglass. I epoxied a couple of layers of fiberglass to the front edge (1118-04). After it cured, I cut off the excess and filled the low spots with some short strand body filler. I cleaned up the edges and fitted it to the grill and body with a 1/8" gaps using the gap tool and tape method as I did for the doors.

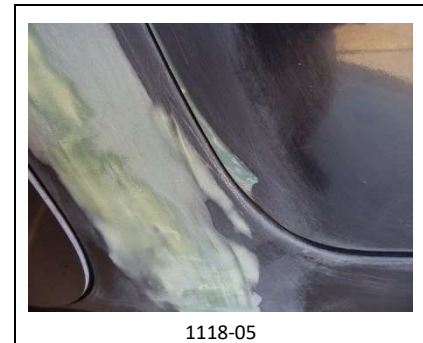
1118-05

The passenger side panel was delivered improperly cut at the aft panel/body interface. The gash and edge was built up with fiberglass using the same process as the front edge (1118-05) and gapped accordingly.

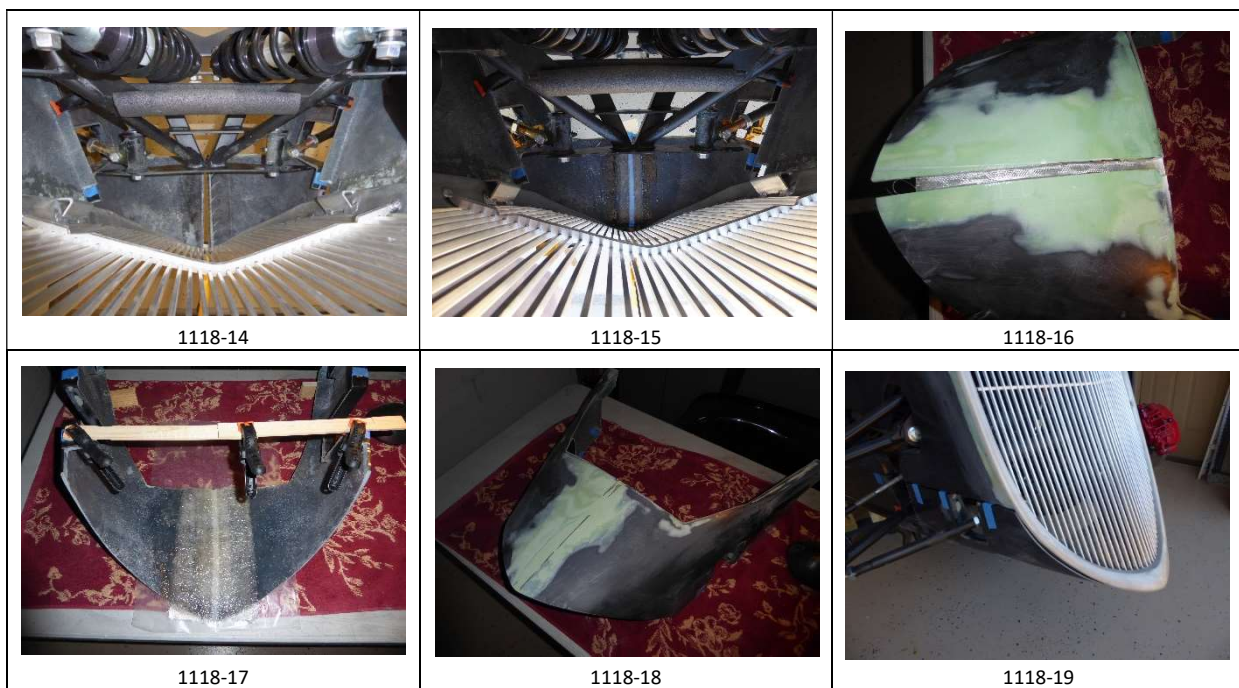
8. Fill in the underside seam with body filler and sand smooth (1118-18).
9. Picture 1118-19 shows the fitment with the slight bulge of the NC/Grill interface.

7. Clamp in place a couple of paint sticks to bring the NC to its correct width. Epoxy several more layers of fiberglass to the seam (1118-17). Sand smooth as required.

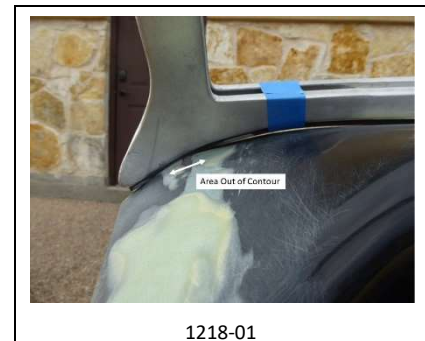
Next what I discovered was that the driver's side body under the windshield was so out of contour that the windshield would never sit correctly even with the gasket (1218-01). Also, I discovered that the underside of the body in this area has a fiberglass flaw that will need to be rectified. Making a note of this, future work will include adding fiberglass on the body underside and contouring the upper surface. Not a big deal, just some more work. I removed the body and stored all the parts.

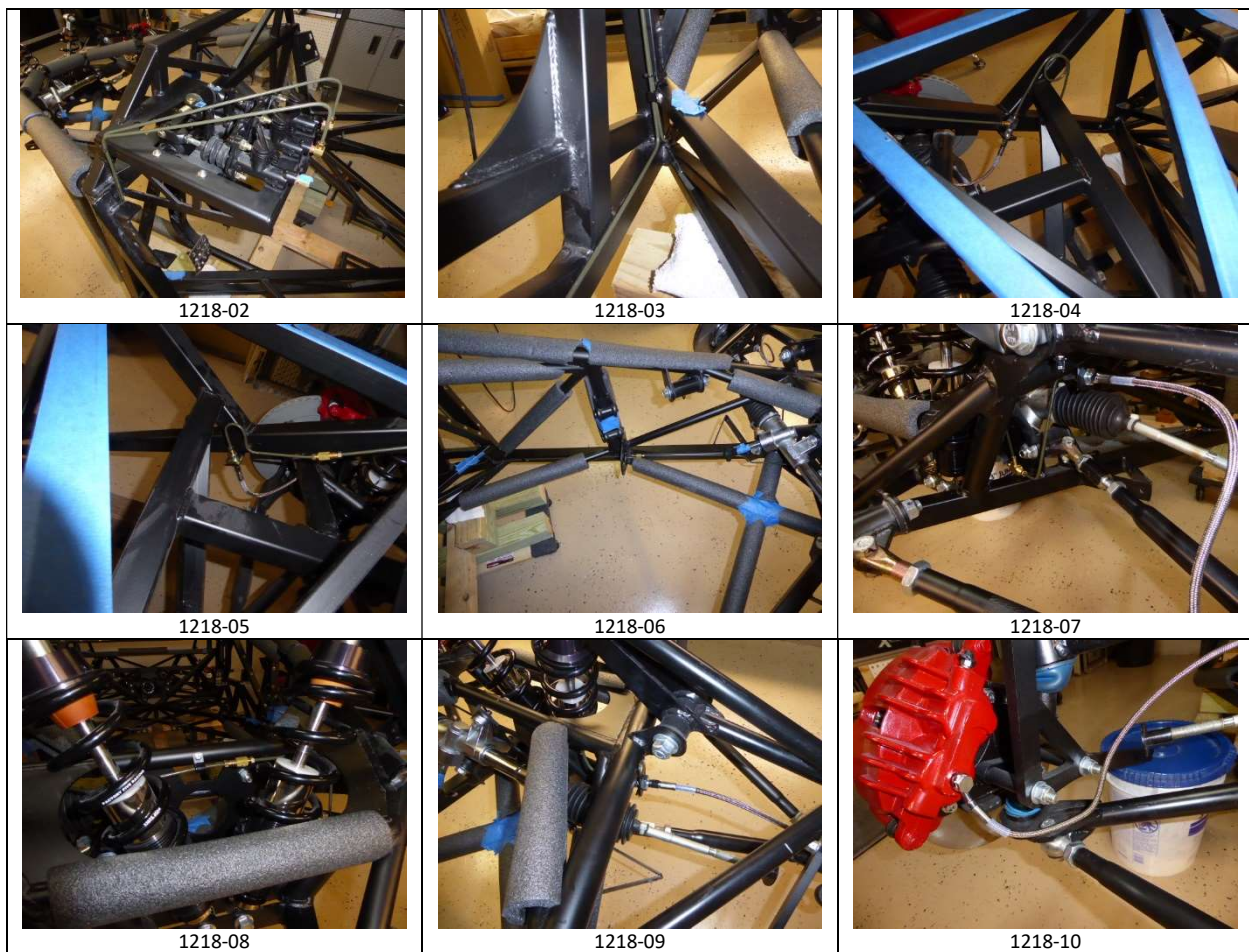
The brake line installation was not too difficult but mistakes were made and I needed to purchase a couple of extra lines from the local auto parts store. I encountered some difficulty getting the lines to fit up based on the assembly manual installation description. This resulted in adding two splice joints, one in the rear system and one in the forward system (1218-05, 1218-08). I now have an additional four possible new leak locations, not desirable but it is what it is. Pictures of the installation include 1218-02 to 1218-09.
