## *VPS Hot Rod Build Blog*

### *Volume 2 – Youth is Here - 2019*

#### **Progress During January 2019 - Happy New Year**

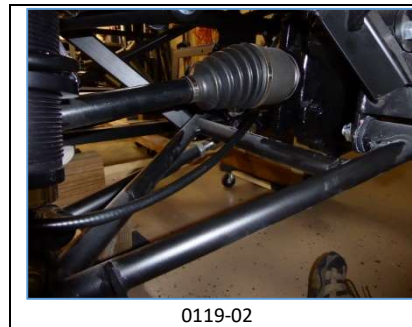
0119-02

01/01/19 to 01/10/19: Starting the year with the body removed and resuming the mechanical work. The E-Brake cables were installed. The only way the driver's side cable can be routed is under the center section, it is not long enough to route anywhere else (0119-01, 0119-02). The Passenger side has a little more length but I routed it the same way (0119-03). These terminated in the chassis mounted bracket (0119-04).

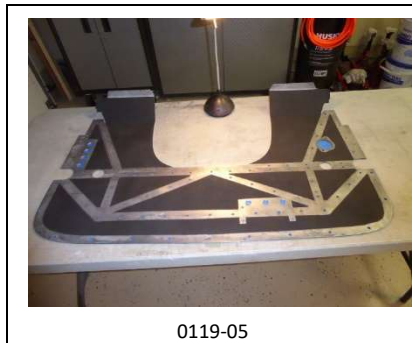
Back to the firewall. I taped over the engine side to provide protection to the polished surface for the remainder of the build. Then I applied two layers each of LizardSkin acoustic and thermal coatings to the interior side of the firewall. I taped over the areas that come into contact with the chassis keeping a flat contact surface. Picture 0119-05 illustrates the results.

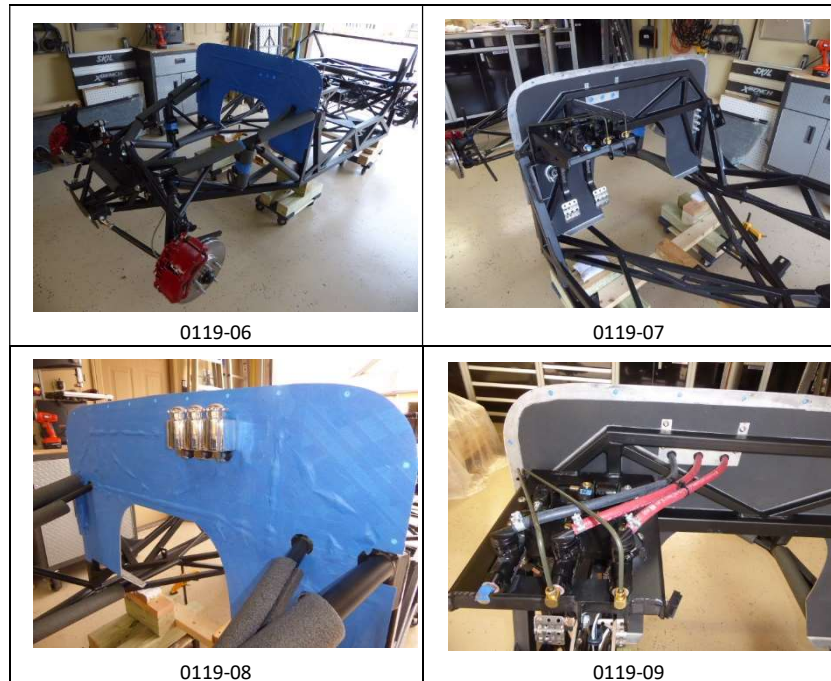
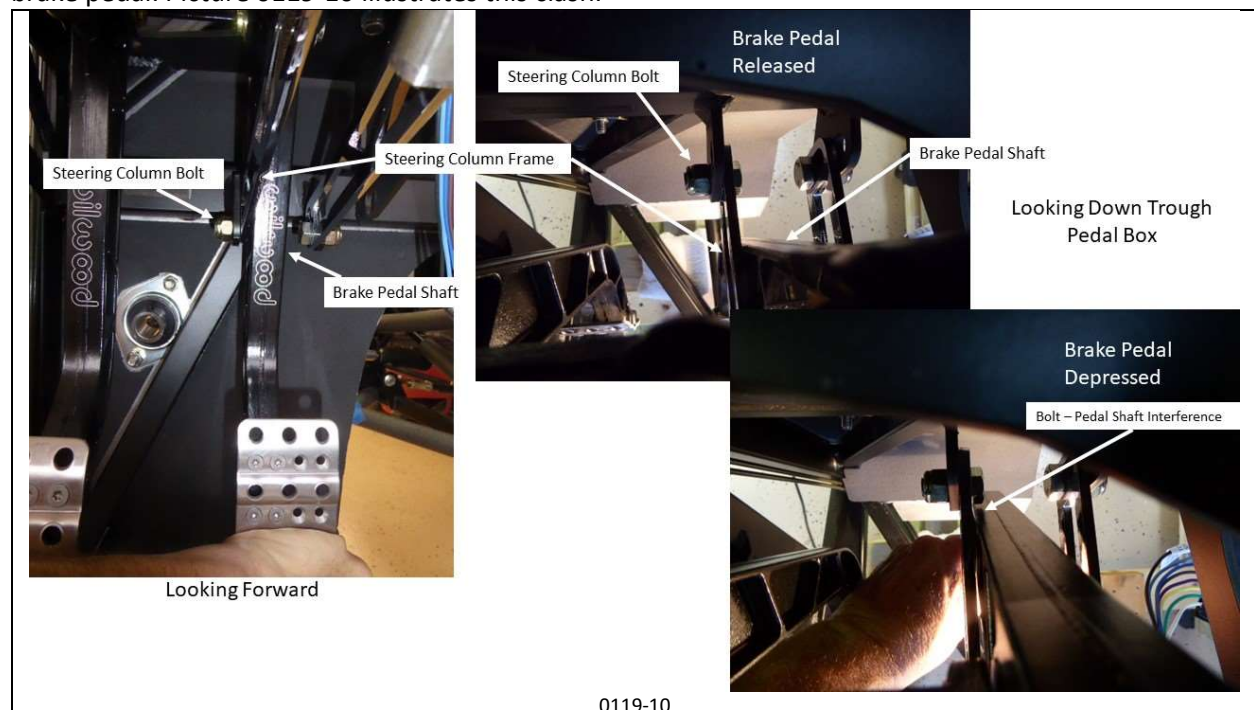
I am using the chrome plated tilt column for my build and I installed it per the assembly manual instructions. However, I discovered an interference clash between the column mounting bolt and the brake pedal. Picture 0119-10 illustrates this clash.

I emailed F5R and advised them of this clash and asked them for their solution. After the email, I researched the forum and, low and behold, this is a known design problem as the chassis mounting brackets are not located correctly. The solution is to locate the column attachment frame on the outboard side of the chassis bracket and use a socket head low profile bolt to secure it. However, then there is about a ½" gap between the inboard side of the column frame and the chassis mounting bracket. I need to order some new bolts, so work came to a halt for a couple of days.

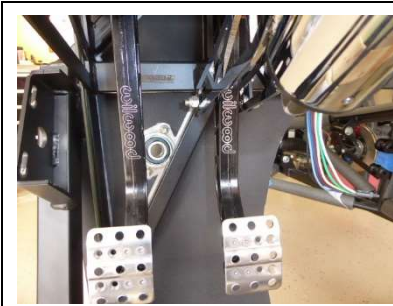
0119-11

I received my new button heads and remounted the steering column to the outboard side of the bracket (0119-11). This eliminated the pedal shaft interference (0119-12).

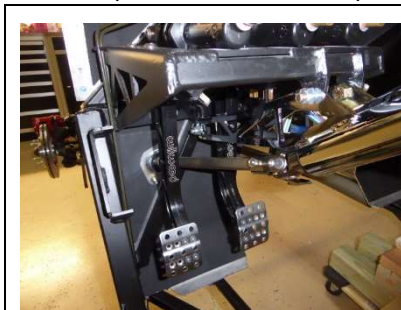
0119-13

The remaining steering links, for the manual steering setup, were installed (0119-13 to 0119-15).

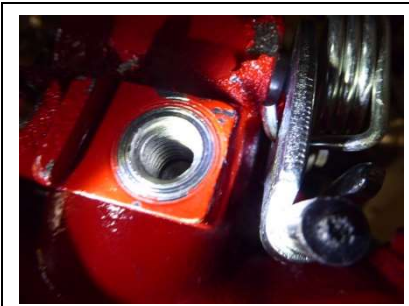
process of gravity filling the system, I discovered a massive banjo bolt / aluminum crush washer leak on the driver's side brake caliper. I removed the banjo bolts, one front and one rear, to inspect and drained the system. Picture 0119-17 shows the front brake caliper banjo bolt port. This port has a nicely

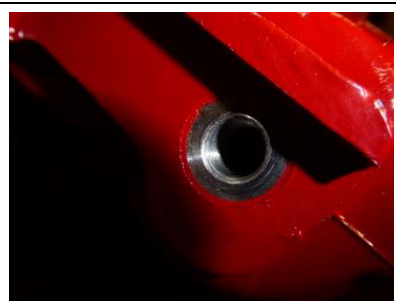
machined smooth face for the crush washer interface. Picture 0119-18 is the rear brake caliper. The concentric ring grooves on the face of the port is of concern. I believe this is why it leaked. I will try copper crush washers and if they do not seal, I will try the Stat-O-Seal type washers. I am currently waiting to receive the crush washers.

I received the copper banjo bolt crush washers and replaced all four of the aluminum washers. After torqueing the banjo bolts, I again gravity fed the brake system and did not discover any leaks. With Barb's help, she pumped the brakes and I bled the system clear of any air bubbles. I did discover a leak in one of the connections but tightening the connection resolved the leak.

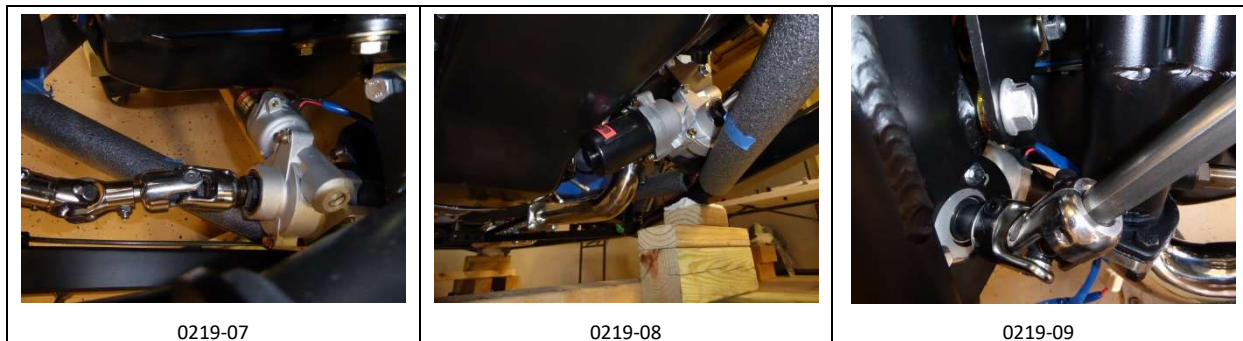
The holes bearing/motor mount bracket needed to be modified so the EASS motor could be rotated and eliminate the clash with the engine oil pan. As installed today, there is about a ¼" clearance between the motor and oil pan. This will need to be monitored during engine start-up, hopefully the engine will not rotate that much and create a clash, we will see. Picture 0219-07 to 0219-09 illustrate the EASS installation.

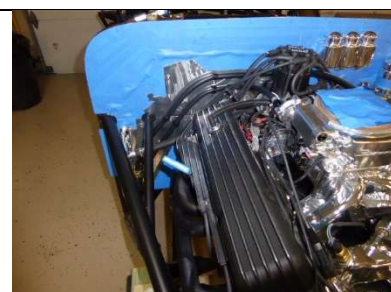
0219-12

I plan on installing the fuel tank and floor after the wiring harness is installed. This will allow easier access to running the harness without the floor installed. Pictures 0219-11 to 0219-16 illustrate the fuel line routing.

The fuel system as outlined in the F5R Assembly Manual requires design modifications in order to meet the needs of the Holley Sniper 4150 EFI. Both F5R kit parts and Holley fuel system parts were reviewed. Holley recommends a 3/8" fuel hose for both delivery and return whereas F5R provided 5/16" hard line delivery and 1/4" hard line return. After the parts and systems were reviewed, I determined that the final configuration will be a hybrid of the Holley and F5R systems. Of importance, the following aspects are included in the design:

- The 5/16" and 1/4" hard lines will provide adequate flow for the Sniper unless the Hot Rod goes full throttle for an extended period of time. (Which it will not, well maybe not!)
- It is extremely important for safety reasons that the 5/16" and 1/4" hard lines be used running fore and aft. These lines could be subjected to road hazards and heat from the exhaust system.

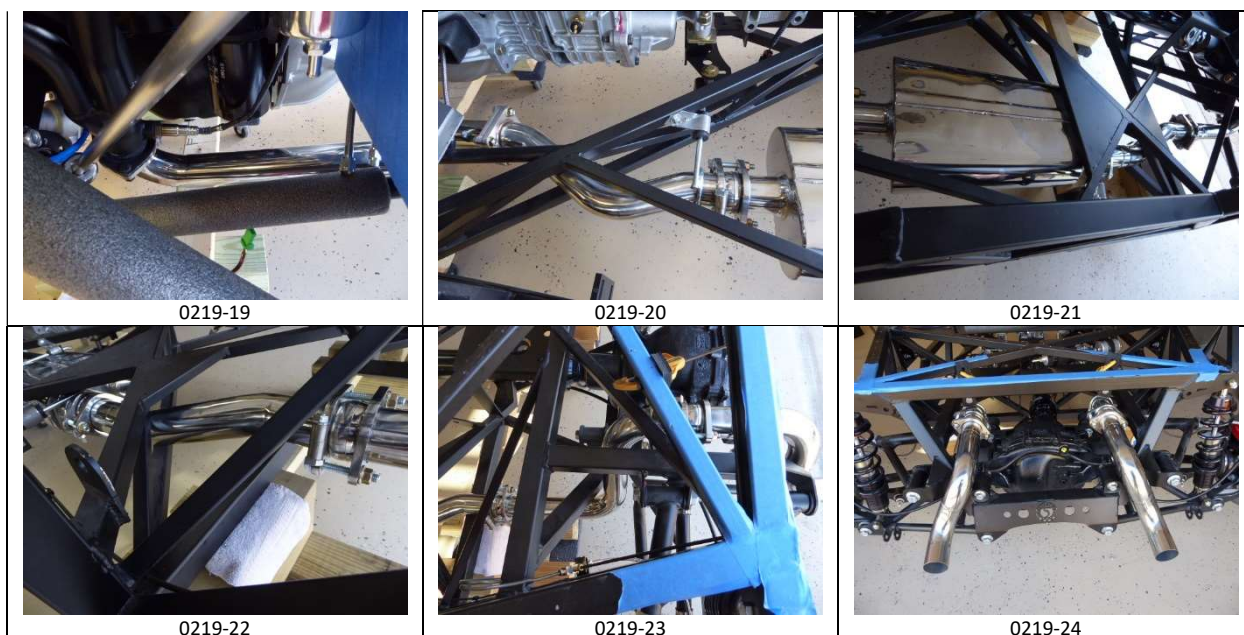
The remaining system of shorty pipes, mufflers, and routing pipes were installed as per the assembly manual. The muffler hangers were installed as well as the aft rubber hanger straps. Pictures 0219-17 to 0219-24 illustrate the exhaust system installation.

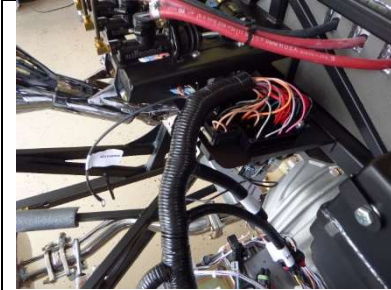
0319-17

- a. Determined placement of the EASS control module which will be mounted just above the pedal box. This will require lengthening of the EASS control and power wires.
  - b. Study the Heater/AC wiring and determine the interface requirements.
    - i. Do not connect the AC compressor clutch wire, this will allow the engine to run without damage to the compressor.
    - ii. Do not install the Trinary Switch to the dryer, the dryer is purged with nitrogen to keep out moisture during storage.
2. Powder coated the fuse block mounting bracket and installed it onto the chassis.
  3. Fitted main harness fuse block into the bracket (0319-17).
  4. Attached the mechanical speedometer sensor to the transmission (0319-18).

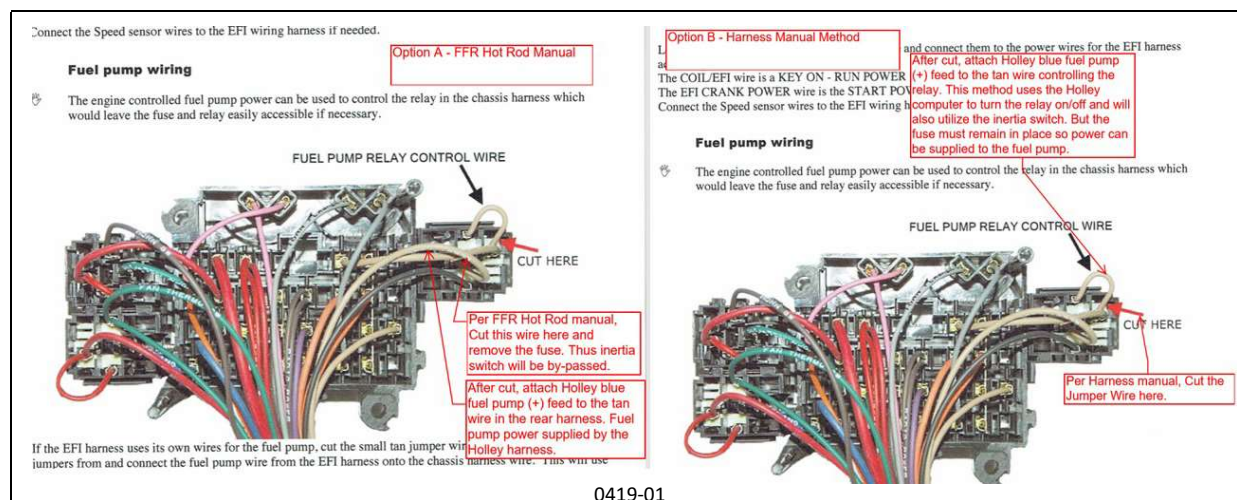
Option B – From the Chassis Wiring Harness instructions, cut the relay jumper and attach the Holley blue fuel pump (+) feed wire to the remaining jumper wire which would only control the relay. Leave the fuse in place and utilize the rear harness for the fuel pump power. This method also uses the inertia switch to control the relay.

Utilizing the inertia switch Option B will provide another degree of safety into the Hot Rod so this option was selected.

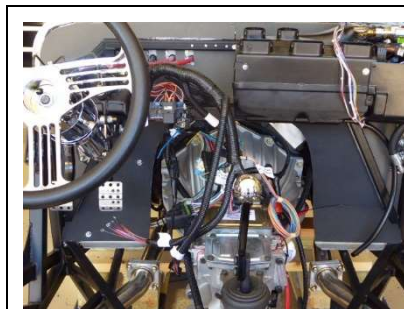
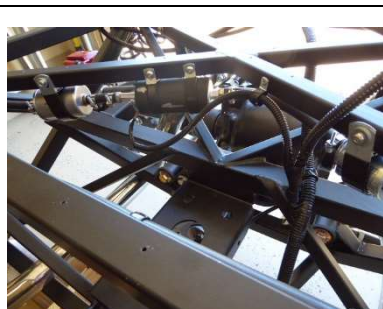
The fuel pump power and ground wires in the harness were relocated to better accommodate the fuel pump location in the Hot Rod. The fuel level (Gas Sender) was temporarily positioned, waiting on tank floor and fuel tank to be installed. The left and right rear taillights and the license plate light wire harnesses were temporarily placed into position.

The location of the battery as per the assembly manual only provides limited access to it once the Hot Rod is complete. Hence, I decided to relocate the battery to the trunk. The kit battery cable is too short to reach the new battery location, but I am going to install a Master Switch in a glove box compartment that will be located using the old battery location. An extension cable will then reach to the trunk location. There will also be a by-pass fuse installed in order to power any devices that have a memory (ie radio, possible EFI computer, etc.). The battery cable was temporarily installed running along the transmission on the passenger side. The Sniper EFI power cable is to be installed alongside the battery cable and run directly to the battery. This will allow the engine computer to retain its memory during engine shut down periods. Pictures 0419-03 to 0419-10 illustrate the rear harness and battery cable installation.

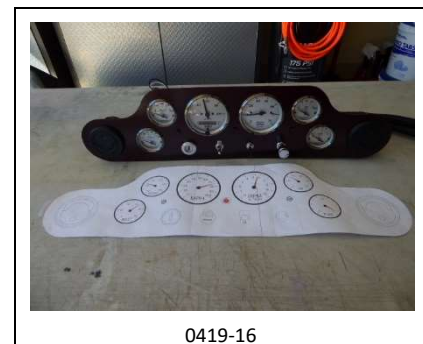
0419-16

The first step was to develop a gauge and switch layout drawing and print it in full scale (0419-16). This drawing was used to ensure proper fit to the body dash area and to estimate a proper fit within all the components mounted to the firewall. The second step was to fabricate a mock up so that the gauges and switches could be mounted, hooked-up, and used during engine start and go-cart. The mock up frame was made from some very economical fiber board.

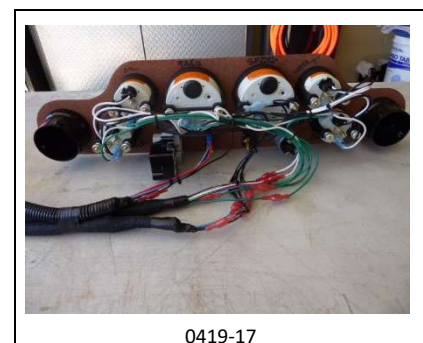
0419-17

Once all the gauges and switches were mounted to the frame, I started to interface the provided dash wiring harness. At this point I realized that none of the turn signal lights, hazard lights, and some of the sensor wires were not needed for the hot rod and that the layout of the harness wires would not work for my custom dash layout. I removed the loom and relocated the wires into 3 groups and adjusted their lengths so that they would terminate at approximate the same place. The three groups are:

- Black – All Ground Wires.
- White – All +12V Power Wires.
- Green – All Sensor Jumper Wires.

All dash connectors have female disconnects on the gauge connections and male disconnects on the harness connections. The provided harness was fitted with female disconnects.

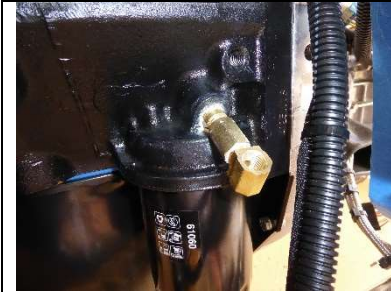
0519-04

The only location that I could utilize on the SBC to install the kit provided oil pressure sensor was the port just above the oil filter. However, because of the angle of the port, there was no room to directly mount the sensor because of interference with the block casting for the oil

filter. The solution was to install a brass nipple with a coupler and elbow and then mount the sensor to the elbow (0519-04 and 0519-05). This was then connected to the (BLUE) sending unit harness wire.

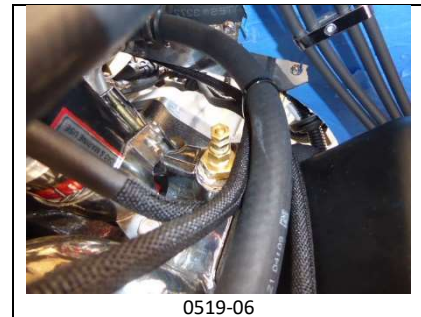
0519-06

The kit provided water temperature sensor was mounted into the rear driver side port of the intake manifold. This was then connected to the (GREEN) sending unit harness wire (0519-06).

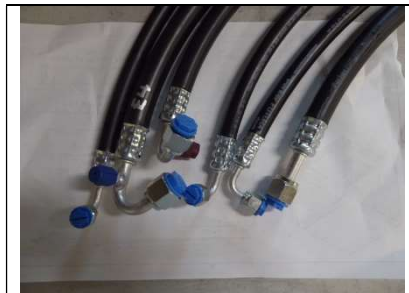
HVAC Hoses: All the AC hoses were provisionally installed but they required final crimping. I made several phone calls seeking out a shop the can crimp AC hoses but apparently there is only one shop left in Austin that has the ability to crimp AC hoses. It seems that no one makes their own hoses anymore as today's cars are equipped with OEM supplied crimped hoses as replacement parts. The shop was very accommodating and had the complete job done while I waited, about 30 minutes. 0619-01 shows the crimped ends and all the hoses were installed and tightened up.

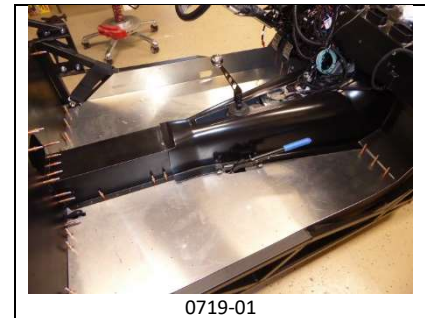
0719-01

The floor panels, rear cockpit wall, and driveshaft cover are installed and held in place temporarily with Cleco's, so it is time to install the transmission cover. My plan is to use the fiberglass cover that came with the kit during the initial outfitting. Once I get to finishing the interior, I am contemplating fabricating a narrower custom console cover that will be integrated with the dash. The kit provided cover will be satisfactory for now for protection during engine start and Go-Cart. It slipped in fairly easily. The wire harness is very bulky and the EFI harness make fitting all of this in somewhat cumbersome (0719-01).

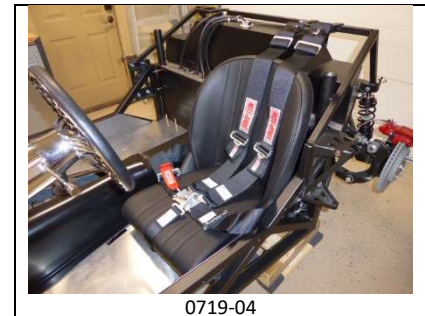
The Driver's seat harness (0719-04) is required for G-Cart and it was installed as per the manual. Just the shoulder and lap harness are installed at this time, the fifth belt will be installed onto the chassis floor tubing when I permanently install the floor panels.

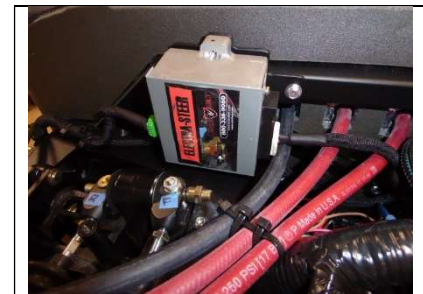
0719-08

- Orange LED: This wire was run the second LED wire.
- Purple wire and White wire: These are diagnostic wires, spade connectors were added to the ends, wrapped in loom and then coiled up by the control module.

- Yellow wire and Blue wire: These are not used, they were terminated and tucked into the power wire loom.

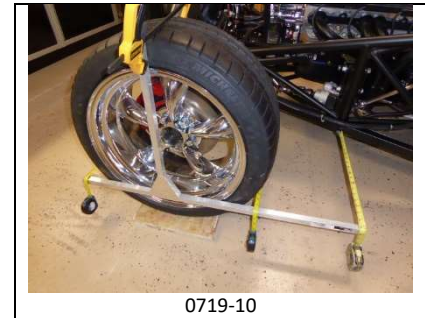
I purchased a camber measurement level which worked well. I built two alignment "Tees" out of orange store  $\frac{3}{4}$ " aluminum square tube riveted together using two 0.019" thick aluminum plates. These tees were clamped onto the tires. The vertical shaft was used in combination with the camber level to measure the wheel camber. I set up a camber level calibration station by clamping a level to my cabinet and shimming it so that vertical face reflected true vertical. This was used frequently to calibrate the camber level. Two tape measures were strung across the Hot Rod to the other clamped on tee just in front of the tire (0719-10), these were used to measure toe. A third tape measure, shown as the aft most tape in picture 0719-10 and forward most tape in 0719-11, was used to measure the parallel-ness of the wheels with respect to the chassis frame. Both driver and passenger sides were measured and adjusted to be identical. Toe was measured with the two tapes by the tires. I did utilize the tile-grease-tile turn-table idea on both the front and rear alignments. These worked well and allowed for numerous adjustments and measurements before making a 3'-4' roll of the Hot Rod.

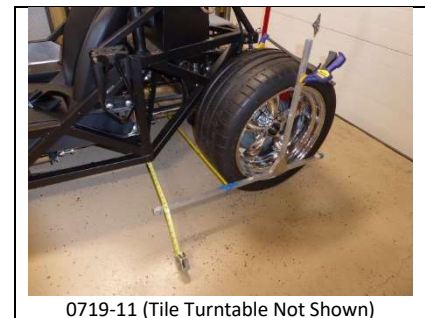
0719-11 (Tile Turntable Not Shown)

The rear tire alignment was first up. When I mounted the rear suspension, I set the lower and upper adjusters so that the disk brakes were reasonable straight, this assumption ended up being very wrong. I decided to track the adjustments on a spreadsheet by keeping count of the rotations, clockwise or counterclockwise, of the adjusters. The following parameters were recorded:

- Turns of the driver side lower adjuster.
- Turns of the driver side upper adjuster.
- Driver side camber.
- Driver side chassis measurement.
- Aft tire tape length.
- Forward tire tape length.
- Passenger side camber.
- Passenger side chassis measurement.
- Turns of the passenger side upper adjuster.
- Turns of the passenger side lower adjuster.

I started by taking my initial measurements and determining, as expected, everything was way off. Iterating through several steps by making  $\frac{1}{2}$  turns or 1 complete turns of the adjusters, then taking all the measurements and recording the results, I began to understand how the upper and lower adjusters affected camber and toe. But I had no idea of where I was at with respect to adjuster thread engagement in the mating suspension tubes. For all I knew, I could have been on the last couple of threads with minimal engagement. This would be obviously unacceptable. I decided to start over. Future Note: Measure and record the thread lengths of all the adjusters, front and rear, so that after alignment the final thread engagement is known.

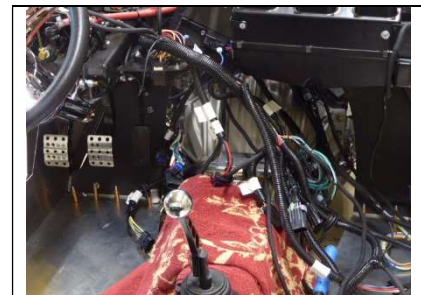
0719-18 – As-Delivered Harness

- I grouped the dash harness connectors and the accessory leads together about 12" from the fuse panel and pointed them aft. (I plan to use a removable dashboard centered on the body dash area.)
- The removable dashboard now has the following connections: 1) The 3 main connectors, 2) The ignition switch, 3) The headlight switch connector, 4) The EAS power switch, and 5) The EAS LED indicator.
- I grouped the front/rear/sensor connectors together, again about 12" from the fuse panel and pointed them forward on the driver side of the transmission cover.

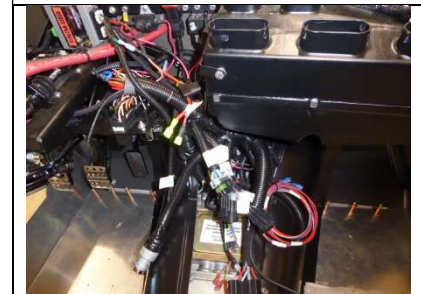
0719-19 – Modified Harness

- The HVAC wiring was bundled, the thermo switch bundle was run adjacent to the main power harness and the other two power and control connections were run to the approximate location for the control panel, which will be installed just below the dash.
- The main power wires in the main harness are too long for the Hot Rod application. This portion of the harness will need to be coiled up in the dash area in order to fit. I left this as-is instead of attempting the re-terminate them to the proper length.

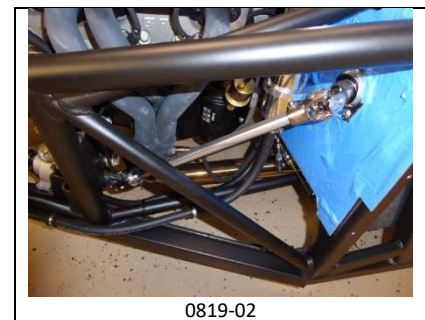
The DD link between the EAS mount bearing and the fire wall bearing was replaced by a plain steel DD link. This link was custom cut to fit the EAS application thus saving the original SS link, which could be re-used if I later decided to scrap the EAS system. So I decided to powder coat the plain steel DD link with a chrome powder. It looks OK (0819-02)

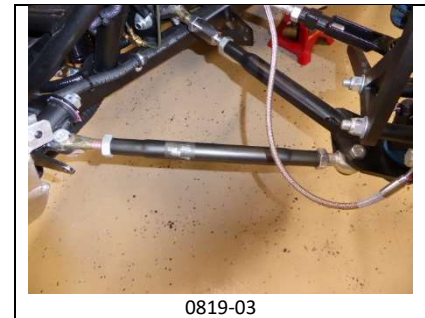
One tries to do their best but sometimes crap just happens. The front suspension adjuster tubes coatings were damaged during the wheel alignment process (0819-03). This is because there are no wrench hex profiles on the adjuster tube to facilitate adjustment and vice grips were used. This will always be a problem as I will most likely need to recoat them again after final wheel alignment.

I did not want to change the alignment length, so the front adjuster links were removed complete with the mounting clevises. The mounting clevises and adjuster locking nuts were protected with high temp tape and aluminum foil. The remaining middle tube was powder coated and oven cured. Hence, the adjuster link length was not altered when it was re-installed.

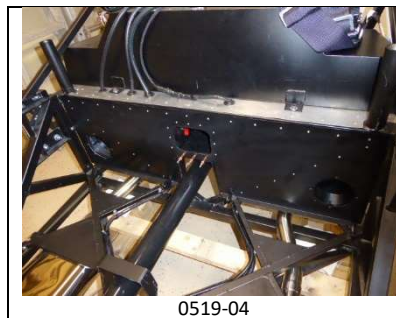
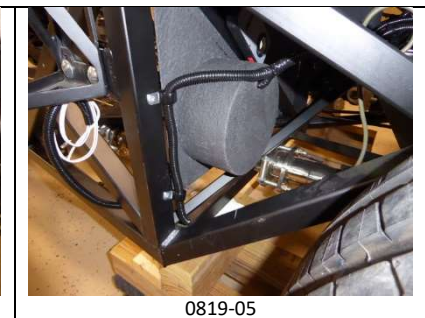
Speakers are to be added forward in the doors and aft mounted behind the cockpit wall, both sides. Holes were cut out of the aluminum aft cockpit wall to facilitate the speaker mounting. Speaker enclosures were built by 3D printing the speaker housing out of ABS plastic. The exterior speaker housings were coated with a layer of fiberglass and epoxy and then sprayed with LizardSkin acoustic coating. A light layer of ceramic coating was added as the final coat. 0819-04 and 0819-05)

The aft cockpit wall could not be installed with the speaker enclosures pre-installed onto the wall or with the glove box pre-installed, so each component was installed individually. Sealant was applied to the glove box front and chassis tubing. The wall was installed using 1/8"

rivets and were applied to the glove box interface and to the chassis tubing. The wall/glove box interior interface was sealed with black caulk. Sealant was applied sealant to the speaker enclosures mating face and then installed onto the aft wall.

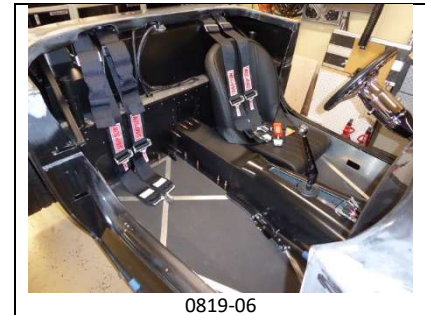
The cockpit floors were temporarily installed (0819-06) along with the driveshaft cover and the kit provided transmission cover, holding all together with Cleco's. The e-brake was also re-installed. A near future modification is to add cutouts to the exhaust system and, in late August, I started the initial design for the modified exhaust system. I will most likely leave the floors in the temporary installed state until after body painting and final body mount. Removal of the floors will greatly facilitate the exhaust modifications.

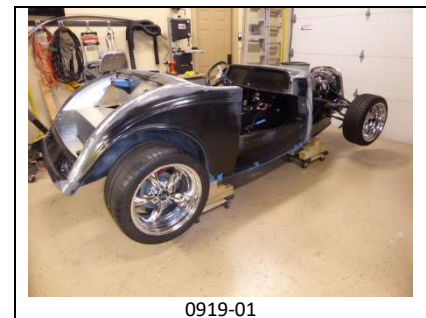
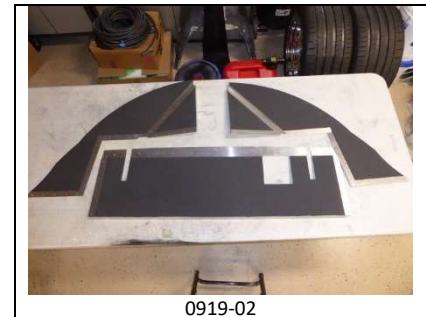
09/01/19 to 09/10/19: The month began by lifting the body up slightly and removing the trunk aluminum. I then LizardSkin'ed the trunk forward panel and side panels with Acoustic and Ceramic coatings (0919-02). The trunk upper floor, front panel, and side panels were temporarily installed, held in place with Cleco's, and the body lowered back down onto the chassis to check fitment. The aft lower edges of the side panels clash with the body installation and need to be gently folded inboard so the body can be slipped over them. (I worry that the trunk hood edge is a big clash issue, I will not know until I can see the fitment.)

After the body was lowered back onto the chassis, it was checked for fitment and clashes (0919-03). The cockpit gap of 45.5" was double checked. At this point, all is Looking Very Good (0919-04). I attached the body to the chassis with the aft wheel well bolts/spacers, side cockpit screws and the firewall button heads.

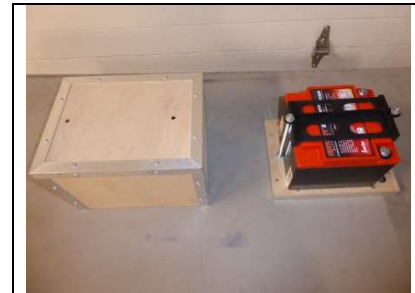
0919-05

I took some time to design the battery box enclosure. I fabricated a clamp spacer/bracket out of ABS plastic with my 3D printer so that the kit provided battery clamp would fit the Odyssey battery more securely (0919-05). Construction of the battery box enclosure was completed on 09/07/19. Next step is final epoxy and finishing. I also determined the final location for the battery and audio amplifier.

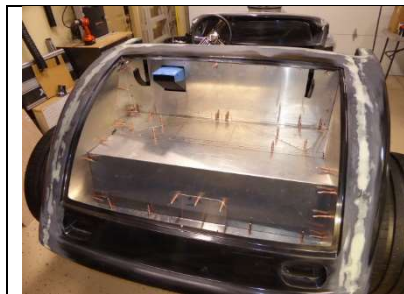
0919-06

Work continued on the trunk aluminum by drilling out all the rivet holes. The battery cable holes were drilled out, grommets installed, and the cables run into position. The battery box enclosure hold-down rivnuts were installed. Holes were drilled into the aft lower corners of the trunk side panels, grommets installed, and the rear wiring harnesses were run through the grommets and placed at the rear taillight locations (0919-06 to 0919-08).

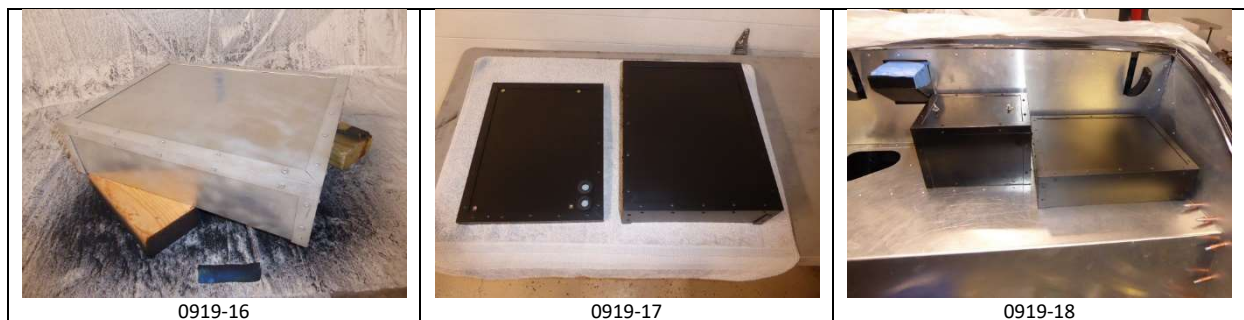
I set the dash cutout work to the side for the moment in order to develop the trunk audio amplifier box. I was OK with the construction of the battery box (epoxied wood with aluminum angle edges) but I wanted to try an all-aluminum amp box so that it could be matte black powder coated the same as all the chassis parts. So far, I'm very happy with the results of the amp box (0919-16 to 0919-18).

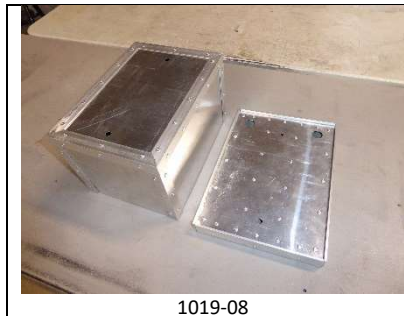
1019-08

10/06/2019: The all-aluminum amp box looked good. I wanted the battery box construction to be identical and it was redesigned. I felt that the battery box base needed to be in a tray configuration so that, if the battery ever leaked, the battery fluid would be contained. I also designed the cover to be smaller so that it can fit inside the tray (1019-08 to 1019-10).

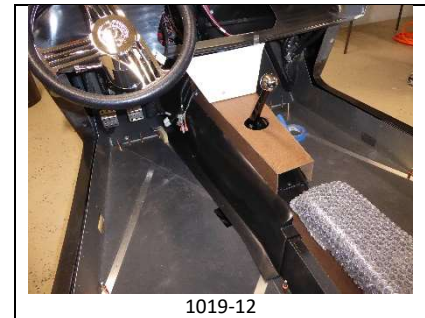
10/11/2019: I plan to design and build a custom center console that will be placed over the kit supplied fiberglass transmission cover. My design is still a work in progress, but I wanted to get a visual of what is possible. I built a quick crude mockup and used some sketches to get the visual (1019-12). Yep, a lot more thought is required here, but this will be for another day.

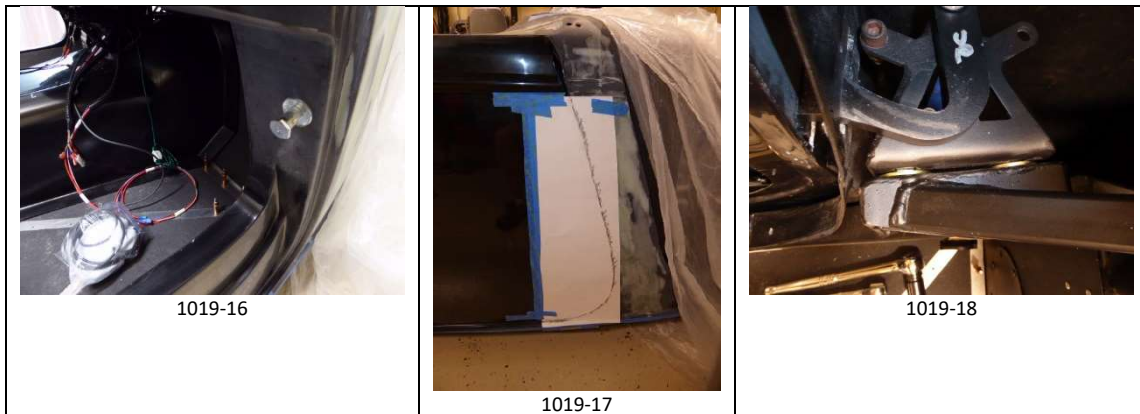
10/17/2019 to 10/31/2019: Having thought about the door installations for over a year now, I decided to mount the strikers as shown in 1019-16. Now the striker head is slightly more aft, both of the doors required a little more fitment work. This mainly consisted of trimming the door aft edge slightly and extending the front edge slightly. Starting with the passenger door, the front edge shape was determined using a cardboard sheet taped to the door and tracing the door sill outline. This was cut to shape and the front edge was built up with layers of fiberglass and epoxy resin. A little body filler was necessary but after some trimming, the door fit well with a 1/8" gap all around.

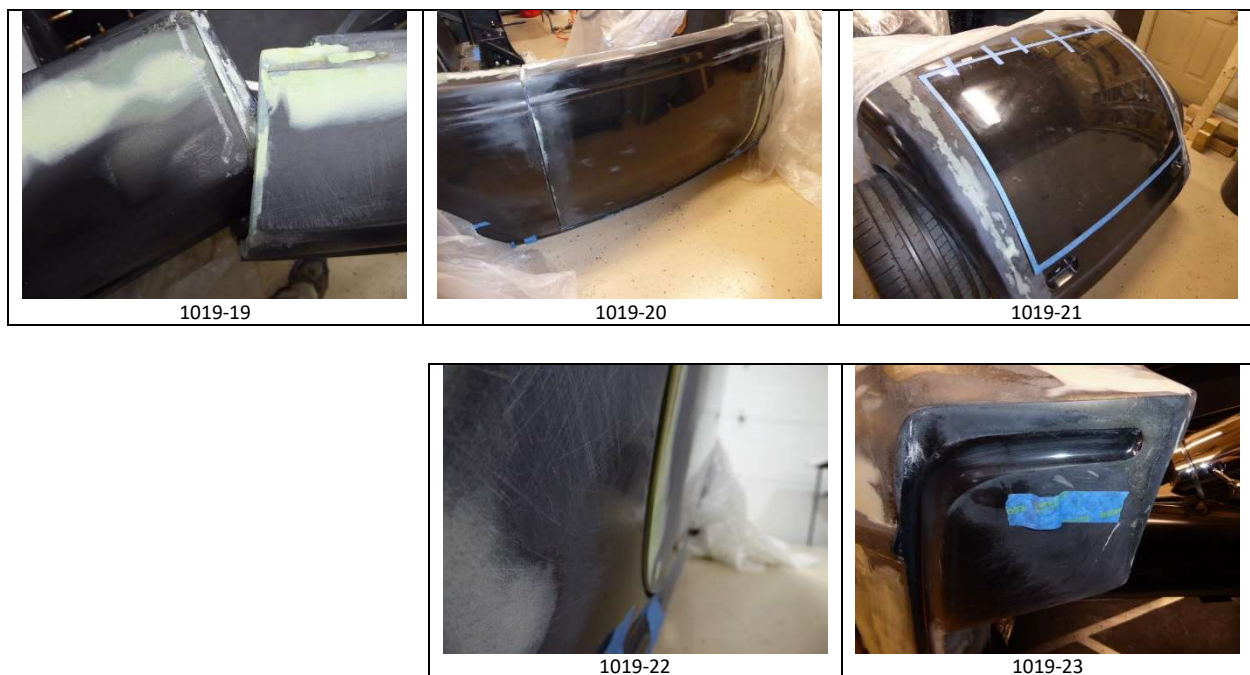
However, the passenger door-body interference that was referenced in 1018-25 (yep, last October's entry) still existed. The only way I determined to correct this was to move the hinge rotation point outboard. I added 1/8" washers between the door hinge standoff brackets and the chassis (1019-19 and 1019-20) and now the door opens without interference. While the door epoxy was curing, I worked a little bit on the trunk lid fitment. Picture 1019-21 shows the lid in place, but a little more work is required along the bottom edge.

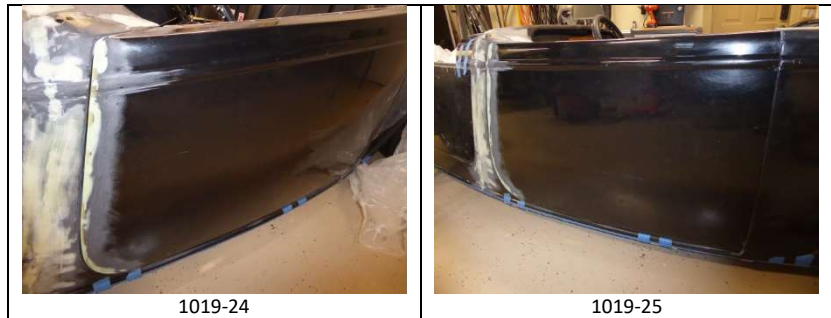
(or body in this area) was slightly warped or out of plane after altering all the door edges for a pretty good fitment. This resulted in the forward bottom edge of the door to be slightly outboard of the body cutout area (1019-22). If I put one of those small rubber bumpers on the body in the area where the door seal will eventually be attached up top (1019-23), the top of the door is pushed out resulting in the bottom of the door to pull back into alignment with the body. I want to find a permanent way to align the front edge of the door with the body prior to primer and paint and not rely on the door seal gasket to accomplish this. I will play with the hinge brackets to see if this helps later, but the aft edge of the door is aligned with the body now. Current fitment of the driver door is shown in 1019-24 and 1019-25.

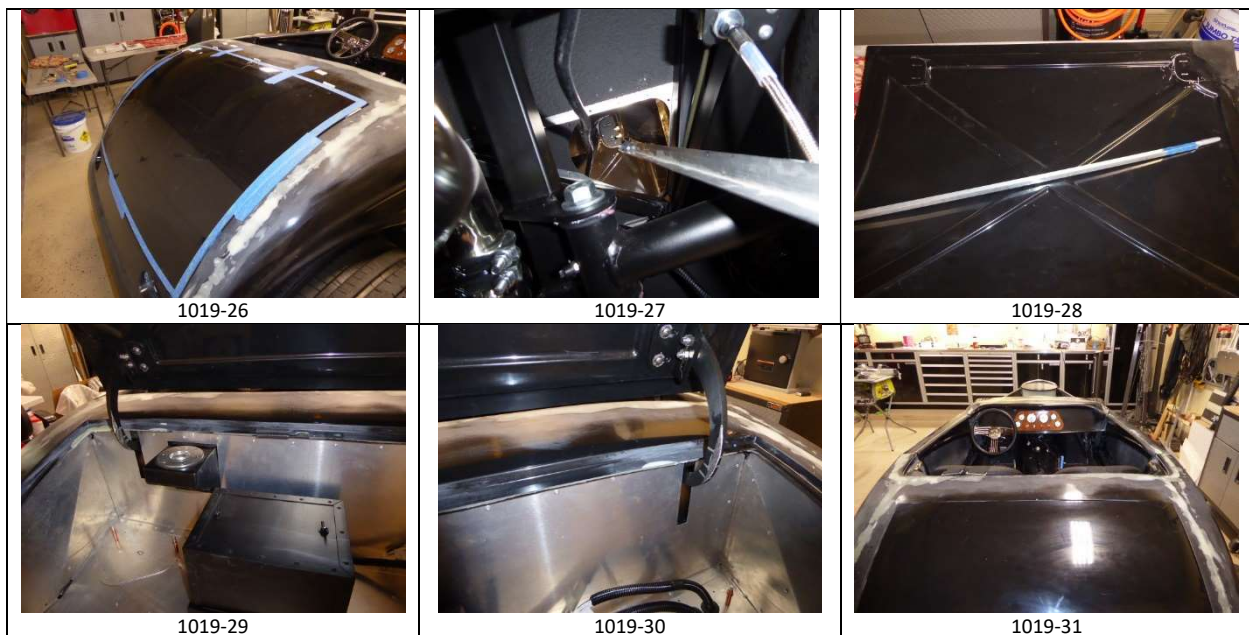
I did not want to redo the rivnuts locations, so I just ground off a small portion of the link to provide the necessary clearance (1019-29 and 1019-30). I will clean the links up and re-powder coat them when I pull the body off for primer. 1019-31 illustrates the final fitment of the trunk. Trunk latch to come later.

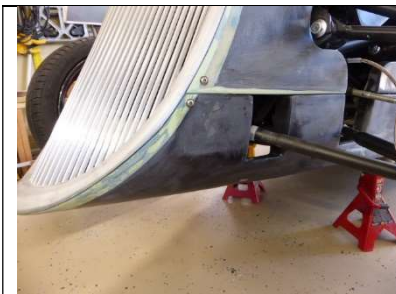
However, I was not satisfied with the gap between the forward part of the engine side cover and the nosecone. Hence, I spent some time filling this in with body filler. Picture 1219-02 to 1219-07 illustrates the nose cone fitment as well as the final gaps between the engine side covers and body interface.

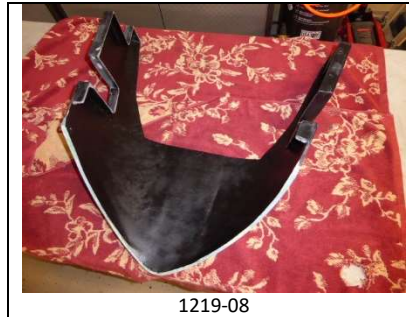
1219-08

Now that the nose cone fit and attachments are complete, I removed it again and brushed on two coats of black undercoat onto the interior portion of the cone (1219-08). This assembly was then re-mounted back onto the Rod.

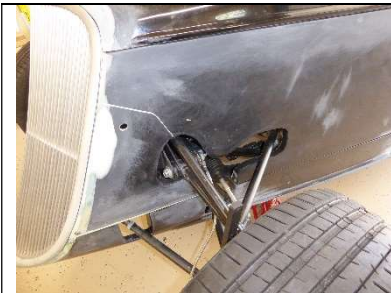
I mocked up and drew out several configurations for the removable side panels searching for an acceptable solution. I also researched the forum to discover how others have done it. As a result, I decided on a hybrid of what I discovered, and I am going to proceed with the cut as shown in Picture 1219-09 which leads from the upper suspension cutout to the grill just above the headlight mounting hole. I plan to fabricate an upper piece that will attach to the grill to be installed when the side panels are removed which will cover up that forward portion of the engine bay/grill area. But this work will need to wait until January as the Holidays are upon us.
