VPS Hot Rod Build Blog

Volume 3 – Adolescence is Tough - 2020

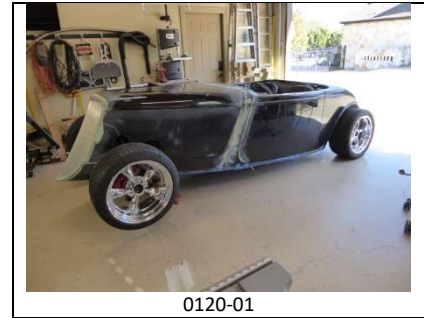
0120-01

I decided to cut the engine side panels along the line shown in 1219-09 and in 0120-01, just above the front tire and just above the headlight mounting hole. I mounted the forward lower piece to the Rod and used a bolt in the headlight hole to hold it temporarily in place (0120-01). The steel spacer provided with the kit that goes between the fiberglass panel and chassis mounting bracket was a bit too large and did not fit very well. I created a better spacer out of aluminum tube.

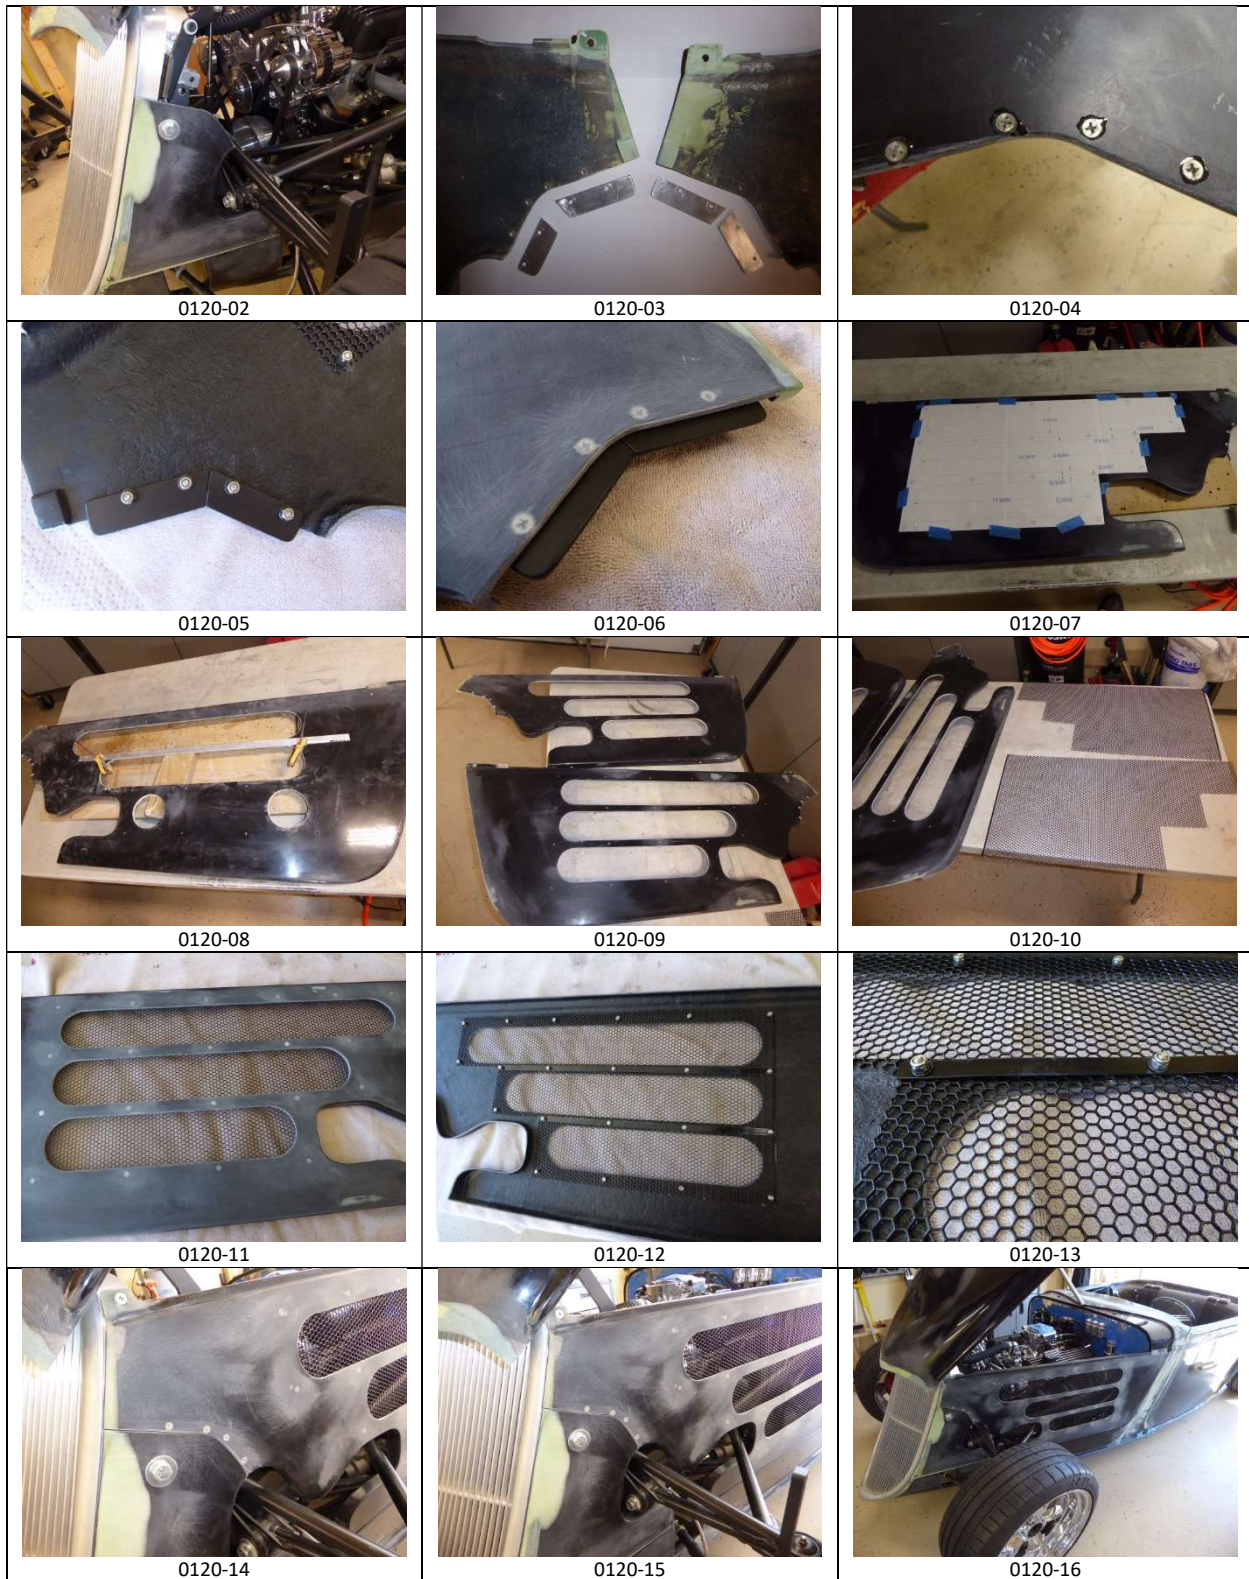
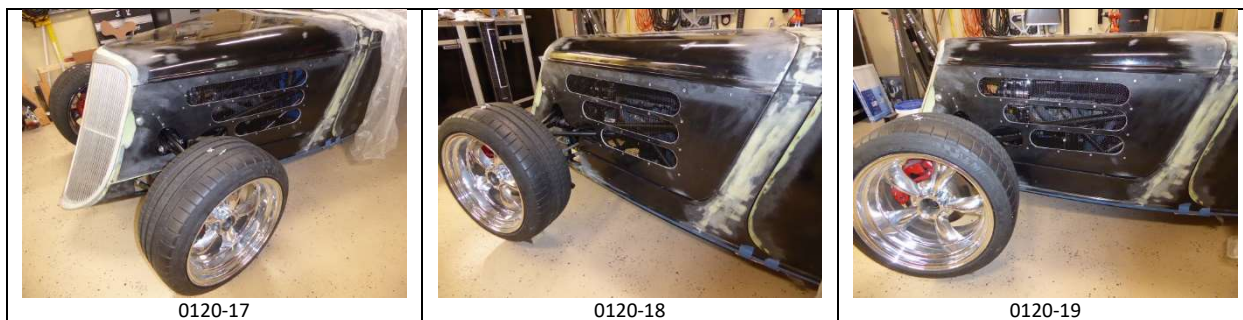
The remaining engine side panel required some type of mounting support along the cut line. A couple pieces of aluminum (0120-03) were fabricated and mounted onto the interior side of the engine panel. I used #8 countersunk machine screws that I epoxied into place (0120-04). After a torque strength test, a quick sanding, and a tiny bit of filler, the powder coated aluminum bars were bolted into place (0120-05).

A full-size pattern for the grill slots was printed out and taped in place onto the side panels (0120-07) in order to locate the 3-1/2" holes at each end of the slots. These were drilled out. A 1" aluminum bar was clamped at the side panel at the quadrants of the hole in order to establish a straight-line guide. A Dremel with a disc cutting tool was used to cut the fiberglass right along the aluminum bar. Just a bit of additional sanding completed the cutouts (0120-08 and 0120-09). The interior side of the engine panels were then painted with the same black undercoat that is being used throughout all of the build.

The grill mesh sheet was large enough to cut out and use just one piece for all three slots per each side (0120-10). #8 machine screws epoxied into the fiberglass countersunk panel holes were again utilized (0120-11). The remaining 1" strip of fiberglass between each of the slots appeared to be a bit on the weak side. A 3/4" x 1/8" aluminum strip was utilized as a doubler along these strips to provide the

needed strength (0120-12 and 0120-13). The finished engine side panels are shown in pictures 0120-14 to 0120-19.

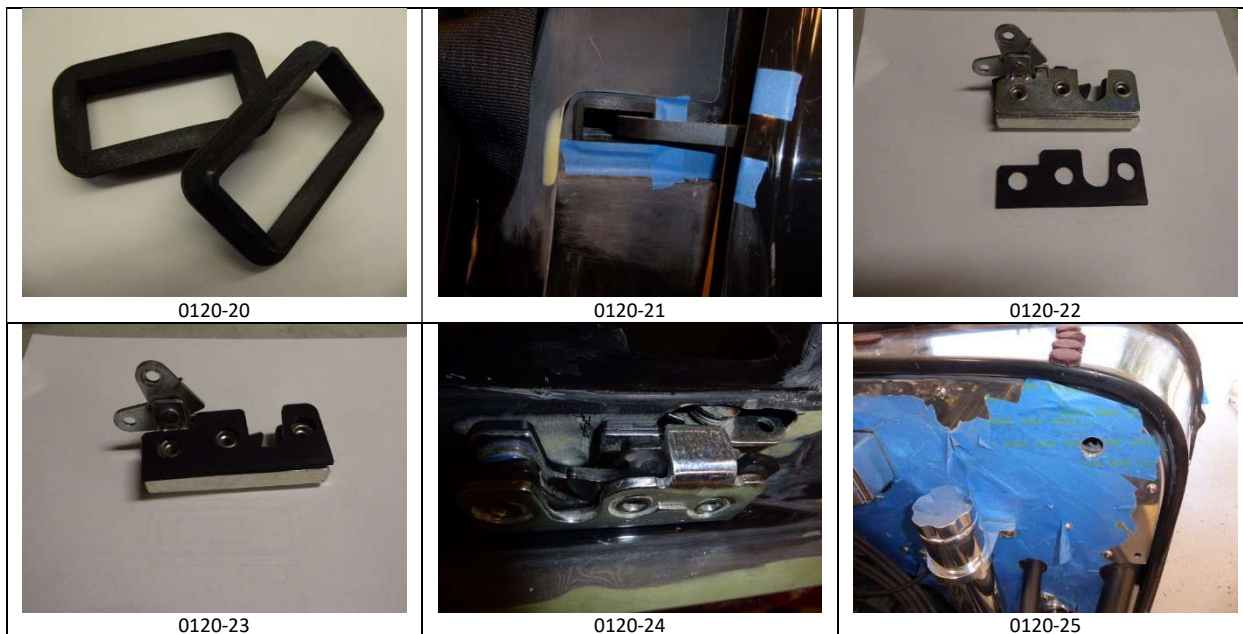
The gaps and the fitment of the closed doors are satisfactory. However, the operation of the doors was not quite right and the cutouts for the hinges in the chassis and doors were crude at best. I tackled the hinge cutouts first by designing a frame that could be epoxied into place and provide a better visual appearance. These frames were created with my 3D printer utilizing high strength ABS plastic. Picture 0120-20 illustrates two of the eight frames manufactured while picture 0120-21 shows one of the frames temporarily taped into place. These will eventually be epoxied into place and become part of the body and door.

Another issue was the driver's door striker latch engagement clash. Even though the door gaps were satisfactory, the latch was slightly too far aft to engage the striker bolt. The solution was to make a spacer/shim to place between the latch and door, thus moving the latch forward but keeping the door in place. I reversed engineered the shim to fit the latch and 3D printed it out of the ABS filament to about 1/8" thick. The latch and shim were mounted onto the door and after everything was reassembled, the door closed perfectly (0120-22 to 0120-24).

While the door work was progressing, the holes for the hood hold-down receiving pins were drilled into the firewall (0120-25). The receivers themselves cannot be installed until the body is removed. Just another item for the to-do list.

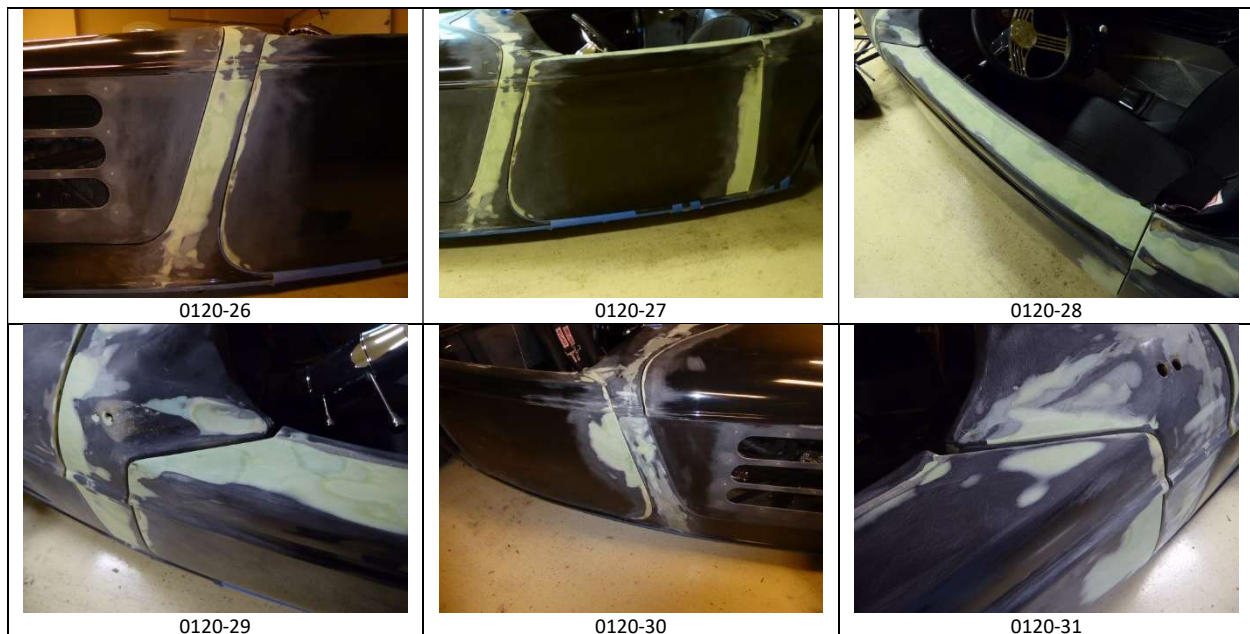
The work on the body fitment to the engine side panels and doors continued. My approach is to work from the grill and continue aft to the trunk as the trunk will need the most work. There is not too much to discuss here as all the work is body filler application and sanding. In general, the areas that needed attention included:

- Engine side panels to the body, 0120-26.
- Driver door aft edge to body, 0120-27.
- Top of the driver's door, 0120-28. This included matching the door top front edge to the body, 0120-29, and the door top aft edge to body.
- Passenger side door front edge to body, 0120-30, and the door top edge to body, 0120-31.

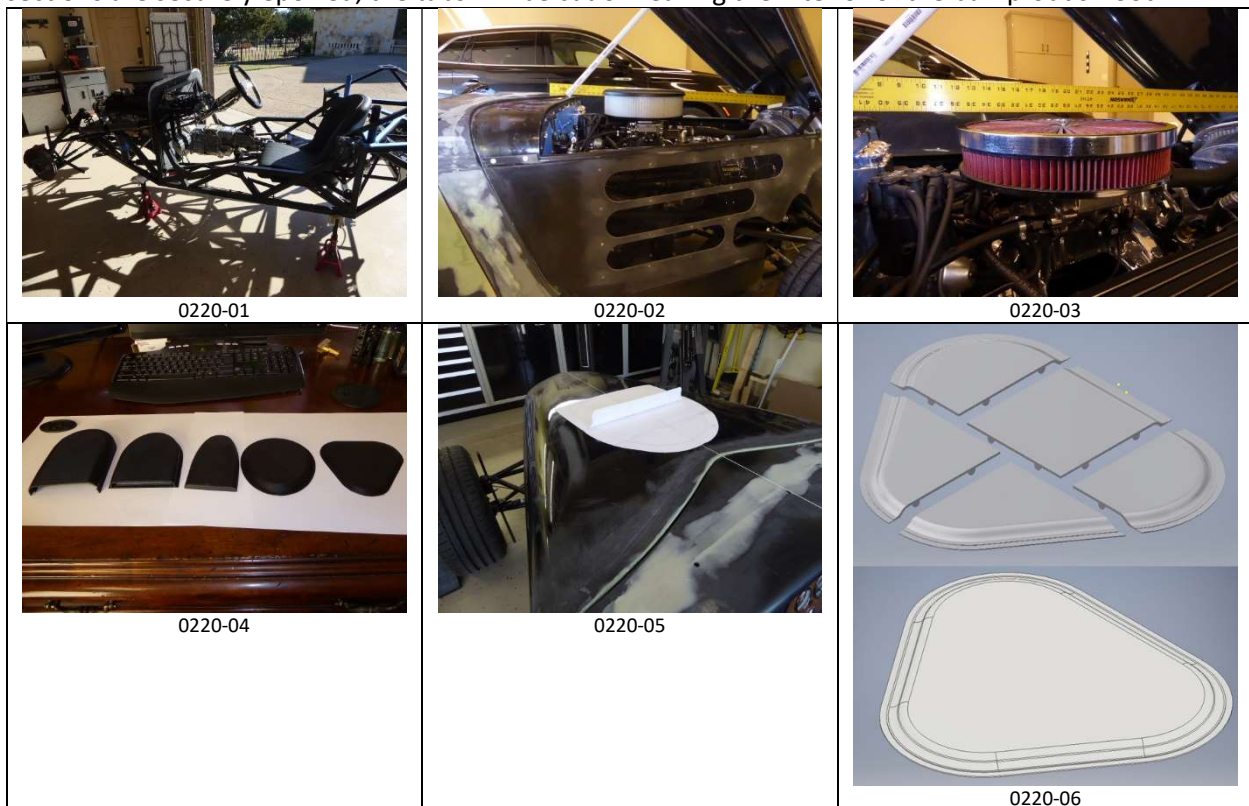
A 1/4 scale model was created for the 5 options above (a couple of others were also completed but not worth including here) in order to get a visual of the enhancement. These are shown in Picture 0220-04. Paper mockups were also created and set onto the hood. Option 1 is shown in Picture 0220-05. I decided that all options related to the original 4" air cleaner unit resulted in a situation where the hood enhancements were too tall and unreasonably blocked driver (and passenger) visibility. The enhancement selected was option 5. It has the lowest profile for visibility and provides about 1-1/2" clearance above the low-profile air cleaner unit.

Another challenge was the creation of the ABS hood bump-out. My 3D printer has limited size restrictions, so the full-size bump-out will need to be printed in five separate pieces and epoxied and fibreglassed together. Picture 0220-06 illustrates the 3D print models. The tabs on the interior of the bump-out will be used to bolt the sections together to facilitate the initial epoxy and fiberglass. Once the sections are securely epoxied, the tabs will be cut off leaving the interior of the bump-out smooth.

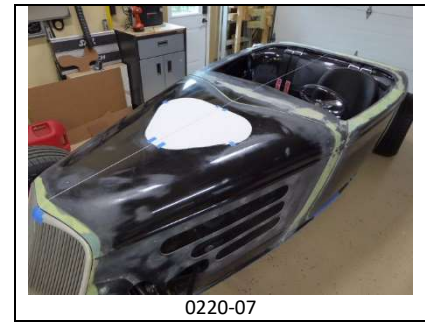
- A solution for the engine air cleaner and hood interference issue was determined. 0220-07 illustrates the paper plan of the final bump-out.

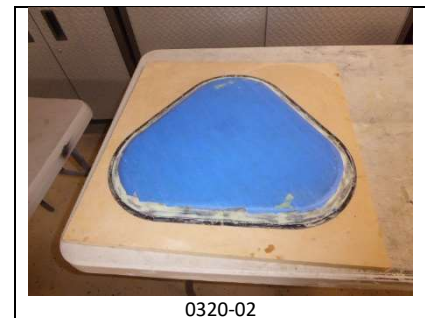
I completed printing out the hood bump sections and assembled it together with temporary machine screws. I used a very level $\frac{3}{4}$ " MDF board as a work surface and epoxied the sections together. The next step was to add some fiberglass strips along the seams between the tabs on the bottom surface. The tabs were then cut off and sanded smooth once the epoxy was dry. Two layers of fiberglass was applied on the top surface and one layer on the bottom surface. Two more coats of epoxy were applied on the top and bottom surfaces and then these surfaces were sanded smooth. Body filler was added to level the top and bottom surfaces. I covered the top surface with blue tape to protect it during installation into the hood. 0320-02 shows the completed part. I decided to set the hood aside and work on the trunk.

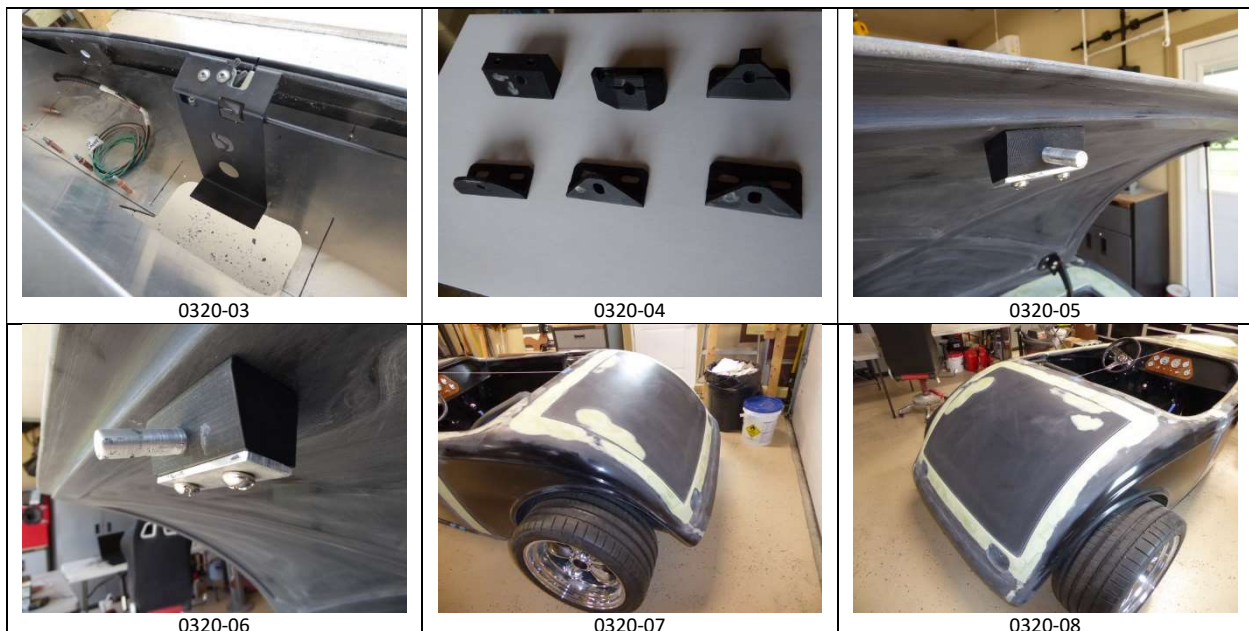
First off, the 90-degree bracket angle interfered with the latch assembly. Even after many attempts to achieve the correct angle, the shoulder bolt was way too short to fit into the latch smoothly and correctly. I decided to set this aside for now an attempt to make my own striker and bracket using my 3D printer and making bracket out of ABS plastic. The geometry of the bracket and its strength were challenges.

It was very difficult to make any measurements through to lower trunk floor opening so I basically went through a trial-and-error analysis in order to get the bracket geometry correct using the already established trunk lid rivnut locations. Fortunately, the bracket is relatively small and it printed rather quickly. Picture 0320-04 illustrates a couple of the configurations I tried. After 17 iterations, I determined that the pin face needed to be at a 70° angle from the mounting base to clear latch bracket. I used a 3/8" diameter aluminum rod for the pin at a length of 1-1/8" (Note: The shoulder bolt was 5/8" long). Strength was provided using a 1/8" x 1" aluminum strap on top of the ABS bracket so that the plastic was in compression with limited bending (0320-05 and 0320-06).

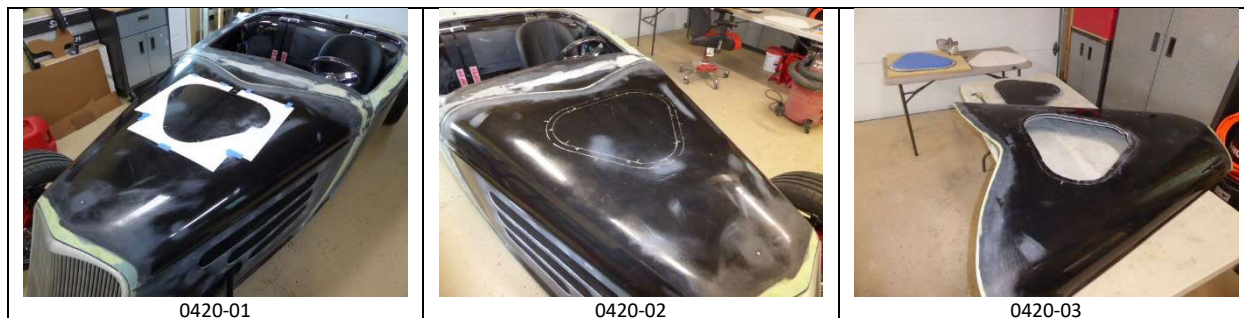
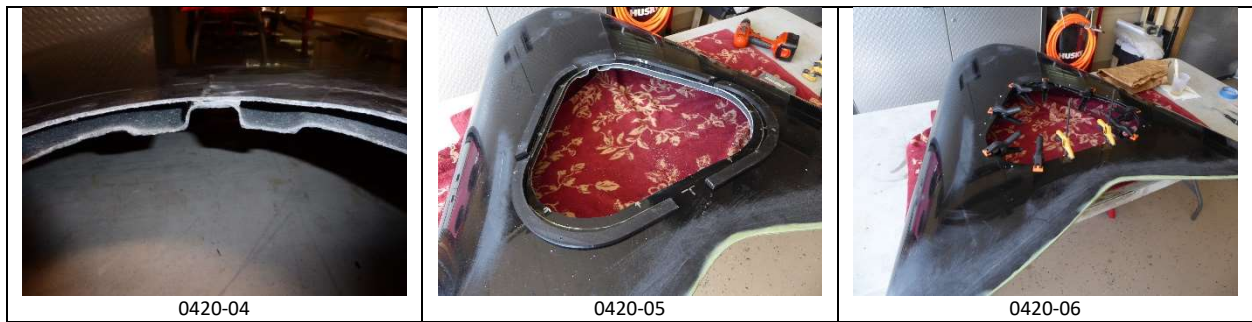
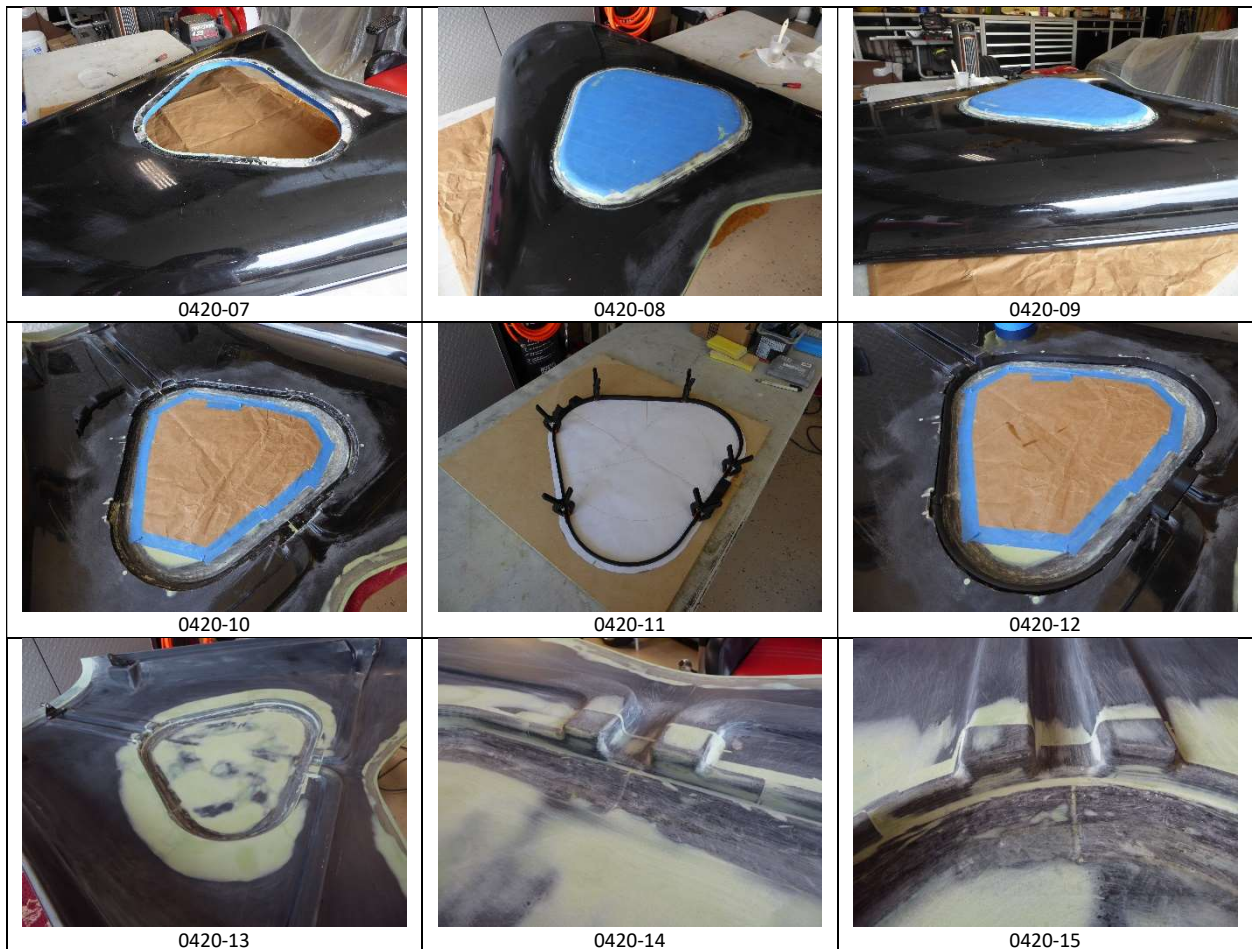
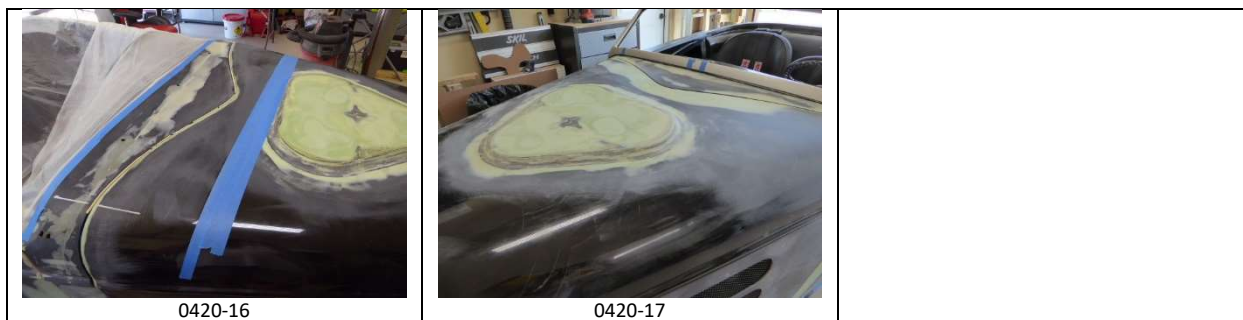
It is time to cut the hood and install the hood bump. I used a full-size pattern and taped it to the hood (0420-01). The hood pump was fabricated with a 1/8" thick perimeter rim. I marked the inside and outside edges of the rim onto the hood (0420-02) and removed the hood. Using a jigsaw, I cut the hood along the inside rim edge (0420-03) and discovered the double skin of the hood (0420-04) needed to be addressed. I utilized the hood bump 3D model and created a set of 3/8" thick perimeter spacers that would be epoxied between the hood skin layers. Picture 0420-05 shows the spacers sitting on top of the hood to illustrate the parts and 0420-06 shows the parts epoxied and clamped between the hood skins.

The next step was to router to a 1/8" depth the area between the rim inner and outer edges (0420-07). The hood bump was epoxied into place and temporarily secured with #6 machine screws (0420-08 and 0420-09).

The hood was turned over and the interior face of the cutout was addressed (0420-10). An interior ring for the cutout was 3D printed (0420-11) and epoxied into place (0420-12). Body filler was added to all gaps and sanded smooth (0420-13 to 0420-15). The hood was re-installed onto the Rod and all was just about perfect. However, now that the hood cleared the air cleaner and rested correctly onto the engine side panels, the body was slightly proud of the hood in the center area and some more body filler was necessary (0420-16 and 0420-17).

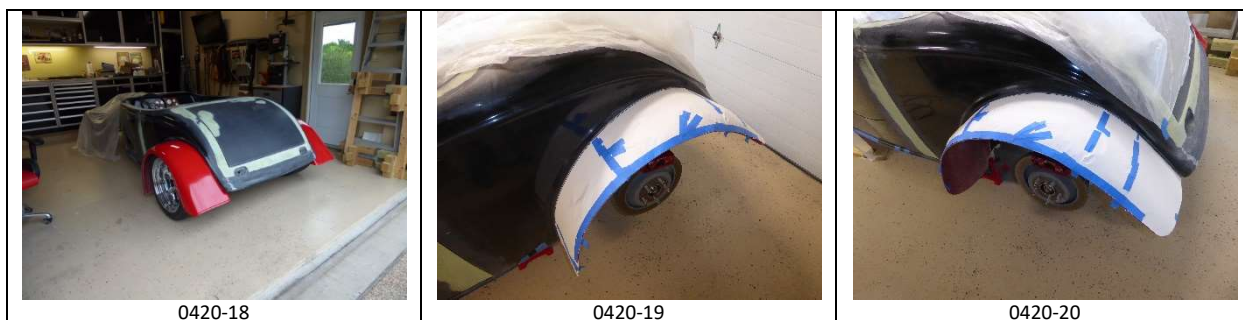
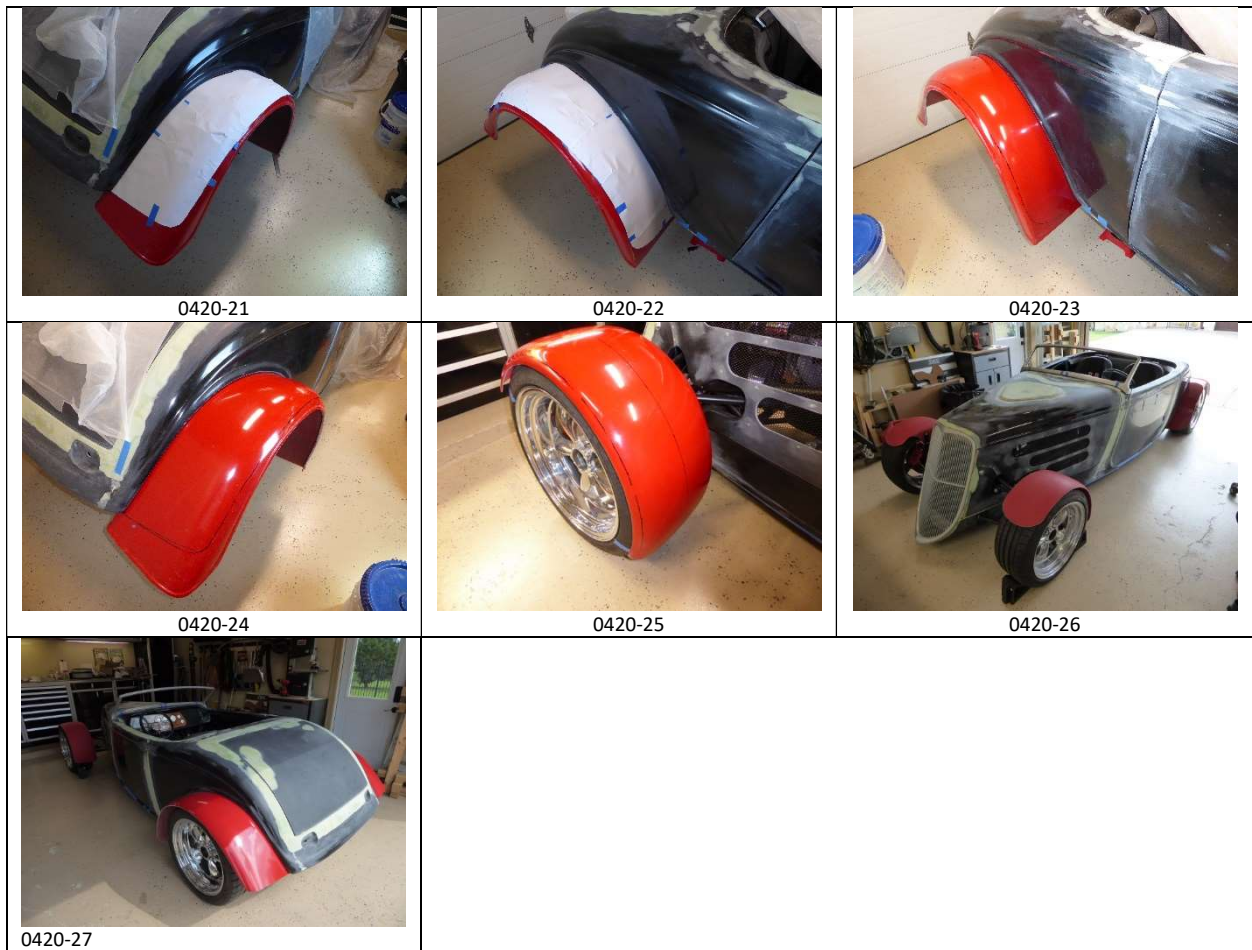
I started with the as-delivered rear fenders and installed them to the body using rivnuts as per the Assembly Manual (0420-18). Time was spent studying the fender trim shapes and I decided that the as-delivered shape was a little bit clunky and a bit too large for my tires. So, I elected to trim the fenders $\frac{3}{4}$ " from the face of the tire/wheel. Starting with the driver side, I made a marking spacer tool using a $\frac{3}{4}$ " aluminum angle and taped a felt tip pen to it. I could then mark the inside of the fender exactly $\frac{3}{4}$ " away from the wheel. A Dremel cut off wheel was used to trim away the excess fiberglass. I made several different paper templates for the forward and trailing edges to be able to visualize the cuts. When I was satisfied with final selection, I taped the pattern to the fender, marked the cut line, and used a jigsaw to trim away the excess. I sanded everything to get to the final shape.

Now I needed to transfer the driver side fender shape to the passenger side fender. I created a template by tightly taping together paper sheets to follow the contour of the fender (0420-19 and 0420-20). I carefully removed the template, inverted the contour, and taped it onto the passenger fender (0420-21 and 0420-22). After transferring the mark up to the fender (0420-23 and 0420-24), the template was removed and the excess fiberglass was cut off using a jigsaw. All the edges were sanded smooth and the fender was reinstalled onto the body.

I followed the same process for the front fenders and used the identical patterns for the trailing edge (0420-25). The front edge is the same ellipse I used for the front edge of the rear fender; however, it is centered symmetrical (0420-26 and 0420-27). The work was completed with an overall sanding and then the fenders were remounted onto the chassis. Just for fun, I set my surplus windshield frame in place and, low and behold, it now looks like a Hot Rod!

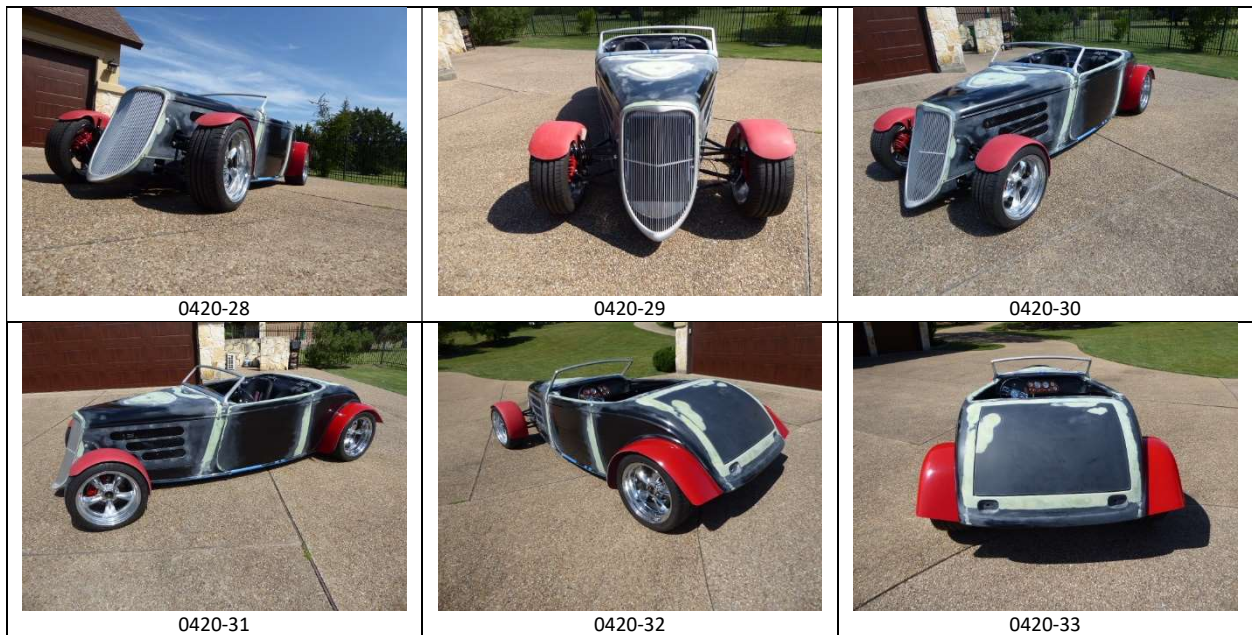
Work on the Rod during April was very satisfying as the body work is complete enough to seriously push towards a paint job, select a paint shop, and get a quote. Picture 0420-28 to 0420-33 illustrate the progress through the end of April 2020.

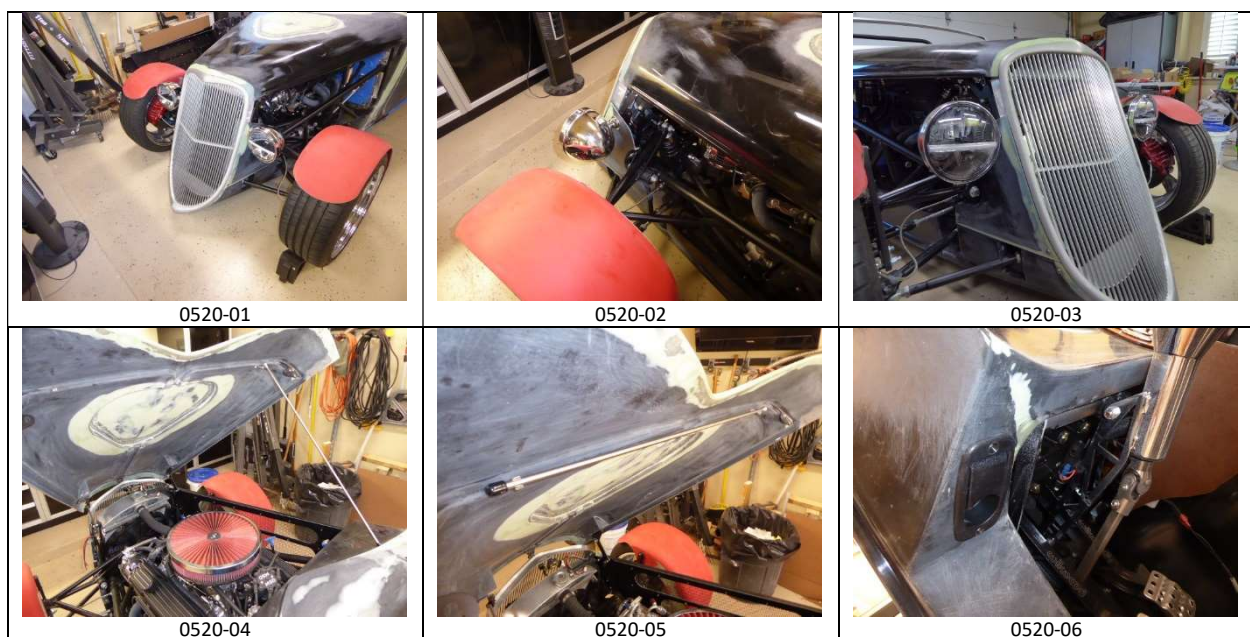
The headlights were then installed, wired up, and tested. Pictures 0520-01 to 0520-03 show the headlight installations.

Because of the hood bump-out and the required air filter clearance, the hood support rod installation was installed transversely as shown in 0520-04 and 0520-05.

The hood release lever was installed into the body door sill area adjacent to the steering column (0520-06). The actual cable will be fitted later with the body off. Final installation and hook up will occur after body paint.

The taillights were installed and wired up with quick disconnects to facilitate the removal of the body (0520-07 to 0520-09).

The hot rod kit does not come with a backup light and I believe it is necessary to have one. This was addressed back in August 2019 when I ran a green wire from the fuse box through the transmission switch on its way to the license plate bracket. I discarded the kit provided bracket and purchased a United Pacific LED Hot Rod License Plate Bracket shown in 0520-10. This bracket includes a backup light and a license plate light. I had to make a mounting bracket out of an aluminum angle which I powder coated matt black (0520-11). The bracket installation with a temporary license plate and mounted exhaust tips are shown in 0520-12.

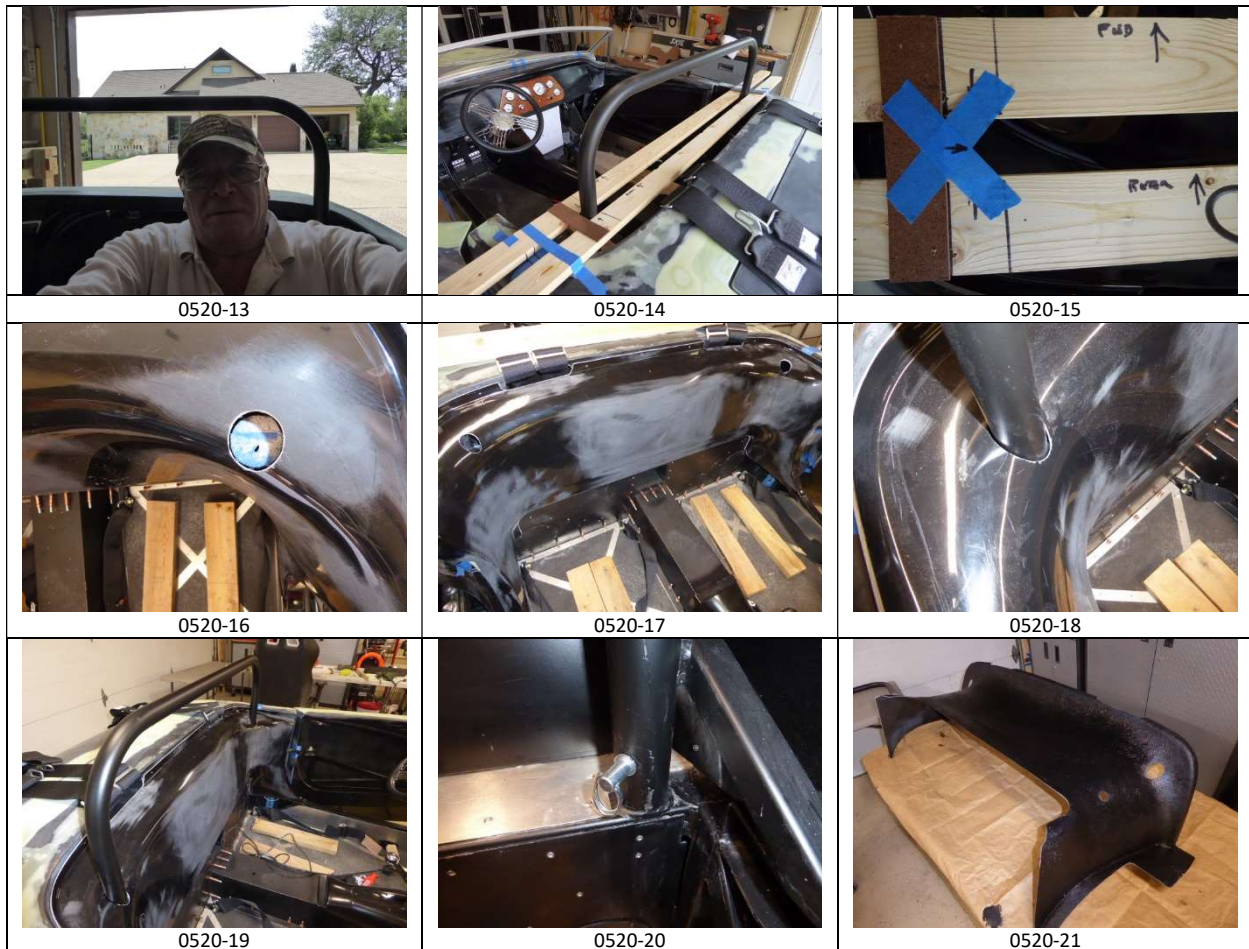
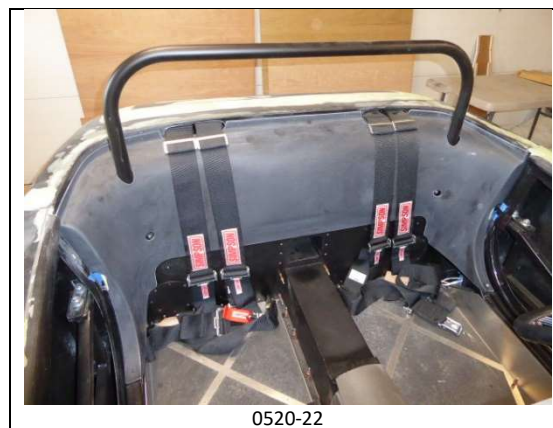
Back in October 2018 I designed a dual roll bar system but, besides the design, never acted on it. Now that it is May 2020, I am opting for simplicity and have decided to install the kit provided single roll bar with no comments on its appearance. The first step was getting it to fit into the chassis receiver pipes. This took a fair bit of time sanding the bare roll bar pipe (the non-powder coated ends) with emery cloth to remove some minor corrosion and to reduce the diameter slightly. The fitment also required some WD-40 and a rubber mallet to pound it into place. After four or five fitment sessions, it could be installed and removed with only some persuasion. It was placed into its lowest position in the receiver tubes and head clearance (2" recommended) was checked (0520-13).

The next step was to drill 1-1/2" diameter hole, accurately located, into the sloping curved surface of the waterfall. The assembly manual suggested to come up from underneath and mark the back of the waterfall. Yea, Right, Not Possible, Laughing Hysterically. Build school provided the suggestion of using a laser light hanging from the ceiling at the center of the receiver pipe, good workable idea. But, being a simpleton, I decided to build a locator jig.

With the waterfall removed (of course) and the roll bar inserted into the receiver pipes, two 1x4's were placed on each side of the roll bar spanning the rod. These were connected together with two pieces of fiberboard adjacent to the roll bar. The roll bar widths and the body to jig interface were marked so the jig could be removed and accurately replaced (0520-14). The roll bar was removed, the waterfall installed, and the jig set into place. I was some tape as straight lines locating the center of the receiver tubes (0520-15). A small plumb bob was used to extend the center point from the tape cross to the surface of the waterfall and the hole center was marked. Using a 1-1/2" diameter hole saw and holding the drill as vertical as possible, the holes were drilled. I had covered the receiver pipes previously with tape so debris would not collect in the pipes and picture 0520-16 shows the waterfall holes looking straight down onto the receiver pipe. Pictures 0520-17 to 0520-19 illustrates the fitment of the roll bar through the waterfall.

Additional holes were drilled into the waterfall for the roll bar hold down pins and with the roll bar and waterfall removed, hole for the pins were drill into the receiver tubes (0520-20). The back side of the

waterfall was black faced (0520-21) and the front face was 2nd stage primer sanded. All of the roll bar components were then re-installed onto the body/chassis completing the roll bar installation (0520-22).

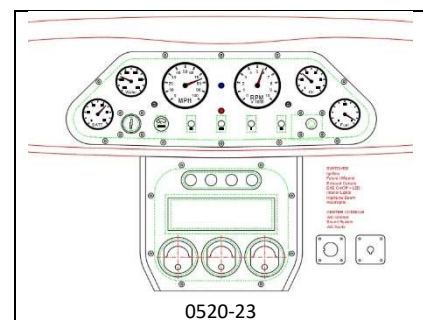
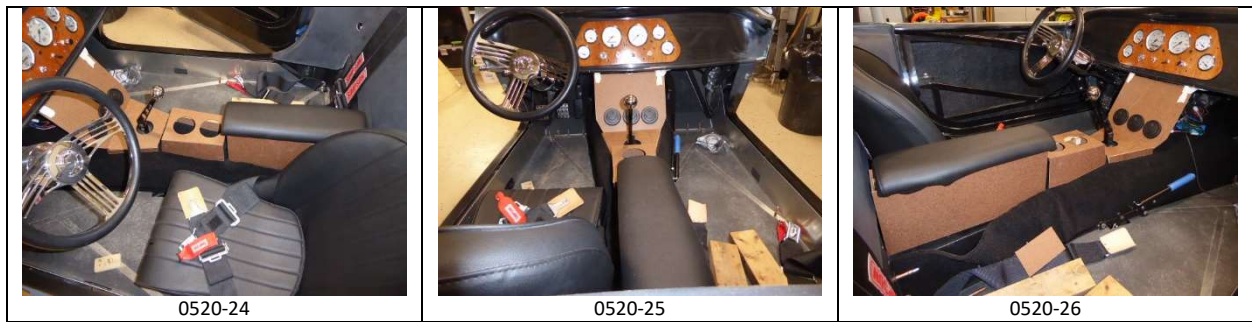
The dash and center console were first drawn to determine the size requirements as well as the component layouts. This is shown in 0520-23. All of the main elements of the console will include wood trim to match the dashboard. The next step was to develop some quick mockups of the console sections. The sound and heat insulation were installed onto the transmission cover and the cover carpet was laid in place. Now more accurate dimensions are possible. A couple of different configurations were developed and placed in the cockpit to get a visual representation of the entire layout. Pictures 0520-24 to 0520-26 illustrate the (almost) final layout.

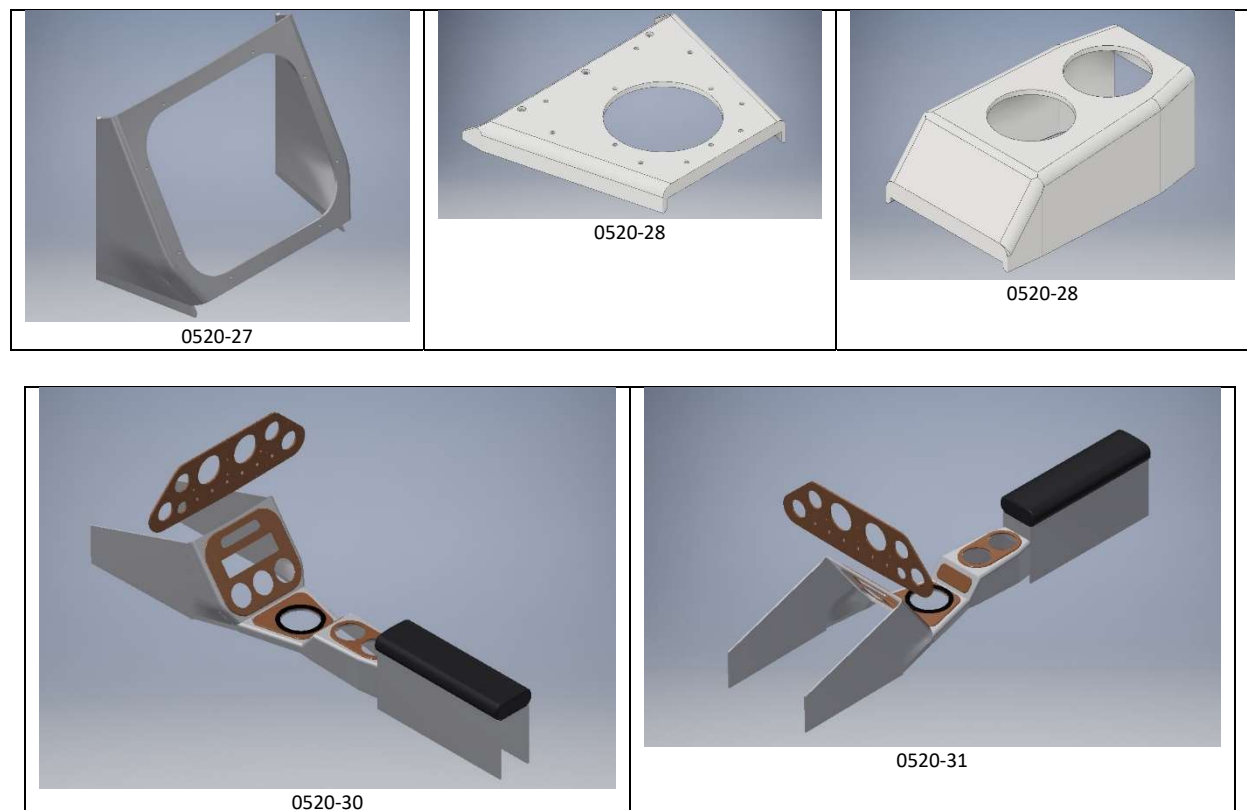
With the knowledge of the mockup layout and the gross dimensions known, the detailed design commenced. This was first drawn in 2D and it was quickly realized that the simplest method to construct the parts was to fabricate them out of ABS plastic utilizing a 3D printer. Each part was then 3D modeled. Pictures 0520-27 to 0520-29 illustrate some of the 3D model components. Pictures 0520-30 and 0520-31 illustrate the vision for the complete center console.

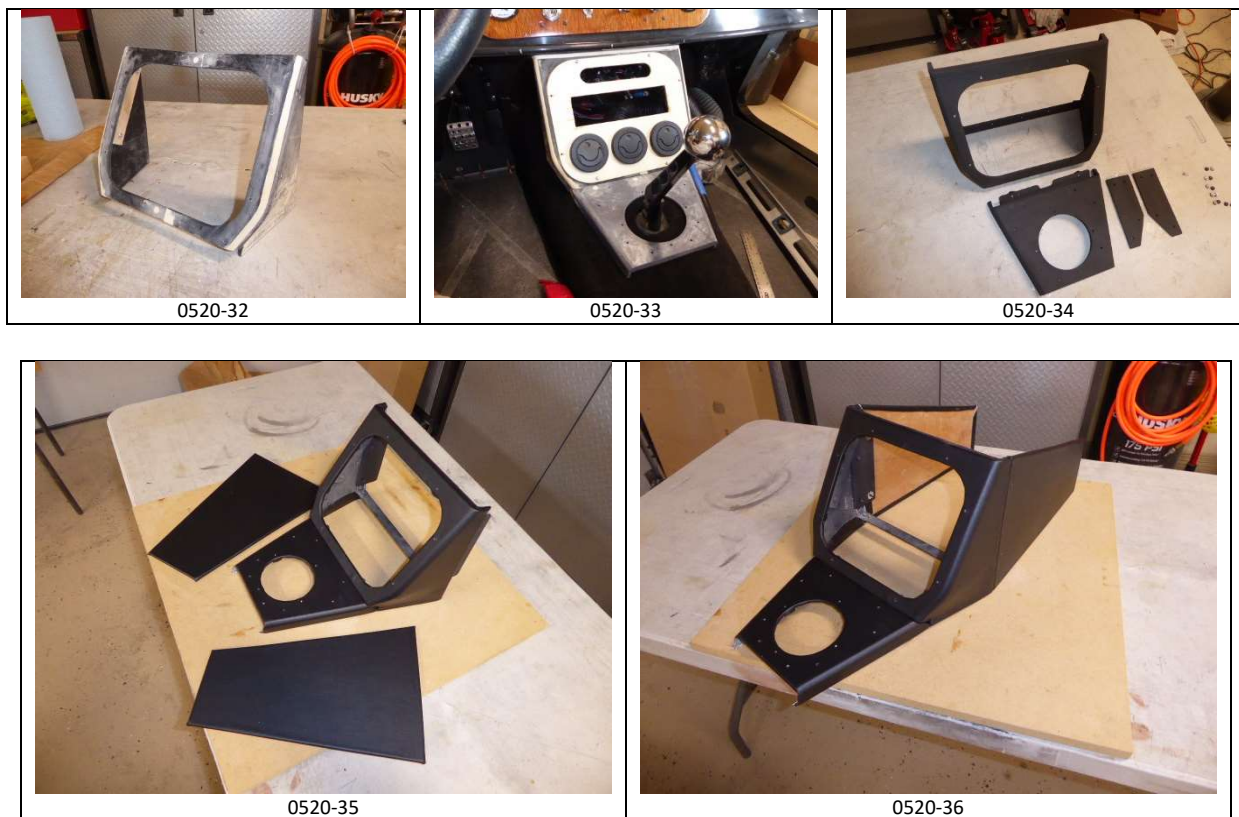
The under-dash console and shifter section was 3D printed first and test fitted. Pictures 0520-32 and 0520-33 illustrate the raw parts as well as a mock-up of the wood panel. Picture 0520-34 shows the components primed and ready for the next step.

The original kit included enough vinyl cloth to cover the rear cockpit waterfall. Early on the decision was made to paint the waterfall to match the body color which made the vinyl redundant. Not to waste anything, the decision was made to cover the center console using this redundant vinyl. The vinyl was cut and attached to the under-dash console, shifter section, and forward panels using 3M Super 77 spray adhesive. Pictures 0520-35 and 0520-36 illustrate the parts covered and assembled.

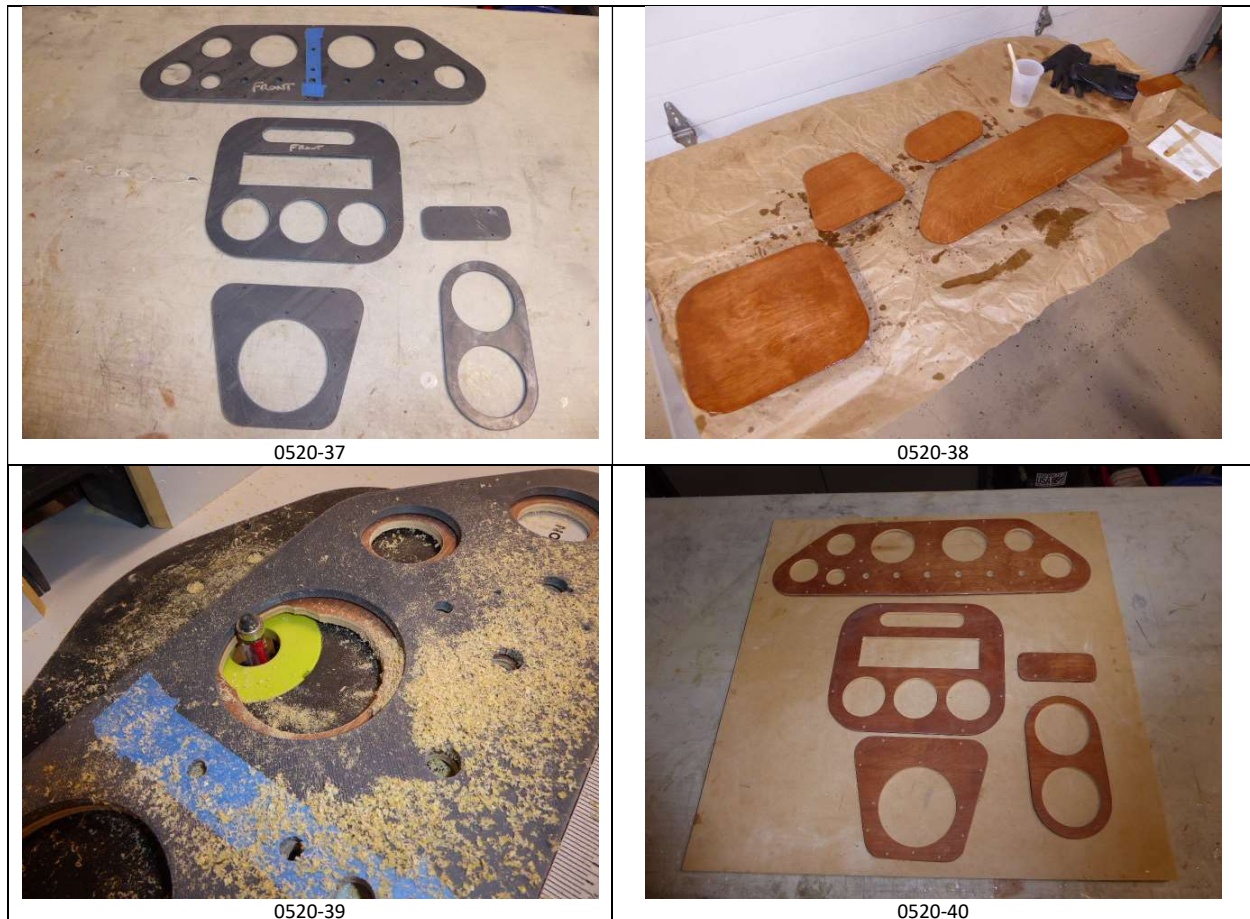
Picture 0520-38 shows the epoxied trim components. The templates were taped back onto the trim panels and the instrument holes were routed out (0520-39) or drilled out. The final trim panels are shown in 0520-40.

The wood trim panels were created utilizing the same 3D printed process making templates to be cut out using a router table. This provided for a fully accurate hole cutout. For instance, the speedometer and tachometer mount in a 3-5/32" hole, no drill or hole saws for that size. Picture 0520-37 illustrates the router templates. 5mm Birch plywood was selected as the wood of choice (today) and the raw pieces were cut out. The process includes the following steps:
