VPS Hot Rod Build Blog

Volume 3 – Adolescence is Tough - 2020

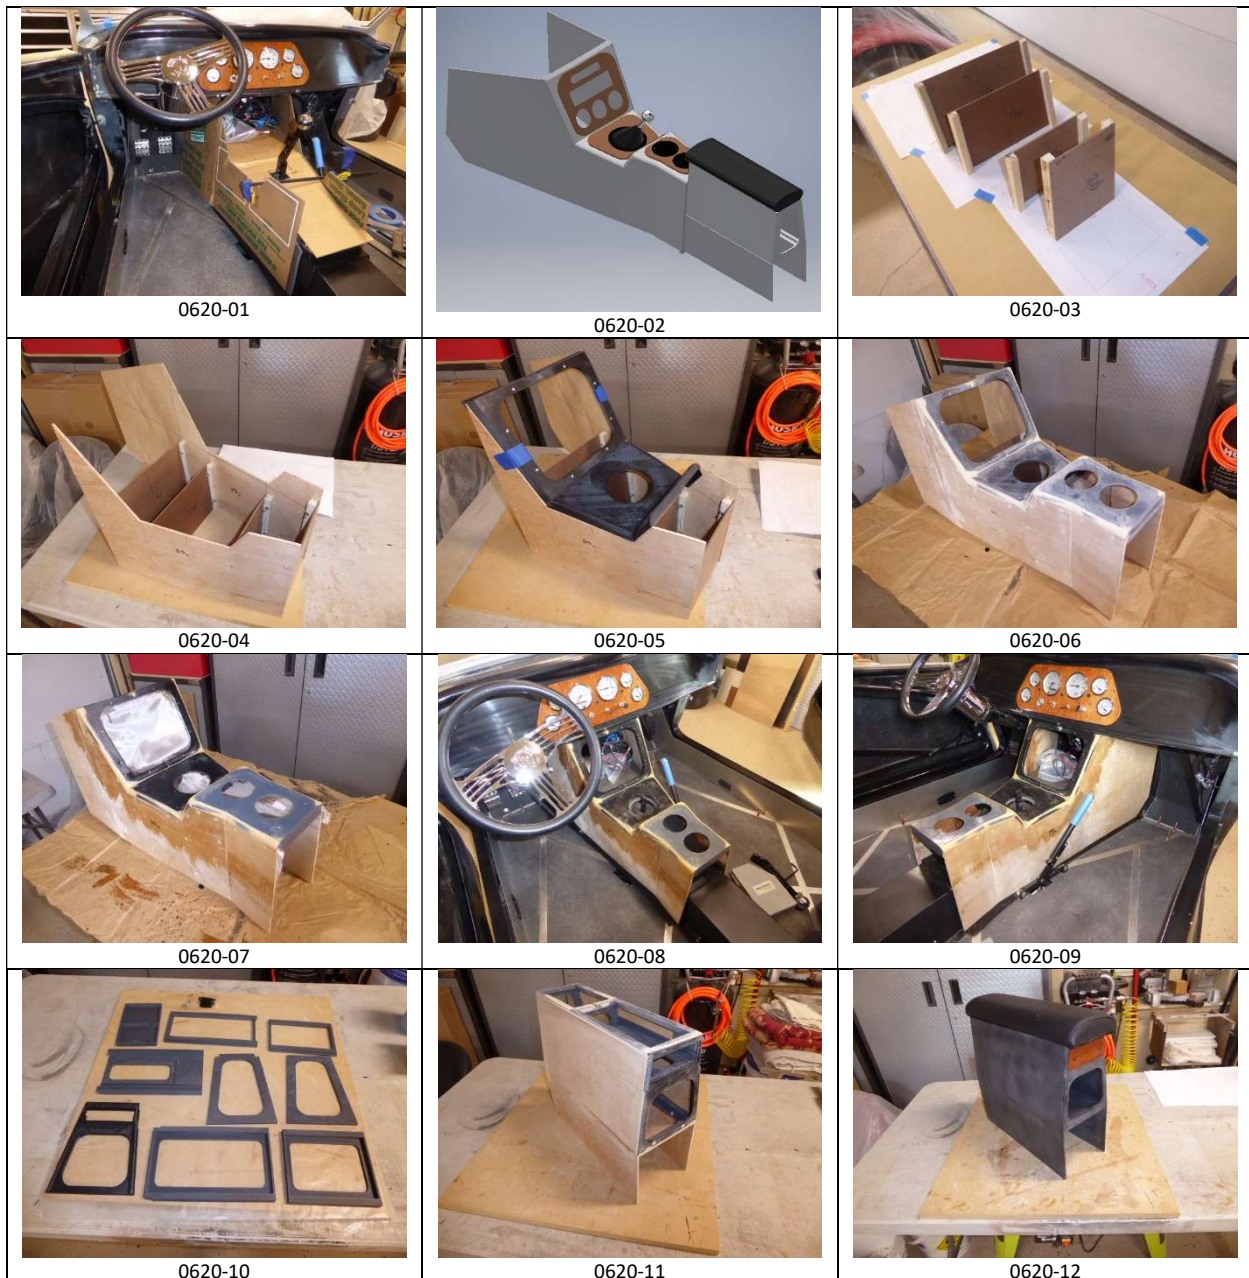
The same design process was used as before so that a crude mock-up utilizing cardboard could be created (0620-01). As more information was gathered, the 3D model was generated (0620-02). A building jig was assembled as the parts were being printed. The assembly steps and test fitting are shown in pictures 0620-04 to 0620-09. The arm rest was assembled in a similar manner and then sprayed with a black primer (0620-10 to 0620-12).

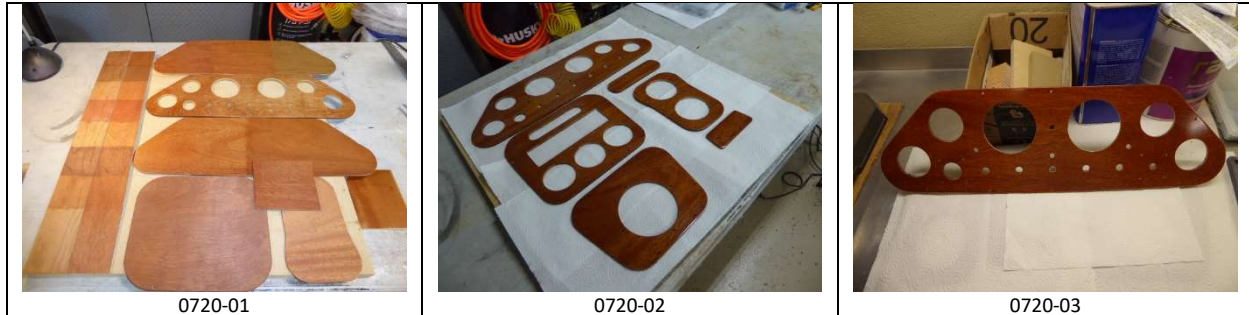
The final selection for the wood trim must be finalized now. The birch solution is just satisfactory but does lack some pop. Fortunately, in Austin there is a specialty wood lumber yard that is fairly close by. I purchased a sheet of mahogany and cherry veneer and then tested numerous stains and topcoats (0720-01). I had my favorites and with the help of some friends, a decision was made. Following the same process utilized in May, a new set of wood trim panels were created (0720-02 and 0720-03).

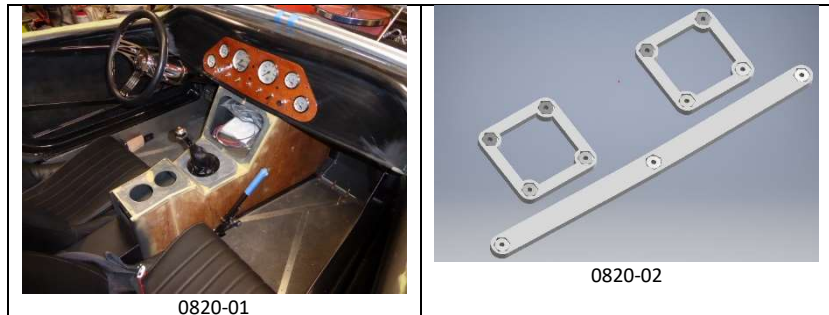
and mounted on the body (0820-01). There will be no access to the upper dash directly above the center console after it is installed so a couple of mounting modifications were made to facilitate its install. This included permanent mounting nuts installed along the lower edge of the dash and permanent mounting nuts installed for the ignition switch. Picture 0820-02 illustrated the nut mounting plates that were epoxied into place.

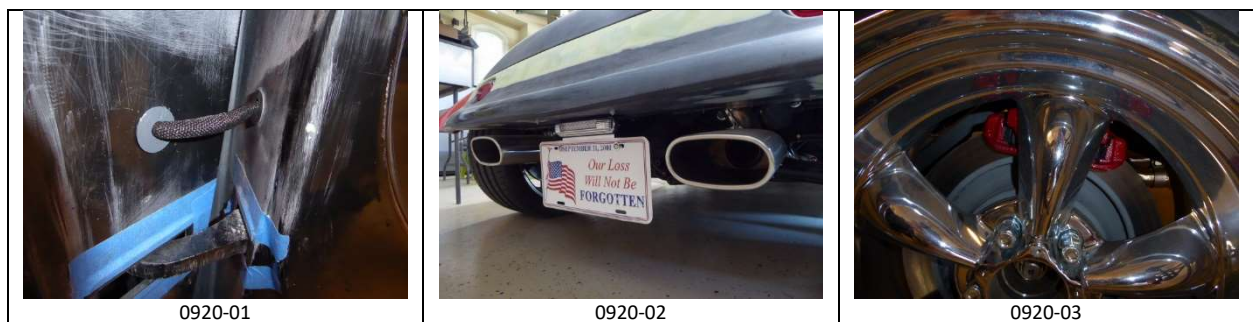
- Installed the body to door speaker wire conduit (0920-01).
- Tightened the exhaust tips as there was a slight misfit gap between the tip and the exhaust pipe (0920-02).
- Red paint touch-up on all the brake calipers (0920-03).
- Re-aligned the doors for better closing fit-up.

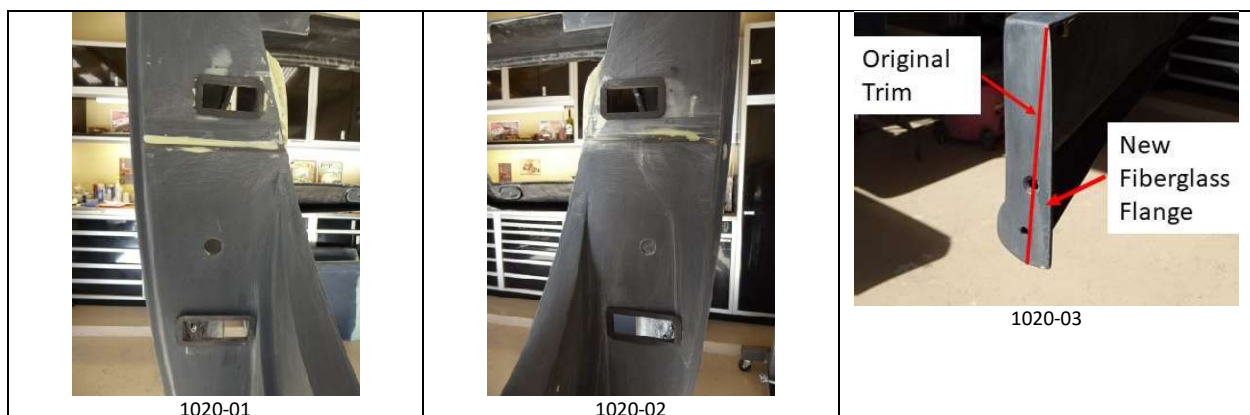
- The area in the main body aft door jam at the waterfall interface was cut short which left a gap when the waterfall is installed. This area, on both sides, was built up with fiberglass (1020-01 and 1020-02).
- The front passenger side where the body bolts to the chassis and nose cone was also cut short and required additional fiberglass so that it could be bolted securely (1020-03).

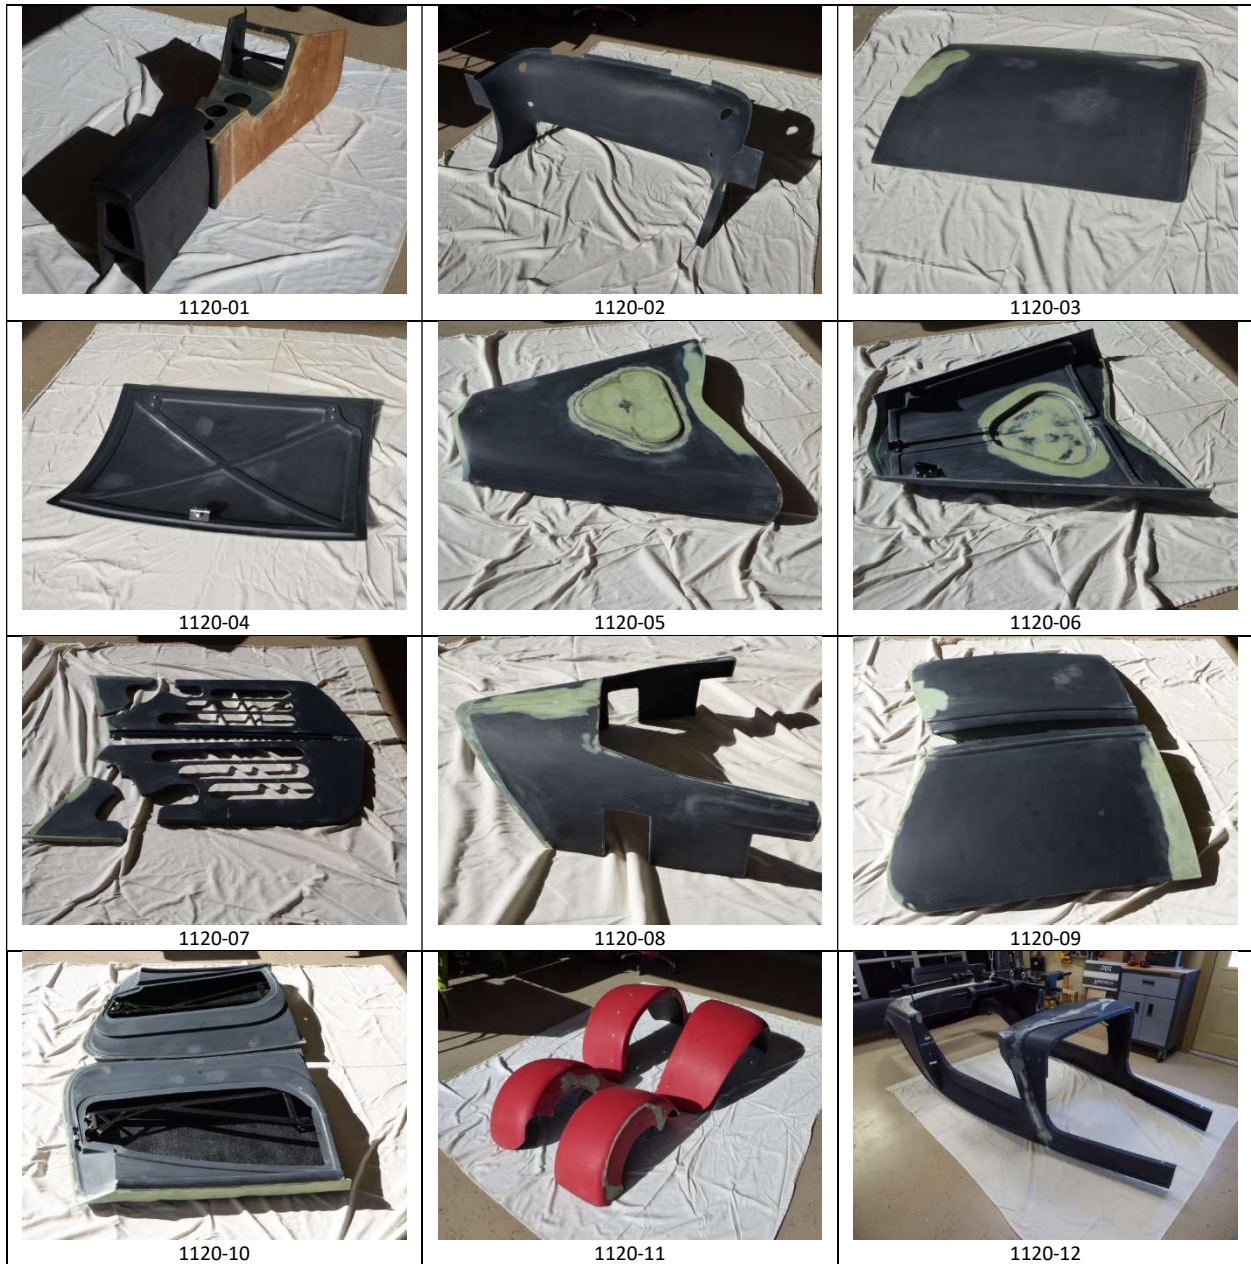
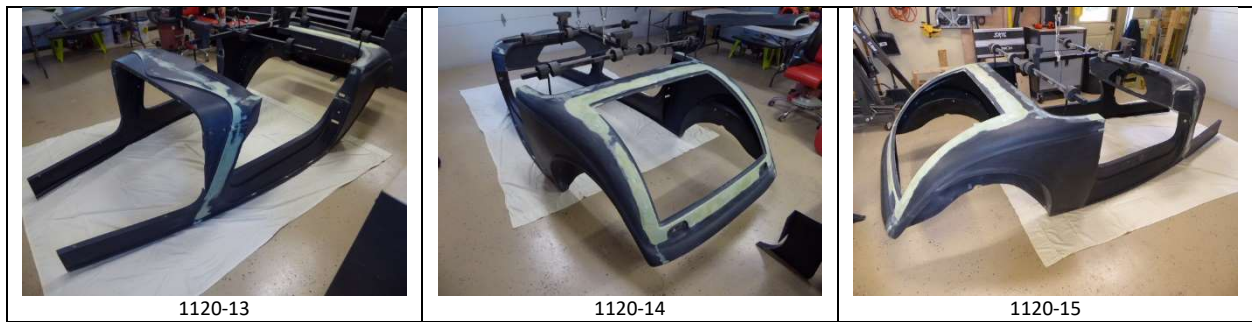
The next 2-1/2 months were spent SANDING. All the fiberglass surfaces that are to receive the color coat was lightly hand sanded with 180 grit and then with 320 grit. When this sanding was complete, each surface was inspected and all imperfections were identified and marked. This included gel coat imperfections (numerous), pin holes, deep scratches, and any other area that just did not feel flat and smooth. These imperfections were filled in with Evercoat Metal Glaze Putty and again sanded smooth with 180 and 320 grit sandpaper. Photos 1120-01 to 1120-15 are the final products ready for primer and paint.
