VPS Hot Rod Build Blog

Volume 4 – Teens Can Have Fun – 2021, 2022, 2023

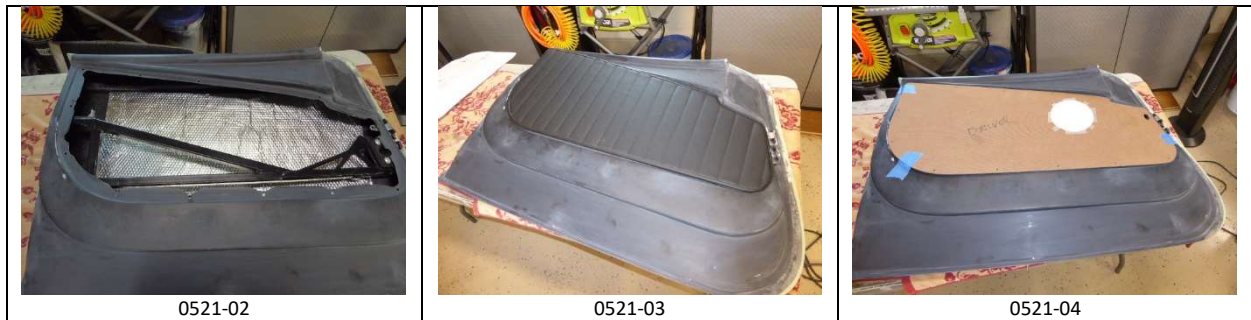
passenger panel cutouts in the door are slightly different, templates were made for each door to model the door panels. It started with a cardboard template and then fine-tuned using felt board (0521-04). Holes were drilled into the door panel mounting sills for the mounting clips using the templates.

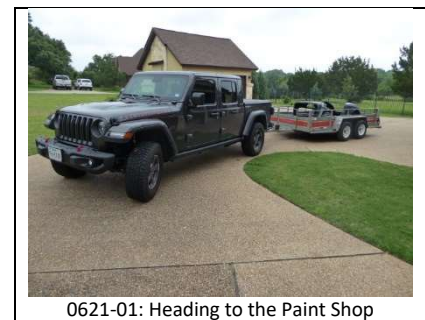
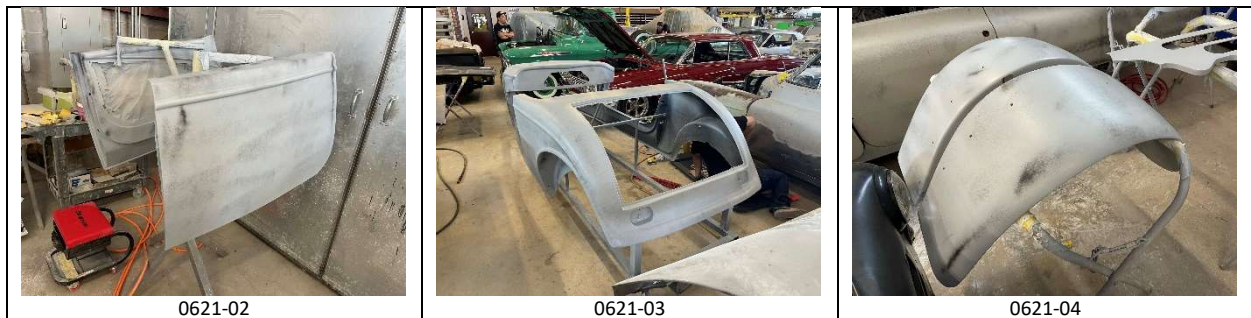
06/07/21: With a rented U-Haul trailer, all the fiberglass body parts were delivered to Murpho's. They floated, sanded, primed, applied basecoat, applied color coats, applied clear coats, sanding between coats and then sanding the top clear coat in steps up to 3000 grit, ending with a final buff and polish. During June, July, and August, it was fun to go down to Murpho's and see the progress.

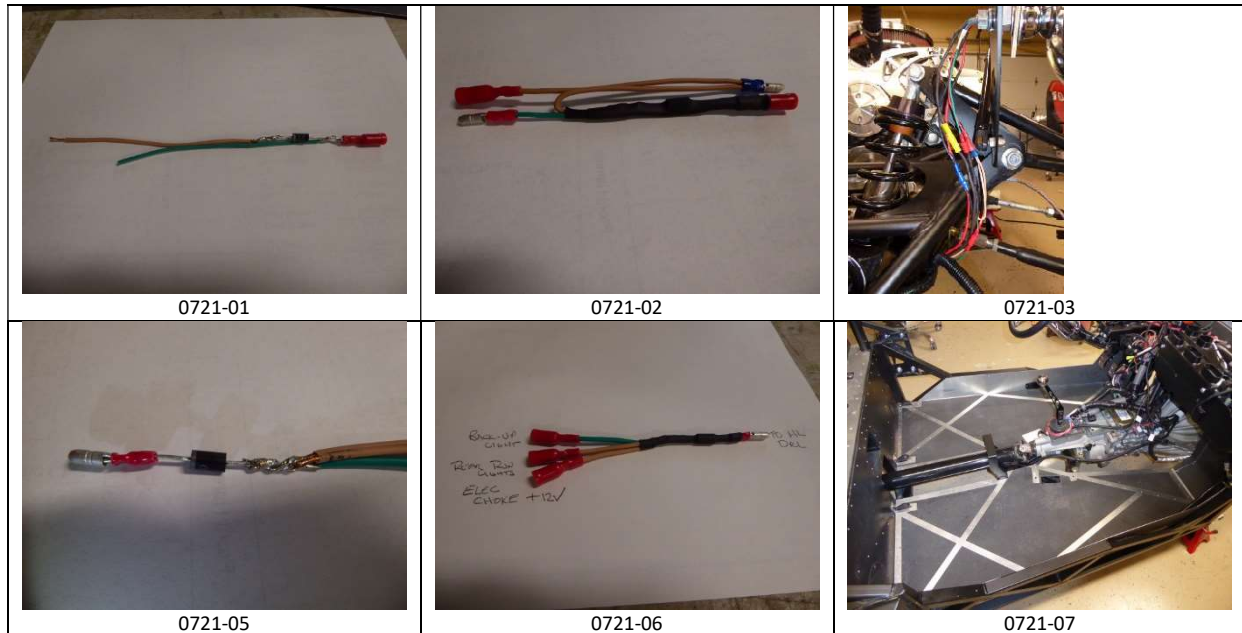
ignition switch. A jumper containing diode #1 was put together and placed at the driver side headlight connections (0721-01 to 0721-03). The second jumper for diode #2 was put together and was placed near the fuse box (0721-04 and 0721-05). (Future Note: In December 2021 some additional headlight wiring was changed and a schematic is posted there showing the diodes and other wiring improvements.)

The next job completed was to permanently install the floor panels and the driveshaft cover (0721-07).

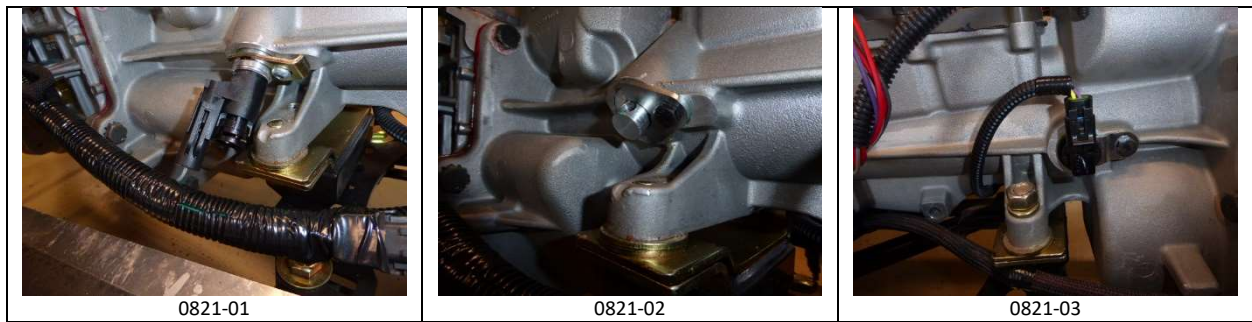
08/26/21: I performed another speed calibration test and now it appears that the speedometer is properly calibrated. Just to tidy up a bit, I removed the F5R speed sensor and reinstalled the port plug that came with the TKO (0821-01 to 0821-03).

On 08/23/21 an attempt was made to calibrate the speedometer. At this time the F5R kit supplied speed sensor was installed. After two attempts to calibrate, the speedometer was not indicating an accurate speed. Previously purchased was a TKO Speed Sensor Connector Pigtail, Part PG-094. This plugs directly into the TKO transmission's speed sensor. The F5R rear wire harness utilizes a dark green speedo signal wire and Gray EFI speedo signal return wire. However, only the dark green wire is utilized on my hot rod. The TKO pigtail has a yellow and purple with. Since it is a two-wire system, one of the wires produces a sine wave that is used to measure the speed. I had a 50-50 chance of connecting it right on the first try so I connected dark green to yellow and gray to purple.

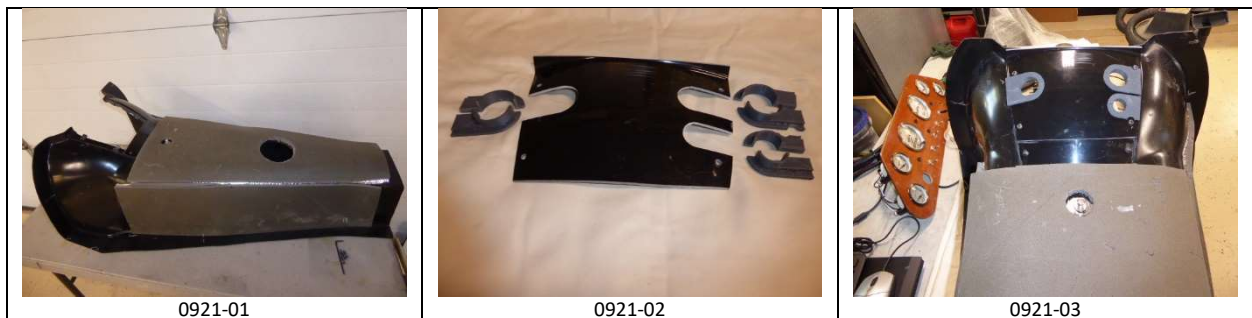
The next job was to find solutions for the incoming cable harnesses through the transom tunnel. Early on the transom tunnel top edge was cut off to allow the tunnel to be installed and removed easily as shown in 0921-01. Slots were cut into the top panel so that it could be installed around the harnesses (0921-02). Then the slot covers were designed and 3D printed using ABS filament. The grommets that came with the harnesses will then be used to seal the openings when the cockpit interior is caulked and sealed. The transmission cover was installed to the floor using bolts just in case it needed to be removed in the future.

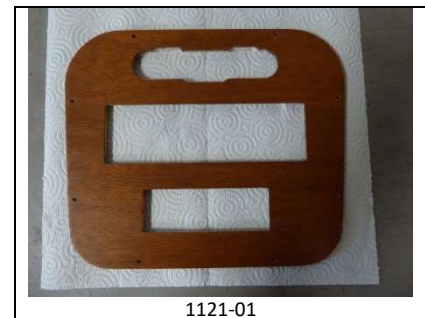
In early November the decision was made to rearrange the HVAC ducts. All three ducts were originally designed to be mounted in the center console but this became too clustered. A single rectangular duct is to be mounted in the center console and a round duct will be installed on the body in the driver and passenger areas. Mounting plates for the round ducts were designed and 3D printed.

The impact of this is that a new wood trim plate is required for the center console. The main dashboard wood trim unfortunately was scratched up a bit so it also needed to be replaced. Therefore, all wood trim pieces were created (again!) so that they would all match. Hopefully this is the last time this is done!

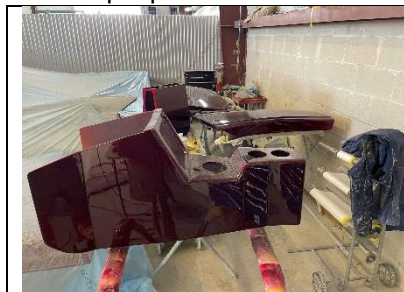
It is time to reveal what some of the body parts look like. This work was completed June-August 2021. The sample pictures include 0122-02 to 0122-04.

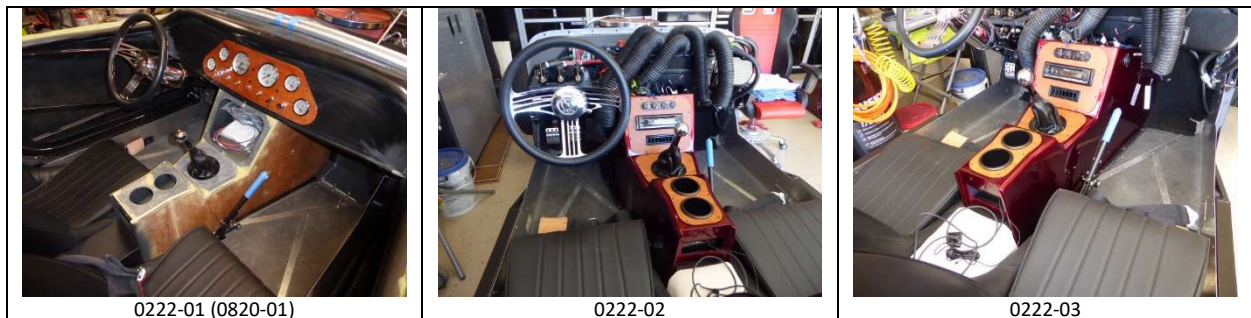
The next step, which started in January, was getting the chassis ready for body installation. First was to install the center console. The forward and aft console sections were test fitted onto the transom tunnel. While they were installed, the locations for the interior lights and accessory plug were determined. The console sections were removed and the interior lights and accessory plug were installed. The forward console was permanently installed onto the transom tunnel. The next step was to hook up all the console's equipment. This work included (0222-01 to 0222-03):

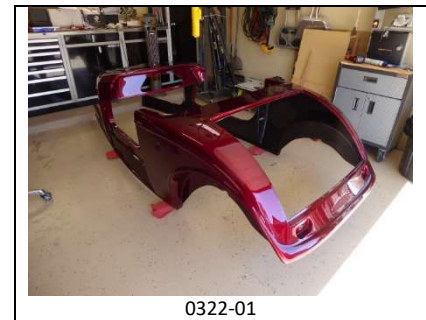
0322-01

- Body Painting – Painting was completed by Murpho's Hot Rod and Customs and all body parts were received from Murpho's during August 2021 and are ready for mounting.
- The body interior was (again) black faced to eliminate the red overspray.
- Prepare windshield for installation. Scuff to clean. Mount seal to windshield.
- Install Windshield on painted body. Secure with fender washers.

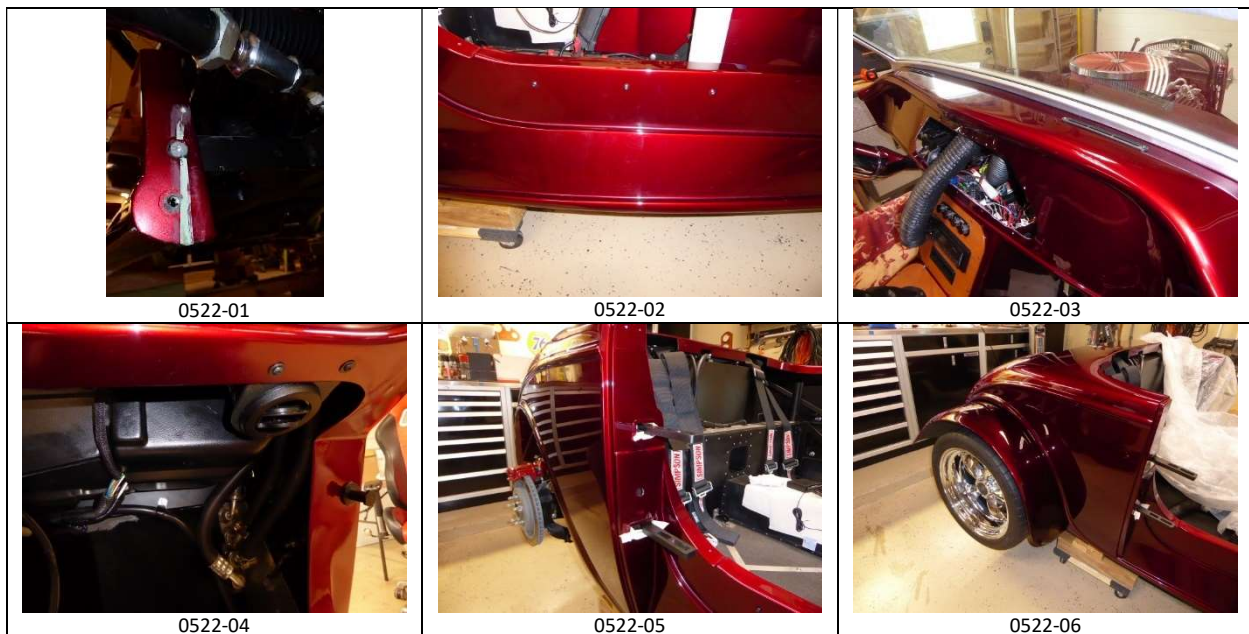
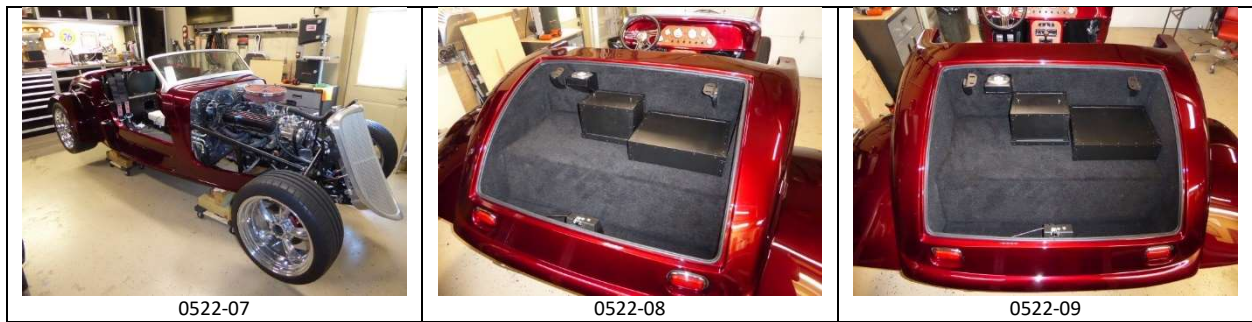
- Install trunk floor carpet, cut access holes for battery cables, amplifier cables, and prop rod connections.
- Install battery, battery box, and amplifier box.

- Install and trunk Prop Rod.
- Install trunk hood weather stripping.
- Install trunk hood on hinges. Check fitment. Test trunk hood action.

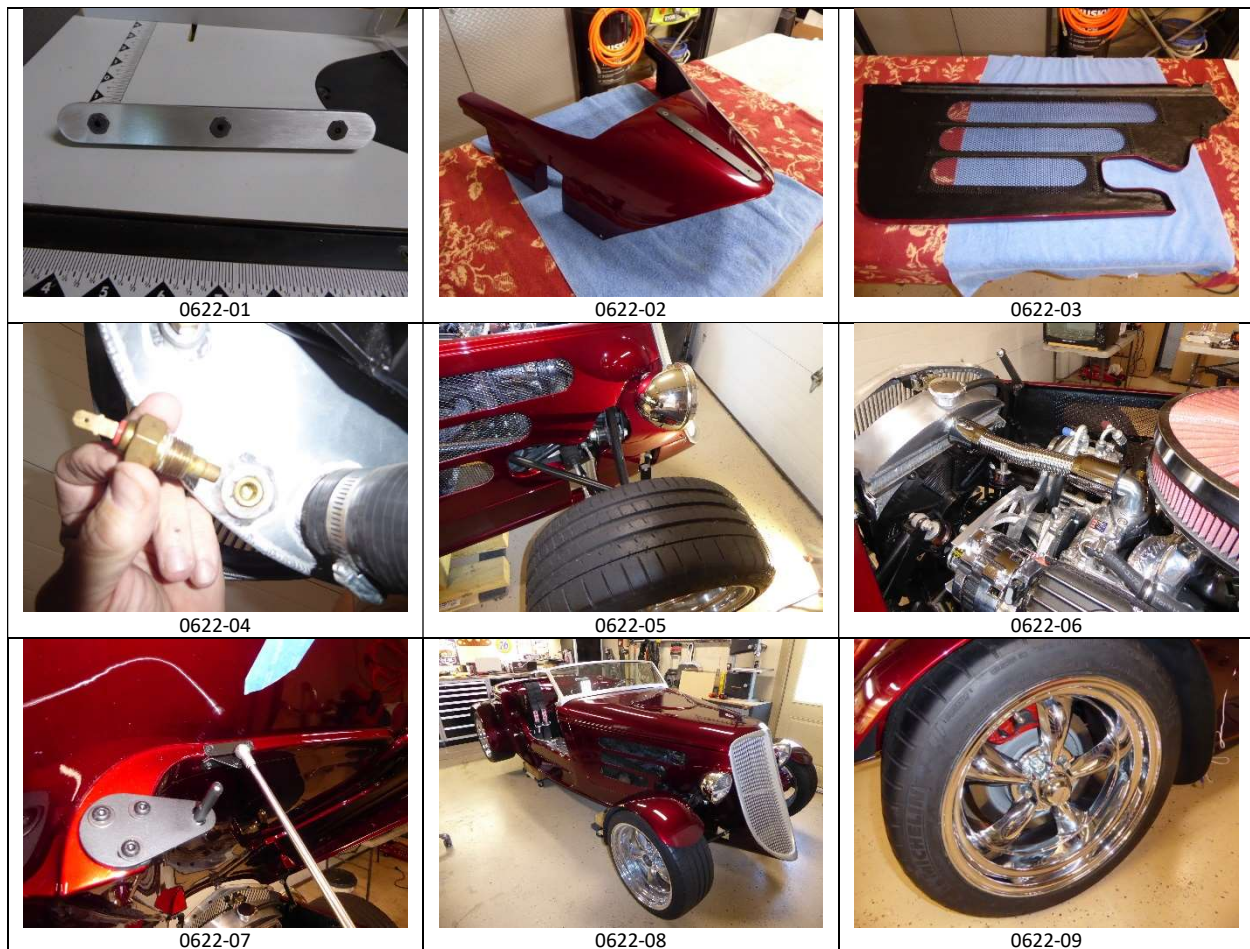
- The nose cone skid saver aluminum to be fabricated, powder coat flat black, and installed onto nose cone (0622-01 and 0622-02).
- Secure hood latch cable, forward engine compartment.
- Black face the interior side with the truck bed paint including the engine side panels, the headlight panels, nosecone.
- Add the mesh and the headlight panel brackets to engine side panels (0622-03).
- The radiator fan temperature sensor was leaking radiator fluid so it was removed and replaced with a bull plug. This sensor is not needed since the EFI computer controls the radiator fan. (0622-04).
- Shape and powder coat matte black firewall pins.

The final position for the radiator was determined by installing engine side panels and adjusting the radiator fitment by aligning engine side panel to radiator mounting hole. This allowed for the installation of the headlight panels and nose cone (0622-05).

The hood was removed hood hardware was installed back onto the hood including the hood prop rod. The chassis hood hinge hardware was re-installed. The radiator rubber grommets and body felt were installed. This was a good time to install the chrome upper radiator hose and the chrome radiator cap. (0622-06).

The front fenders and wheel axle chrome covers were installed. (0622-08 and 0622-09).

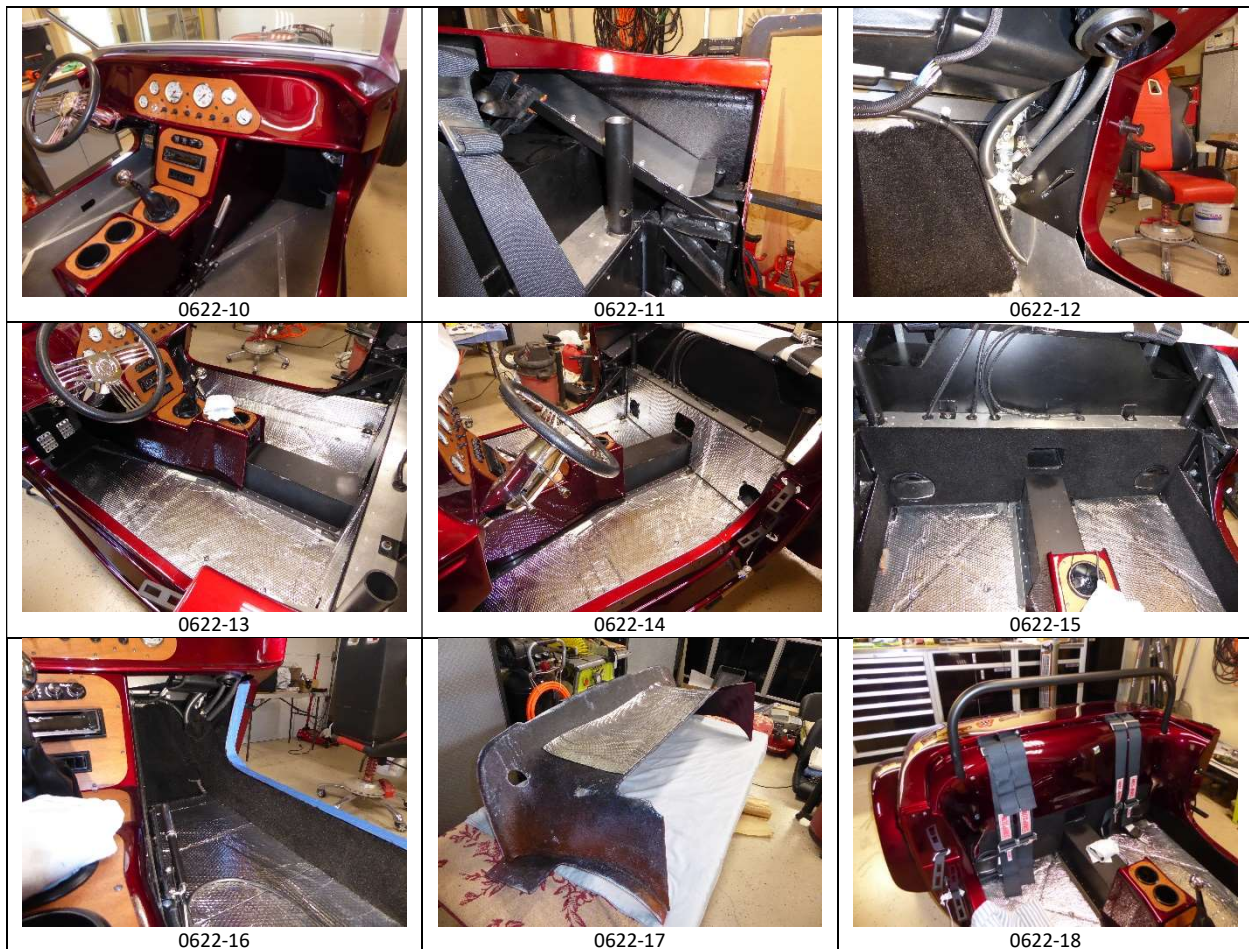
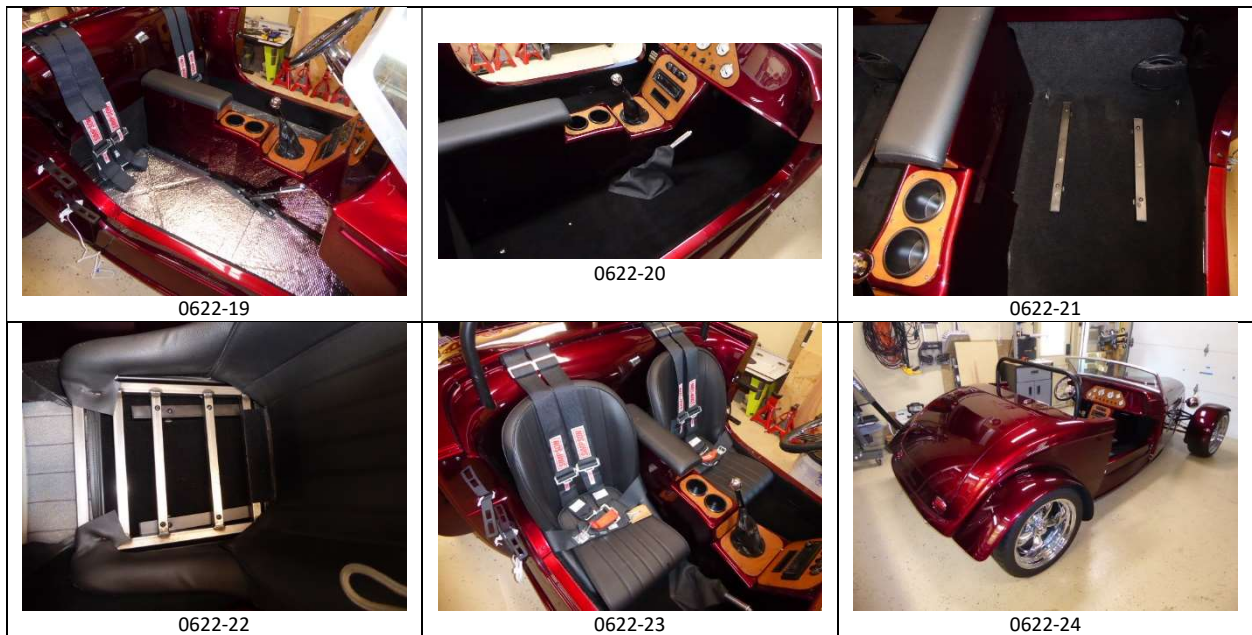
- Installing the aft center console to the cockpit.
- Moving the engine computer and mic into the armrest pop-out storage tray.
- Developing the Velcro mounting foundations for the arm rest, painting them black, and bolting them into place. Attaching Velcro where required and mounting the arm rest onto the aft console. (0622-19)

The seat foundations were made from 1" square aluminum and bolted to the previously installed cockpit floor rivnuts. With the seat in place, matching holes were drilled through the seat bottom frame and the square foundation tubes. Rivnuts were installed in the foundation tubes and the seats were installed. (0622-21 to 0622-23).

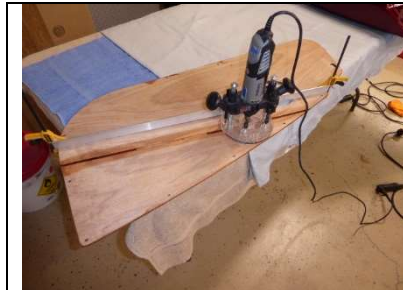
0722-02

thickness of the veneer on the back side of the panels (0722-02). The panels were test fitted to the doors as shown in 0722-03.

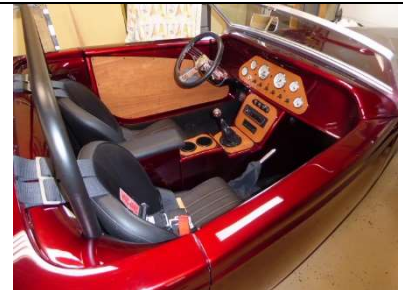
0722-04

Albeit the Hot Rod is still an infant. The door panels still require some more work and the door sills need to be installed. The speakers, armrests and rear cockpit trim panel are missing but these items will come as the Hot Rod matures in the coming months. And of course, the Registration process has yet to be formally addressed, oh help us all.

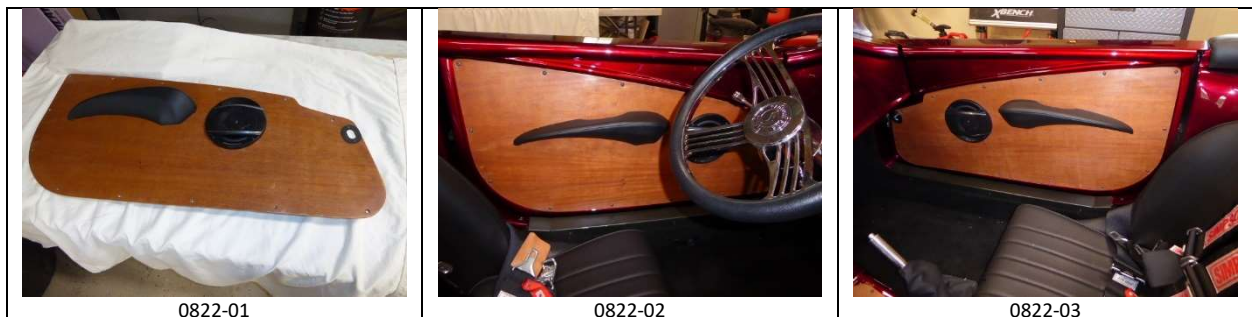
The finished driver side wood panel was installed onto the door. I sat in the driver seat and determined a comfortable height/spot for my elbow and marked it. After removing the panel, the armrests and speakers were attached to the door panels and the panels were installed onto the doors (0822-01 to 0822-03). The door sill aluminum pieces were finished matt black and installed onto the chassis/body just below the door panel as shown in 0822-02 and 0822-03.

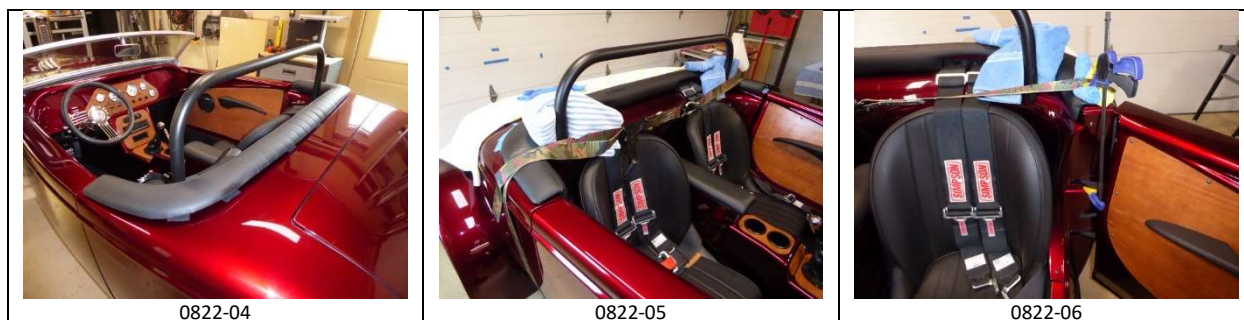
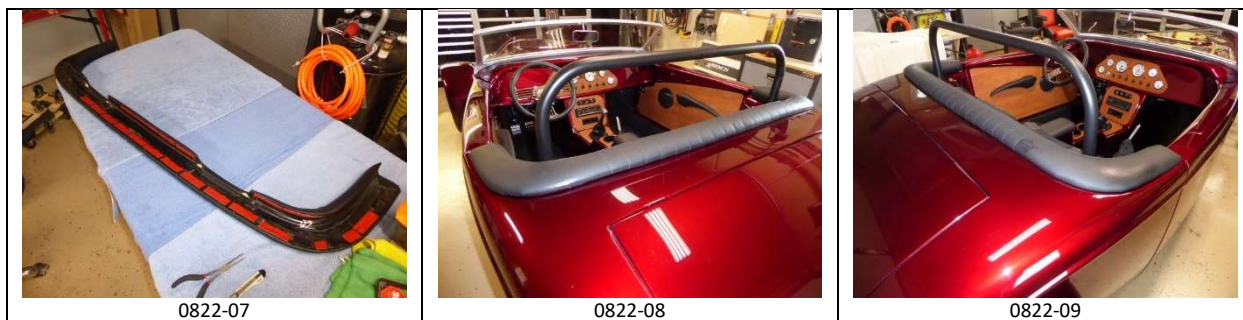
Second Attempt: Use silicon. I rigged up some clamps and straps, added silicon to the body surface and to the trim panel, set it in place, strapped it down, and left it to dry overnight (0822-05 and 0822-06). The next morning, I released the clamps and straps and the panel just popped up off the body, total failure.

Third Attempt: The lessons learned from the first two attempts; With the front part by the door flat on the body, the back part was raised up quite a bit. As one would expect, when the back part was against the body, the front part was way up in the air. Nothing I found was strong enough to hold both areas to the body, even though I could push down on both areas forcing the trim piece to conform to the body shape. The trim piece backing is made of plastic (I believe). So, I used a heat gun to soften it up and gently reshaped it. After multiple sessions, the reshaped trim piece laid flat onto the body in all areas. I then used some extra strength double-sided tape (0822-07) to attach it to the body and it feels pretty firmly connected. Final installation is shown in 0822-08 and 0822-09.

(A note from the future: I drove the Hot Rod to an Inspection, a 72 mile round trip, most of it at 55-60 mph, no issues with the trim piece, seems to be holding in place. Just wondering if the Velcro would have worked after the trim piece was reshaped?)
