Watershed Based Plan for Morris Creek, Implementation of the Upper Kanawha TMDL 2013

December 2013

DEPs Nonpoint Source Program and
the Morris Creek Project Team

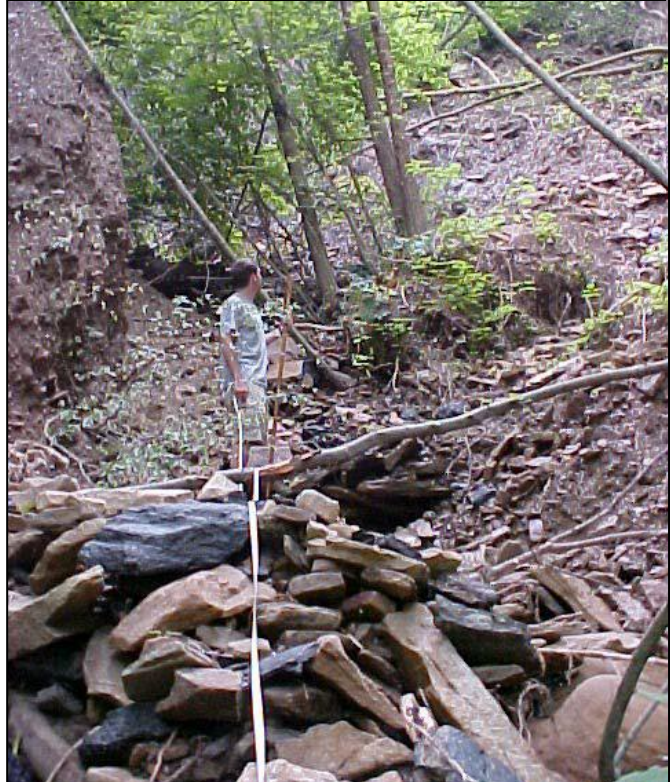
Figure 4 - Jones Hollow Slip

The Jones Hollow Slip is actually a huge gully approximately 400 feet long, over 50 feet wide and 30 feet deep at its deepest point. This site was created during reclamation on a mine site when the drainage was changed from its original course and forced into a new direction. In 1999, the new drainage was responsible for an estimated 9,000 tons of sediment into Morris Creek and the Kanawha River. A second site located above the confluence of Schuyler Fork and Morris Creek is contributing an estimated 63 tons of sediment annually. A poorly placed culvert is responsible for compromising the toe of the opposing hillside of

the outfall area. The affected area measures approximately 30' x 60' and is denuded of all vegetation. Erosion calculations were derived using RUSLE calculations. In addition to the documented isolated sources of sediment, more chronic diffused sources exist within the watershed; dirt roads and failing streambanks.

The Jones Hollow slip described in section (A) was the greatest contributor of sediment into the Morris Creek Watershed for many years. In 2007, it was determined that any effort to construct sediment control would be dangerous and potentially destabilize the slip. The slip was primarily caused by the excess drainage from the road above. A plan was implemented and completed in 2008 to stabilize the road and the installation of cross drains allowed for water to drain in its original pattern. The estimated load reduction from this project is 213 tons/yr based on the assessment model used in the WBP. Presently, it is still a contributor of sediment; however, remedial actions and time has removed it as the main source of sediment pollution.

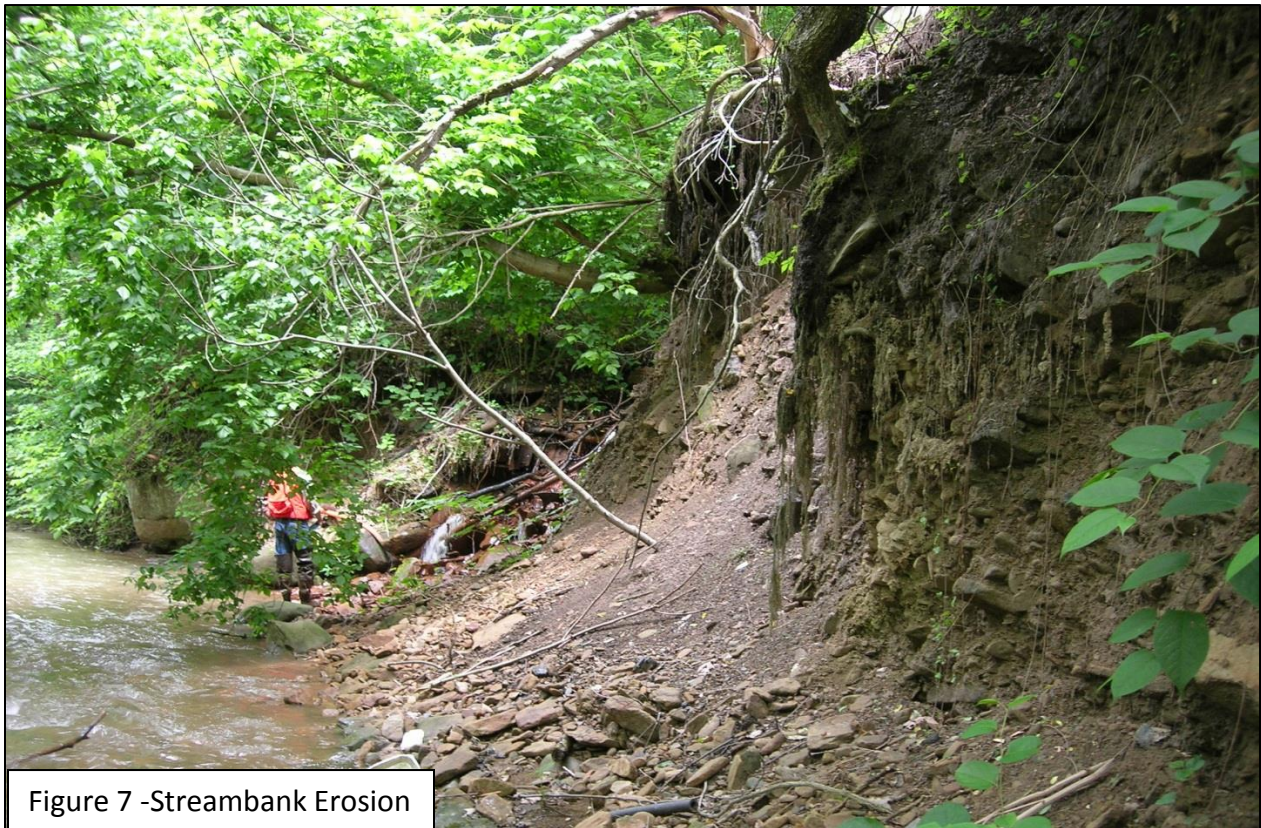
Figure 7 -Streambank Erosion

Sedimentation issues are still present within Morris Creek from unstable and eroding streambanks, see Figure 7. In 2011, MCWA members identified sites and WVCA staff documented current sediment load potential. Some of these sites were determined during the CVI study of 2005. WVCA and WVDEP were able to address four (4) of these identified sites.

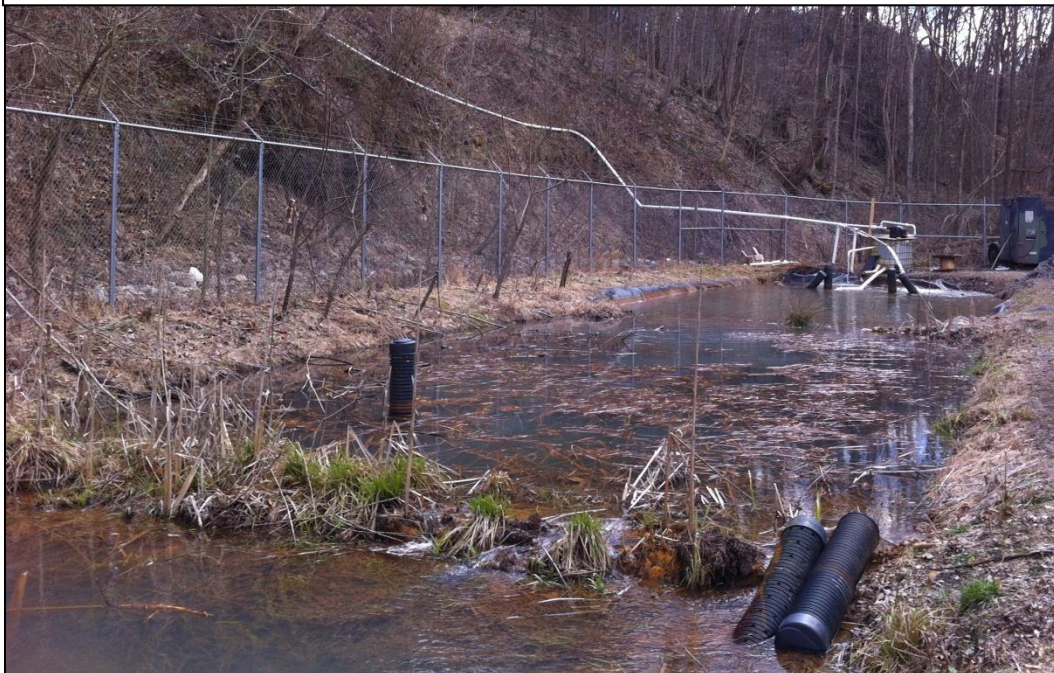
Figure 12 - Present state of Lower Mainstem treatment system; hillside seep has been rerouted to head of the treatment. It is piped through a hydro-generator and limestone diversion well before entering the system.

In an effort to enable the system, MCWA has rerouted the hillside seep to the start of the system. The water is piped into a limestone diversion well and through a hydro-generator to collect the energy of and boost the alkalinity of the hillside seep (See Figure 10 and Figure 12).

This whole Lower Mainstem system also needs refurbished and enhanced. The piping of the seep to the start of the system needs to be permanently installed. Within the series of polishing ponds, baffles need installed in ponds one and two, limestone check dams need refurbished throughout the series, and floating wetlands need installed in the fourth final polishing pond to aid in metal uptake and retention of the water. The construction of a fifth polishing pond to the treatment system would also aid in retention time and allow for metals to fall out in the system rather than to discharge into the creek.

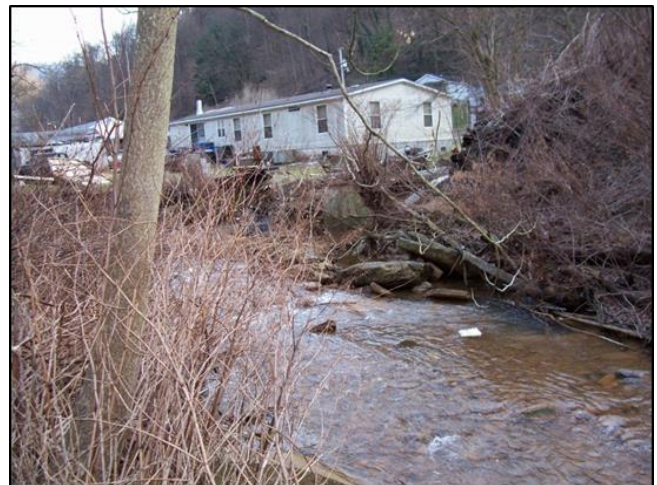
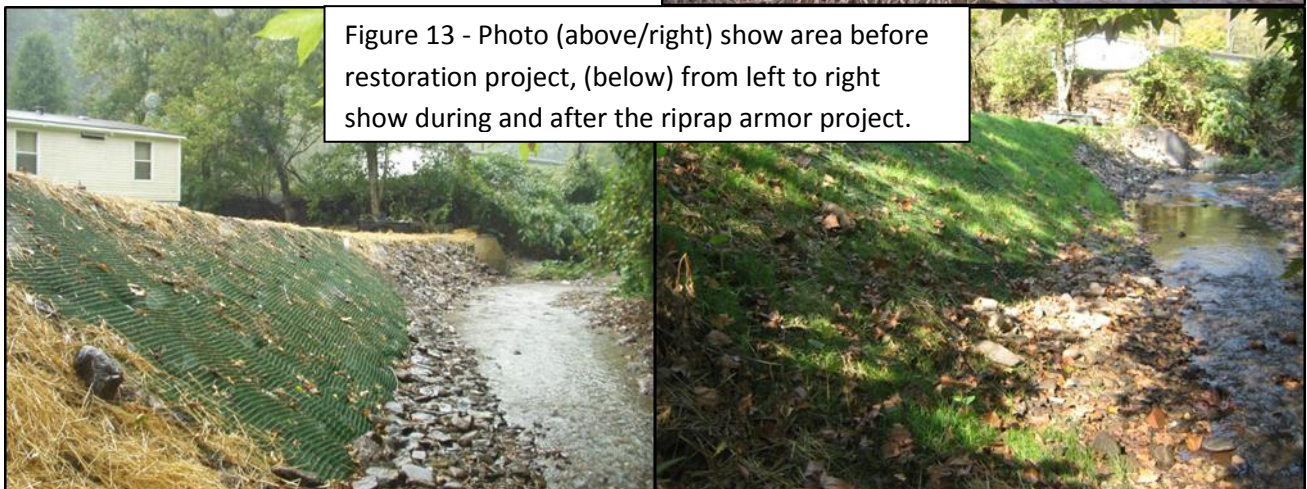
FIGURE 14 - PROPOSED STREAMBANK PROJECTS ALONG MORRIS CREEK

sediment reduction projects (see Table 4 and Figure 14) such as riprap armor, re-vegetation of the streambank, and gabion walls have been installed along sections of Morris Creek, but long stretches of the stream still show significant erosion (see Figure 13). Currently, there is an estimated 1.25 miles of streambank within Morris Creek that is unstable and eroding; the highest priority will be the 772.50 ft of severely eroding banks.

Stream bank restoration projects will utilize natural stream channel design principles whenever possible. These projects rely on techniques that direct the force of the stream away from the banks, but enable the stream to adequately carry its normal sediment load. In some cases natural stream channel designs may not be possible, especially around bridges and culverts. The urbanized nature of the lower reaches of the watershed have,

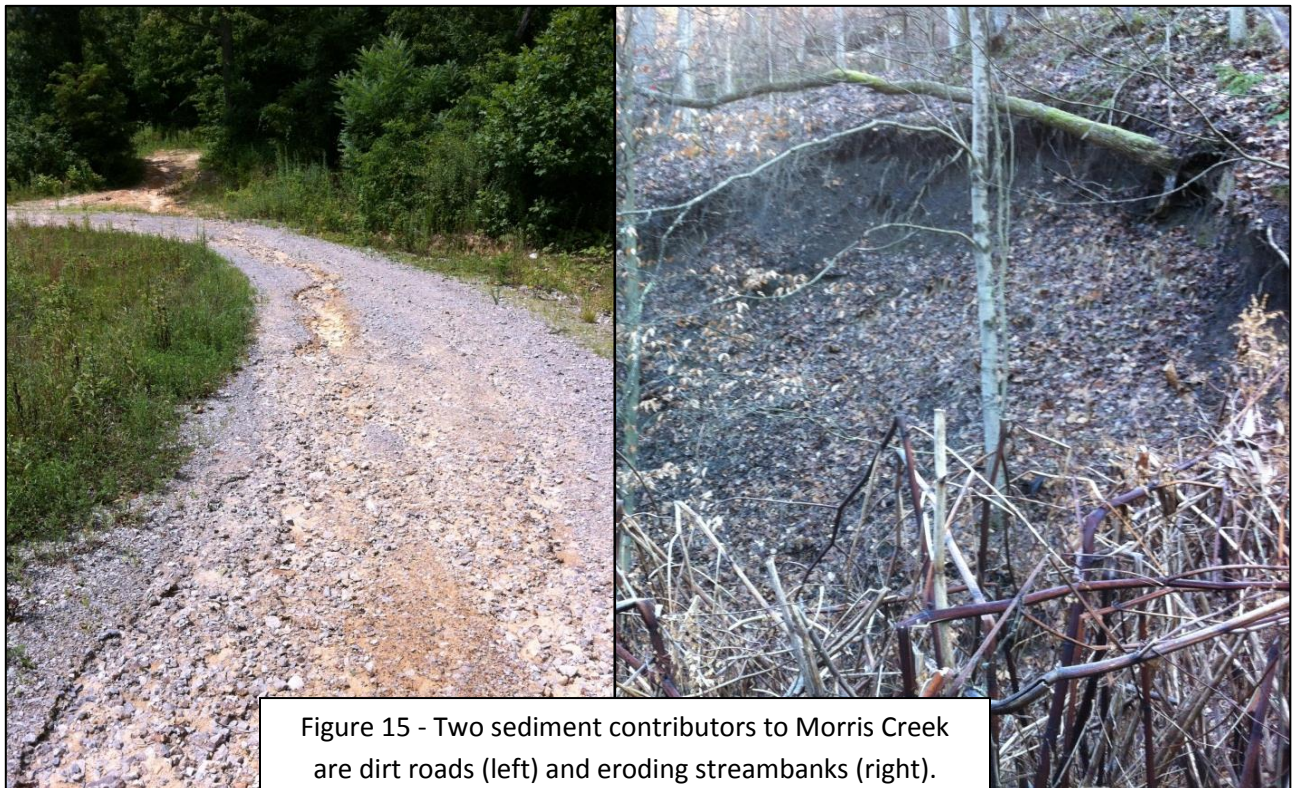
Figure 15 - Two sediment contributors to Morris Creek are dirt roads (left) and eroding streambanks (right).

Road Restoration is needed on the dirt roads, which are the final contributor to the sediment loads found in Morris Creek. There is an estimated 155 miles of discernible dirt roads that contribute sediment to Morris Creek watershed. The cost to manage these roadways is dependent on the topography, condition of the road, and which management plan to implement. It is anticipated that the cost may be as much as \$40,000 per mile for restoring roads retired from the system. Conducting a thorough assessment of the road system will be the first step. After this, roads can be categorized into either “roads in use” or “retired with BMPs.” Techniques that can be employed on any eligible road include: surface hardening or protection, drainage swales, water bars, ditches and sediment catch basins. The techniques used on these roads must be sufficient to require little or no maintenance for at least ten years. In the Blacksnake Hollow project area, the culvert was properly installed, but became plugged with sediment over the years due to unstable gravel roads (cell tower road, Figure 15). A culvert needs attention; it is currently plugged with sediment.
