Morris Creek Watershed HUCs

Introduction

MORRIS CREEK WATERSHED BASED PLAN

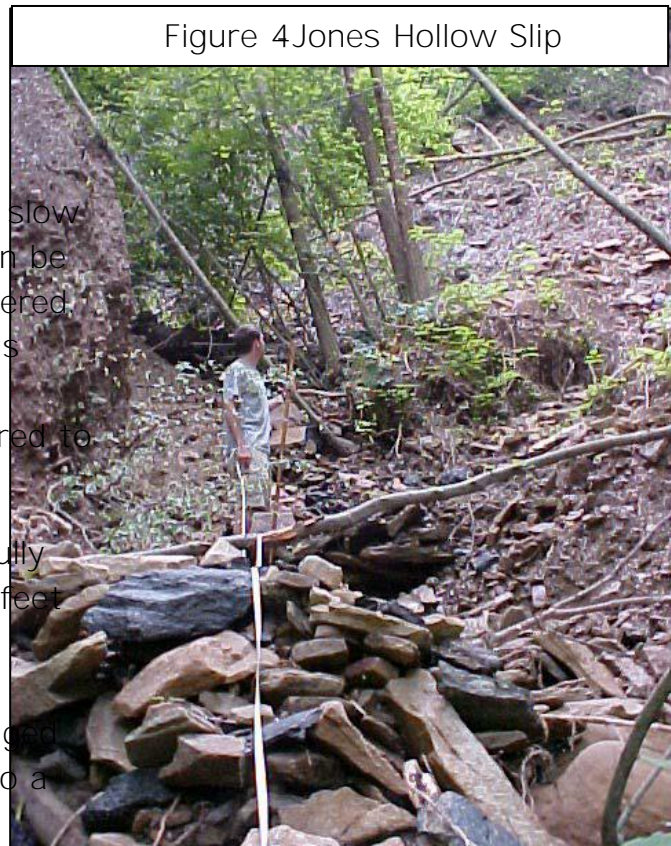
Figure 4 Jones Hollow Slip

The Jones Hollow Slip is actually a huge gully approximately 400 feet long, over 50 feet wide and 30 feet deep at its deepest point. This site was created during reclamation on a mine site when the drainage was changed from its original course and forced into a new direction. In 1990 new drainage was responsible for an estimated 9,000 tons of sediment into

The Jones Hollow slip described in section (A) was the greatest contributor to the sediment in Morris Creek Watershed for many years. In 2007, it was determined that any effort to control sediment would be dangerous and potentially destabilize the slip. The slip was primarily caused by the excess drainage from the road above. A plan was implemented in 2008 to stabilize the road and the installation of a cross-drain for water to drains in its original pattern. The estimated load reduction from this project is 21% based on the assessment model used in the WBP. Presently, it is still a contributor of sediment; however, remedial actions and time have removed it as the main source of sediment pollution.

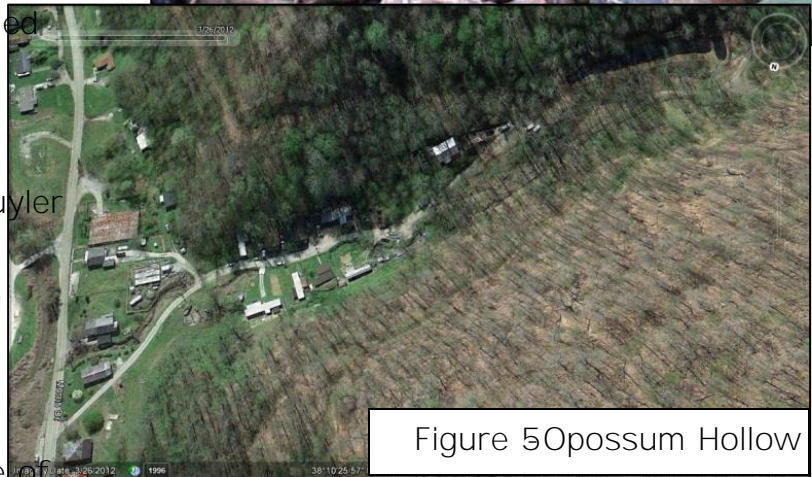
Figure 5 Opossum Hollow

Morris Creek and the Kanawha River. A second site located above the confluence of Schuyler Fork and Morris Creek is contributing an estimated 63 tons of sediment annually. A poorly placed culvert is responsible for compromising the top of the opposing hillside of

the outfall area. The affected area measures approximately 30' x 60' and is devoid of vegetation. Erosion calculations were derived using RUSLE calculations to the documented isolated sources of sediment, more chronic diffuse sources within the watershed; dirt roads and failing streambanks.

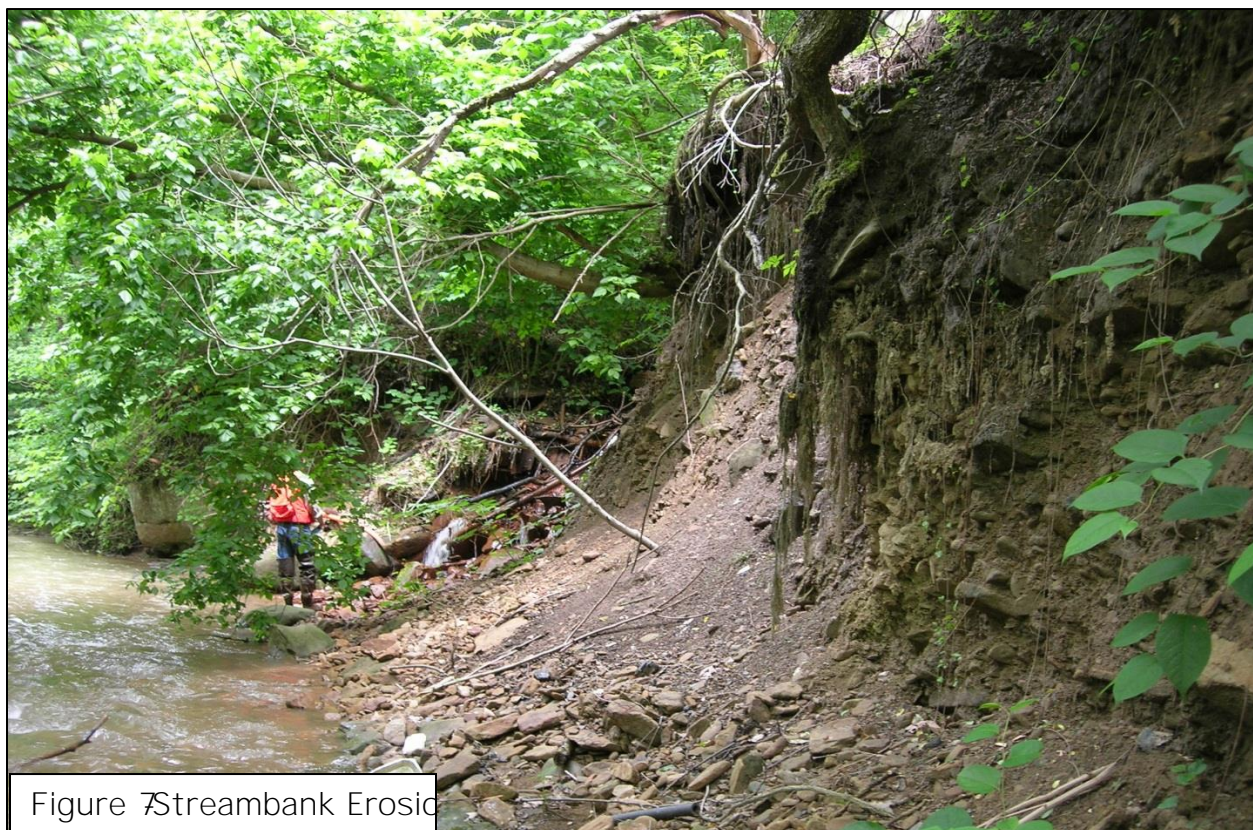
Figure 7 Streambank Erosion

Sedimentation issues are still present within Morris Creek and eroding streambanks, see Figure 7. In 2011, MCWA members identified sites and WVCA staff documented current sediment potential. Some of these sites were determined during the CVI study of 2005. WVCA and WVDEP were able to address four (4) of these identified sites.

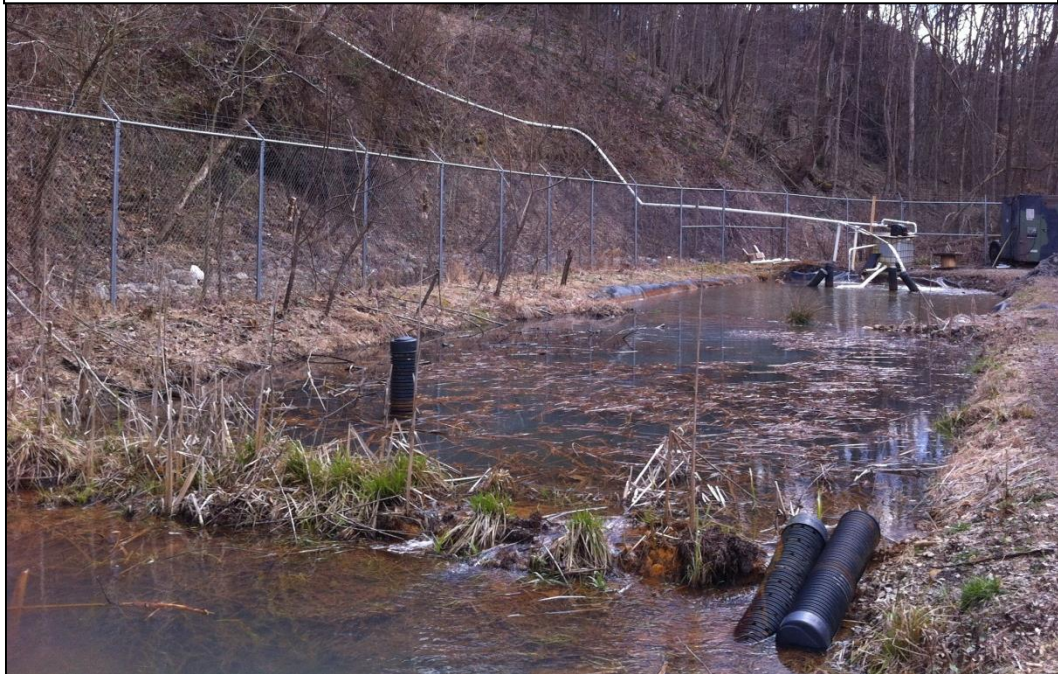
with an aerobic wetland and a series of polishing ponds were constructed. A seep from the hillside bypassed the first polishing pond in the system. Presently, the piping to allow first cell to be anaerobic is no longer functioning, therefore, retention time in this system is lacking

Figure 12 Present state of Lower Mainstem treatment system; hillside seep has been rerouted to head of the treatment. It is piped through generator and limestone diversion well before entering the system.

This whole Lower Mainstem system also needs refurbished and enhanced. The deepening of the seep to the east of the system needs to be permanently installed. Within the series of polishing ponds, baffles need installed in ponds one and two, limestone check dams need refurbished throughout the series, and floating wetlands need installed in the fourth final polishing pond to aid in metal uptake and retention of the water. The construction of a fifth polishing pond to the treatment system would also aid in retention of flow and metals to fall out in the system rather than to discharge into the creek.

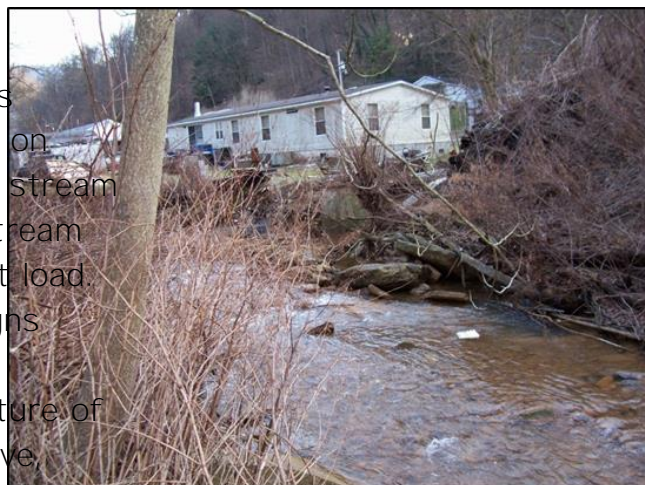
Stream bank restoration projects utilize natural stream channel design principles whenever possible. These projects rely on techniques that direct the force of the stream away from the banks, but enable the stream to adequately carry its normal sediment load. In some cases natural stream channel designs may not be possible, especially around bridges and culverts. The urbanized nature of the lower reaches of the watershed have

Figure 13 Photo (above/right) show area before restoration project, (below) from left to right show during and after the riprap armor project.

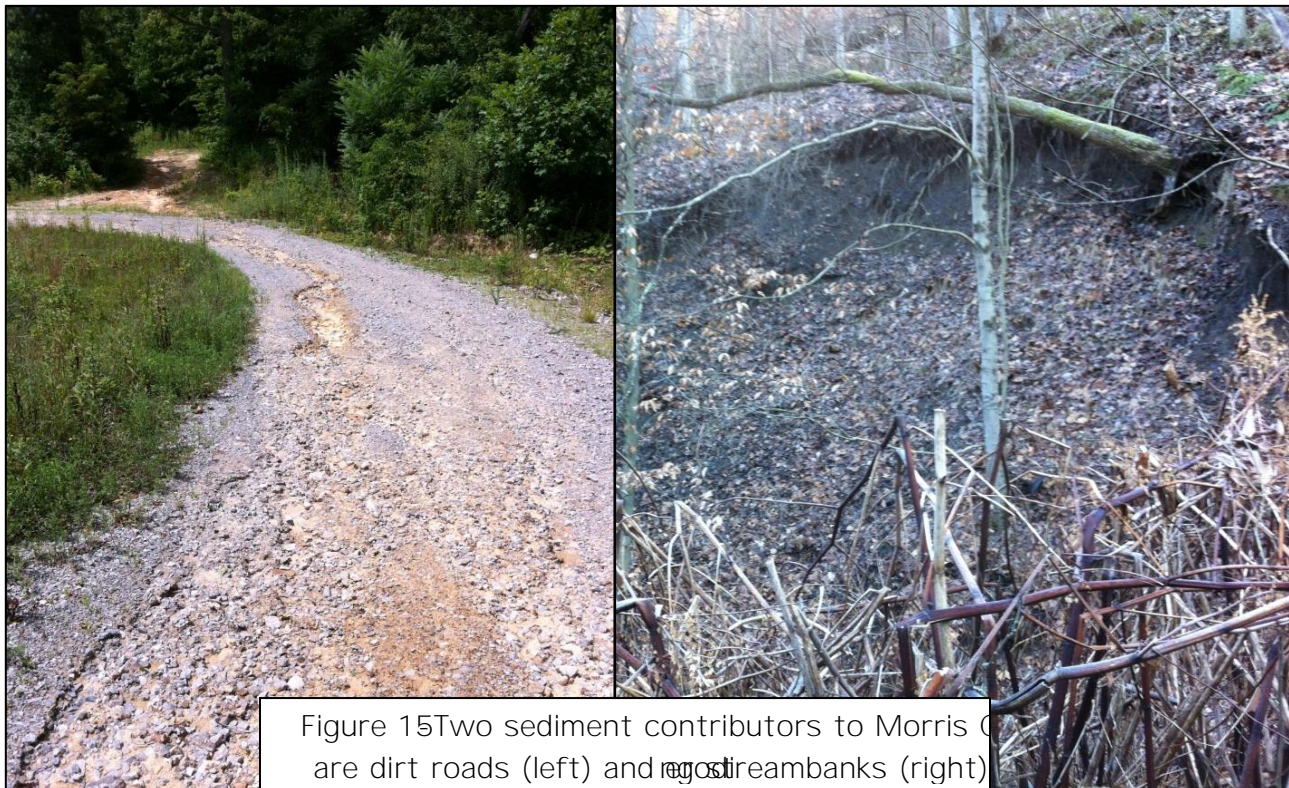
Road Restoration is on the dirt roads, which are the primary contributor to the sediment loads found in Morris Creek. There is an estimated 155 miles of discernible dirt roads that contribute sediment to Morris Creek watershed. The cost to manage these roadways is dependent on the topography, condition of the road, and which management plan to implement. It is anticipated that the cost may be as much as \$40,000 per mile for restoring roads retired from the system. Conducting a thorough assessment of the road system will be the first step. After this, roads can be categorized as BMPs. "Techniques that can be employed on any protection, drainage swales, water bars, ditches and catchment basins. The techniques used on these roads must be sufficient to require little or no maintenance for at least ten years. In the Blacksnake Hollow project area, the culvert was properly installed, but became plugged with sediment over the years due to unstable gravel roads (see Figure 15A) culvert needs attention; it is currently plugged with sediment.

Figure 15 Two sediment contributors to Morris Creek are dirt roads (left) and eroding streambanks (right)
