Analytical Method Development for MCHM Spill at Elk River (WV)

- May 15, 2014
- Niranjan Selar

Presentation Overview

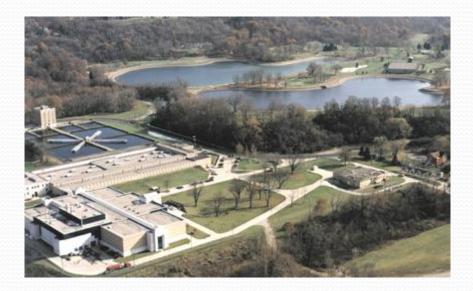
RMTP

- GCWW has two water treatment facilities
- The Richard Miller Treatment Plant (RMTP) which draws water from Ohio River (Surface Water). (240mgd Capacity)
- Charles M. Bolton Treatment Plant (CMBP) which draws water from the Great Miami River (Ground Water). (40mgd Capacity)

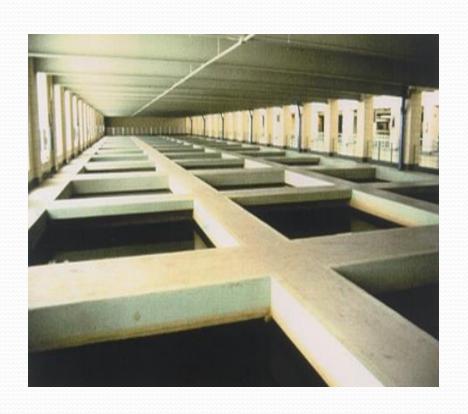
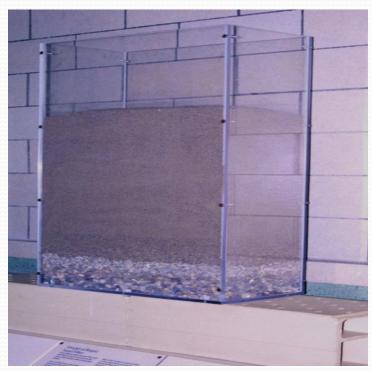
Sand Filtration

- 47 Rapid Sand Filters
- Filtration Rate @ 3.0gpm/ft²
- Effluent Turbidity < 0.3 NTU

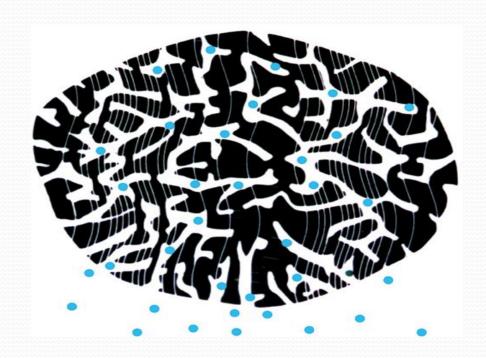
GAC Adsorption

Granular Activated Carbon (GAC): Bituminous coal for natural and synthetic organics adsorption

12 GAC contactors

Area: 1950 ft² each

Depth: 11.5 ft of carbon

EBCT: 15 min

Effluent TOC < 1.2 mg/L

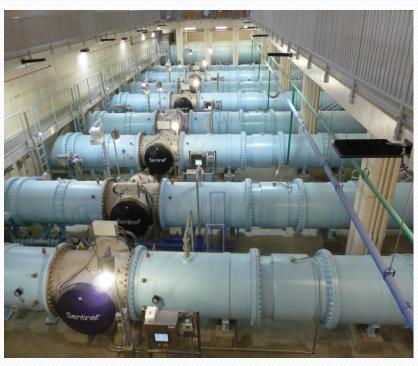
UV Disinfection

- 8 UV Reactors
- Medium Pressure = Polychromatic UV Light
- Designed to disinfect up to 4-log Crypto, Giardia

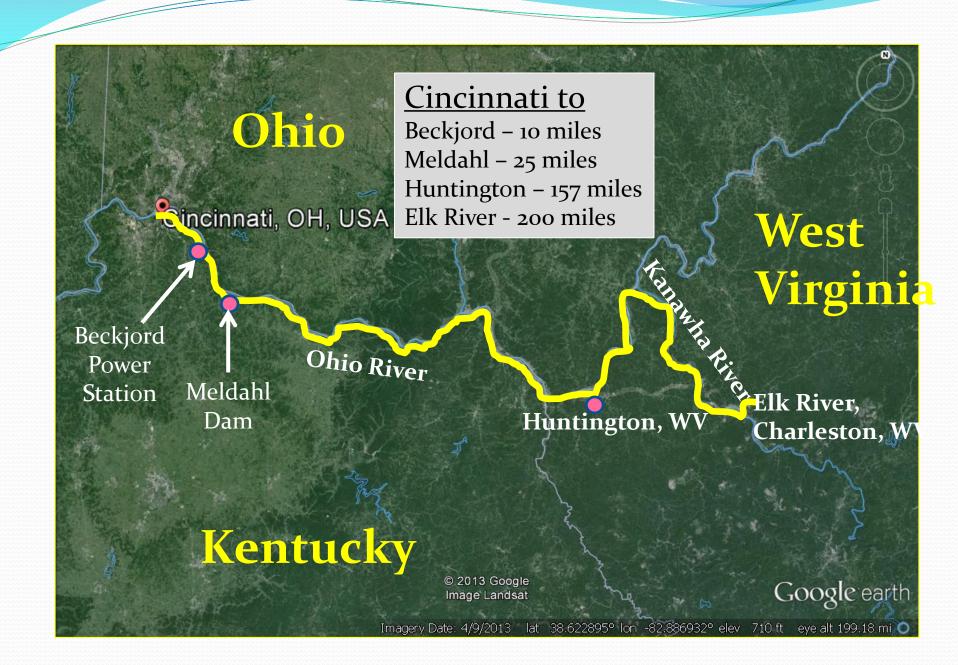
- January 9, 2014: At least 8000 gallons of an industrial chemical 4-Methylcyclohexanemethanol (MCHM) are spilled into the Elk River, a secondary tributary of the Ohio River
- Chemical is used for Coal Processing to separate impurities from the coal.
- The MCHM was taken into the Kanawha Valley Drinking Water Plant (1.5 miles downstream) where it is subsequently distributed to drinking water customers
- "Do Not Use" orders are issued for roughly 300,000 people
- Because of the Do Not Use order, media coverage was intense
- Spill Continued Downstream toward Cincinnati
- Spill Location was approximately 200 miles upstream of Richard Miller Treatment Plant

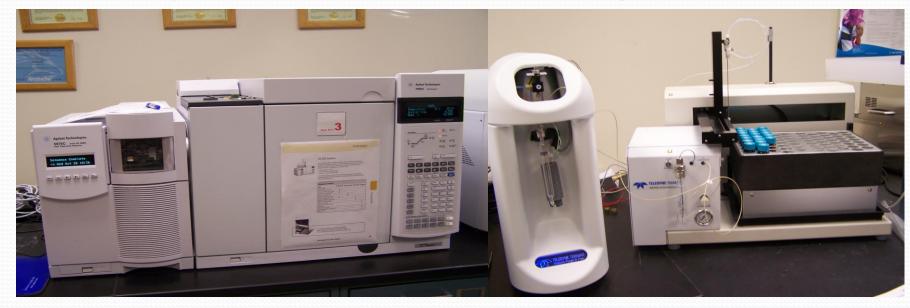
GC/MS for 524.3 Method

(VOCs, THMs, Gasoline)
