Corrosion Control Advancements Reduce Water System Leaks

***Presented By:
James T Lary
Corrpro
1055 W. Smith Rd.
Medina, OH 44256
Tel. 330-241-6615
email: jlary@corrpro.com
<http://www.corrpro.com>***

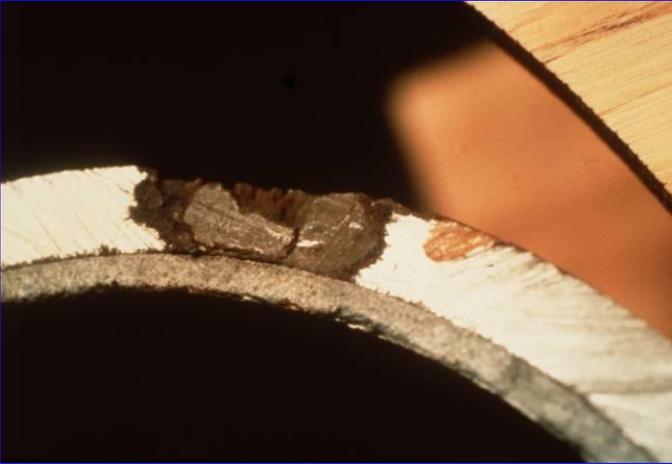
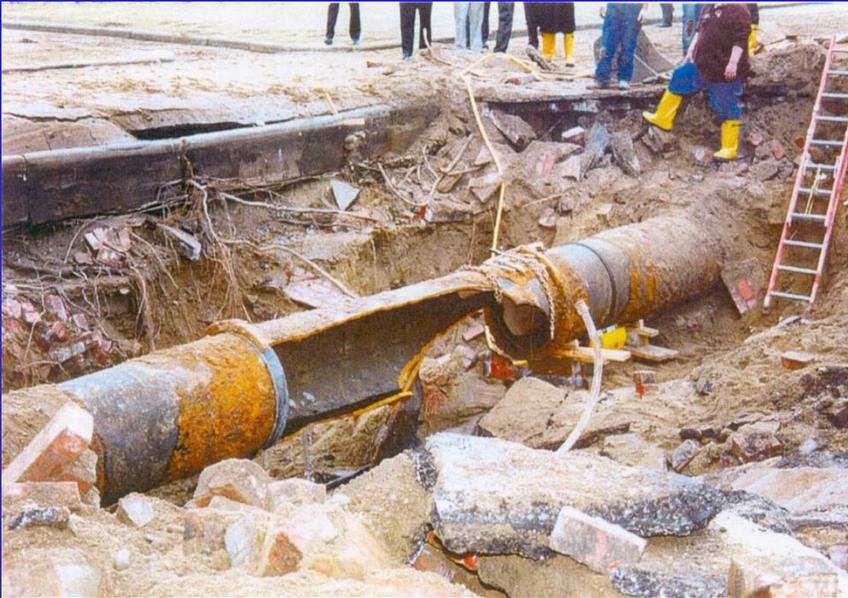
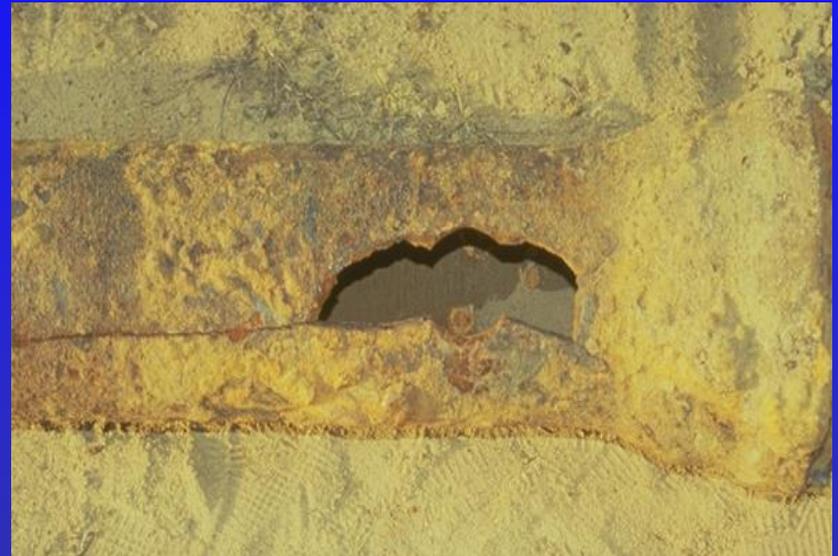
Cast (Grey) Iron Failures

Graphitization leaves pipe brittle and weakened.

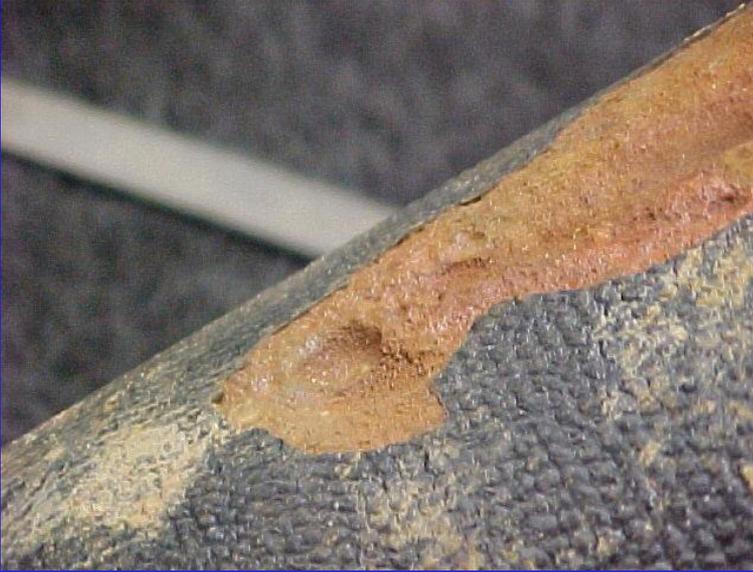
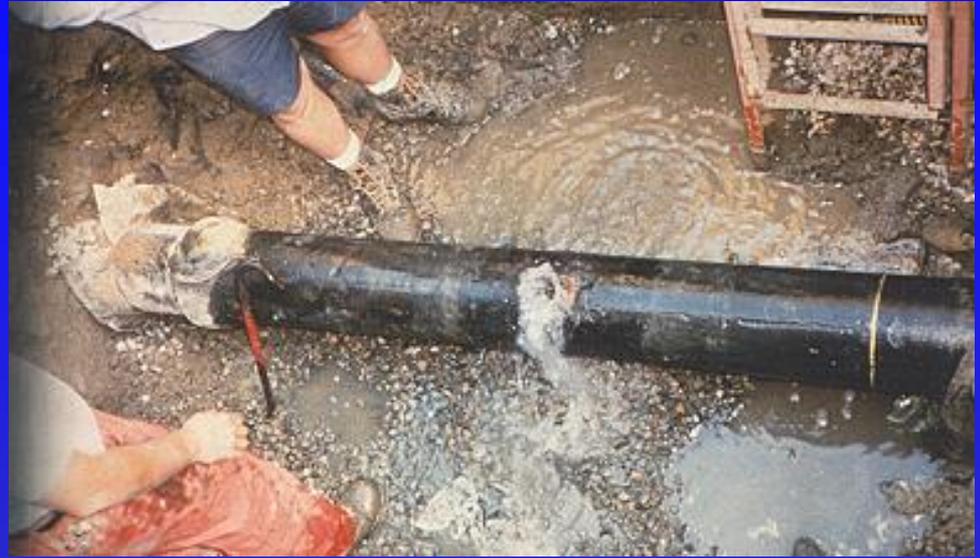
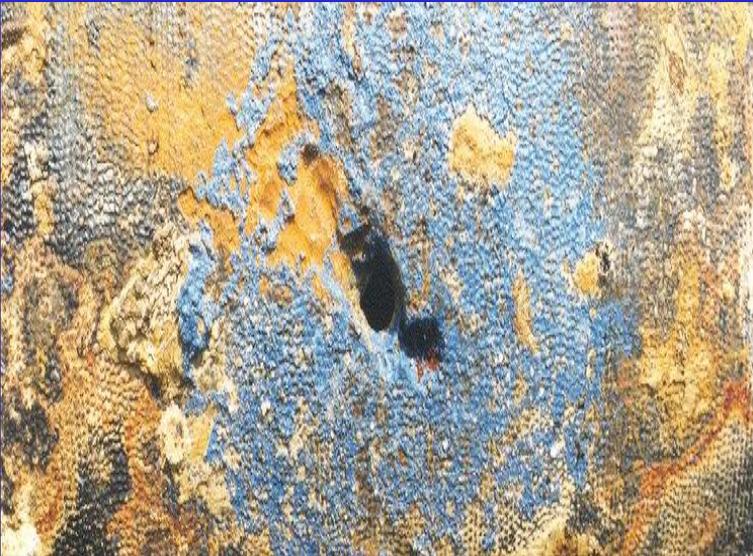
Ductile Iron

Pitting (concentrated) corrosion attack on ductile iron pipe.

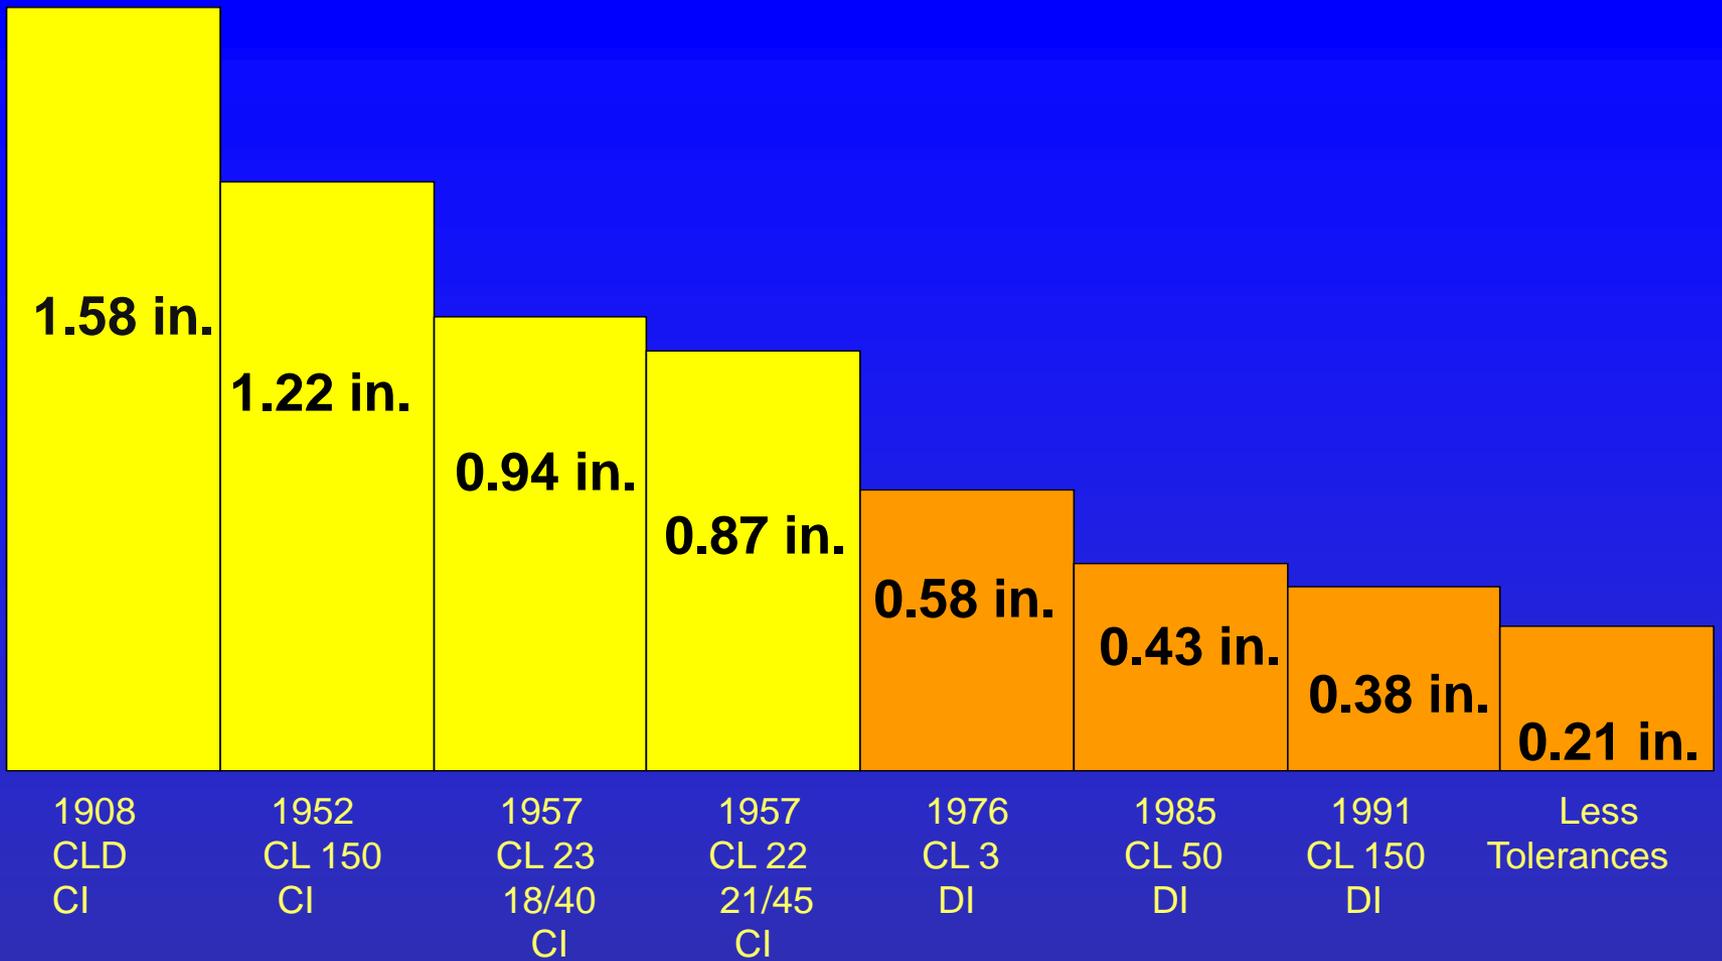
Actual size of AWWA Specification Thickness Reductions for 36-inch Diameter Cast and Ductile Iron Pipe - 1908 to Present (150 PSI Operating pressure)

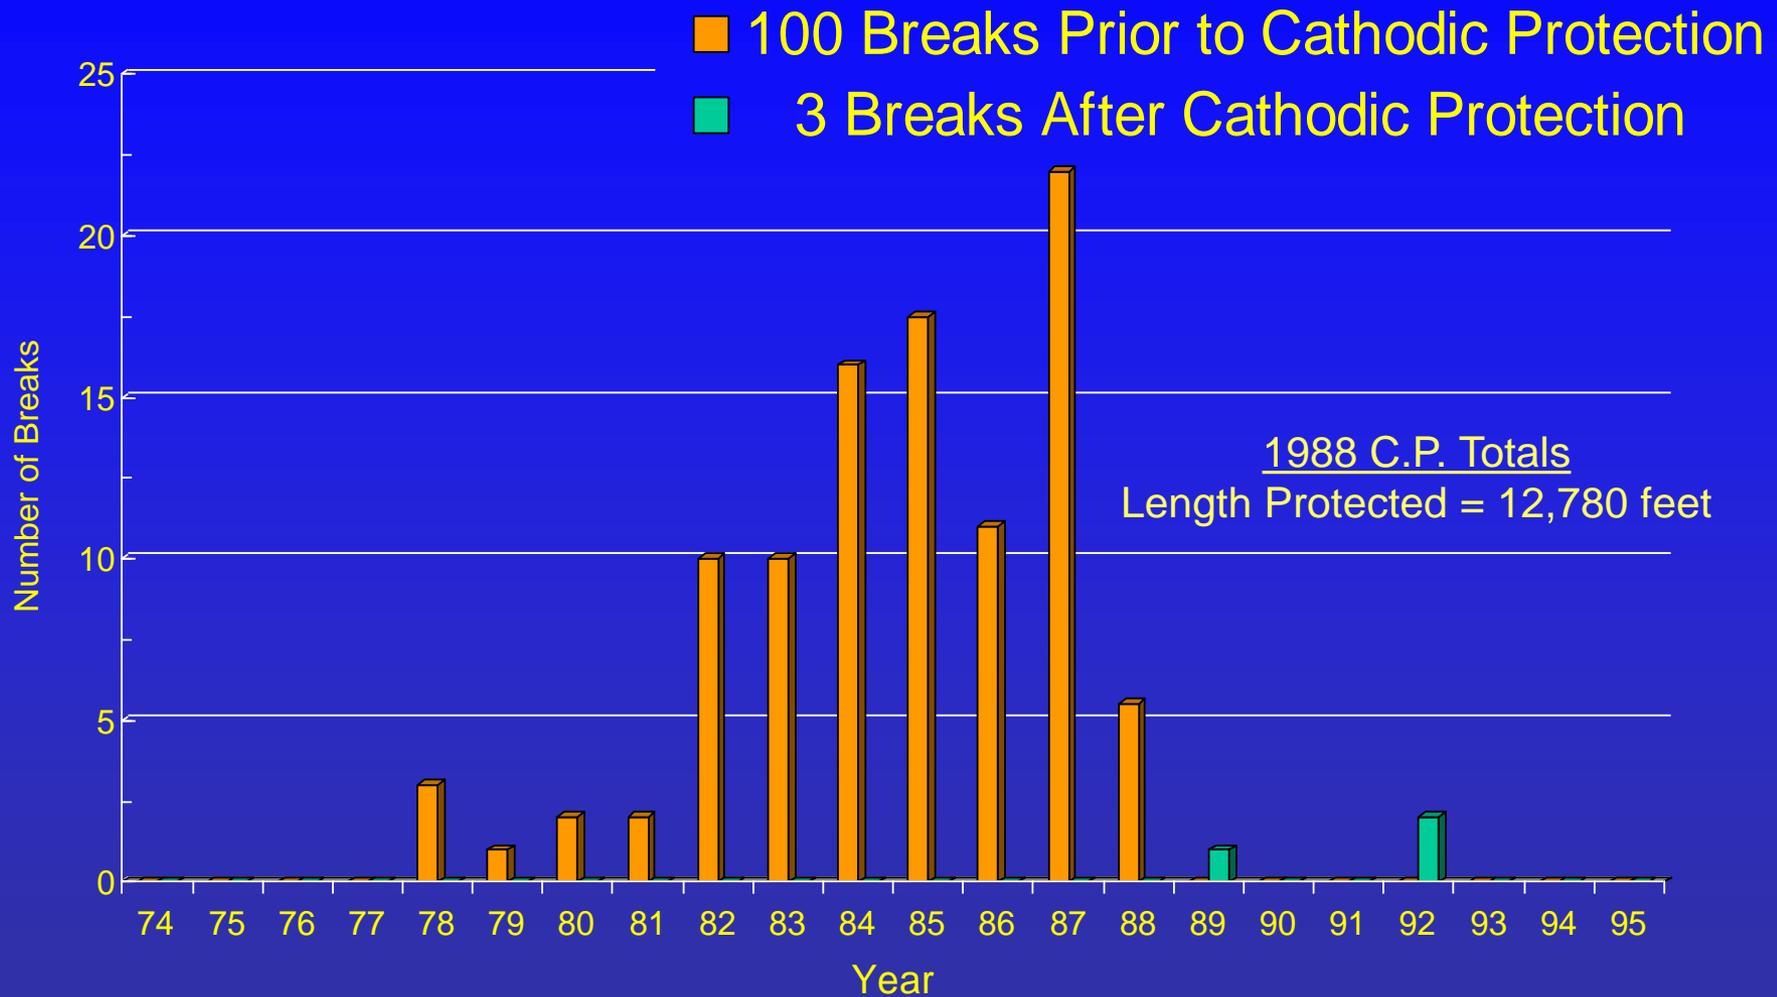
Break Records for Water Mains Cathodically Protected in 1988

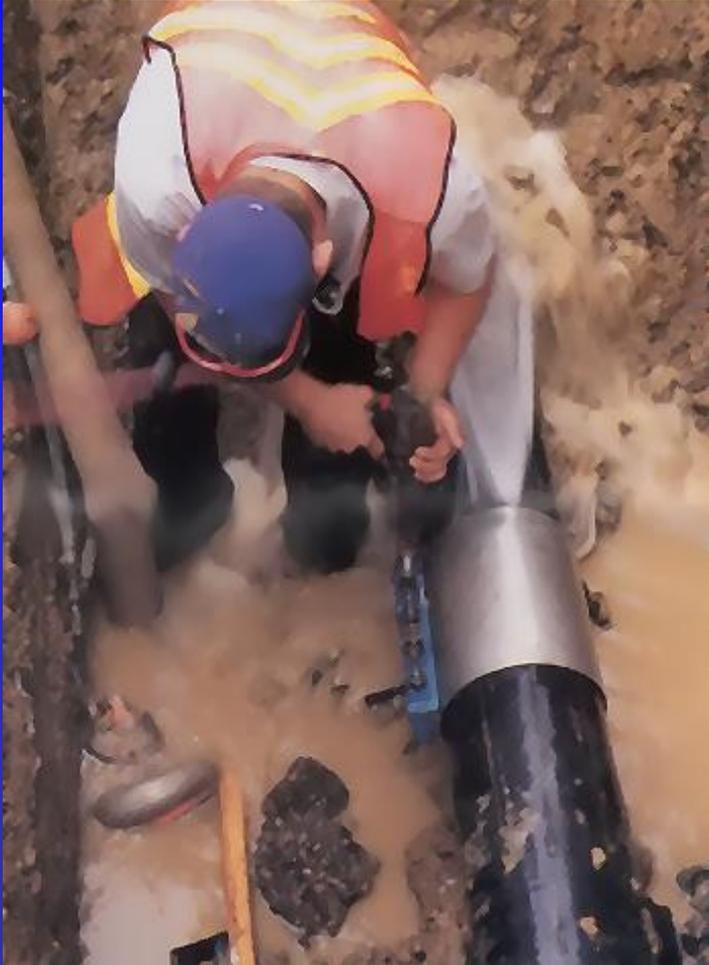
Incomplete

Repair of Break Should Include Anode Installation

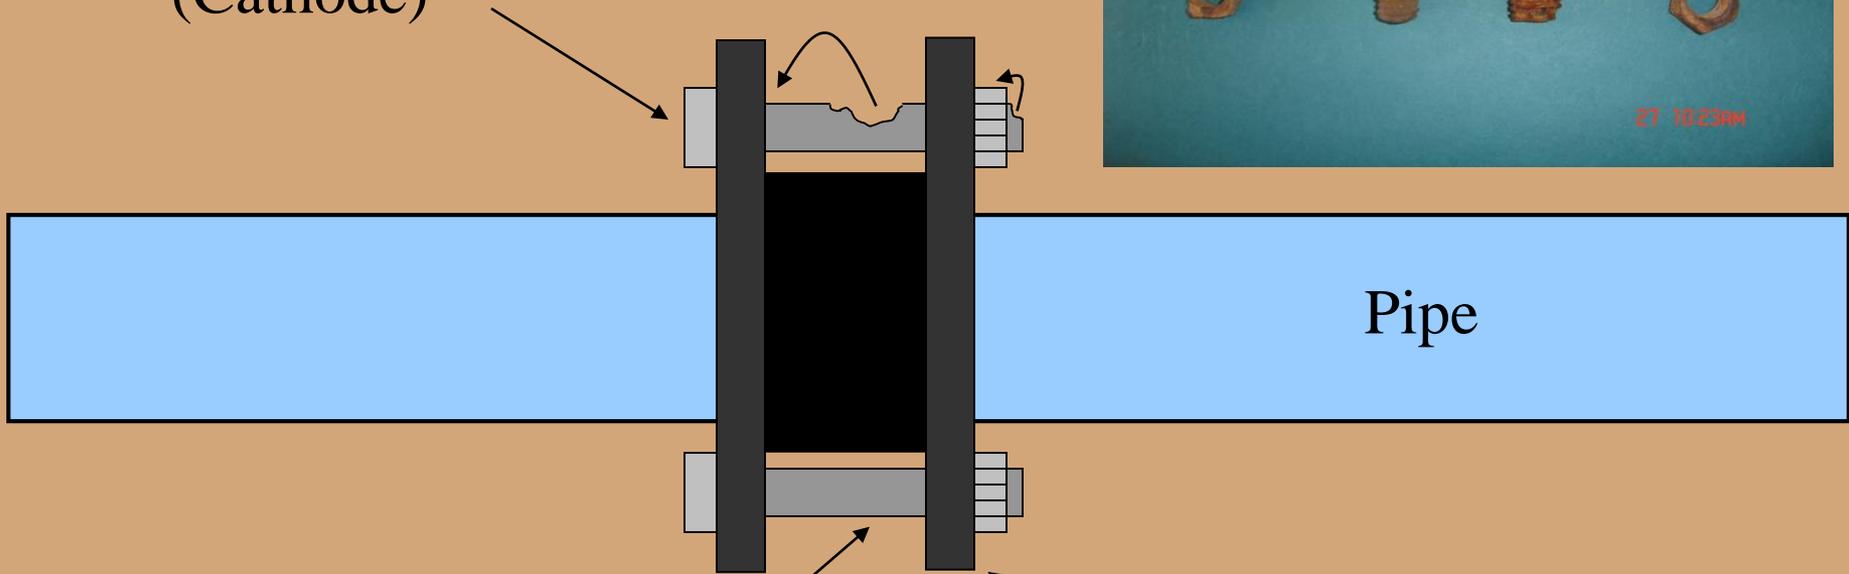
Stress Corrosion

Lower Stress Area
(Cathode)

Threaded Bolt
Higher Stress Area
(Anode)

Metallic Coupling

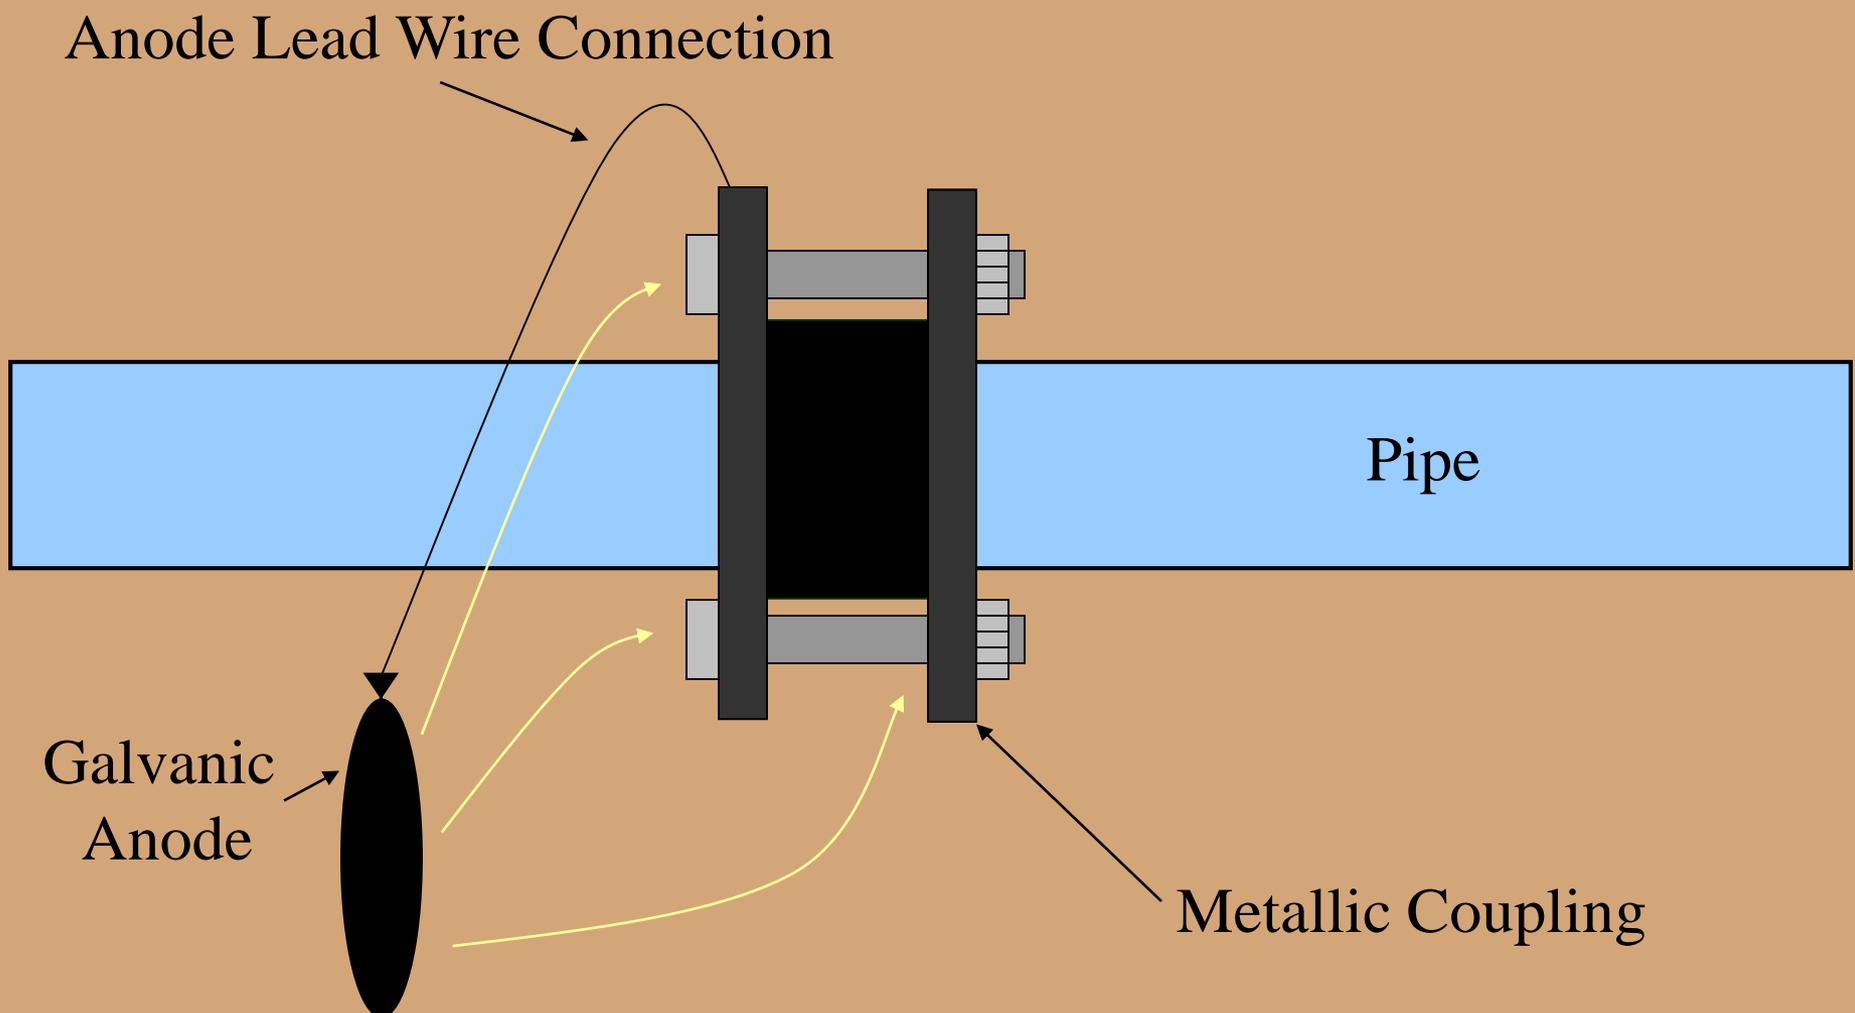
Cathodic Protection of Metallic Fitting

Anode Lead Wire Connection

Pipe

Galvanic Anode

Metallic Coupling

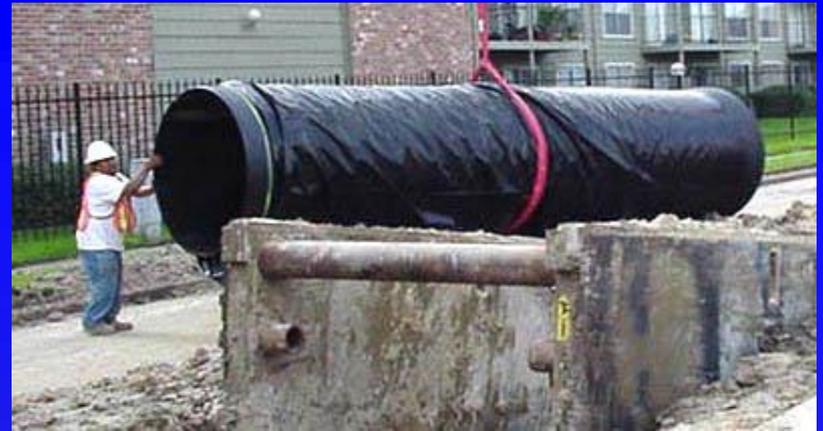
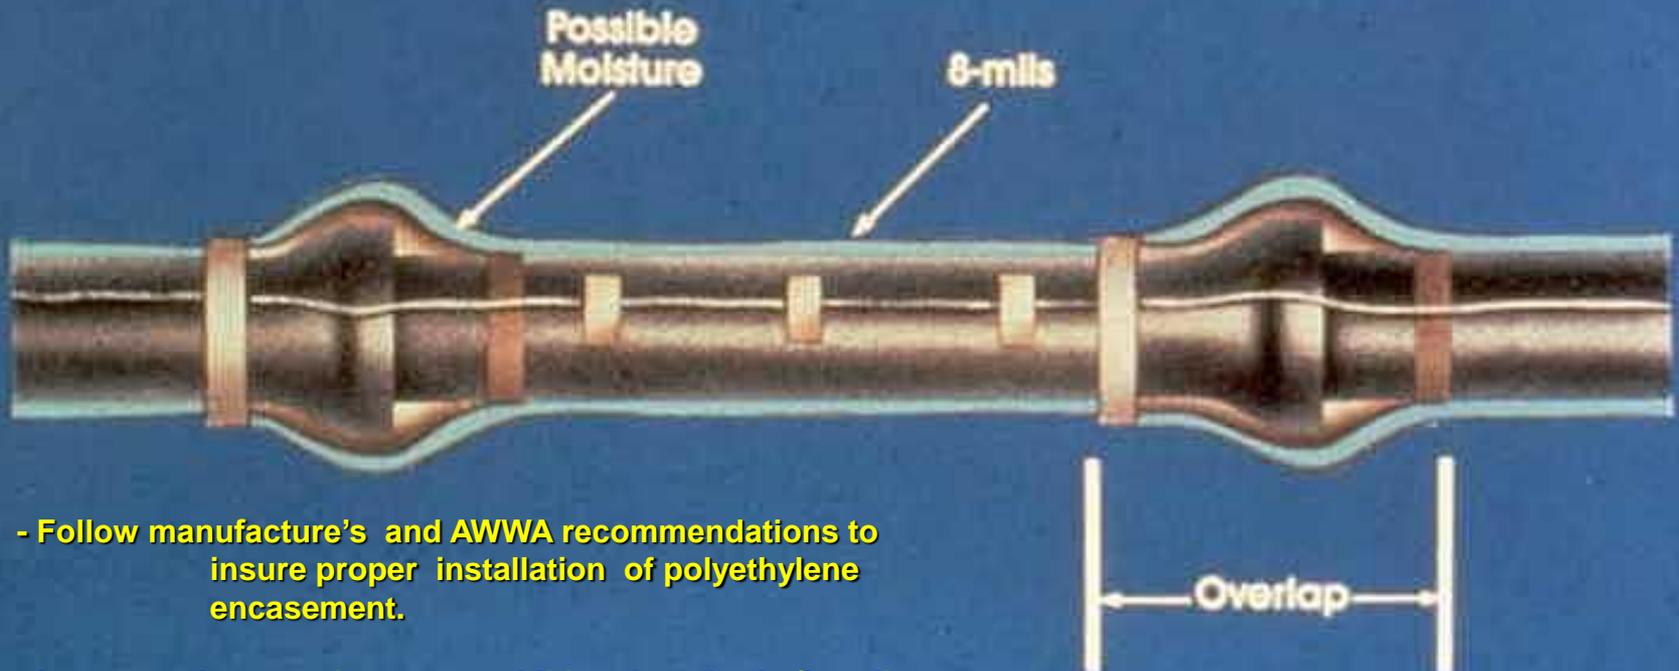
Polyethylene Encasement

- Follow manufacture's and AWWA recommendations to insure proper installation of polyethylene encasement.
- In extremely corrosive areas, additional methods (bonding of joints, cathodic protection, may be required).

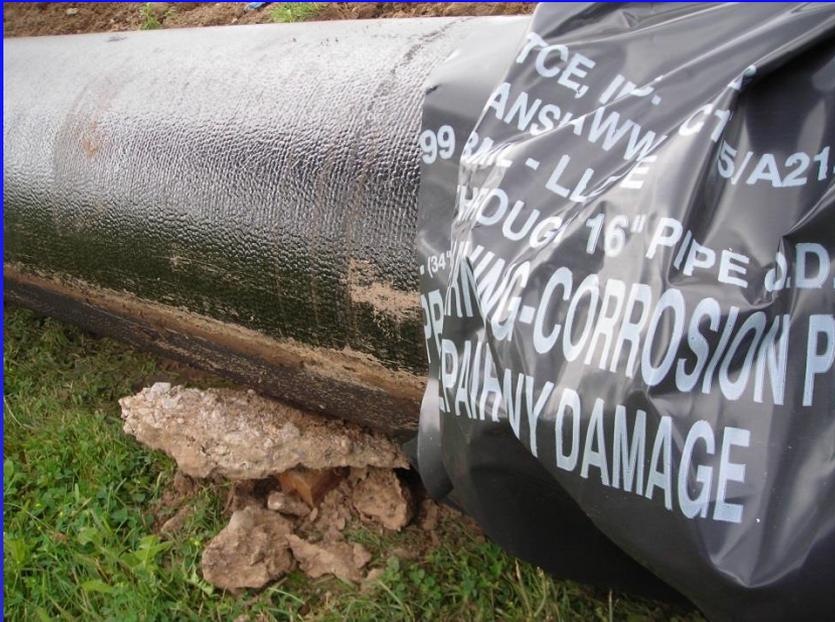
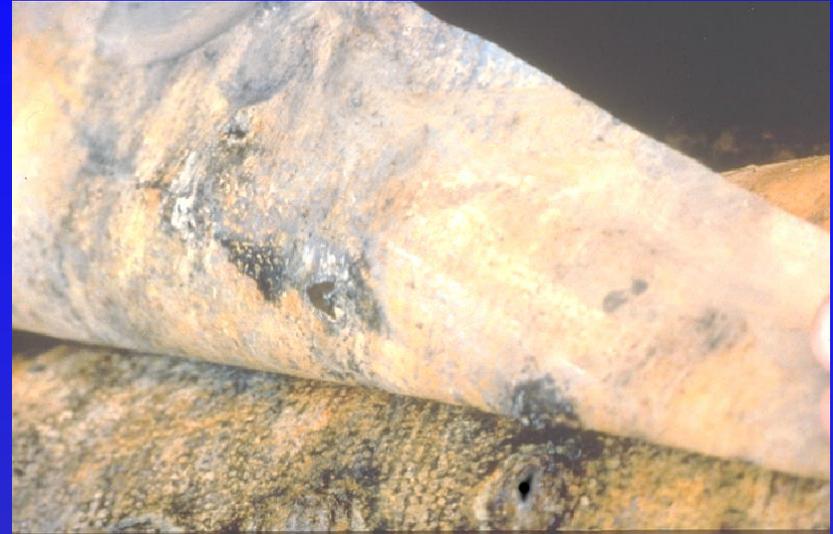
Polyethylene Encasement of Ductile Iron Pipe

- Follow DIPRA installation procedures
- Clean pipe before installing polywrap
- Repair tears or damage to encasement
- Engage an inspector to oversee installation
