Data-Driven Source Water Management and Decision Support

Ashley Bair | July 12, 2022

OTCO Reservoir Management Workshop

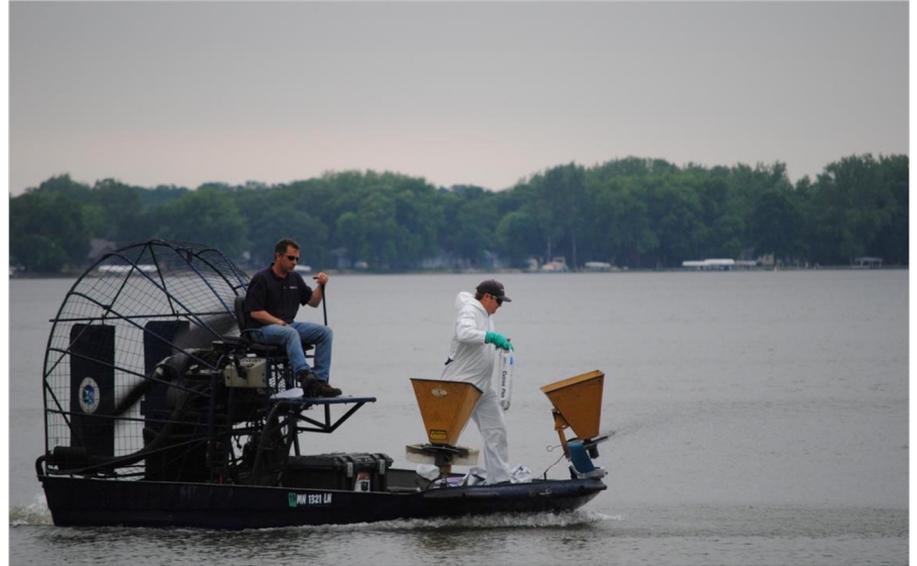
- Mixing / Destratification
- Hypolimnetic Oxygenation / Aeration
- Ultrasonication
- Algaecide (e.g. Copper Sulfate, Peroxide)

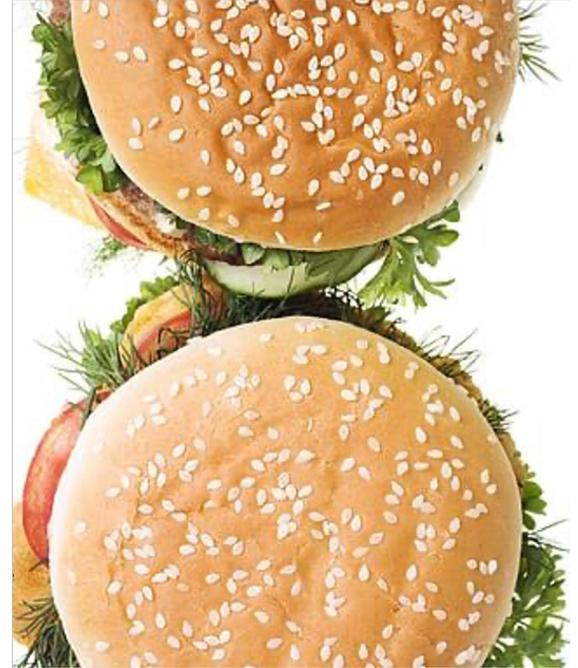
- Reservoirs are three-dimensional, water intakes are one-dimensional
- Reservoirs are highly variable across horizontal and vertical dimensions and time
 - Temperature
 - Nutrients
 - Light intensity
 - Primary productivity
- Responding to information from a single point samples in like tasting a single sesame seed and then trying to judge the quality of the whole burger

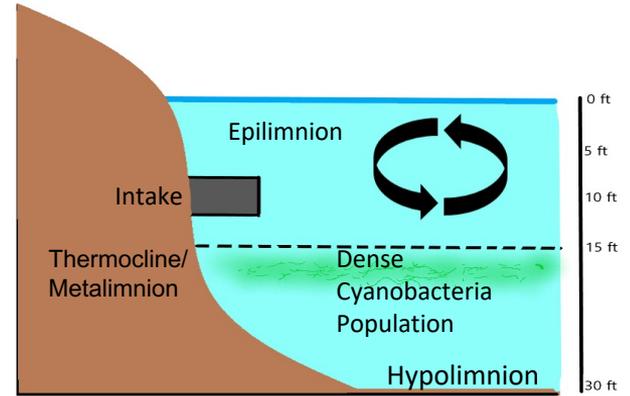
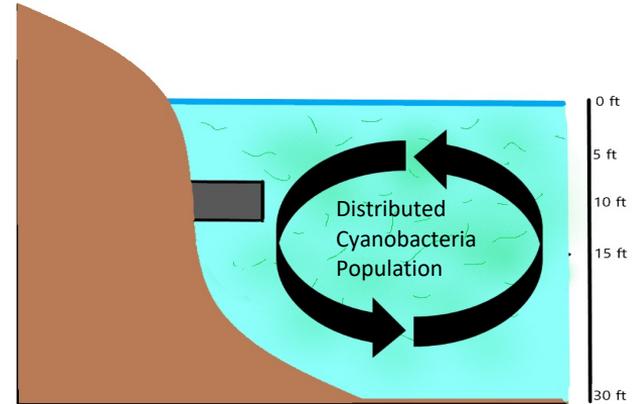
Cyanobacteria Blooms can lurk in Stratified Layers

- Cyanobacteria are known to survive and concentrate at varying depths (eg metalimnion)
 - This includes potentially toxic species such as Planktothrix
- Population may rise with the thermocline, subjecting to mixing and entrances into intake
- Loss of the thermocline forces mixing in lower depths, distributing cyanobacteria throughout water column

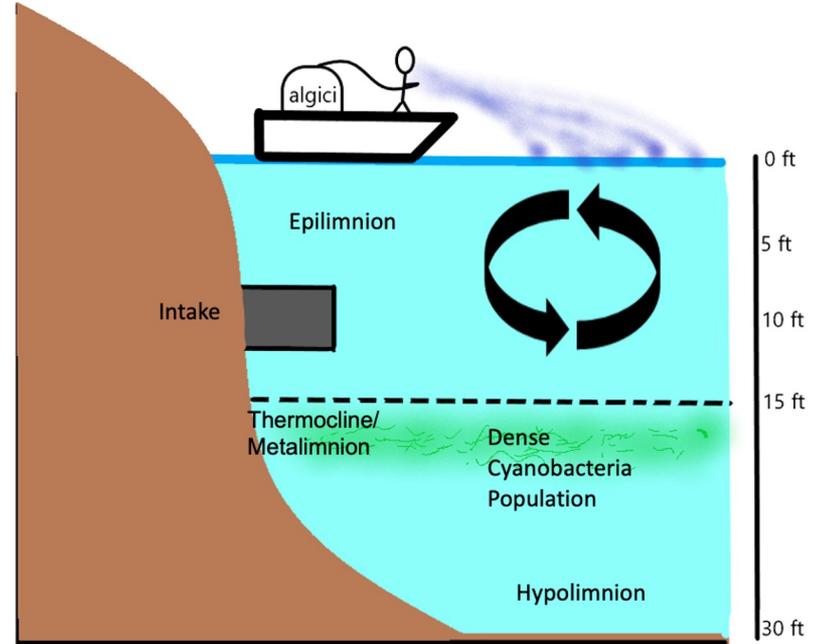
It's Easy to Apply Algaecide Ineffectively

- Epilimnion mixes well
- Little mixing between epilimnion and metalimnion
- Application of algaecide at the surface may not reach stratified cyanobacteria

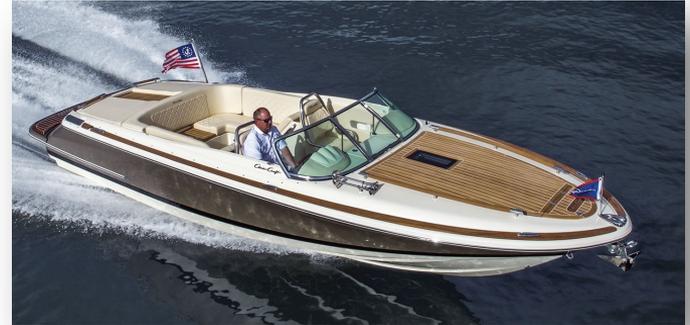
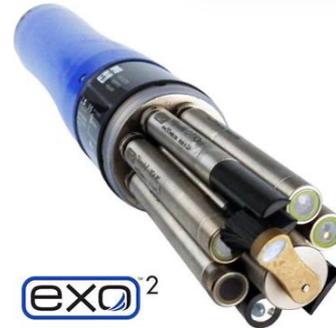
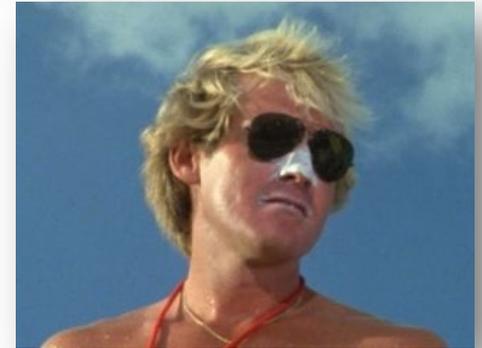
Water Column Profiling - Tools

- Boat
- Sonde
 - Temperature
 - Phycocyanin RFU (cyanobacteria pigment)
 - Chlorophyll RFU (photoautotroph pigment)
 - Dissolved Oxygen
 - pH
 - Dissolved Organic Matter
- PPE – Sunglasses, sunscreen, lifejacket

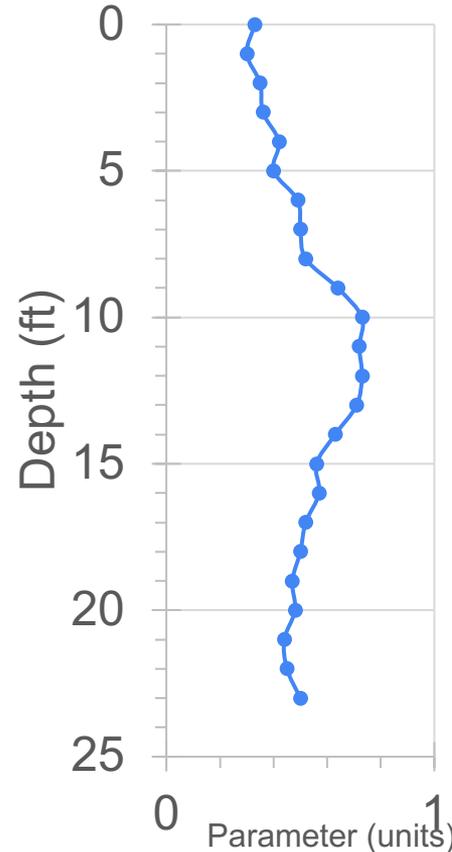
Visualizing Water Column Data

- Scatter Chart
 - Y-axis: Depth (values in reverse order)
 - X-axis: Parameter
- Track the impact of any HAB management technology (Phycocyanin peaks)
- Track the performance of mixing or aeration (Dissolved Oxygen)
- Understand relative HAB risk throughout the reservoir

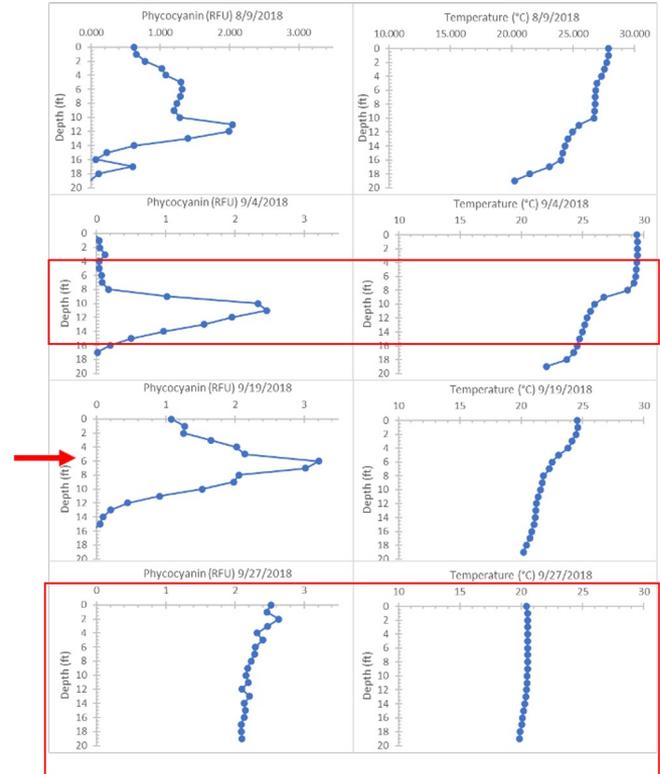
Water Column Profiling Trends

- Phycocyanin peaks observed in metalimnion
- Peaks sometimes cross intake depth
- Peaks disappear when thermocline disappears

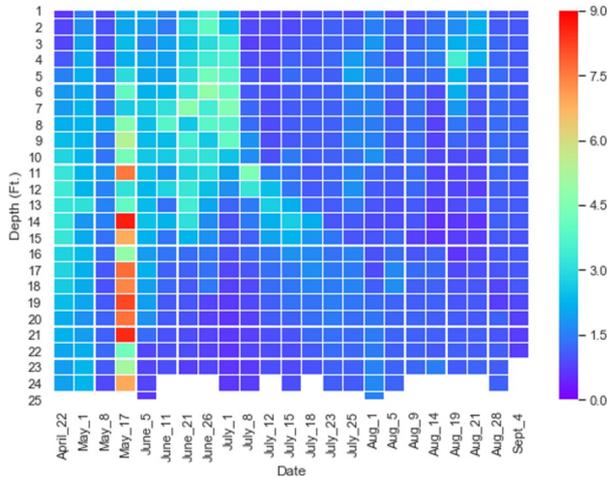
2019 Site 3 Chlorophyll (RFU)

- Chlorophyll - quantify primary productivity
- Phycocyanin - quantify cyanobacteria specific productivity
- Temperature - identify thermoclines and seasonal turnover

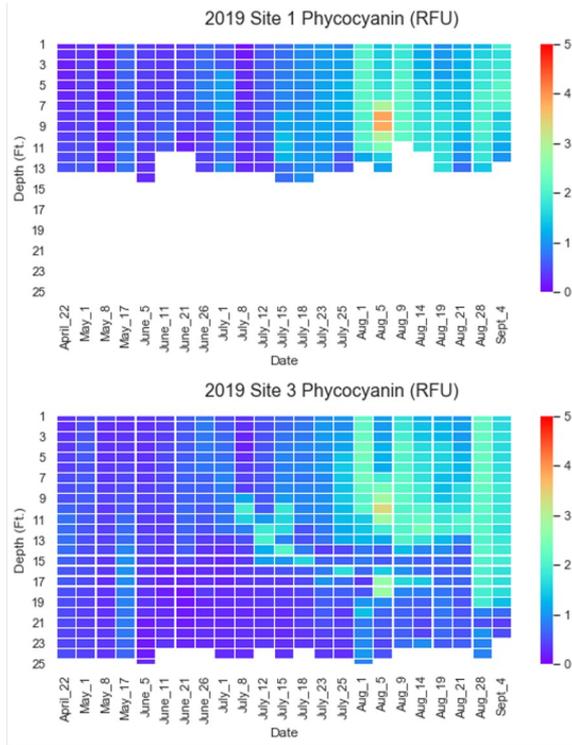
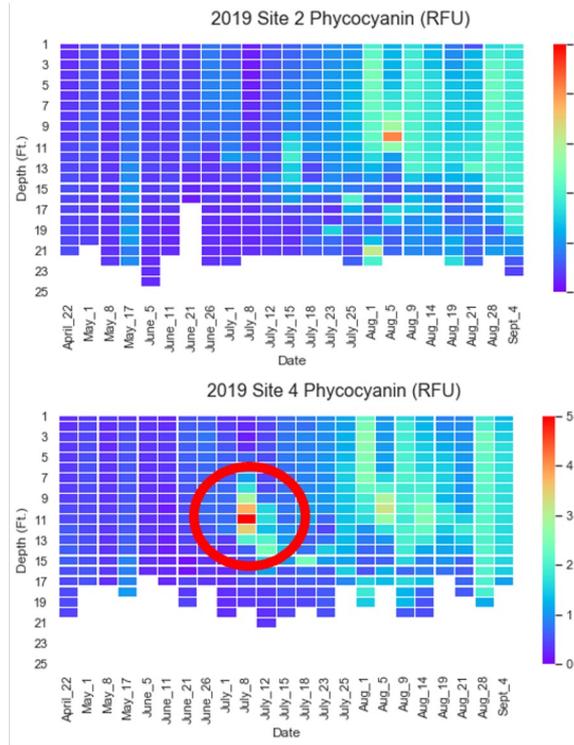
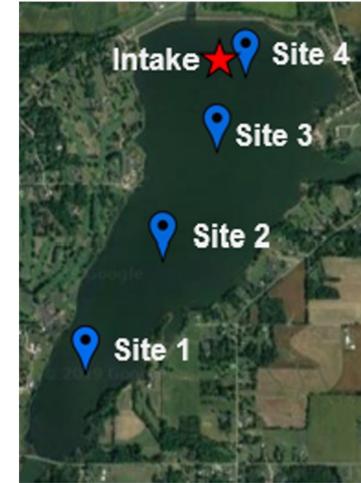
Comparison Between Sites

- Identify problems and areas early
- Identify stratification trends and limits

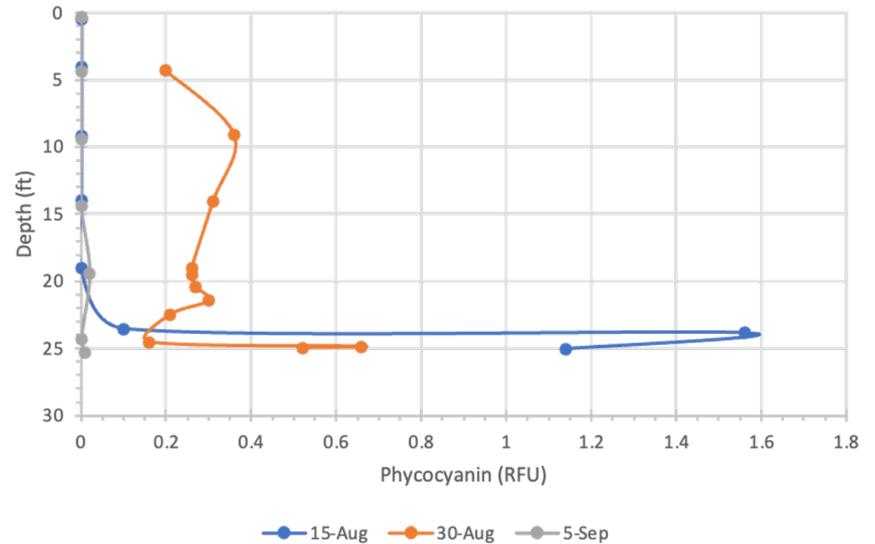
Delphos, OH WTP

- Fall 2018-Winter 2019 persistent bloom of *Planktothrix rubescens* caused high raw microcystin
- Late-Summer Profiling showed stratified cyanobacteria bloom near reservoir bottom (>100,000 cells/mL)
- Targeted application followed by whole lake application decreased phycocyanin to below detectable levels throughout most of the water column

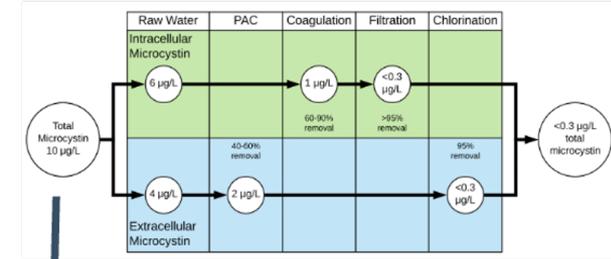
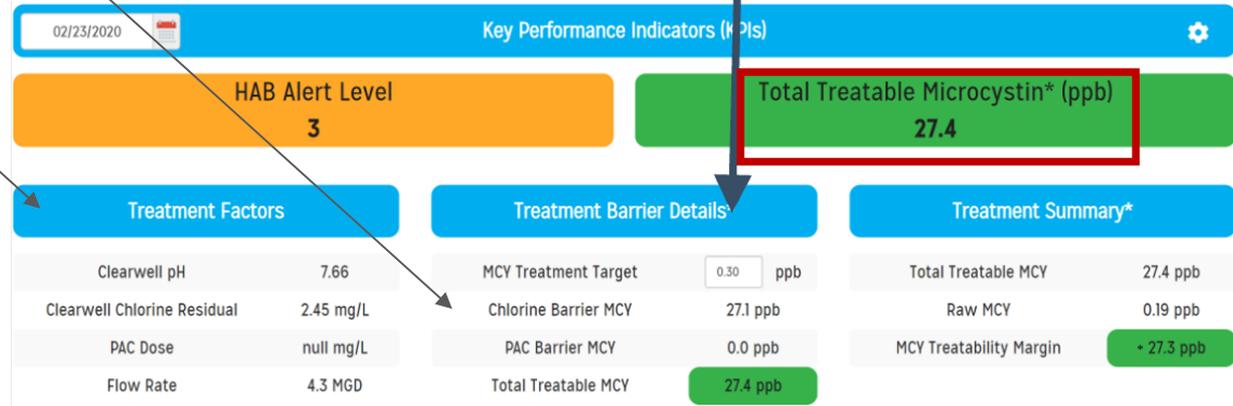
HAB Monitor™ Treatment Details

- **Sequence of treatment barriers** to achieve treatment target
- Incorporates current conditions (i.e. treatment factors)
- **Total Treatable** is current estimate of toxin barriers

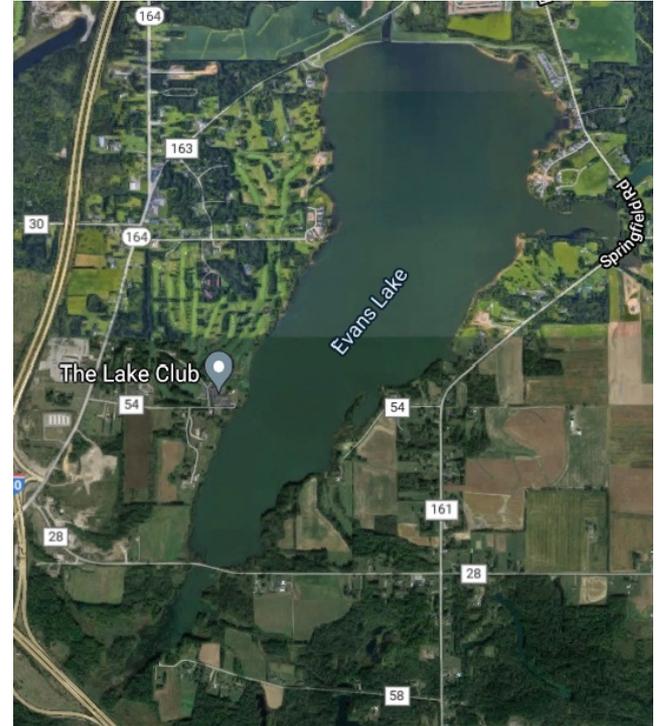
Struthers Source Water – Evans Lake

- Evans Lake
- Near Youngstown, OH
- Profiling since 2018
- 4 Sample Sites
- Average max depth 30ft (Site 3)
- Intake at 10 feet (Site 4)
- Surface Area 582 acres
- Max volume 12,574 ac-ft

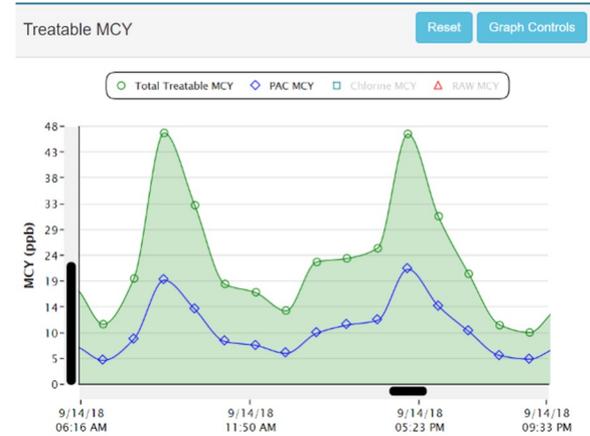
2018 Struthers HAB Event

Staff followed and Observed:

- Total treatable estimate for each toxin barrier
- Notification when total treatable was below 5 ppb

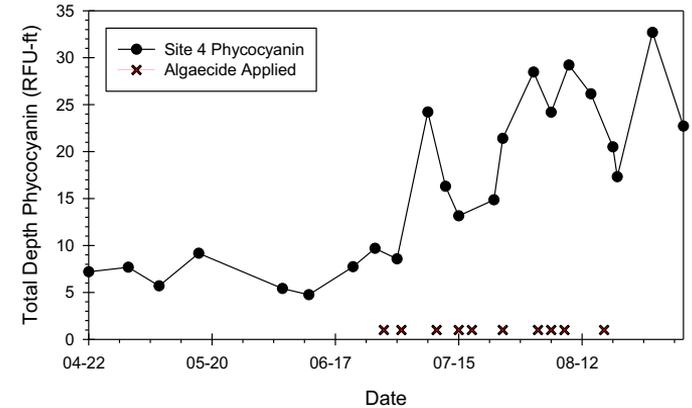
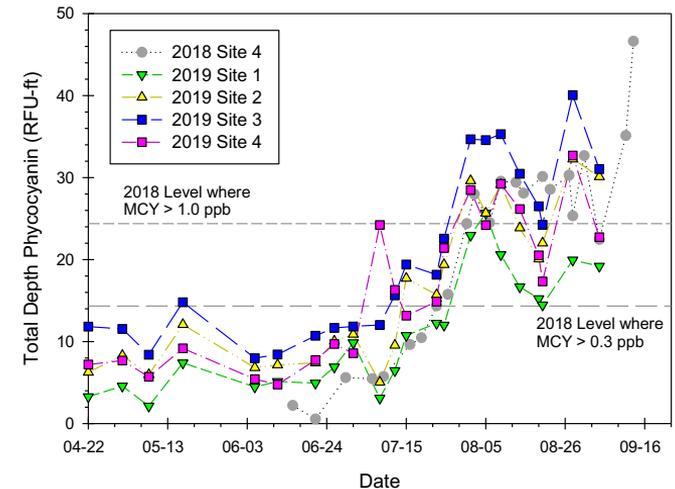
Struthers 2019

- 582 Acres, 4000 MG
- Struthers applied 40-75 gallons every 3-8 days
- Managed well when applying more frequently (3 days) and at all sites
- Application stopped when saxitoxin was detected and HAB grew uncontrolled
- Increased Dosage in 2020

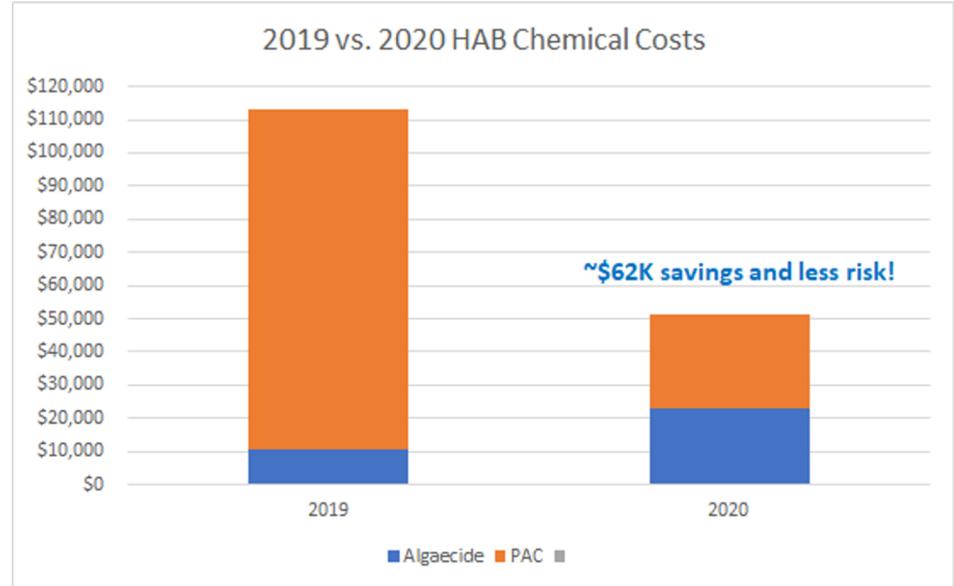
Struthers Cost Savings 2019 vs 2020

- Manage HABs with low-dose, targeted algaecide, use less PAC in treatment
- Maintained consistently low levels of microcystin and saxitoxin
