Membrane Filtration – The Right Choice for Wheeling's WTP Upgrade

OTCO Water Workshop, March 8, 2017 Brian T. Bisson, P.E.

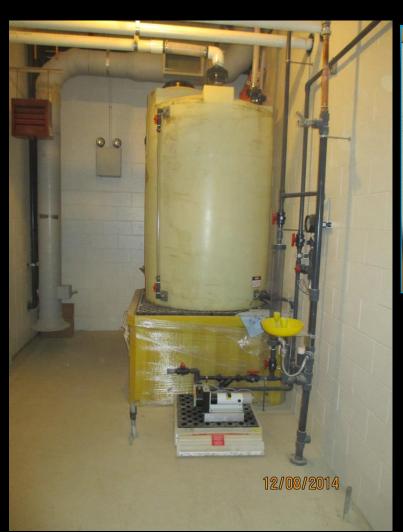
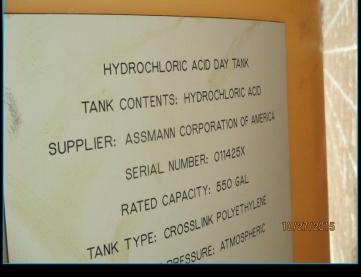
HCI Tank

- Leak of valve on site glass 4/15/15
- Fumes noticed reported to General
- Investigated on Monday, 4/18/15
- Lots of damage

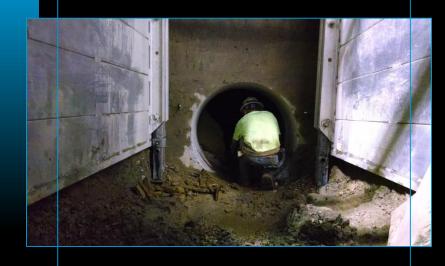
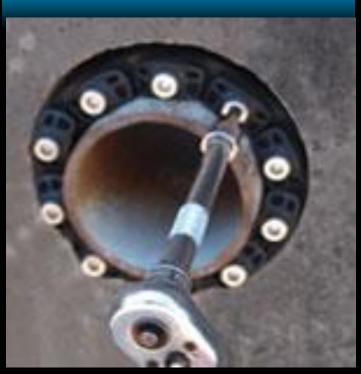
Link-Seal

Pipe connection to Settling Basins
Performed during plant shutdown
Slight alignment problem
Couldn't get link-seal to fit
