Stantec

Gary D. Silcott, Jr, PE presents:

Micromonitoring:
A Cost Effective
Approach for
Locating I&I in
Sanitary Sewers

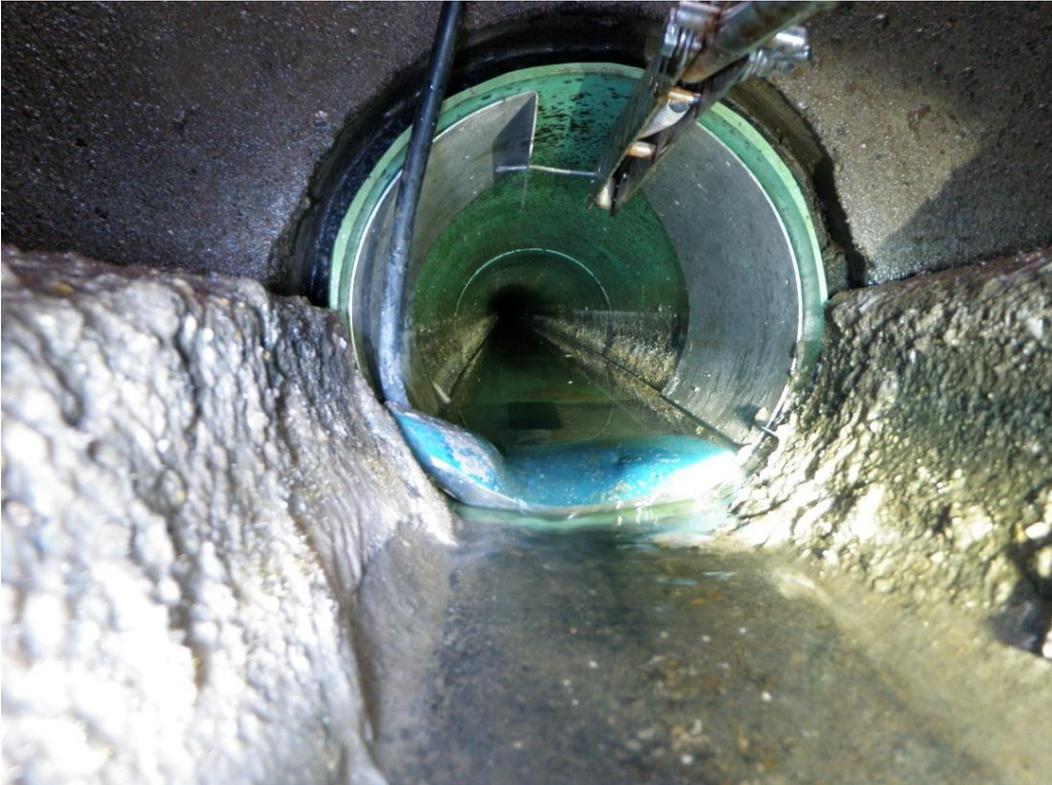
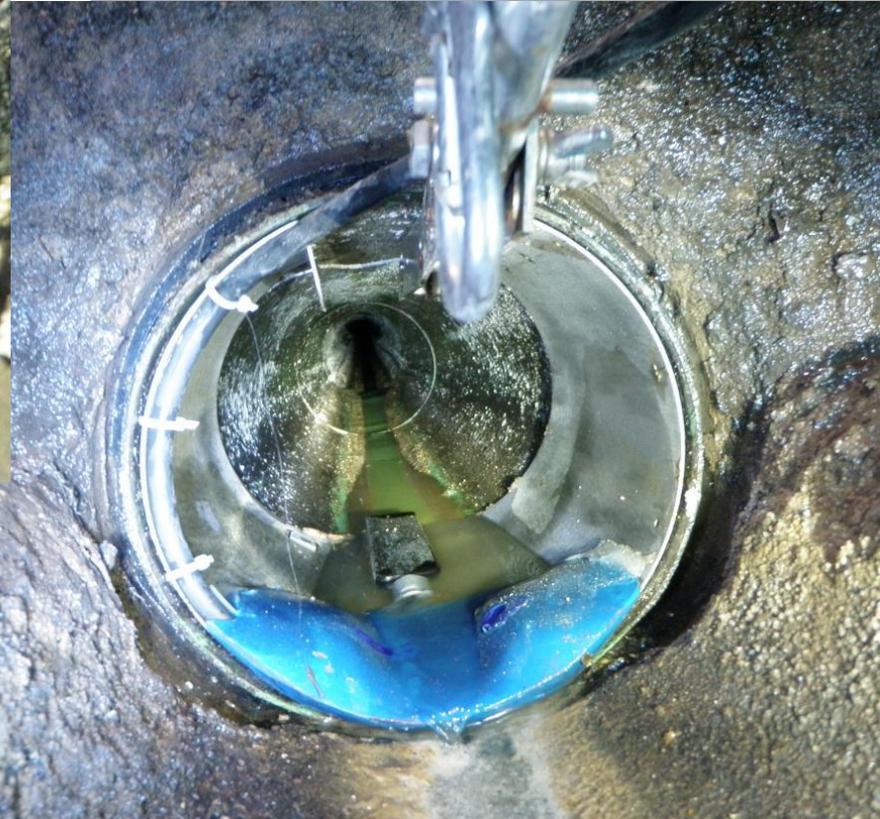
$Q = AV$ at high flow

**ISCO 2150 Flow Monitor
with a Customized Weir**

$Q =$ weir curve at low flow

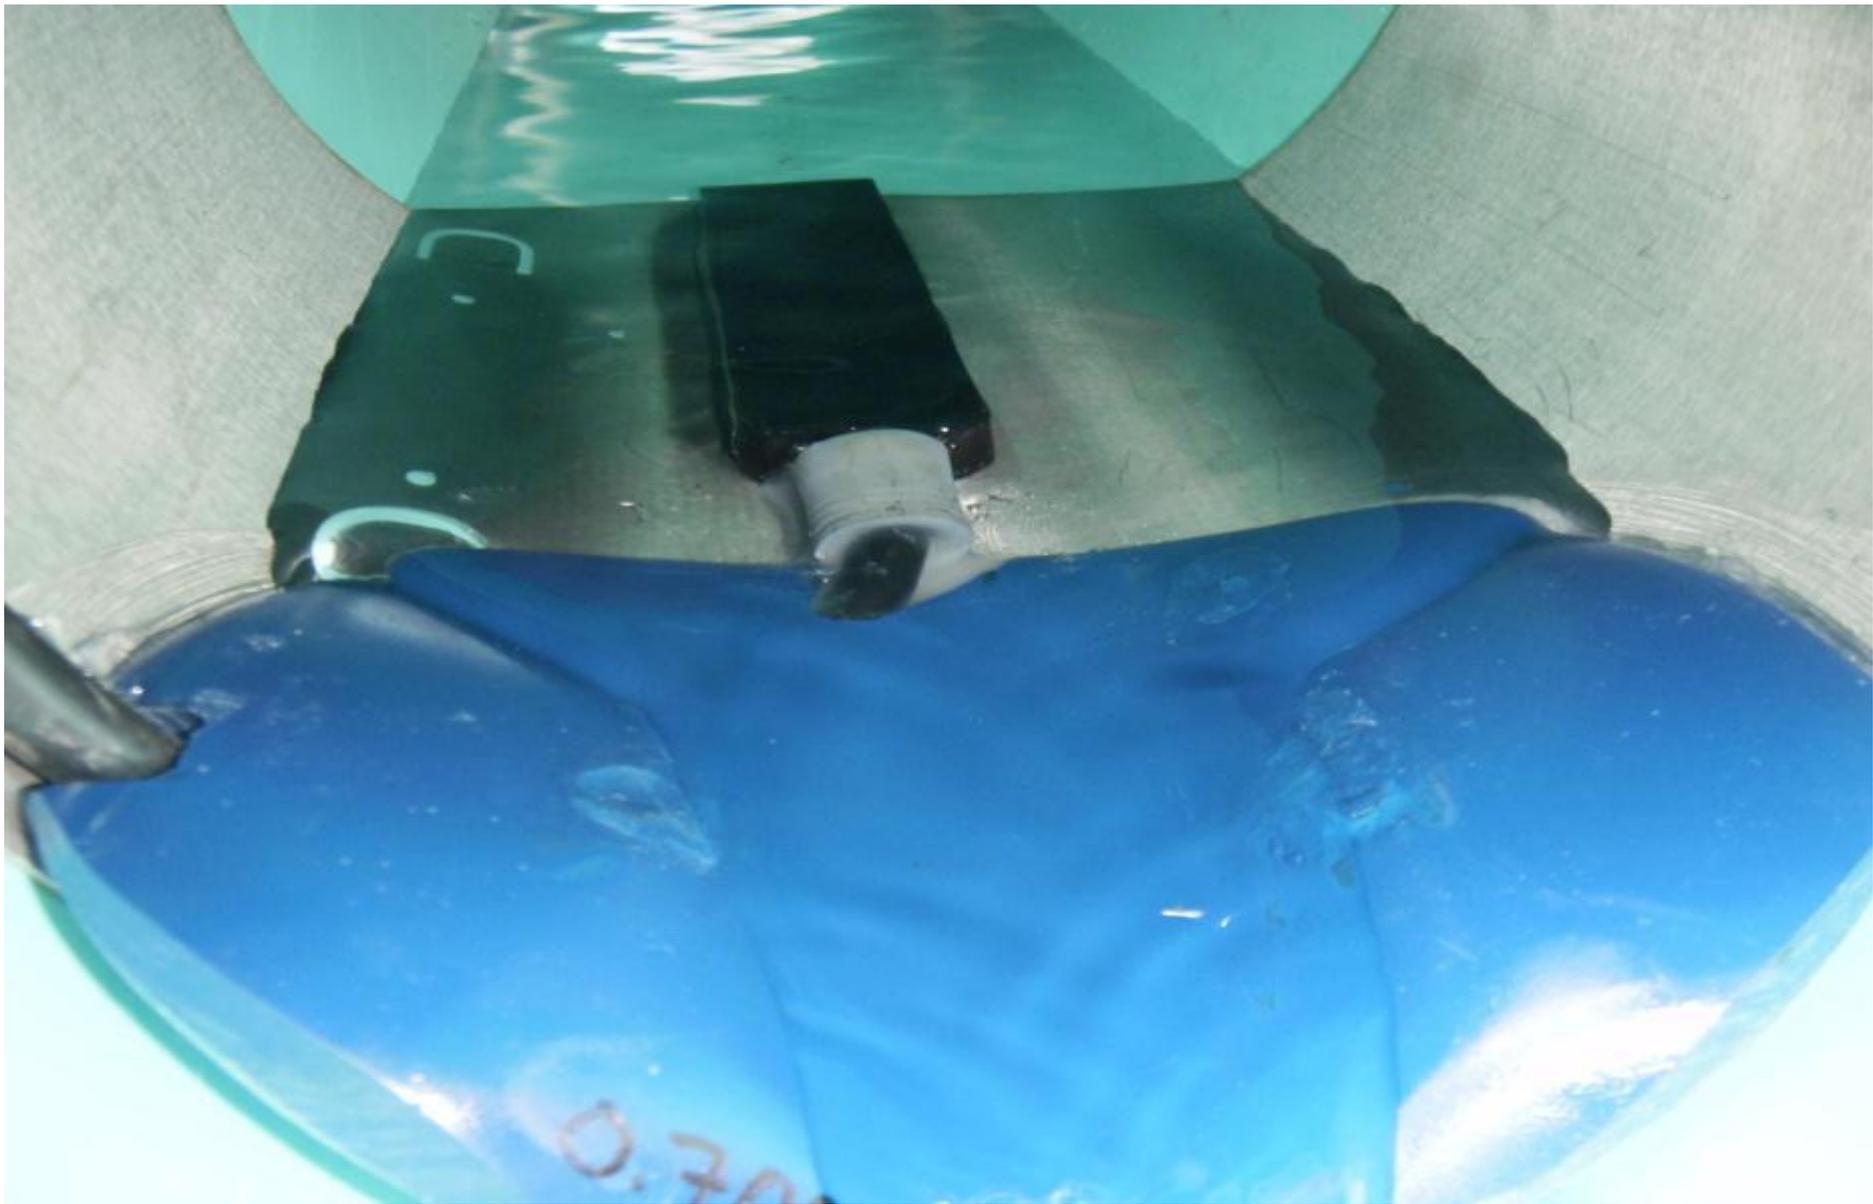
A smooth weir

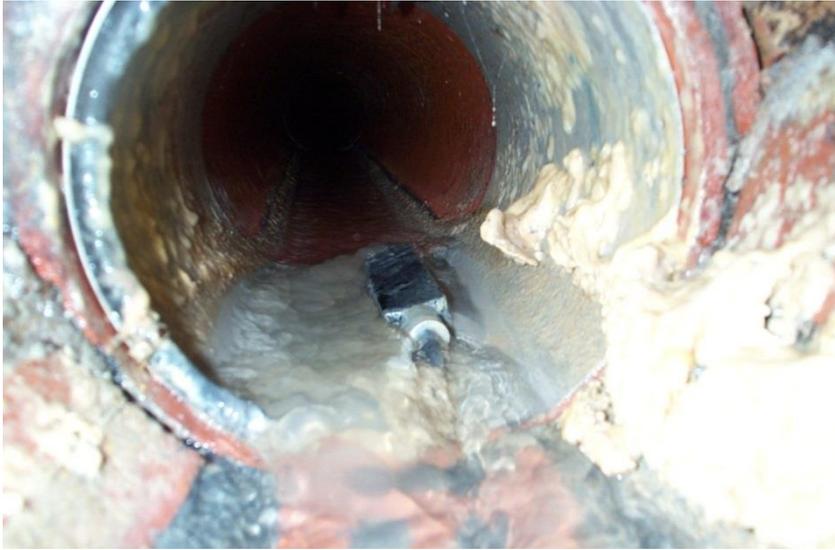
Accuracy

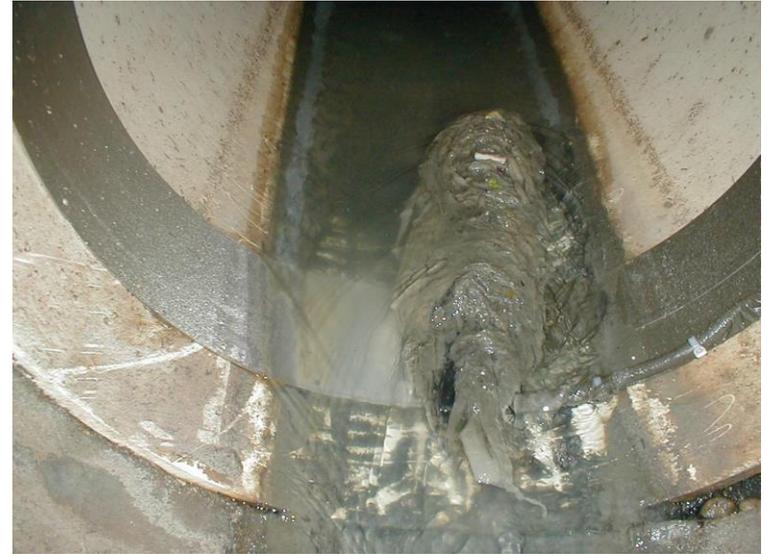
Debris

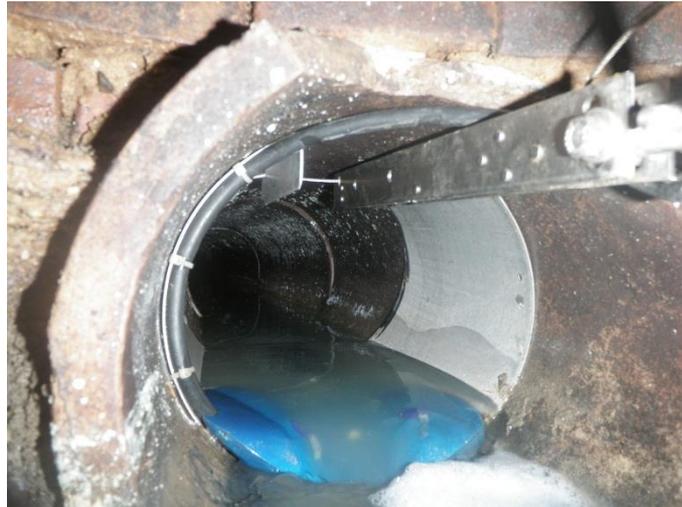
No problem

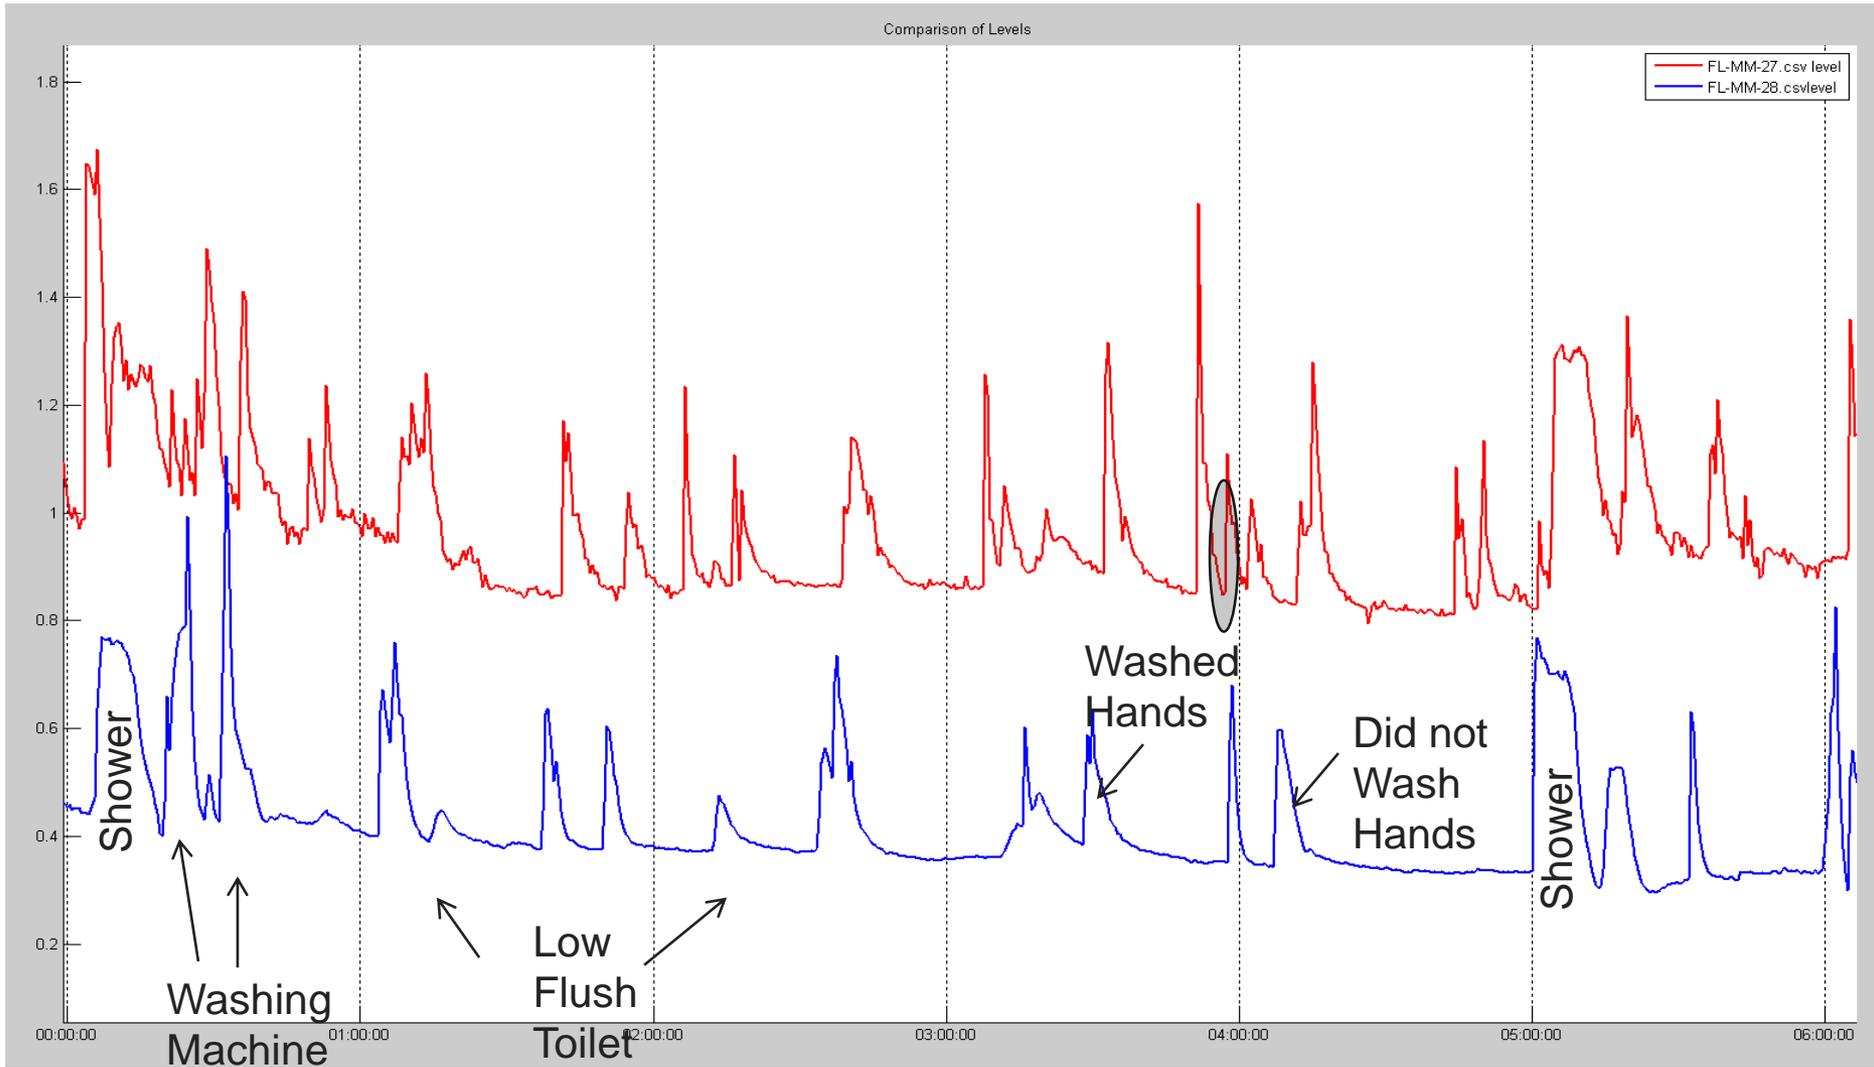
Domestic Usage Identified

Midnight

6:00AM

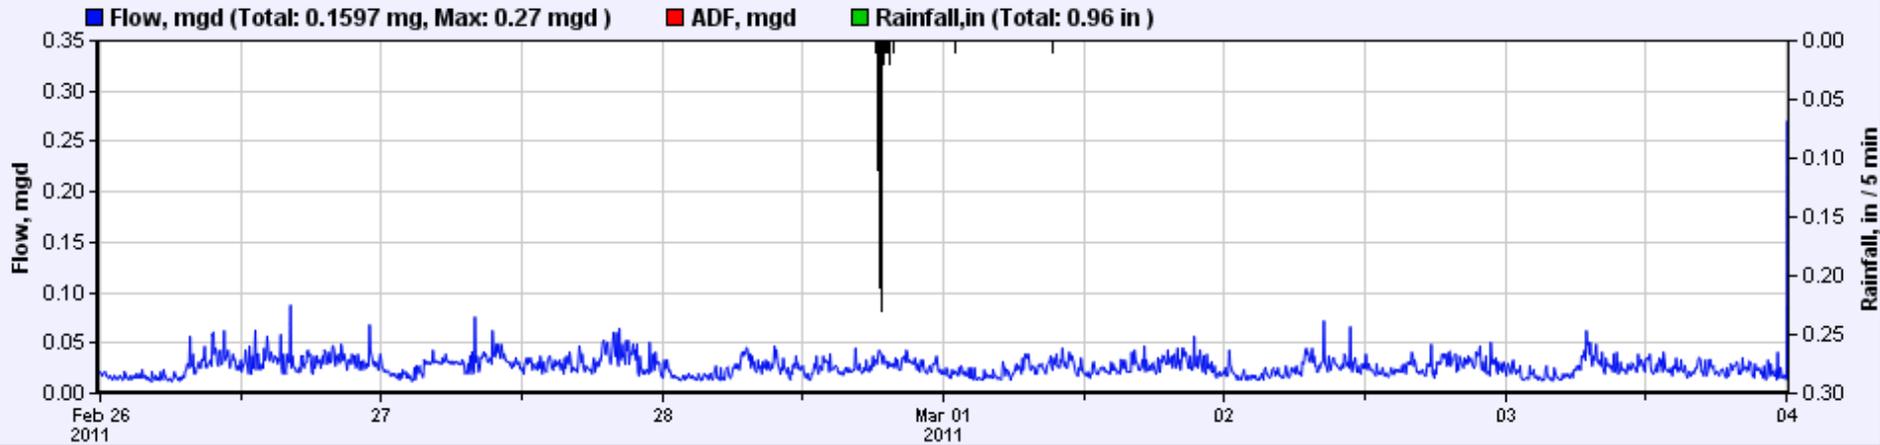
CC-CW-071-MM1 From Feb 25 23:50, 2011 to Mar 04 00:10, 2011 (Duration 6 Days; 1 Hours; 20 Minutes)

Where is the I/I Problem Here?

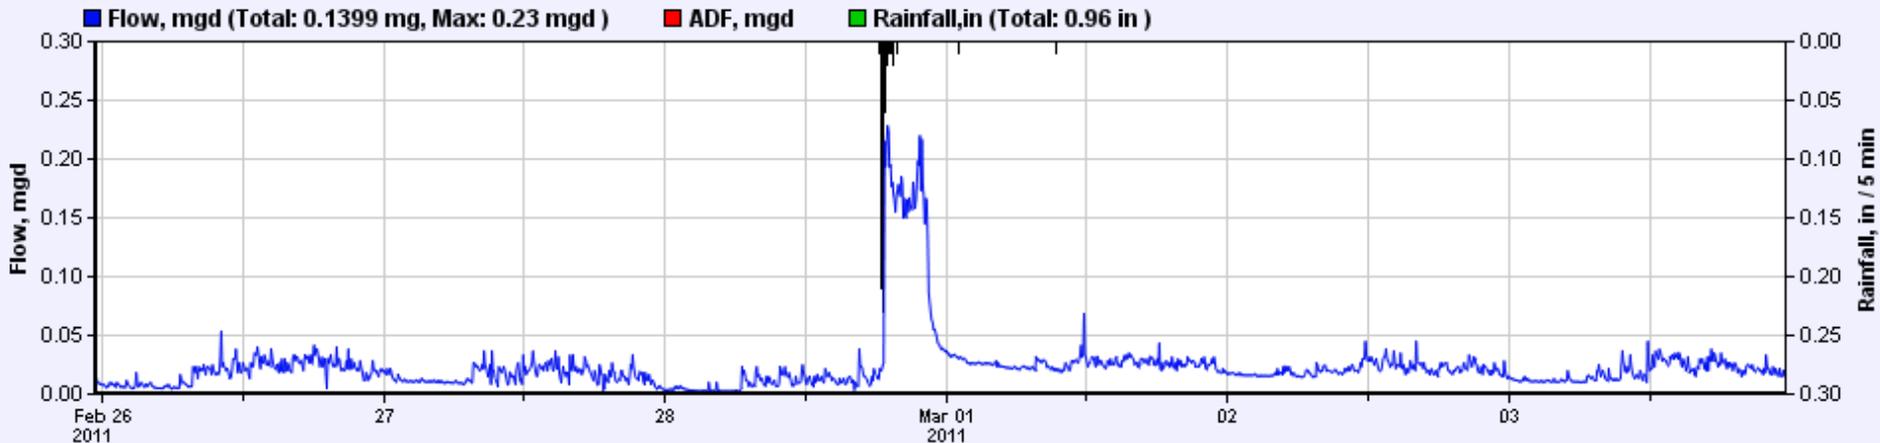
CC-CW-071-MM6 From Feb 25 23:30, 2011 to Mar 03 23:35, 2011 (Duration 6 Days; 0 Hours; 5 Minutes)

All you need is ONE storm!!!

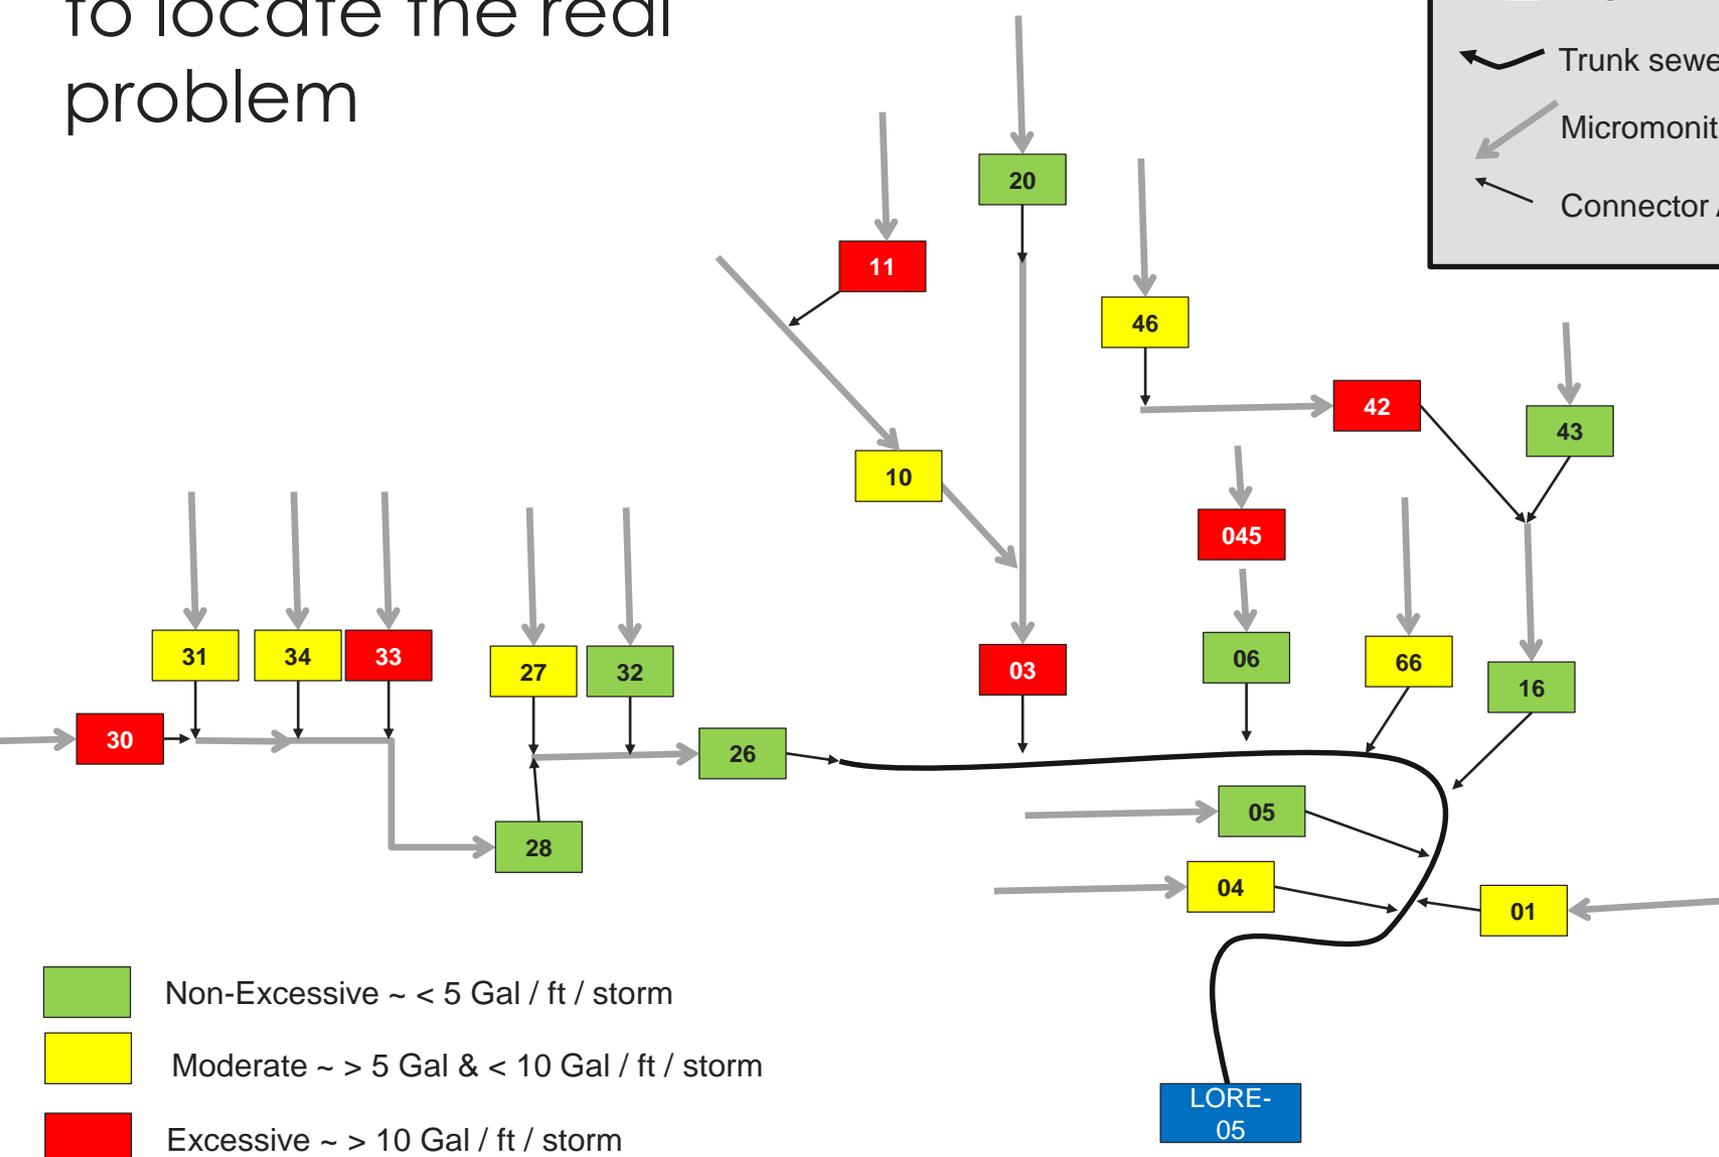
Monitor numerous sites to locate the real problem

- Non-Excessive ~ < 5 Gal / ft / storm
- Moderate ~ > 5 Gal & < 10 Gal / ft / storm
- Excessive ~ > 10 Gal / ft / storm

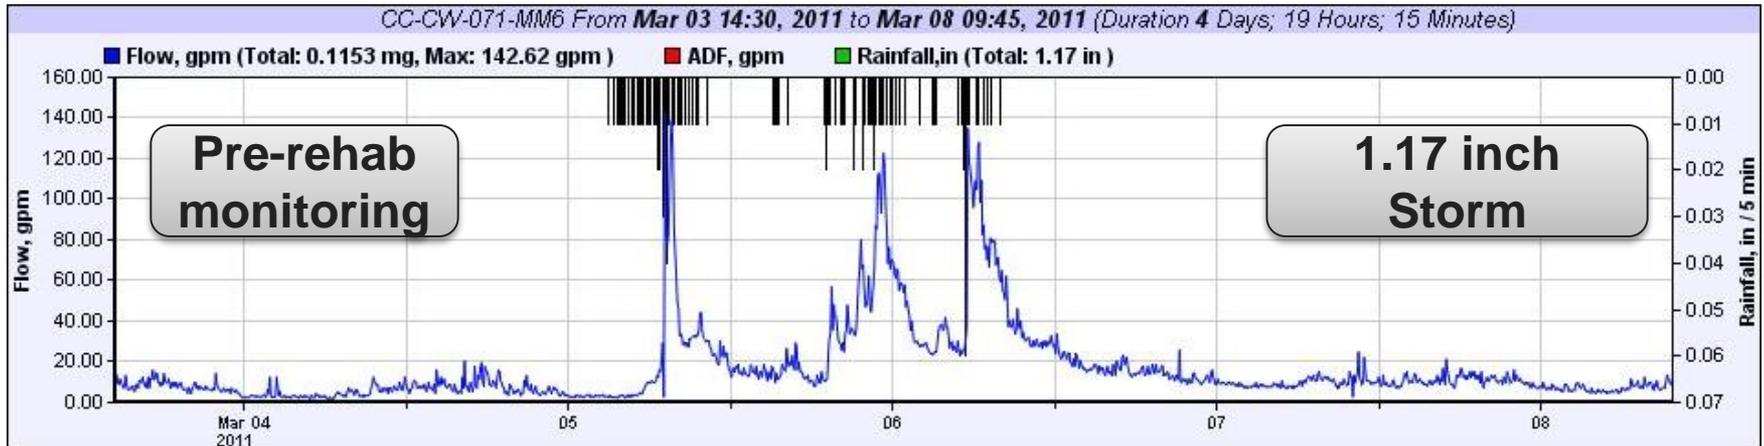
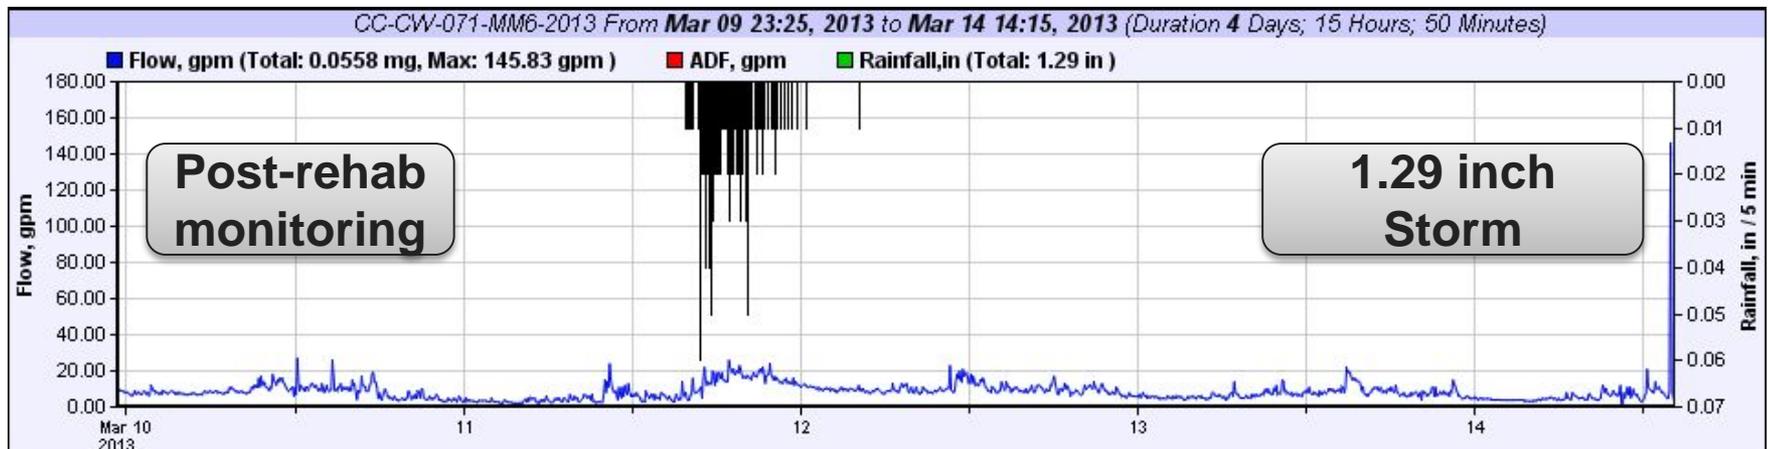
A gas line bored through the sewer line was found, which was removed during the monitoring period below.

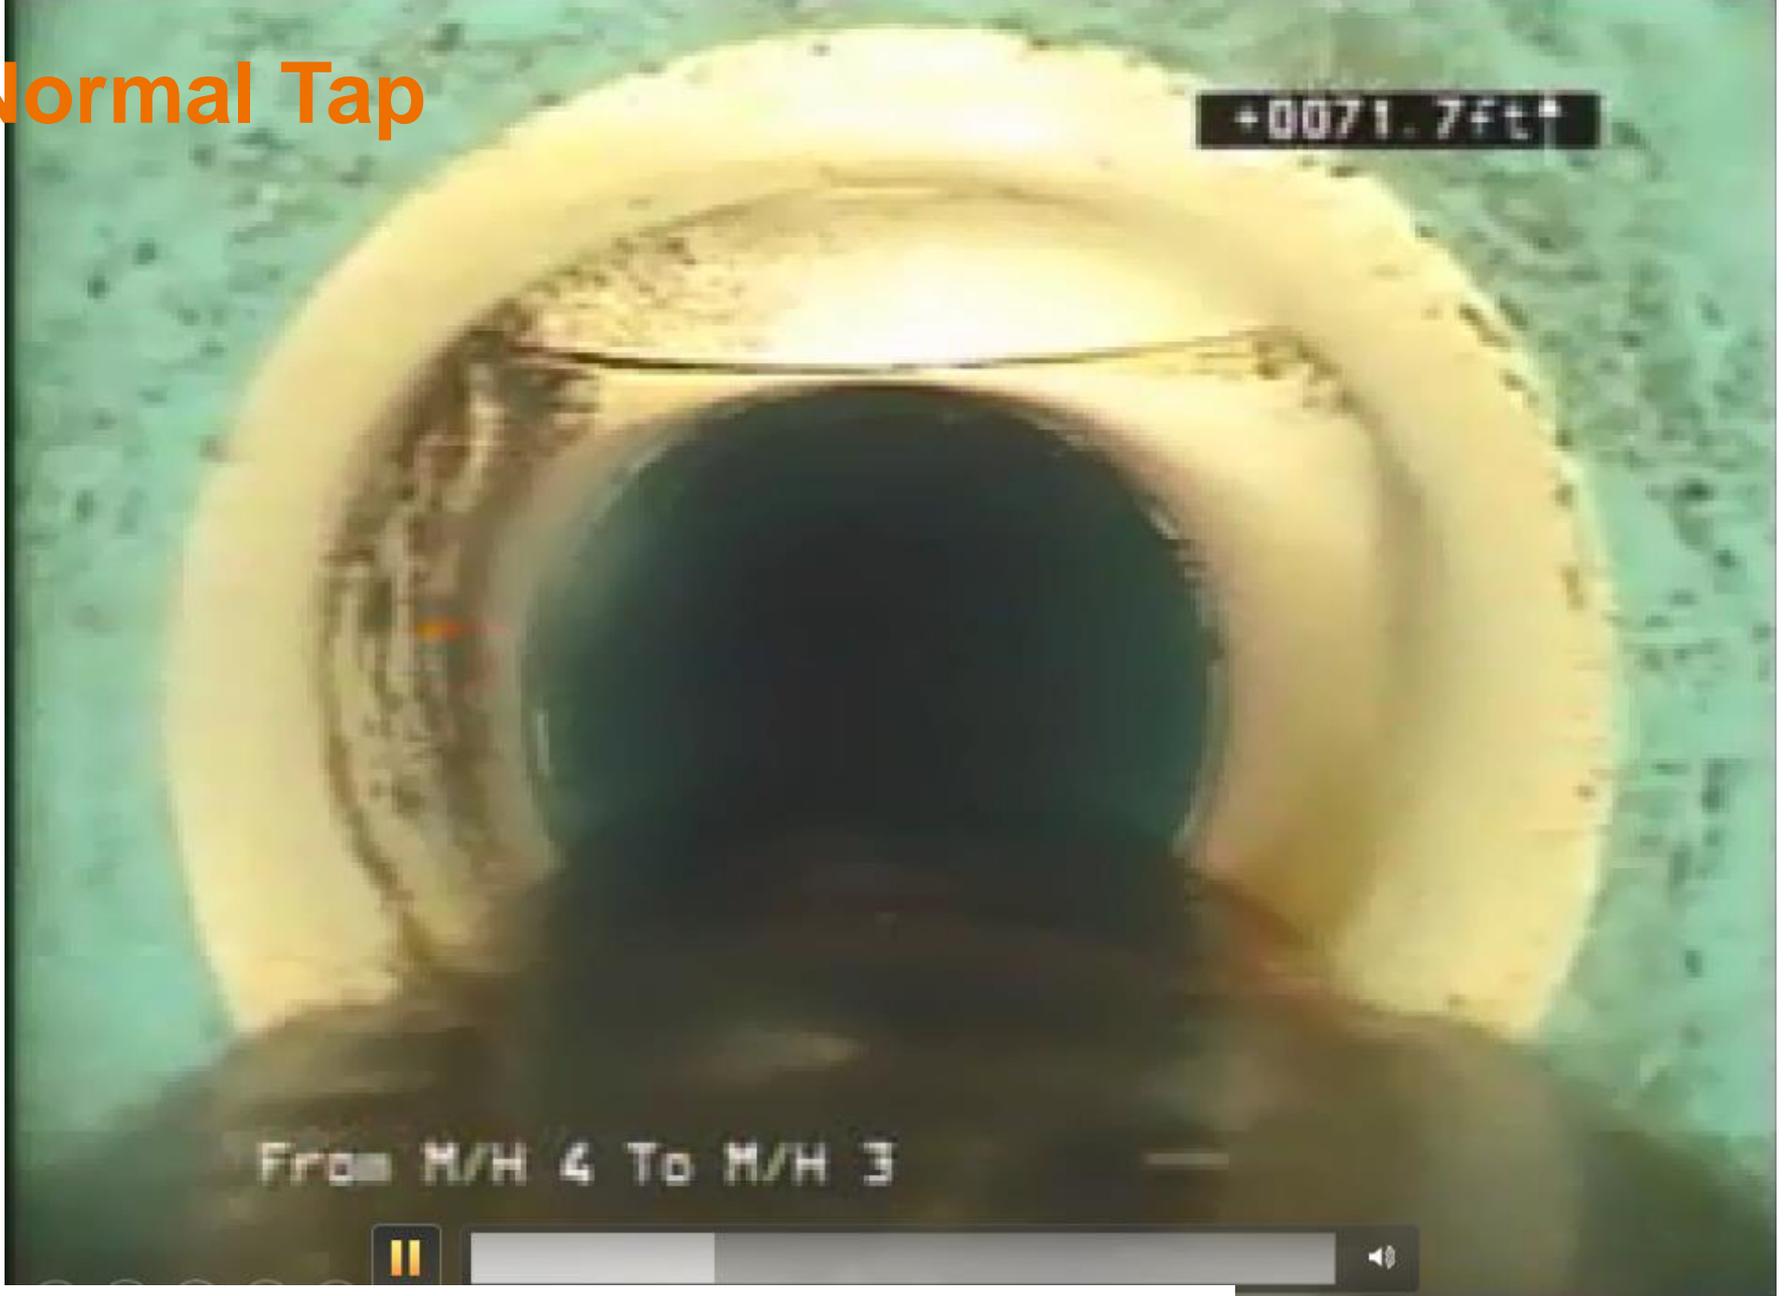
Normal Tap

This is what a tap look like in Dry Weather.

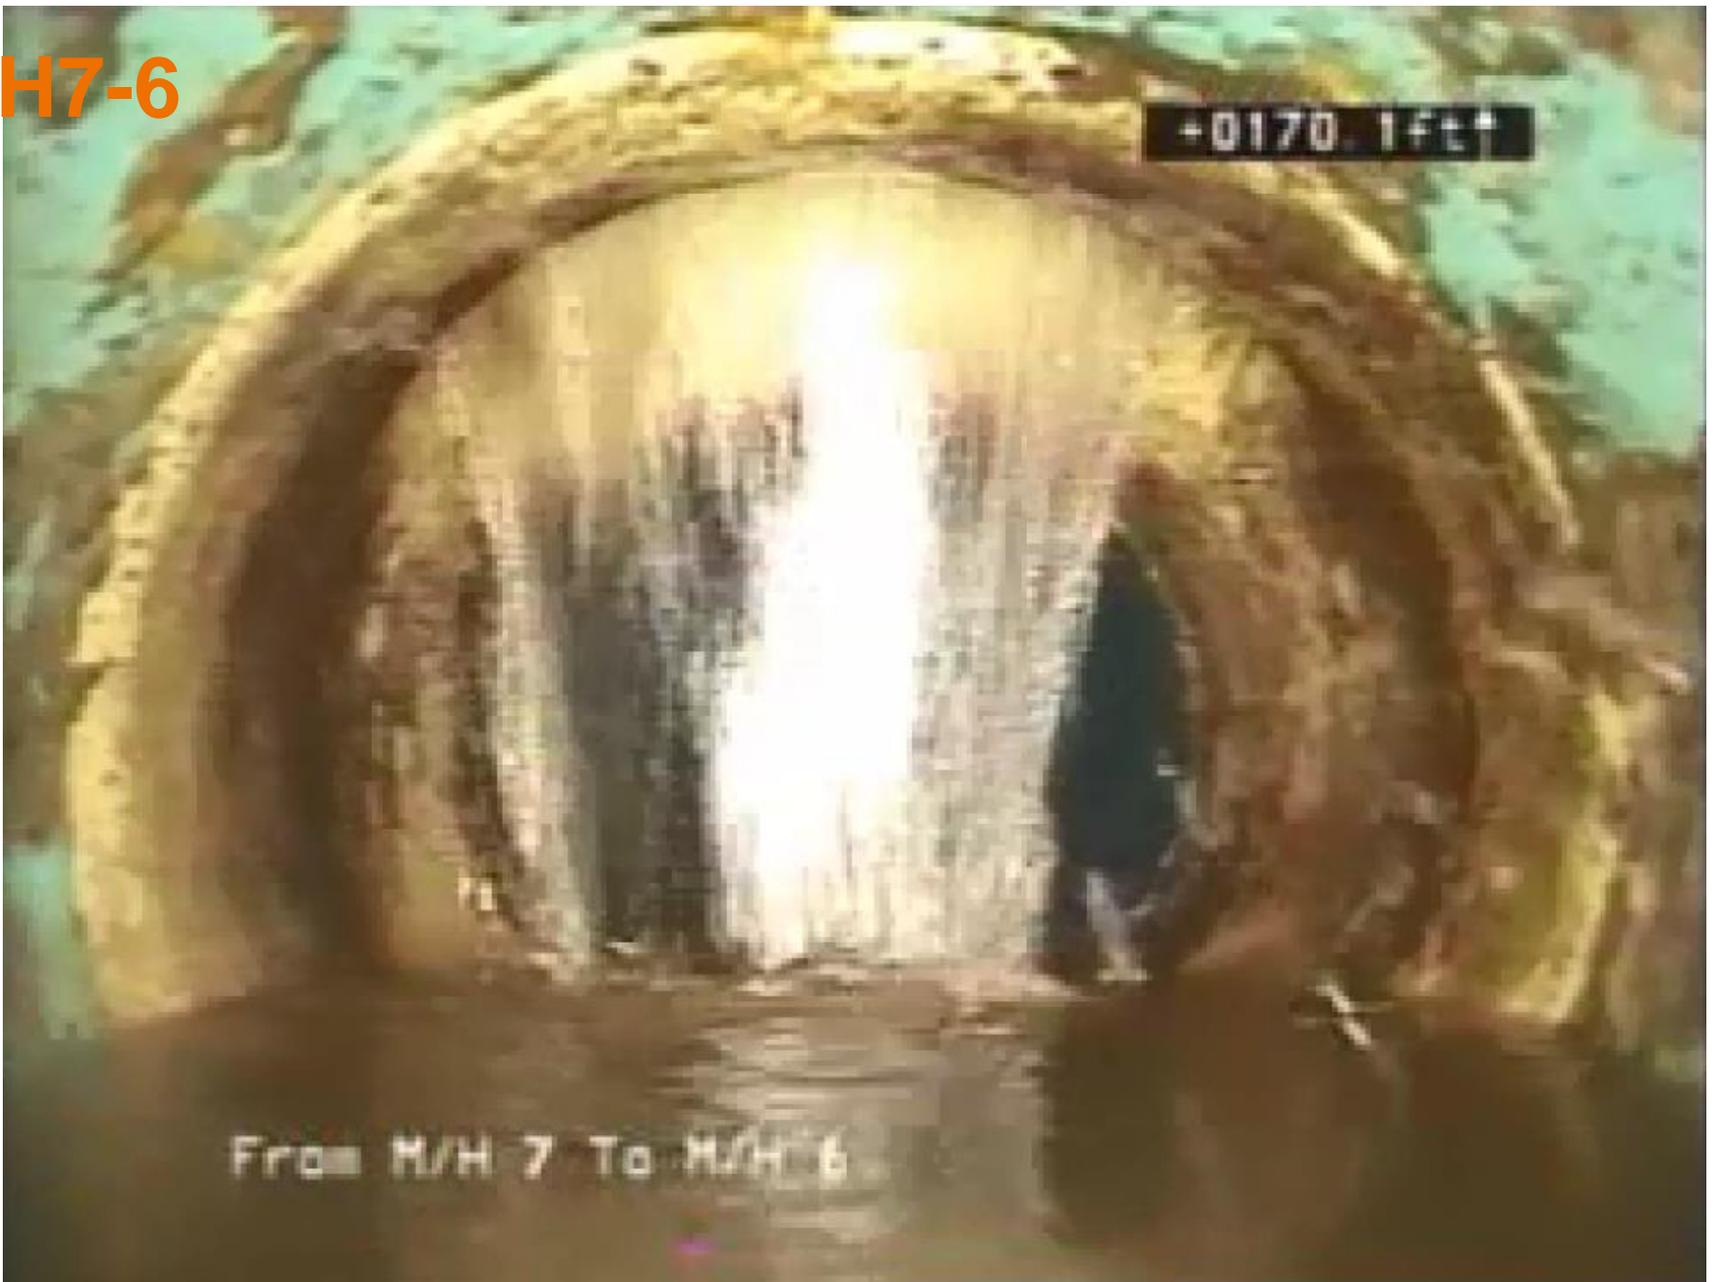
Infiltration Tap

Would have been missed using just CCTV!

This is looking into the Infiltration.

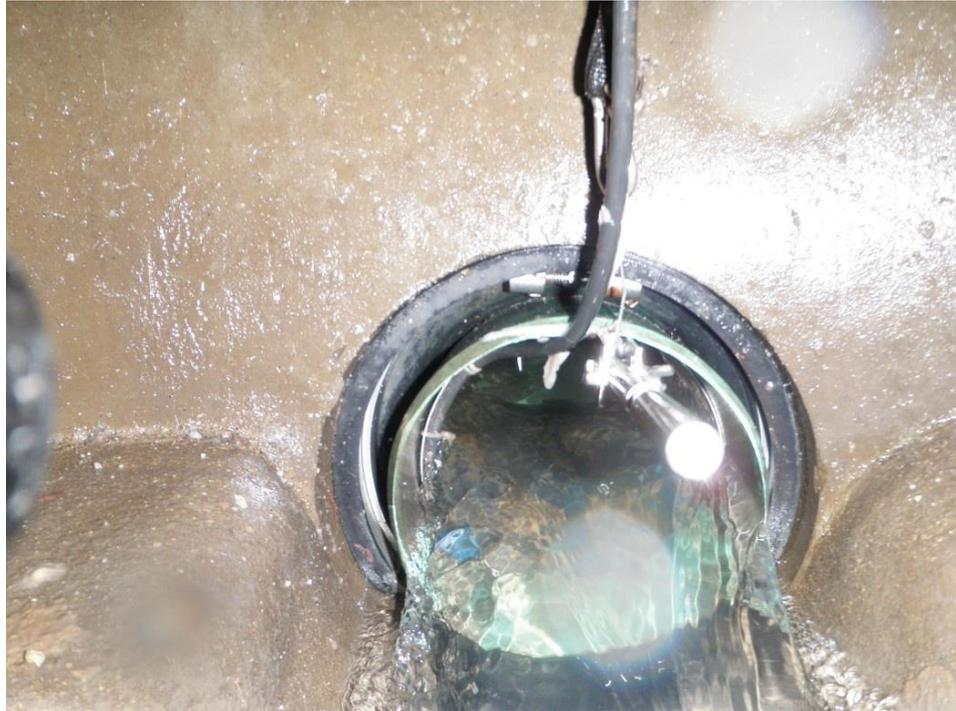
I&I Can be elusive!

Main Line and Manholes replaced but laterals remained.

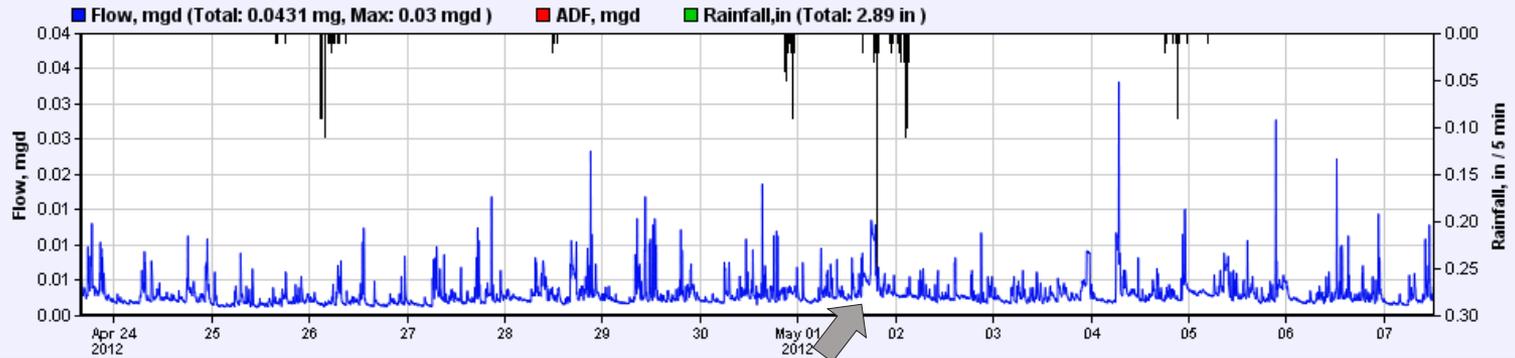
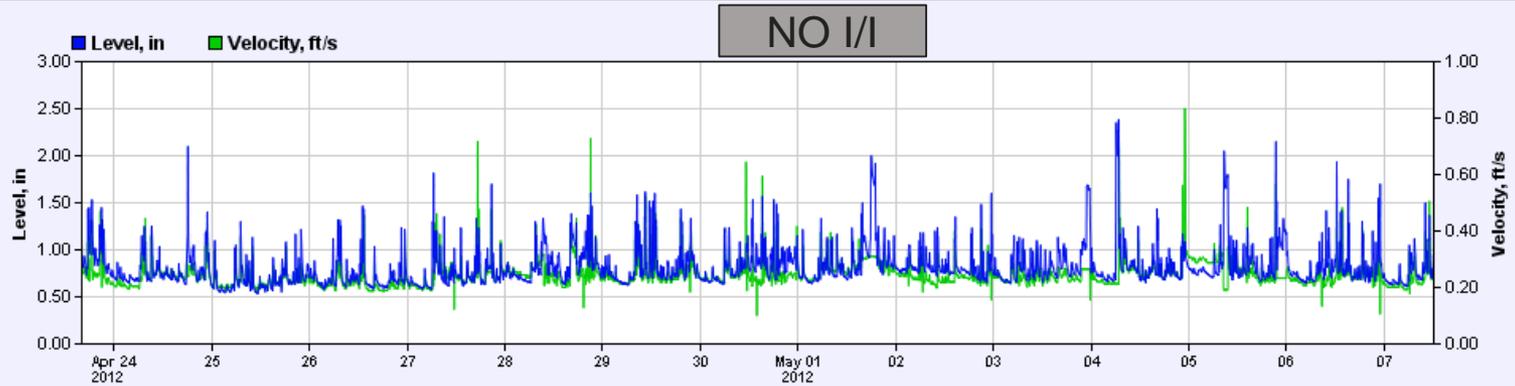
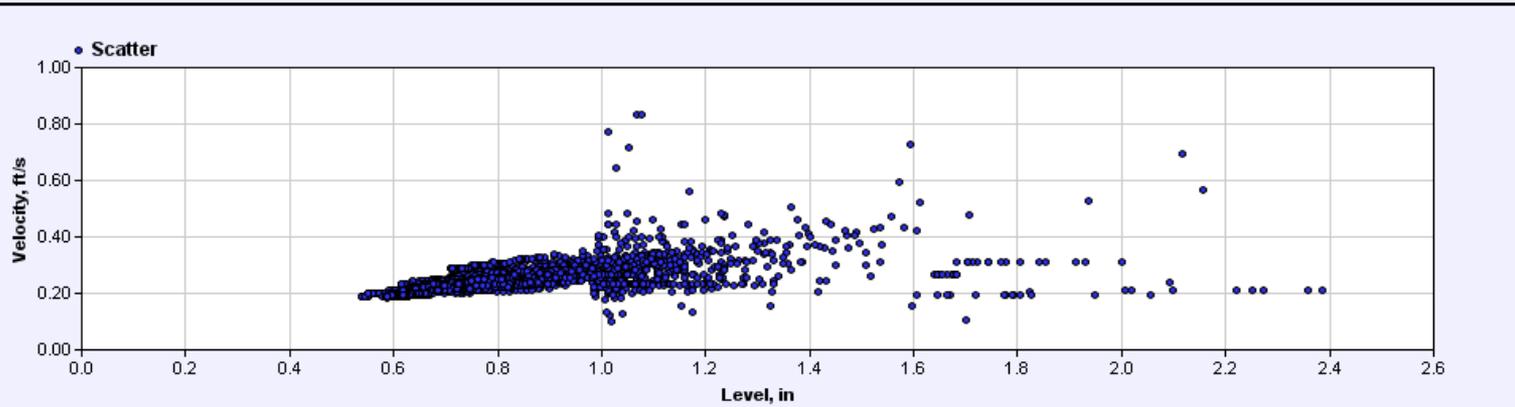
Monitoring Location 6

MI-MM06-U1 From Apr 23 16:05, 2012 to May 07 12:10, 2012 (Duration 13 Days, 20 Hours, 5 Minutes)

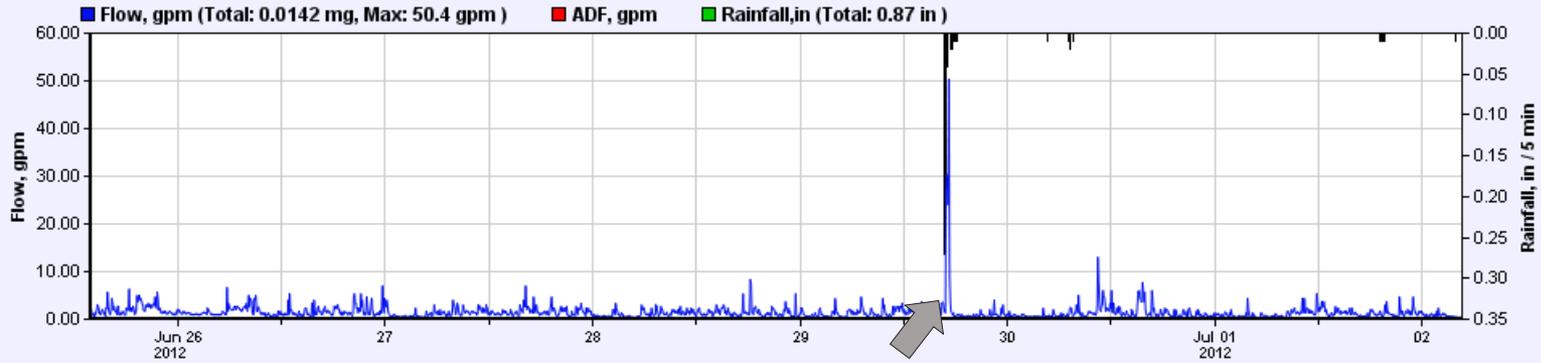
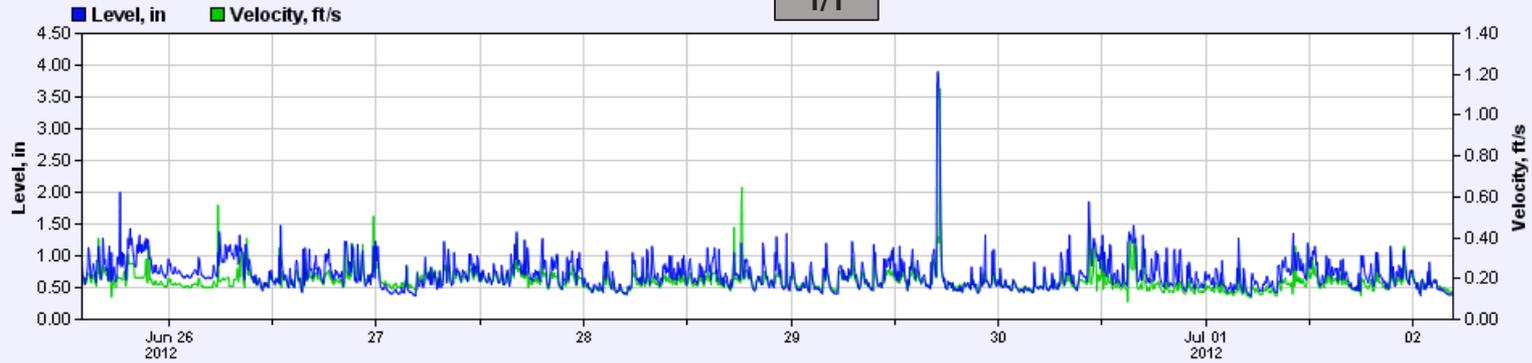
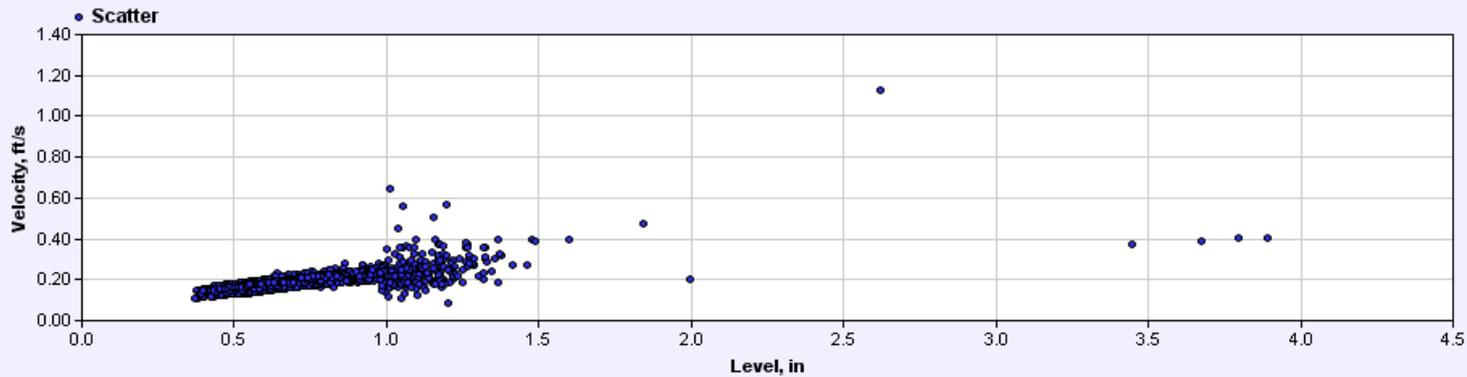
Monitoring Location 10

MI-MM10-R1 From Jun 25 13:55, 2012 to Jul 02 04:40, 2012 (Duration 6 Days; 15 Hours; 45 Minutes)

I/I

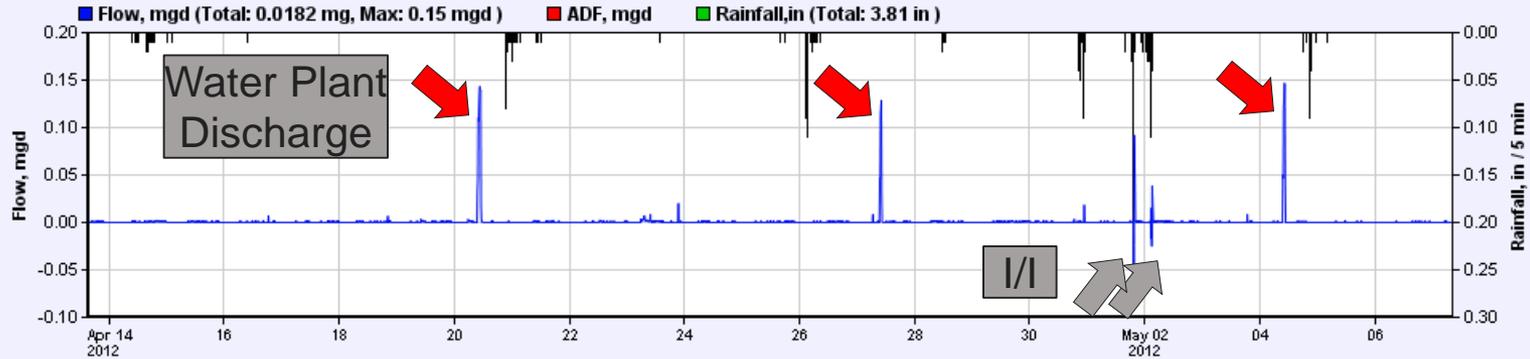
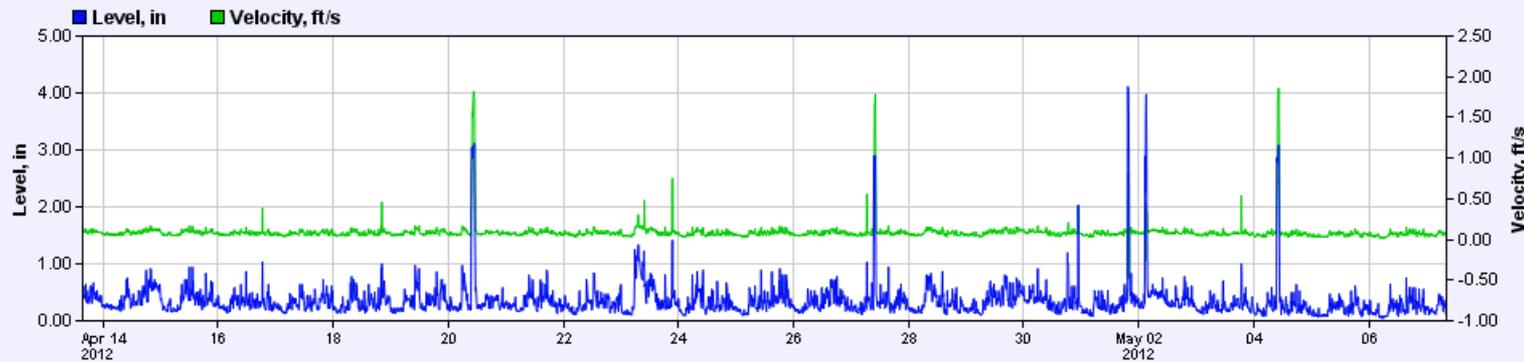
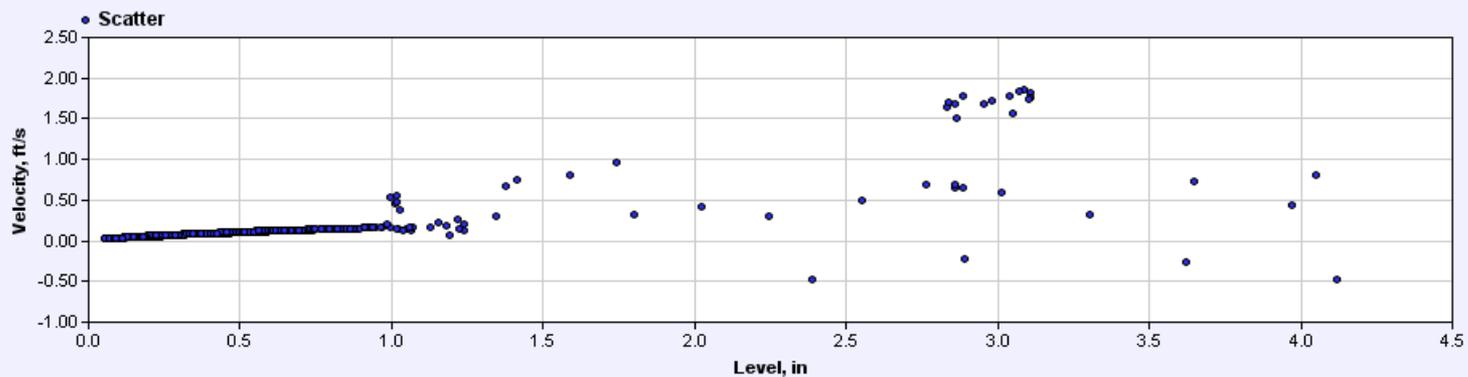
Monitoring Location 01

MI-MMO1-R1 From Apr 13 15:30, 2012 to May 07 08:25, 2012 (Duration 23 Days; 17 Hours; 55 Minutes)
