Stantec

Gary D. Silcott, Jr, PE presents:

Micromonitoring:
A Cost Effective
Approach for
Locating I&I in
Sanitary Sewers

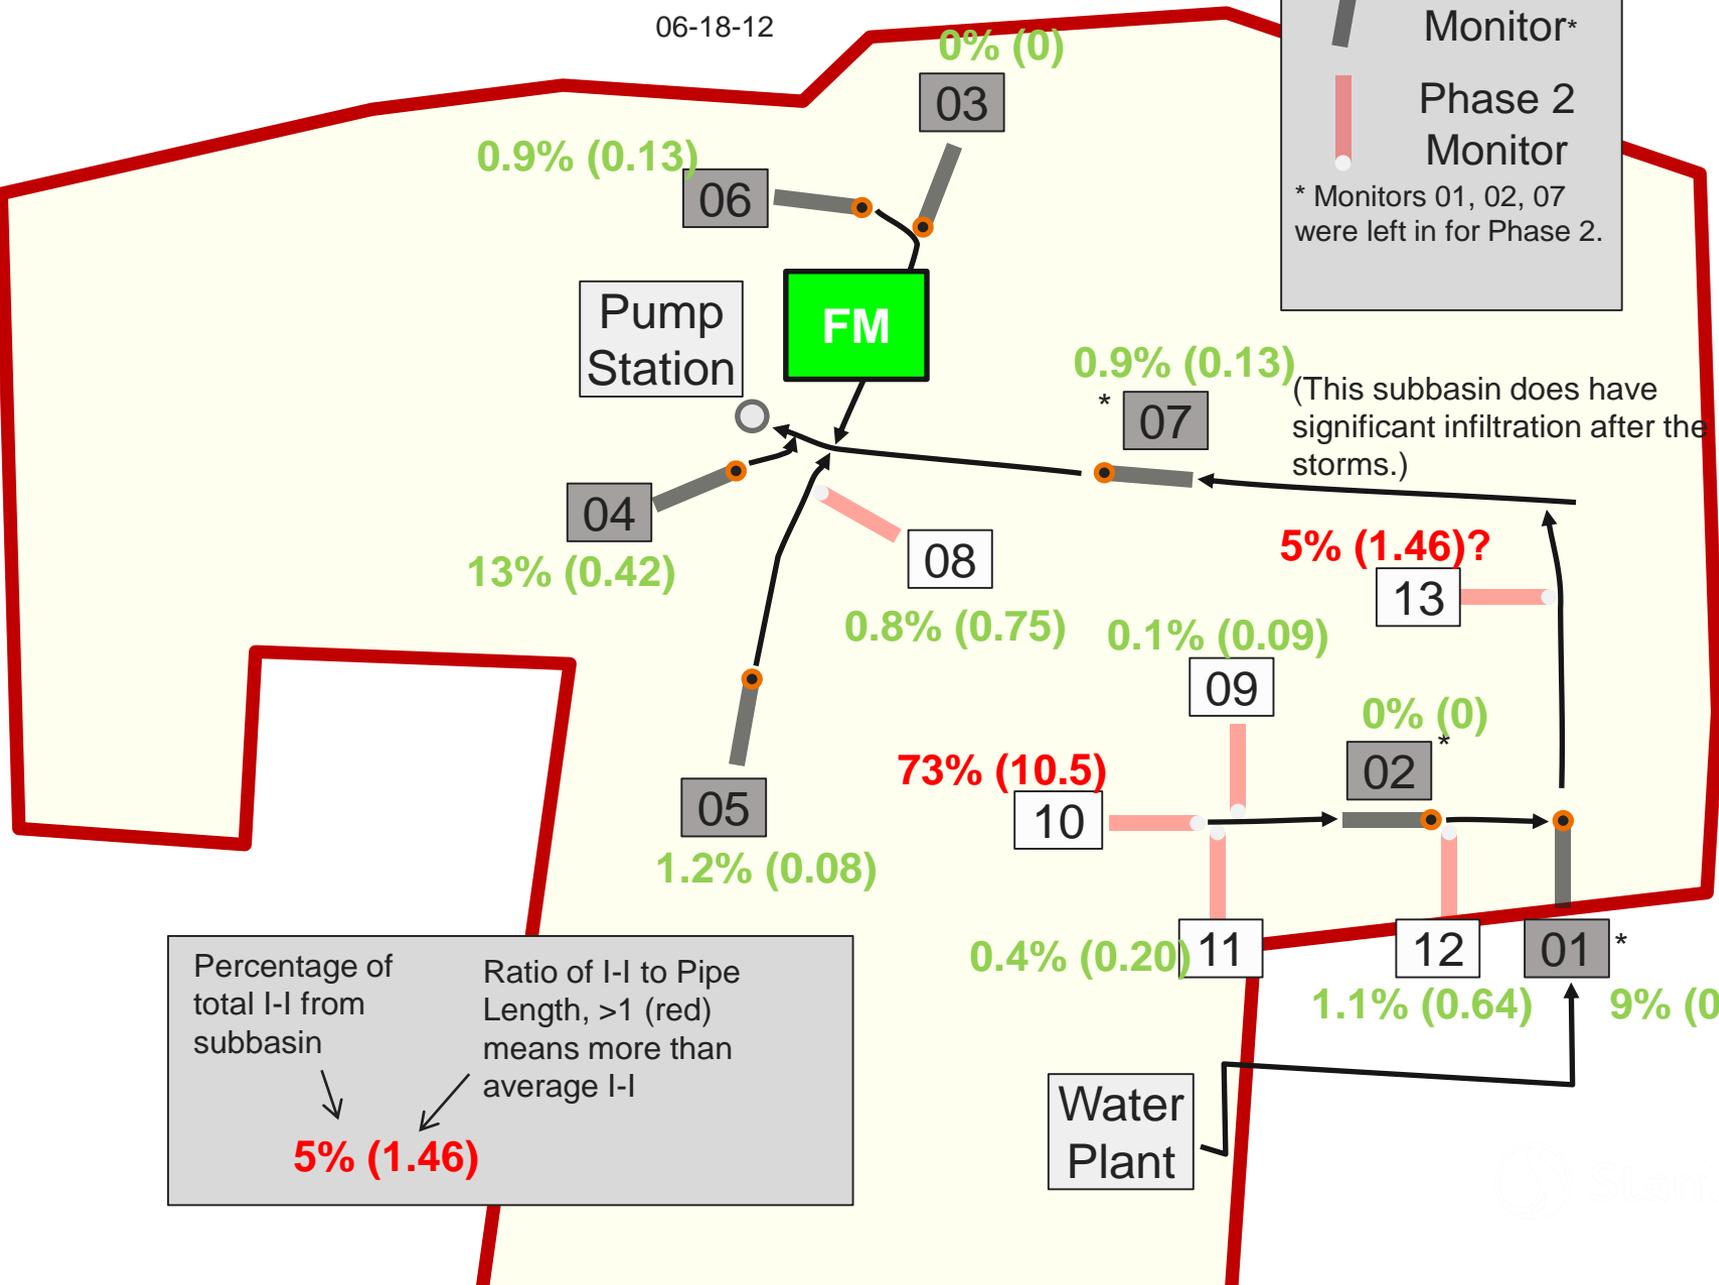
Milford Center Schematic

(This subbasin does have significant infiltration after the storms.)

Percentage of total I-I from subbasin
 Ratio of I-I to Pipe Length, >1 (red) means more than average I-I
5% (1.46)

- Isolated Inflow sources to three sewer pipes in alley between South Mill St. and Pleasant St.
- Isolated infiltration sources to three sewer pipes along the creek
- In all, the sources were isolated to 1,900' of sewer out of the ~30,000' that make up the Village's system

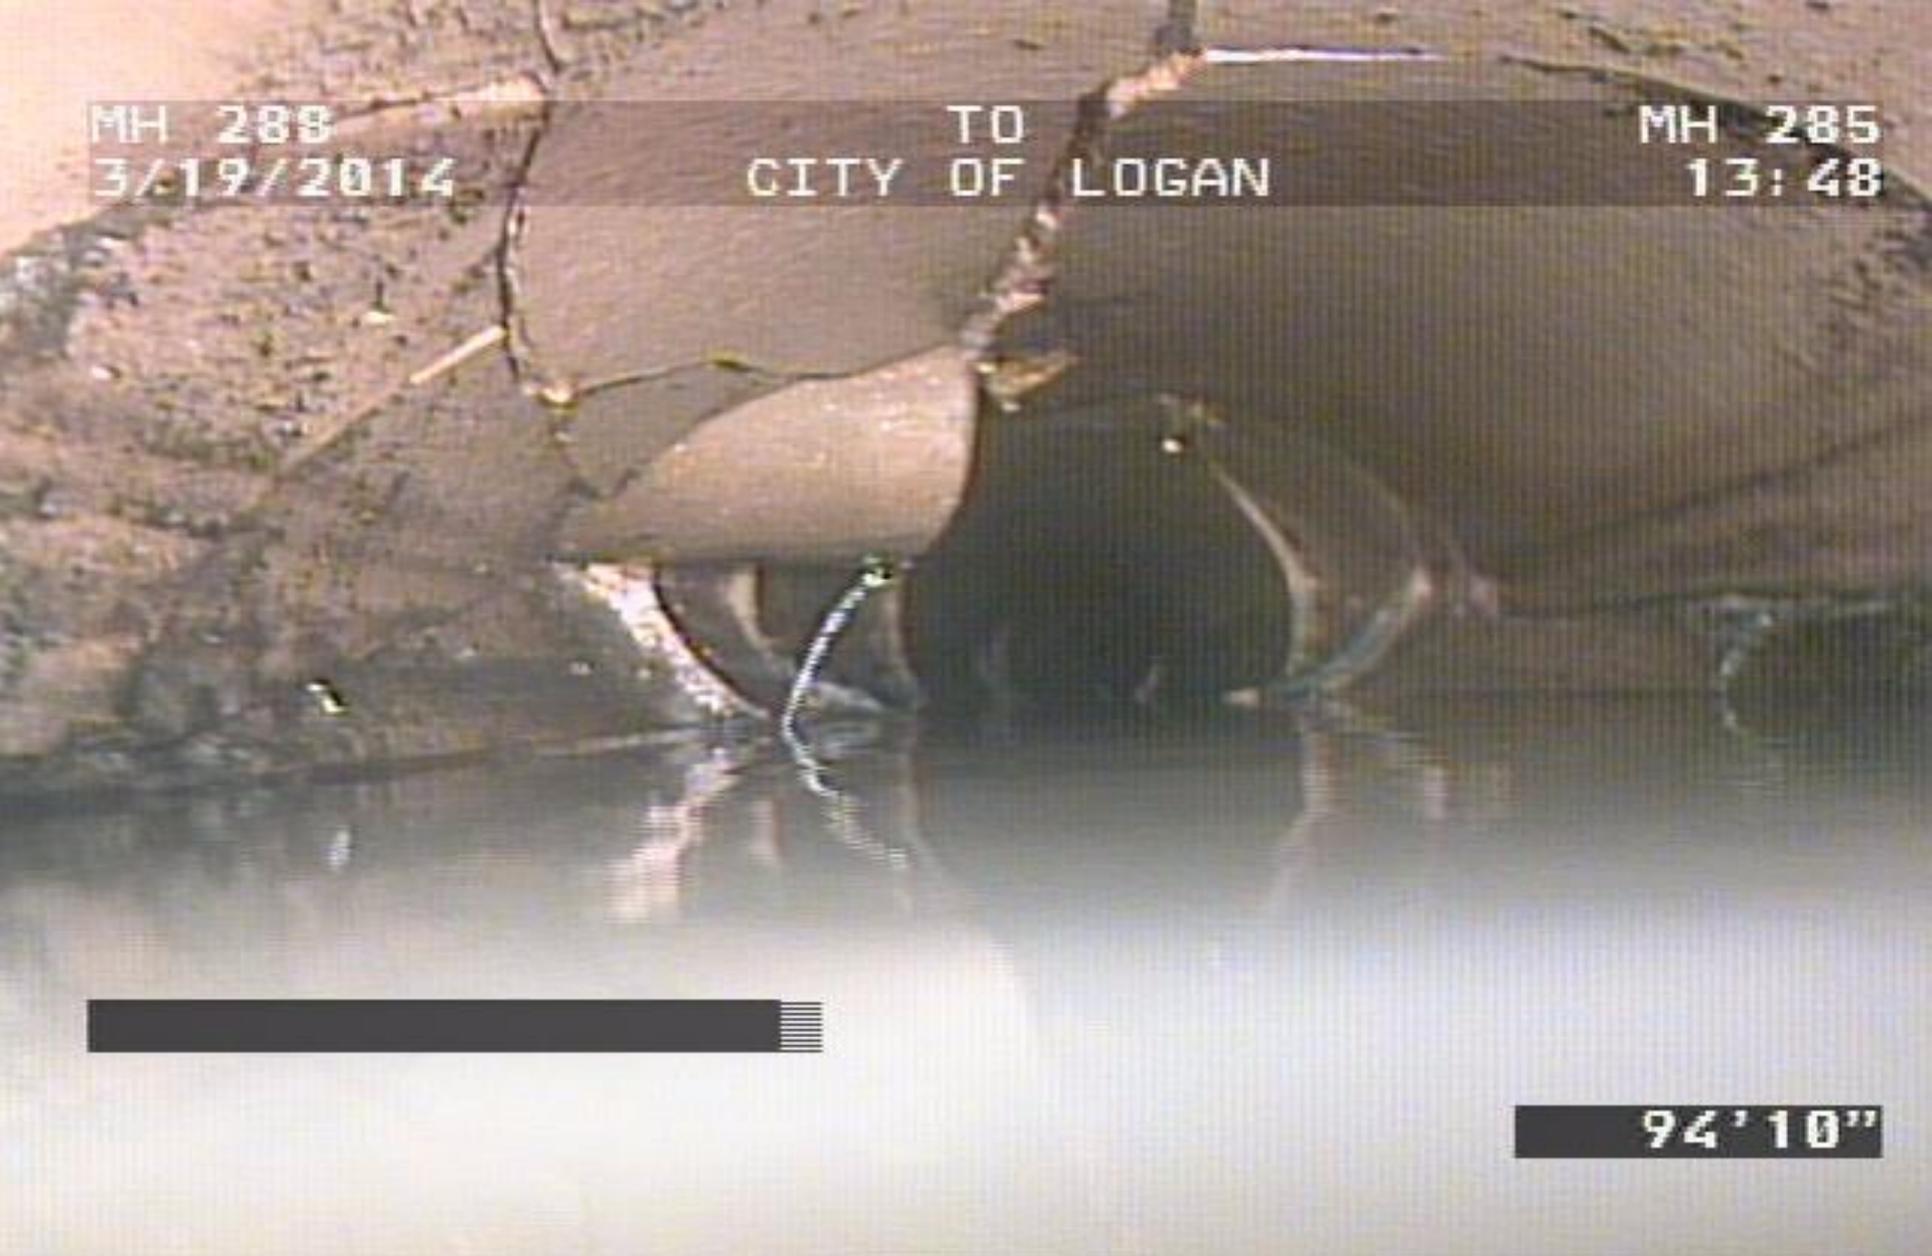
Fractured Pipe &
Hammer Tap

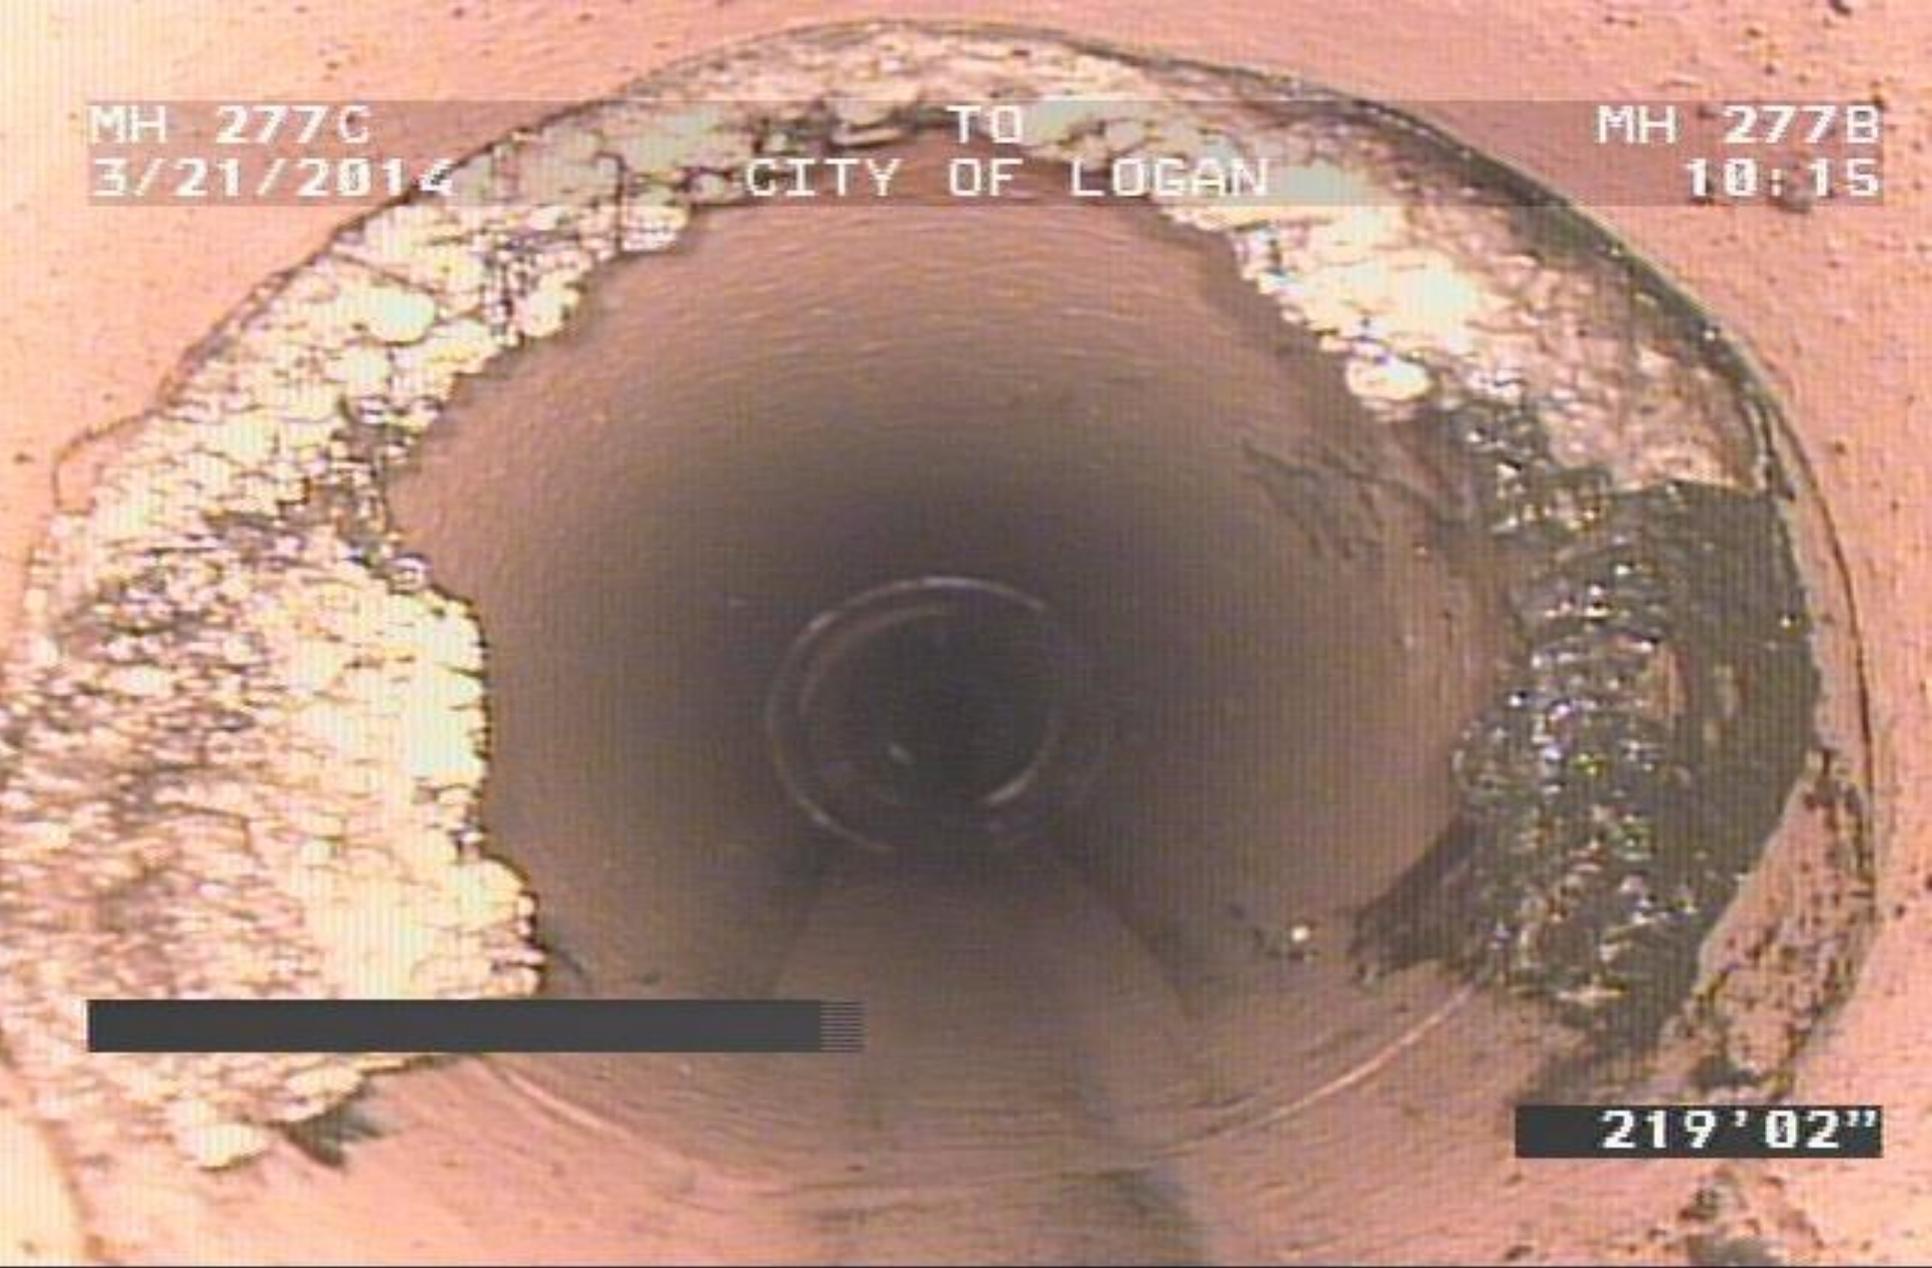
Deposits w/ Infiltration

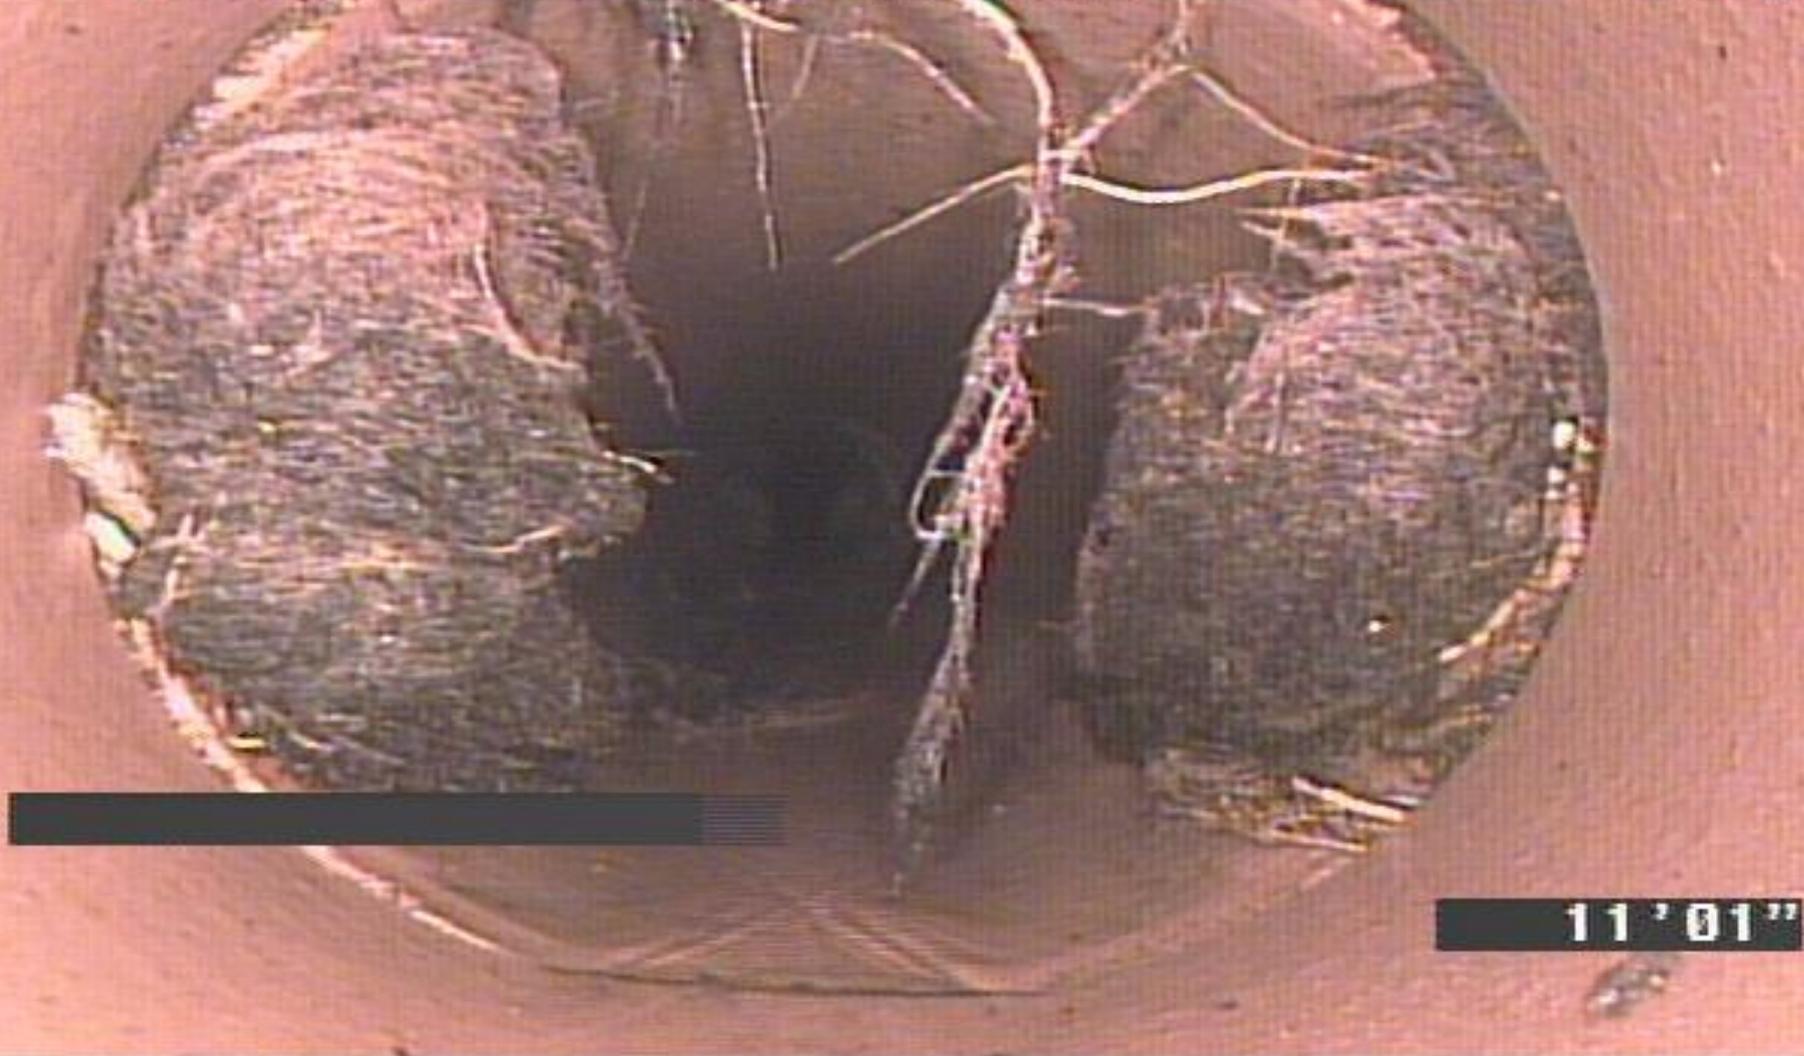
Root Intrusion

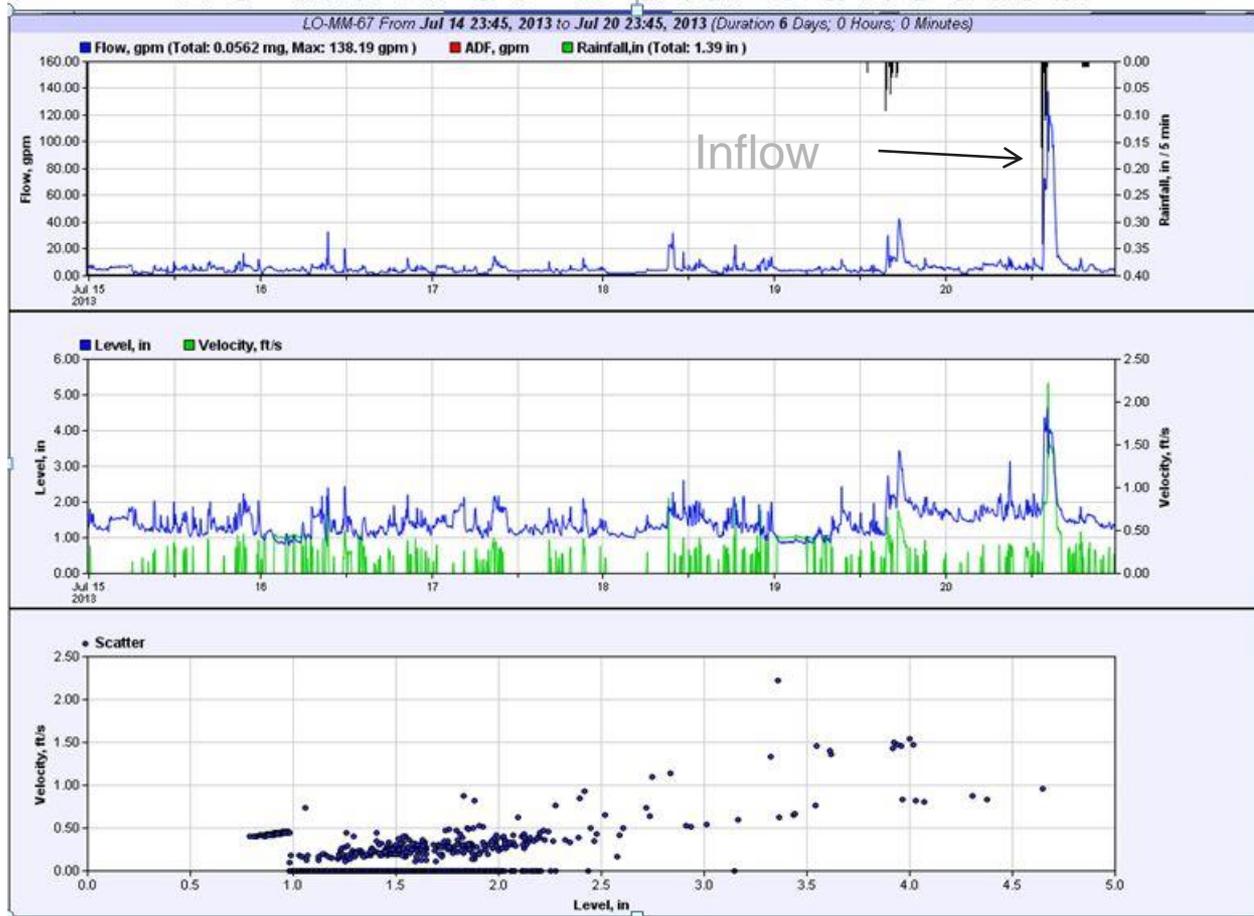
LO MM 67 Data Collected

Inflow vs. Infiltration

Micromonitoring data analysis can be used to direct specific focused SSES work

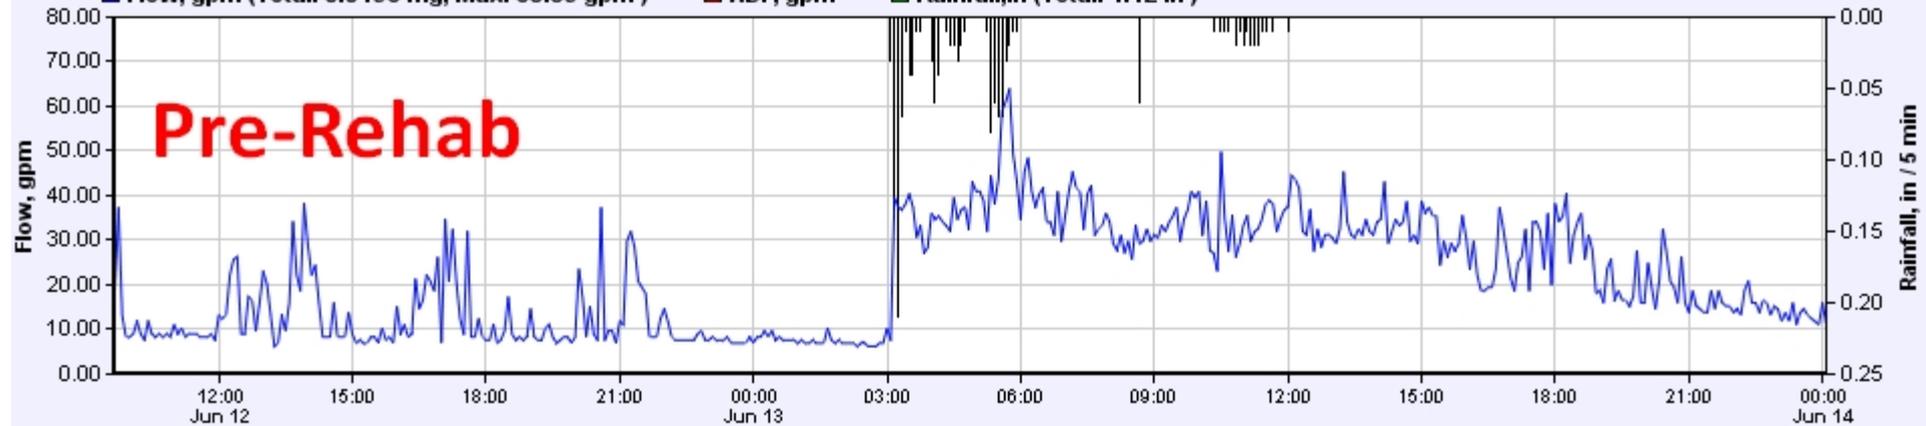
LO-MM-30 From Jun 12 09:40, 2013 to Jun 14 00:05, 2013 (Duration 1 Days; 15 Hours; 25 Minutes)

Phase I Rehab Results

■ Flow, gpm (Total: 0.0496 mg, Max: 63.89 gpm) ■ ADF, gpm ■ Rainfall, in (Total: 1.42 in)

- Additional rehabilitation projects are currently being developed from the second round of CCTV work completed in March 2014
- The City secured grants and low interest loans to finance the projects
 - Phase 1 was funded through the Ohio Public Works Commission. The Phase I improvements resulted in a 95% reduction in I&I in the project area.

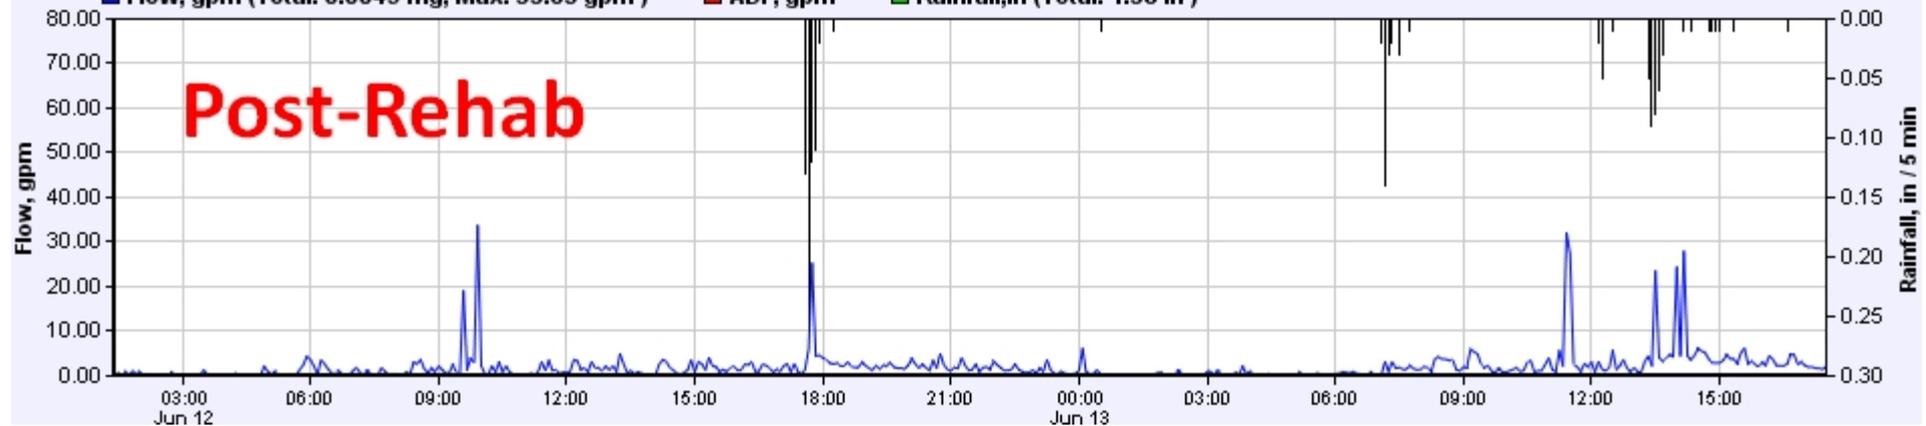
LO-MM-GLENWOOD From Jun 12 01:25, 2015 to Jun 13 17:30, 2015 (Duration 1 Days; 16 Hours; 5 Minutes)

■ Flow, gpm (Total: 0.0049 mg, Max: 33.65 gpm) ■ ADF, gpm ■ Rainfall, in (Total: 1.38 in)
