AEROSTRIP® AERATION SYSTEM

Bremerton, WA Testing of 11-Year Old Diffusers

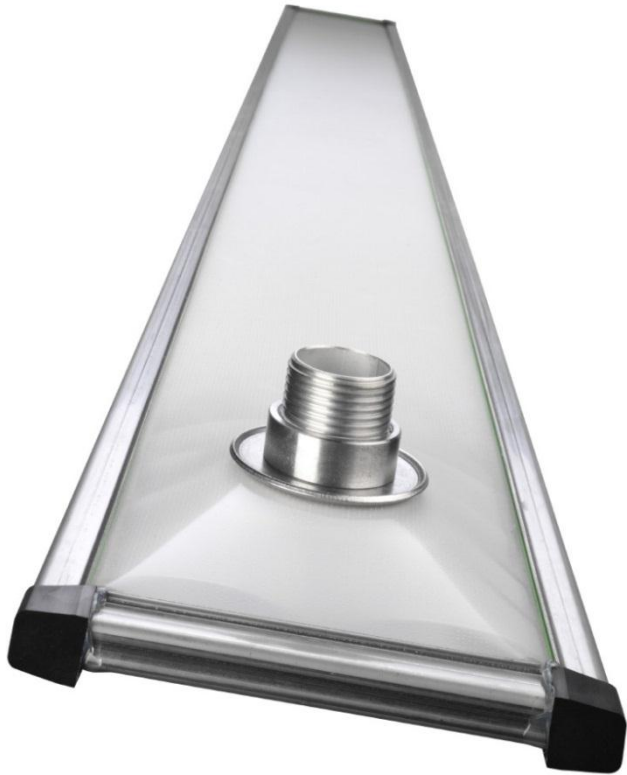
7-in wide x 8 - 13 ft long (TYP)

316 SS Base: "T" Type

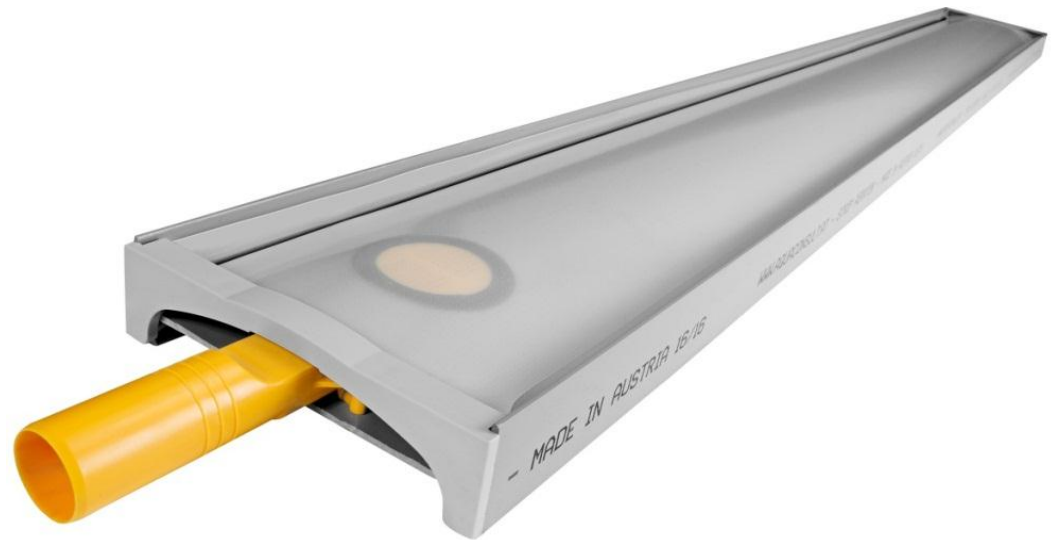
PVC Base: "Q" Type

(Identical Performance)

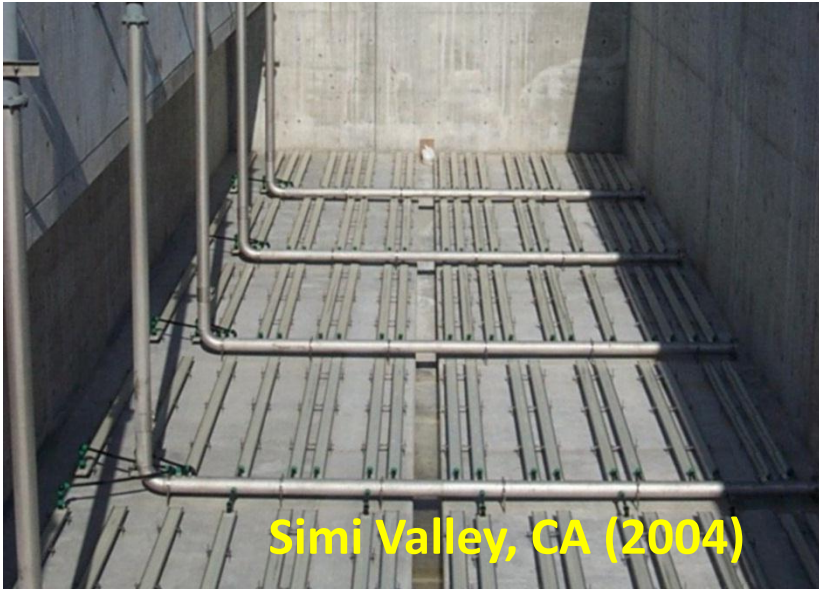
Simi Valley, CA (2004)

SS Laterals

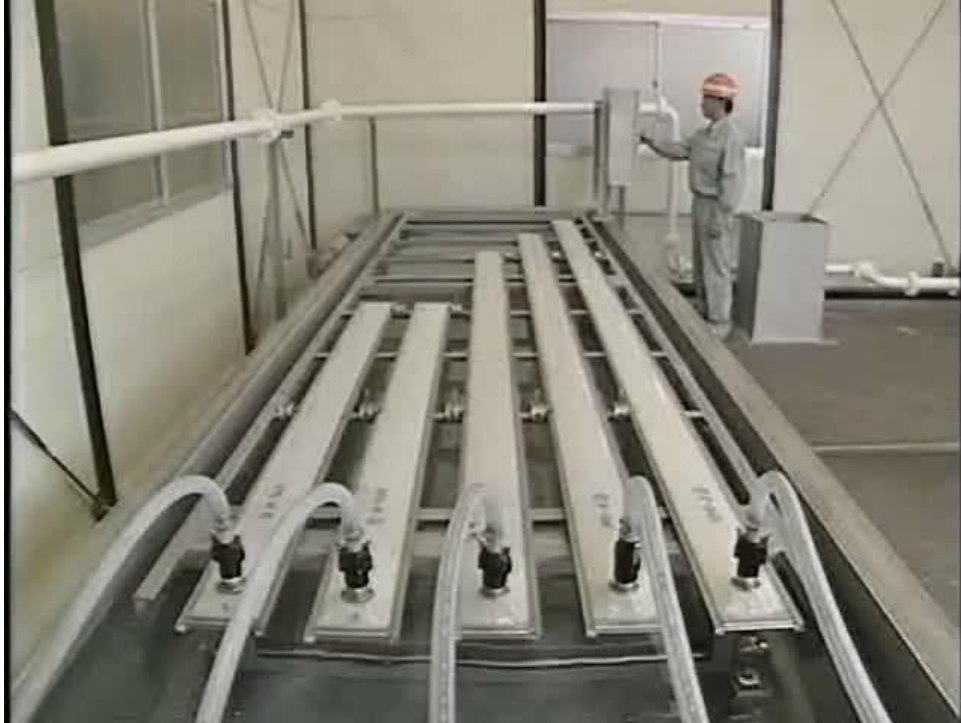
AEROSTRIP® Perforation

- Leak testing for every diffuser
- Ensures even airflow distribution
- Allows low and high air flux rates

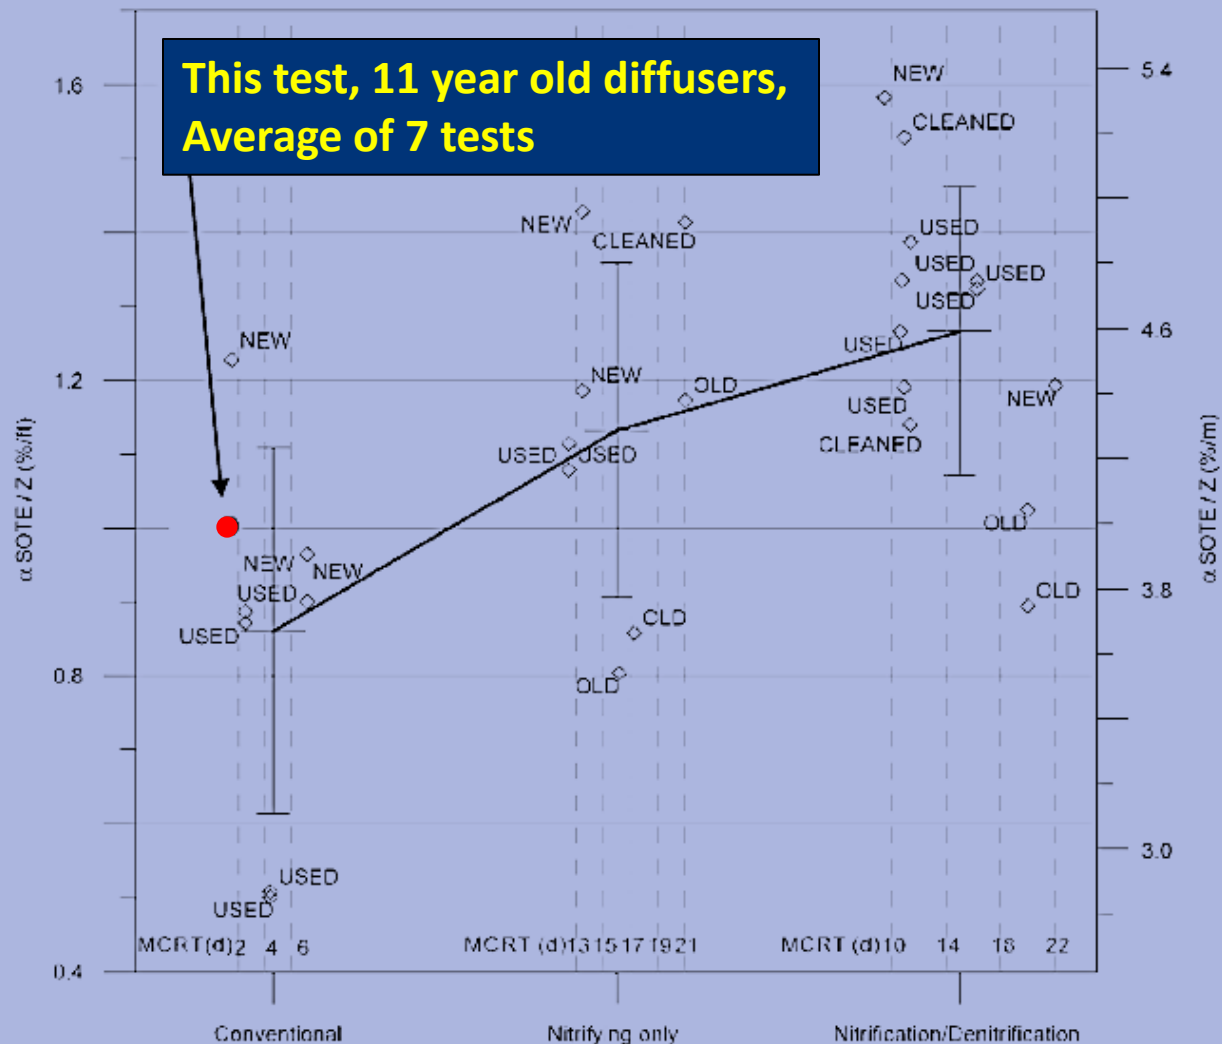
Figure 1. Comparison of this tests to other off-gas tests

**This test, 11 year old diffusers,
Average of 7 tests**

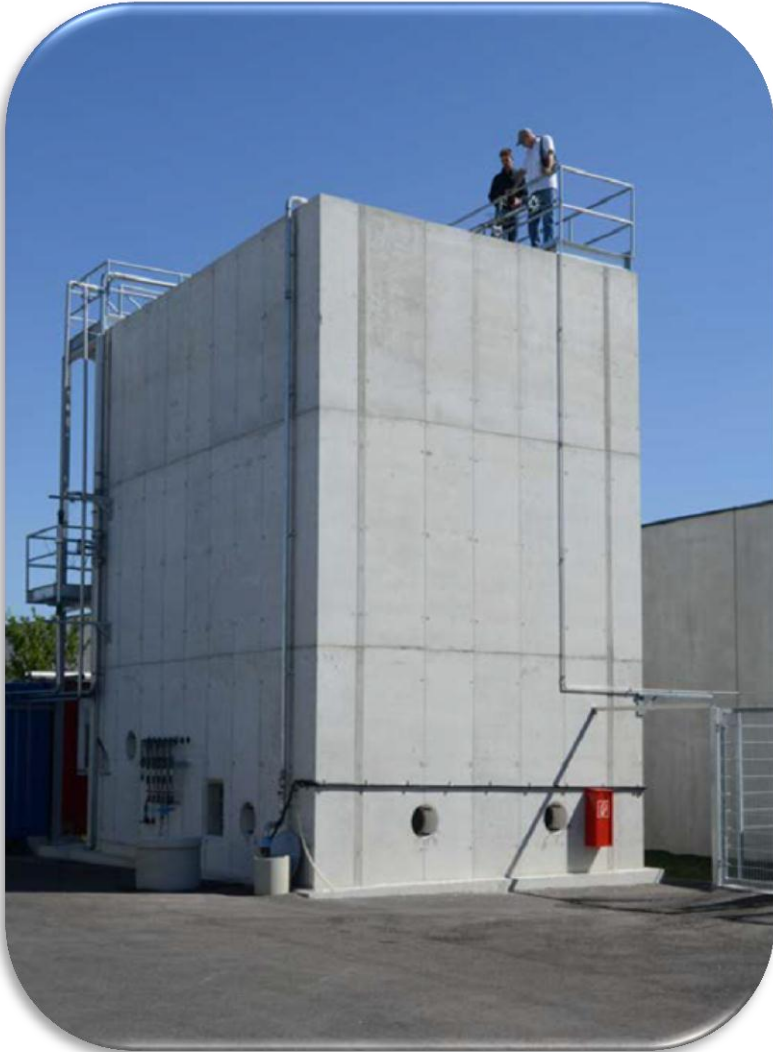
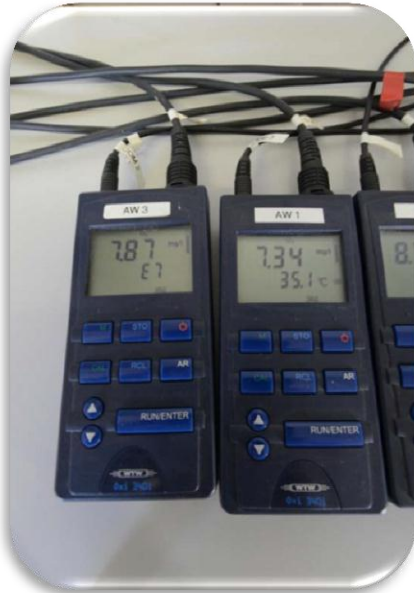
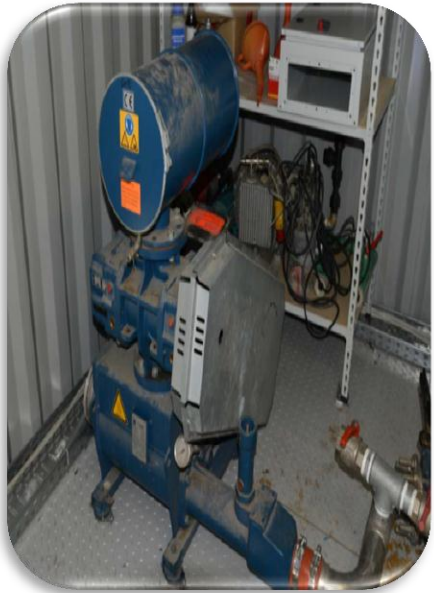
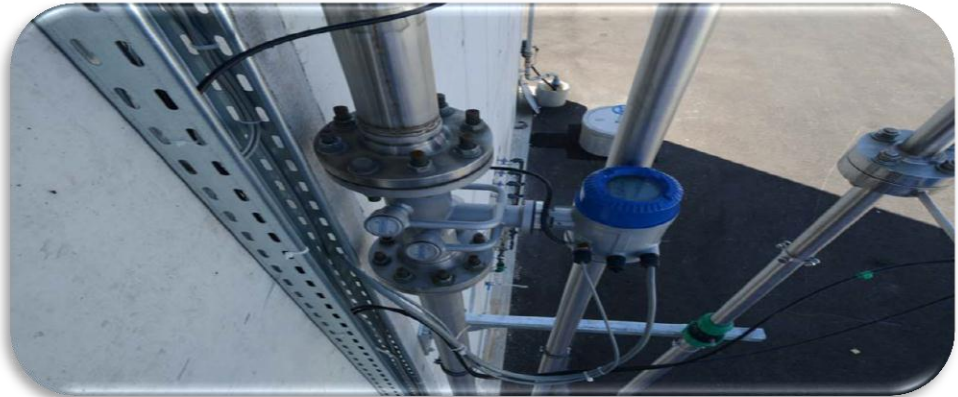
Bremerton, WA: Clean Water Test August 28-30, 2012 (Austria)

- SOTE of 11-Year Old Diffusers Was 2%/ft SWD (2.2%/ft after pressure washing)
- Diffusers are operating at ~90% of their original efficiency after 11 years and pressure washing
- Average α Factor of ~0.5 for this 1.5 day SRT System
- Operator reports only 5 out of 280 have failed in 11 years
- Subsequent Material Testing currently being performed
