*Moloka'i Irrigation Cooperative*  
*P.O. Box 506 ~ Anahola, HI 96703*

Final Report to the Hawai'i Community Foundation – Wai Maoli Freshwater Initiative

**LEAK DETECTION & METER UPGRADE  
TO HELP FARMERS IN MOLOA'A CONSERVE WATER**

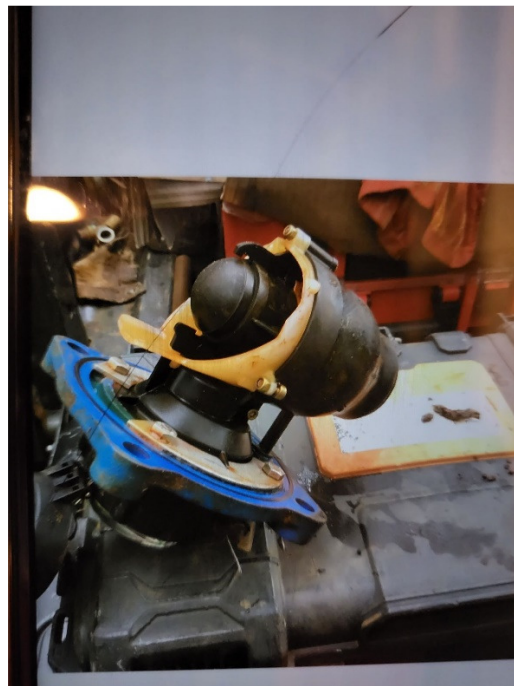
Debris in Turbine for Whitlock Meter was causing meter not to report.

Moloa'a Organica'a – Ned and Marta Whitlock own a 28.5-acre diversified farm. When EyeonWater reported leaks on a number of occasions, MIC operators were able to pinpoint the line with the pipe locator where the two-inch lateral had several leaks. Previously, the AML pipe locator came in handy when the Whitlock meter stopped recording due to debris in the turbine. Locating the pipes in the area of the meter, the operators were able to excavate without damaging any pipes in the area of the meter and backflow preventer.

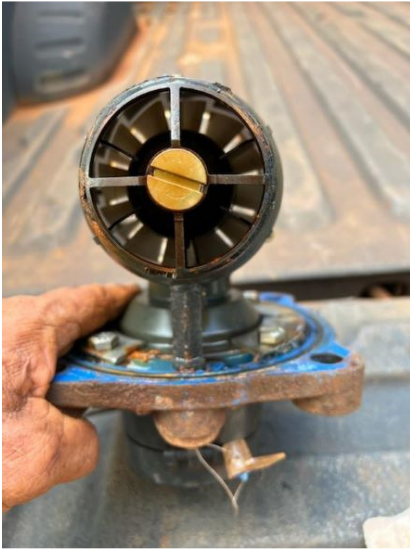
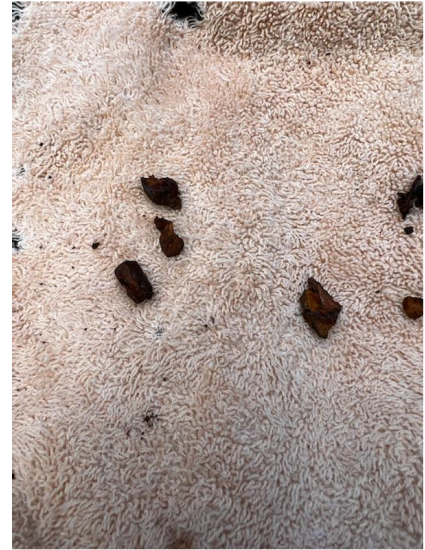
Hole in the Mountain Farm – Early in August 2022, it was discovered that the 2” meter on this property had stopped recording. The EyeonWater reported no water usage for this 20 acre pineapple farm. Using the AML pipe locator, the lines leading to and from the meter were located to prevent damage during excavation to remove the meter. The meter was disassembled, and it was found that debris inside had prevented the turbine from spinning.

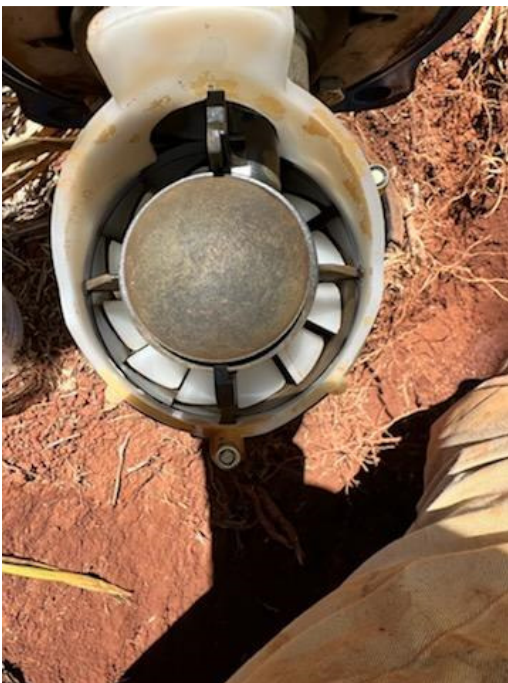
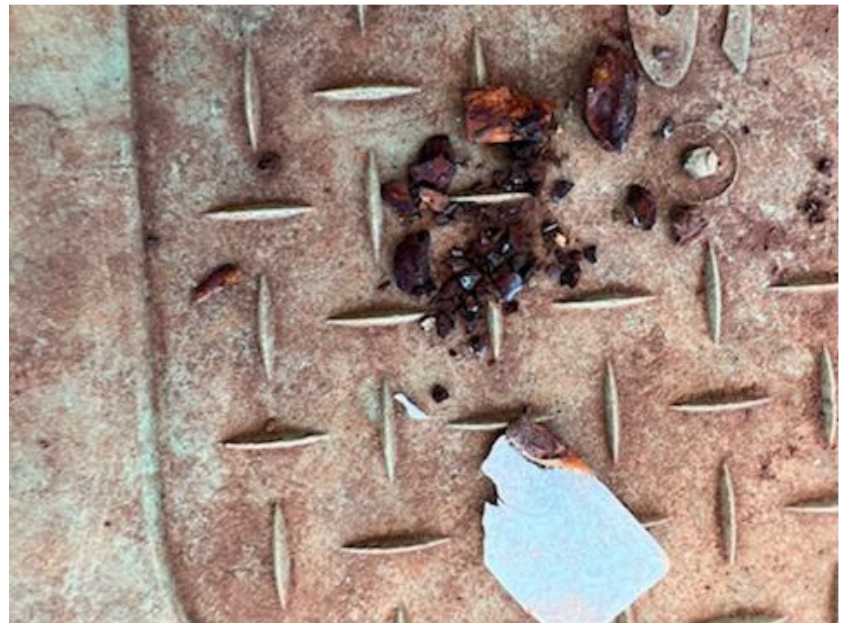
Viva Rains Farms also had a similar issue the same week as Hole in the Mountain Farm with debris that prevented the turbine from recording the water flowing through it. This was discovered after MIC operator Paul Huber used the AML pipe locator to identify the pipe routes so the area could be excavated to remove the meter and clear the debris.

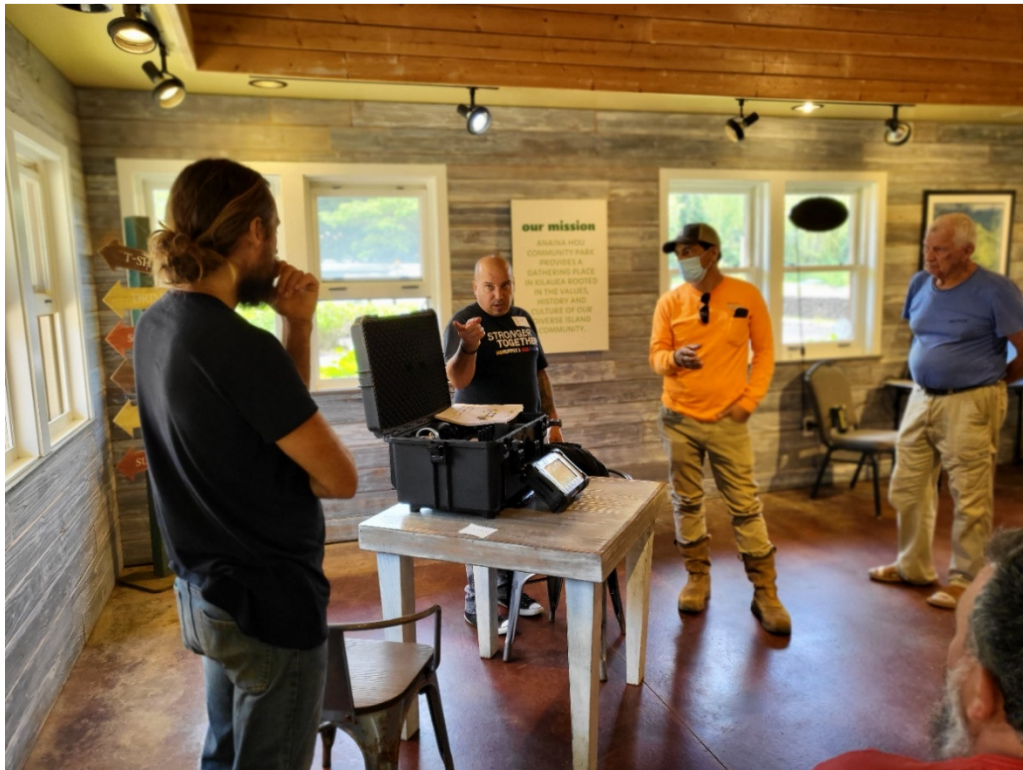
Scott Renslow, USA Bluebook, explains operation of the Quattro 5000 Correlator

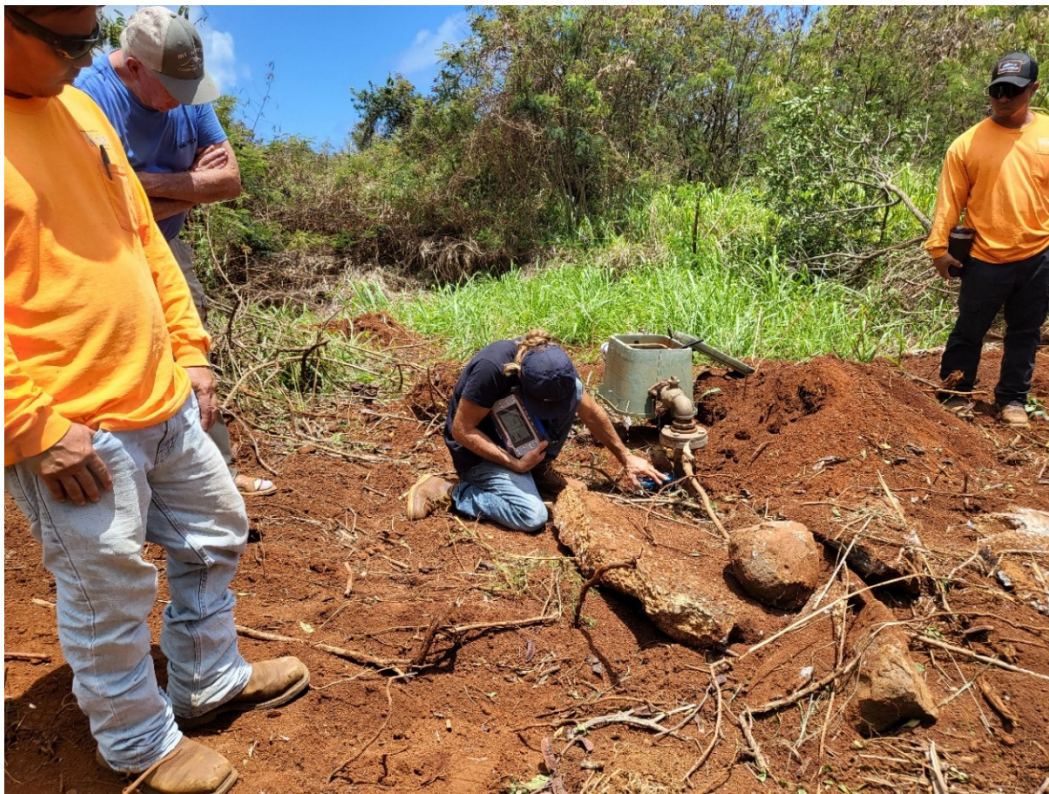
Placing the sensors on the steel pipes

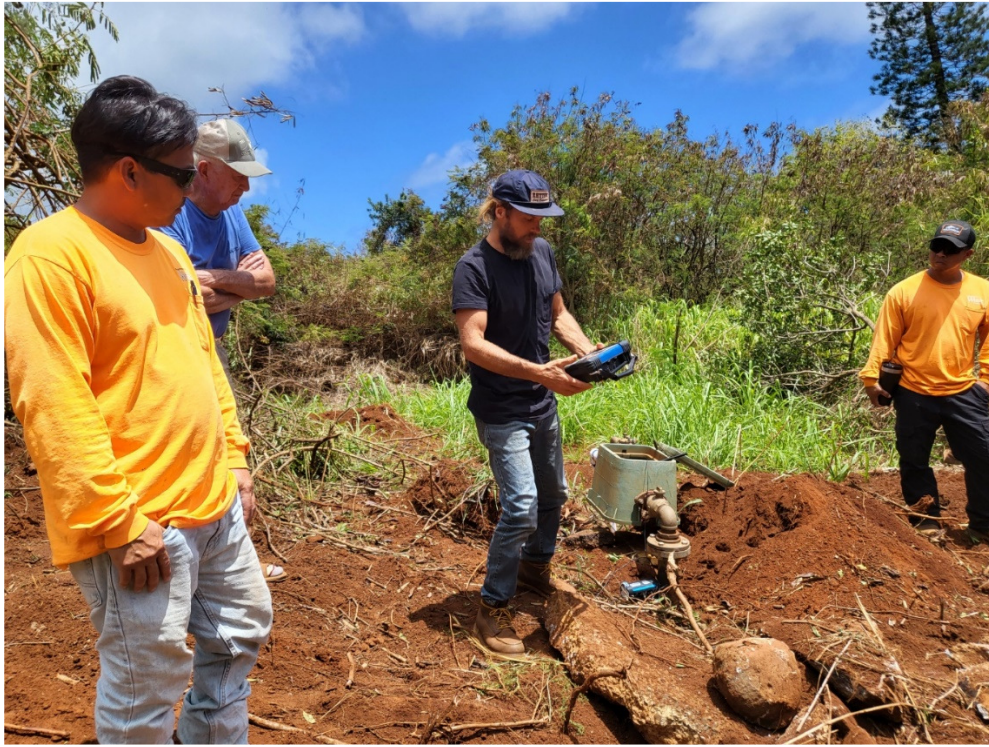
Adam Neaves, MIC DSO, takes first reading

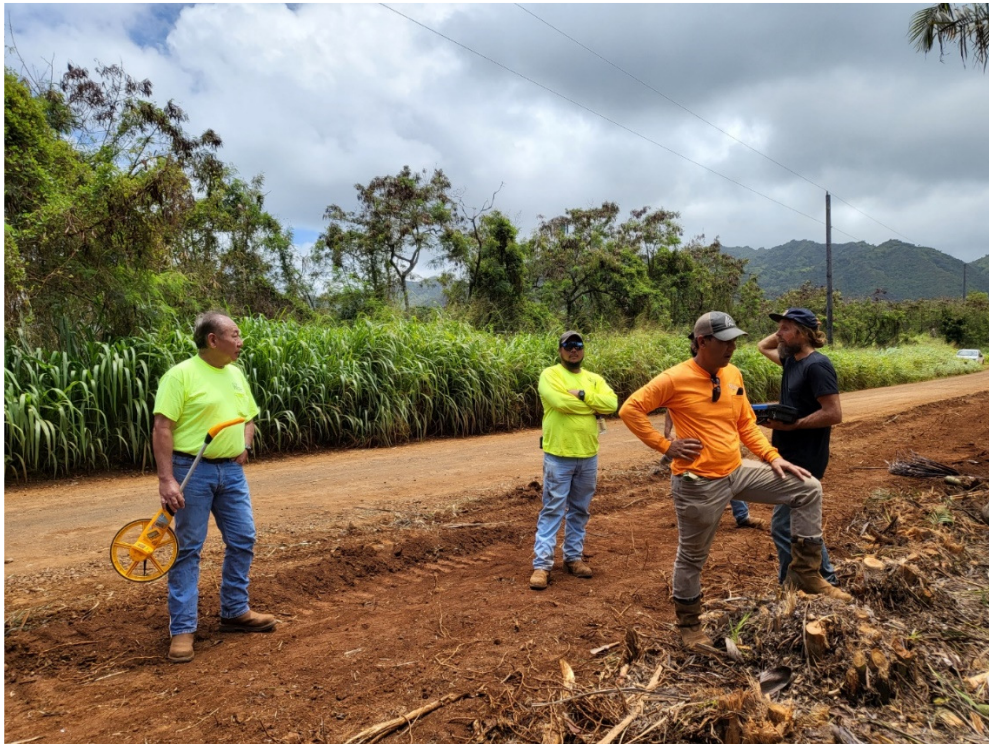
KDOW crew helping with measurements/pipe location
