2023 Point-Intercept Survey Results

Hooker Lake

Hooker Lake Management District

Lake and Pond Solutions, LLC

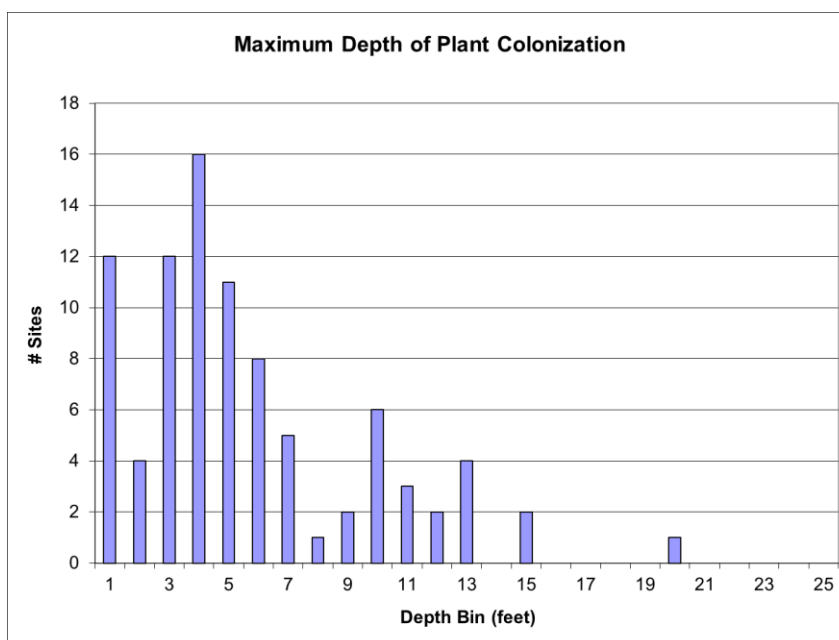
Table 4: Hooker Lake 2023 Depth of Plant Colonization

Depth of plant colonization was recorded (Table 4). The deepest sampled plant was in 20.0 feet of water. The clear majority however was in the three to six-foot depth range, accounting for more than 52% of the vegetated sample sites.
