# 2024 Point-Intercept Survey Results

Hooker Lake

Hooker Lake Management District

Lake and Pond Solutions, LLC

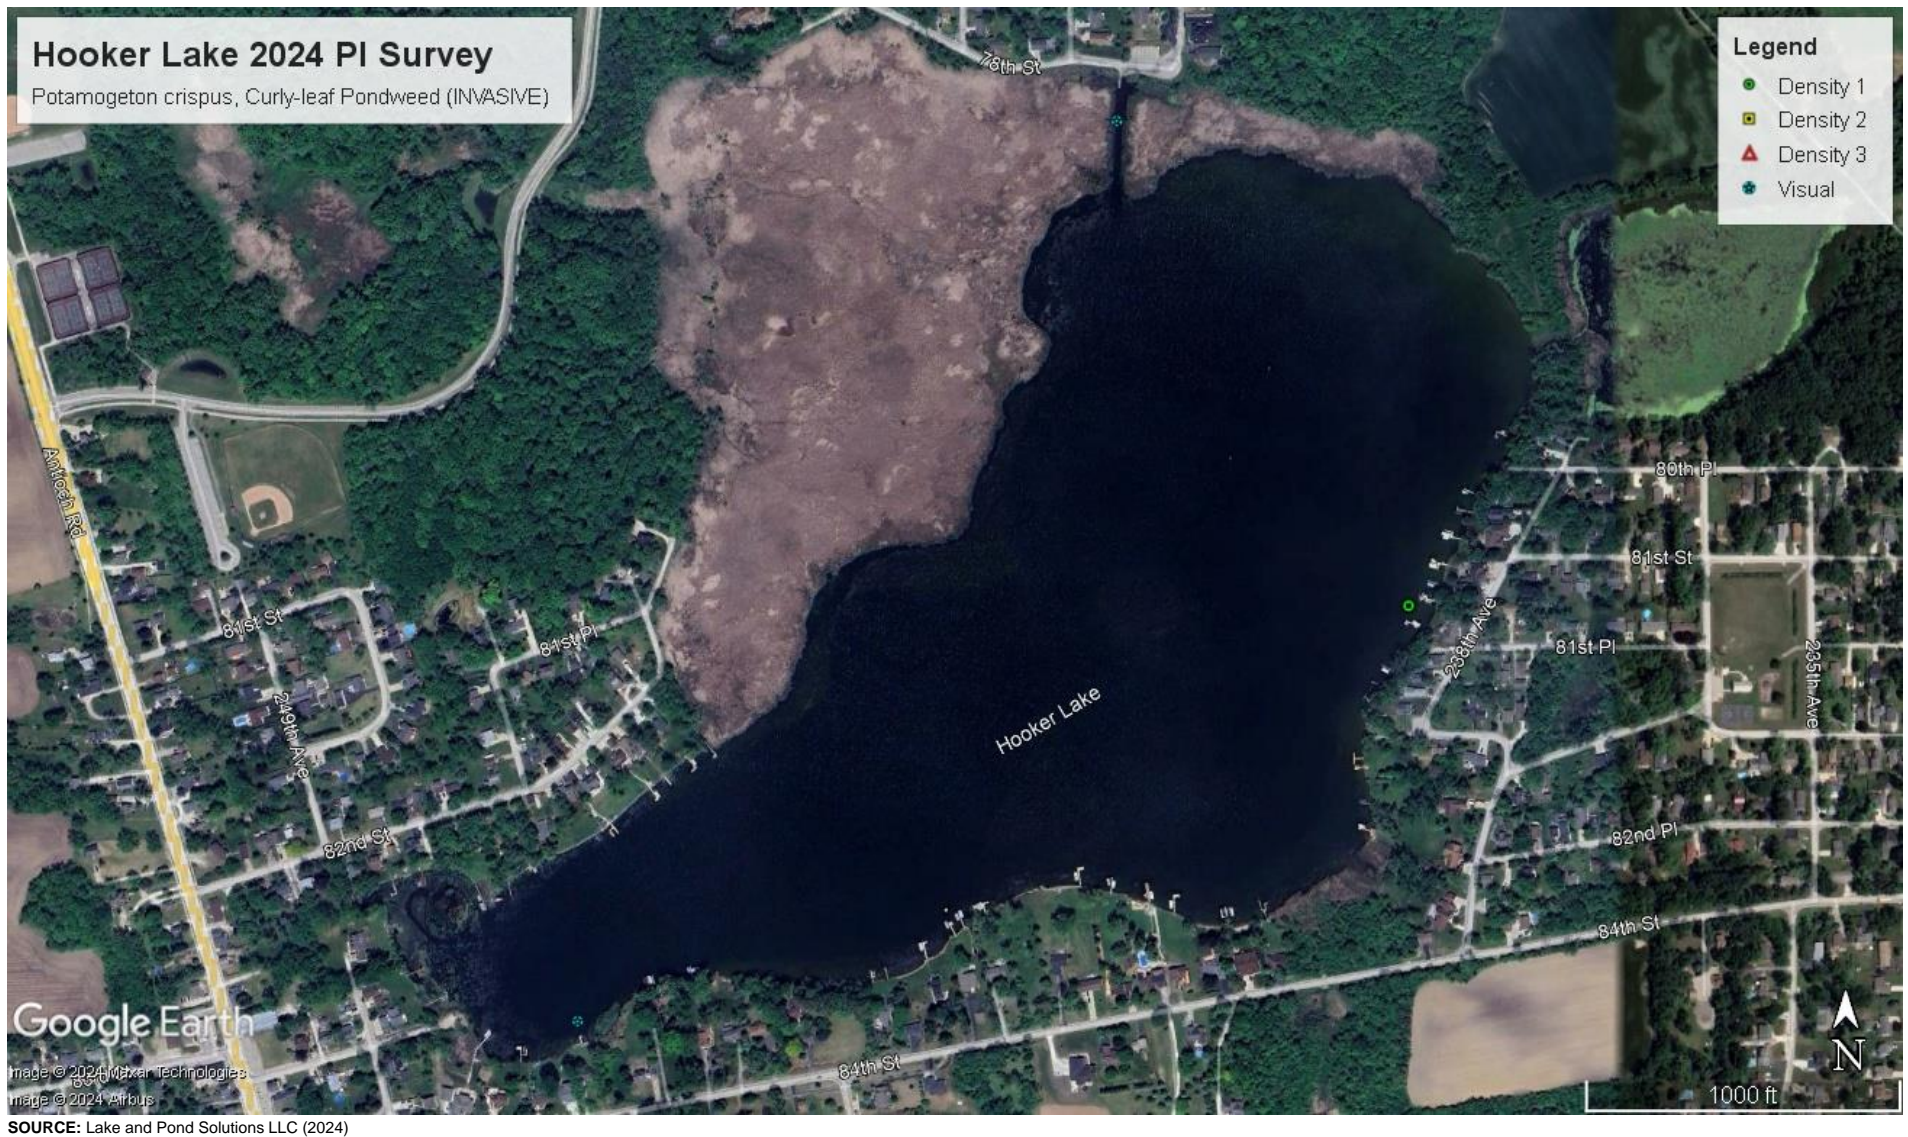
Figure 9: Hooker Lake Curly-leaf Pondweed (INVASIVE) Distribution

While it was not found in the 2023 PI survey due to a whole lake fluoridone treatment in 2022, Eurasian water-milfoil (EWM) had popped back up this year during the Spring meander survey leading to a small treatment using ProcettaCOR EC. Our recent PI Survey did not reveal any locations of EWM although it was found at four locations during an informal inspection of the lake last week. CLP was only found at one site during the PI Survey. It should be noted that late summer is not the ideal time for recording CLP as it dies back in July.
