Appendix D

HYDROLOGY AND DRAINAGE

# Hooker Lake Drainage Meeting MEETING MINUTES DECEMBER 12, 2008

# LAKE OUTLET DAM

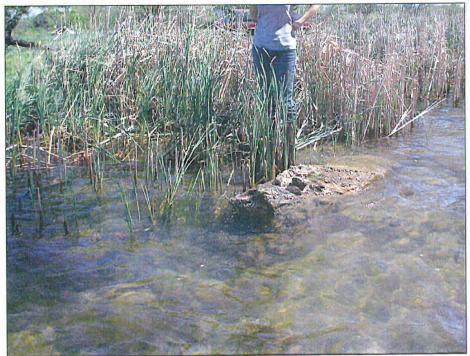
Photo #9 – Hooker Lake Dam (deteriorated left abutment) (May 20, 2009)

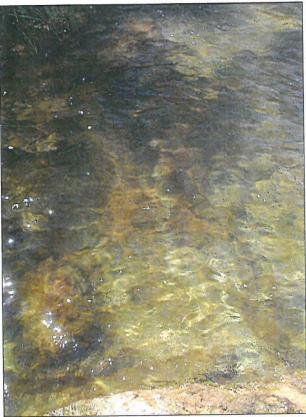
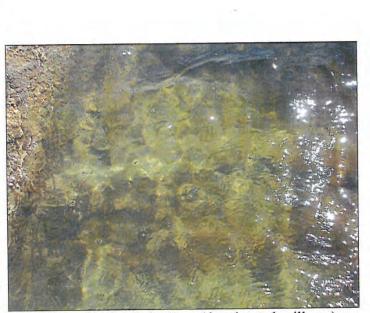
Photo #10 – Hooker Lake Dam (deteriorated spillway) Photo #11 – Hooker Lake Dam (deteriorated spillway) (May 20, 2009)

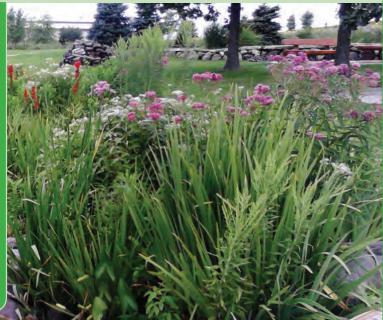
...template planting plans with corresponding lists of native plants suited to the given function of the plan. The 350 ft<sup>2</sup> area should be planted adjacent to the lake and include a contiguous area, rather than be planted in patches. Functions are based on the goals for the site. For example, one property owner may want to increase bird and butterfly habitat while another would like to fix an area with bare soil. Native planting functions include the following: lakeshore, bird/butterfly habitat, woodland, low-growing, deer resistant, and bare soil area plantings.

LAKE HEALTH BENEFITS	Improve wildlife habitat Slow water runoff Promote natural beauty
COSTS	<u>Range</u> - \$480-\$2400 for 350 ft <sup>2</sup> area, installed <u>Average</u> - \$1000 per 350 ft <sup>2</sup> , installed
TECHNICAL	Healthy Lakes Fact Sheet Series: 350 ft <sup>2</sup> Native Plantings
REQUIREMENTS	350 ft <sup>2</sup> Native Plantings Best Practices Manual
REGULATORY	DNR: an aquatic plant chemical control permit may be necessary if using herbicides in or adjacent to the lakeshore.
INFORMATION	Native plantings must comply with the local shoreland zoning ordinance. Consult with your county or municipal zoning staff.
HEALTHY LAKES	Maximum of \$1000/350 ft <sup>2</sup> native plantings installed and implemented according to the technical requirements. Only one 350 ft <sup>2</sup> native planting per property per year is eligible for funding.
	The native plantings dimension must be 350 ft <sup>2</sup> of contiguous area at least 10 feet wide and installed along the lakeshore. Final shape and orientation to the shore are flexible.

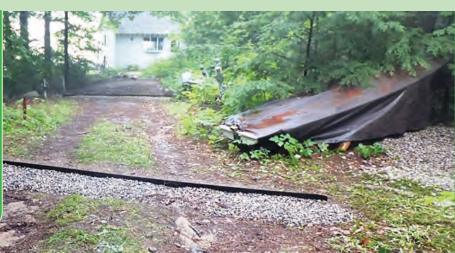
...includes a water bar, diverter, and broad-based dip. These practices use a berm or shallow trench to intercept runoff from a path or road and divert it into a dispersion area. Depending on the site, multiple diversion practices may be necessary.

LAKE HEALTH BENEFITS	Divert runoff water.
COSTS	<u>Range</u> - \$25-\$3750, installed <u>Average</u> - \$200, installed
TECHNICAL REQUIREMENTS	Healthy Lakes Fact Sheet Series: <i>Diversion Practice</i> http://tinyurl.com/healthylakes
REGULATORY INFORMATION	DNR: none. Diversion practices must comply with the local shoreland and floodplain zoning ordinance. Consult with your county or municipal zoning staff.
HEALTHY LAKES GRANT FUNDING	Maximum of \$1000/diversion practice installed and implemented according to the technical requirements. Healthy Lakes diversion practice grant funding is not intended for large, heavily developed parcels, sites with large volumes of runoff, or sites with complex problems that may require engineering design.

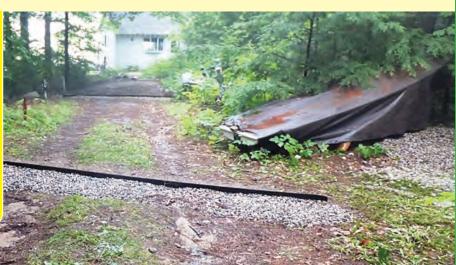
...includes a water bar, diverter, and broad-based dip. These practices use a berm or shallow trench to intercept runoff from a path or road and divert it into a dispersion area. Depending on the site, multiple diversion practices may be necessary.

17 - S. A.	
LAKE HEALTH BENEFITS	Divert runoff water.
COSTS	<u>Range</u> - \$25-\$3750, installed <u>Average</u> - \$200, installed
TECHNICAL REQUIREMENTS	Healthy Lakes Fact Sheet Series: <i>Diversion Practice</i> http://tinyurl.com/healthylakes
REGULATORY INFORMATION	DNR: none. Diversion practices must comply with the local shoreland and floodplain zoning ordinance. Consult with your county or municipal zoning staff.
HEALTHY LAKES GRANT FUNDING	Maximum of \$1000/diversion practice installed and implemented according to the technical requirements. Healthy Lakes diversion practice grant funding is not intended for large, heavily developed parcels, sites with large volumes of runoff, or sites with complex problems that may require engineering design.

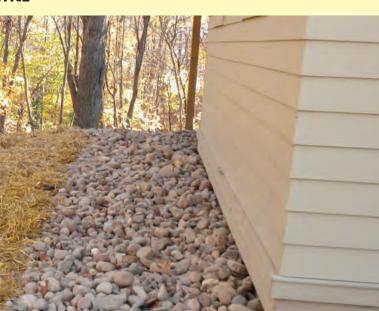
...ian excavated pit or trench filled with rock that reduces runoff by storing it underground to infiltrate. A catch basin and/or perforated pipe surrounded by gravel and lined with sturdy landscape fabric may be integrated into the design to capture, pre-treat, and redirect water to the pit or trench. Pit and trench size and holding capacity are a function of the area draining to it and the permeability of the underlying soil.

LAKE HEALTH	Divert runoff water.
BENEFITS	Clean runoff water.
COSTS	<u><b>Range</b></u> - \$510-\$9688 per rock infiltration practice, installed <u><b>Average</b> - \$3800 per rock infiltration practice, installed</u>
TECHNICAL	Healthy Lakes Fact Sheet Series: <i>Rock Infiltration Practice</i>
REQUIREMENTS	http://tinyurl.com/healthylakes
REGULATORY INFORMATION	DNR: none. Rock infiltration practices must comply with the local shoreland zoning ordinance. Consult with your county or municipal zoning staff.
HEALTHY LAKES	Maximum of \$1000/rock infiltration practice installed and implemented according to the technical requirements.
GRANT FUNDING	Healthy Lakes rock infiltration practice grant funding is not intended for heavily developed parcels, sites with large volumes of runoff, or sites with complex problems that may require engineering design.
