Atchison Village: Groundwater Flooding, Sea Level Rise (SLR), and Atmospheric River Conditions (ARCs)

March 12, 2023 presented to the Atchison Village Community at Atchison Village Hall, live and by Zoom

Atchison Village: Sea Level Rise (SLR), Groundwater Flooding, and Atmospheric River Conditions (ARCs)

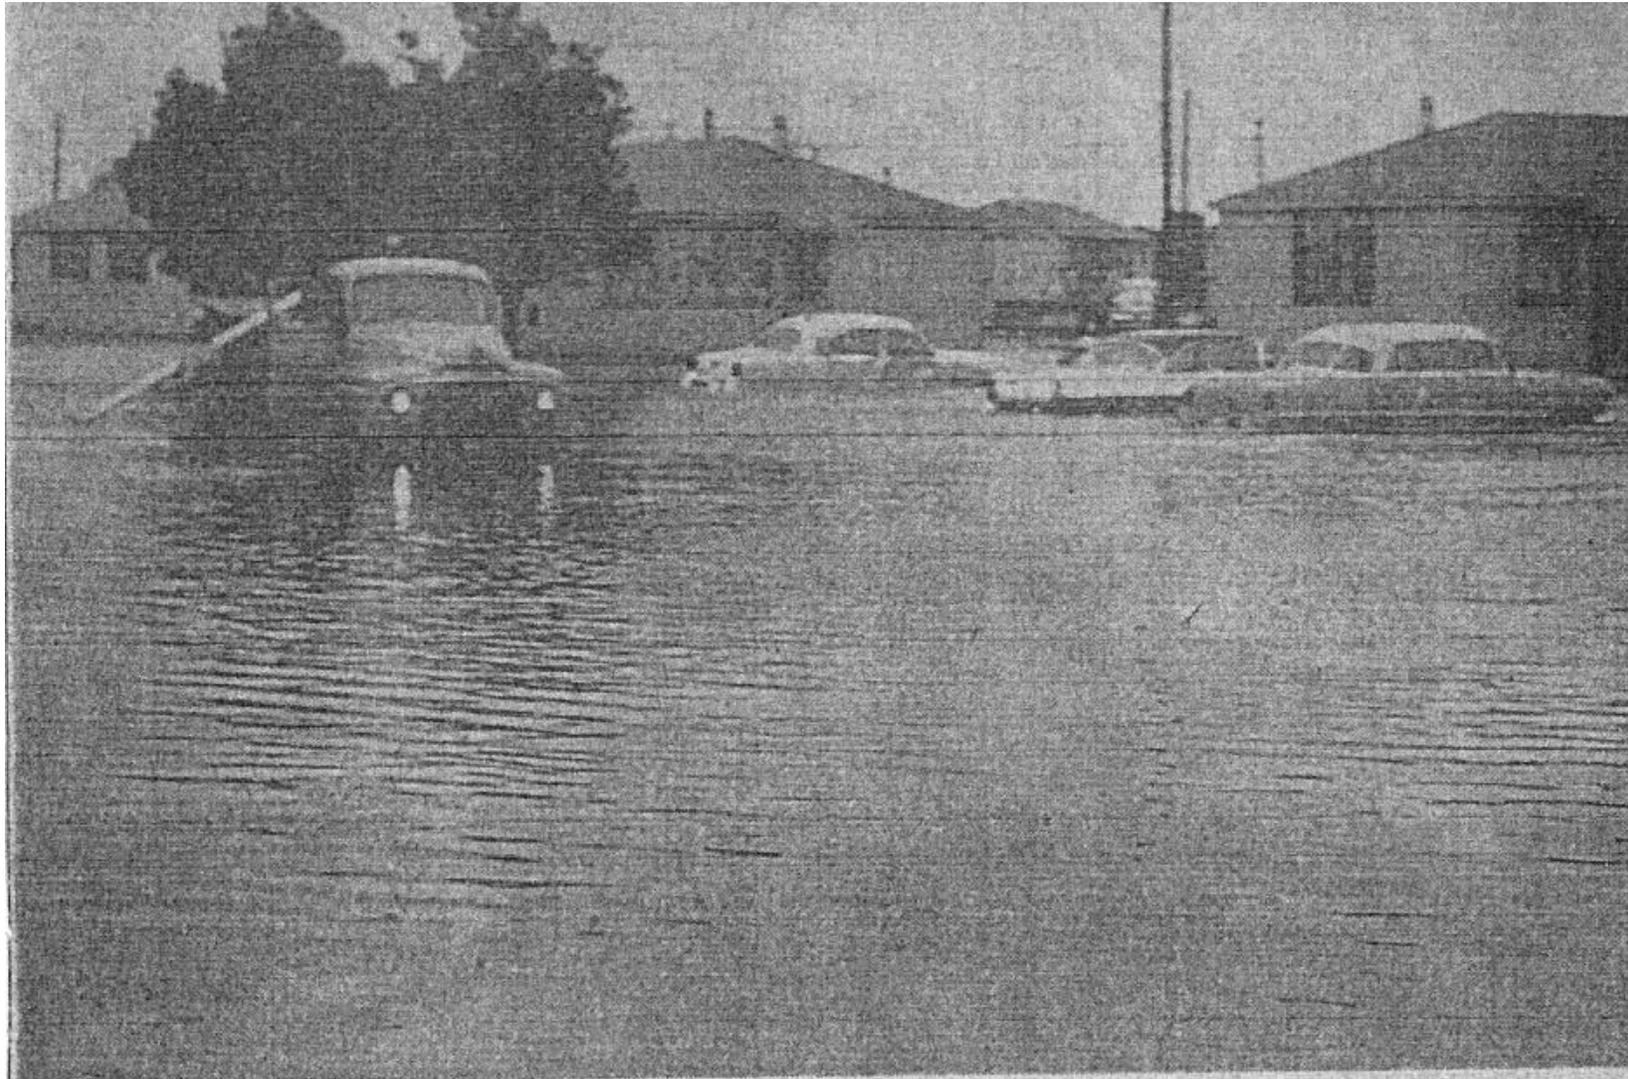
Richmond, CA (Atchison Village) – Lake Curry, Dec 1960

A CITY LAKE—This was Richmond after torrential rains, accompanied by lightning and gale force winds, pounded the city today. A typical scene as storm drains failed to cope with the downpour,

was this picture taken at Chanslor Ave. and Curry St., in Atchison Village, showing cars isolated by sudden flash flooding.

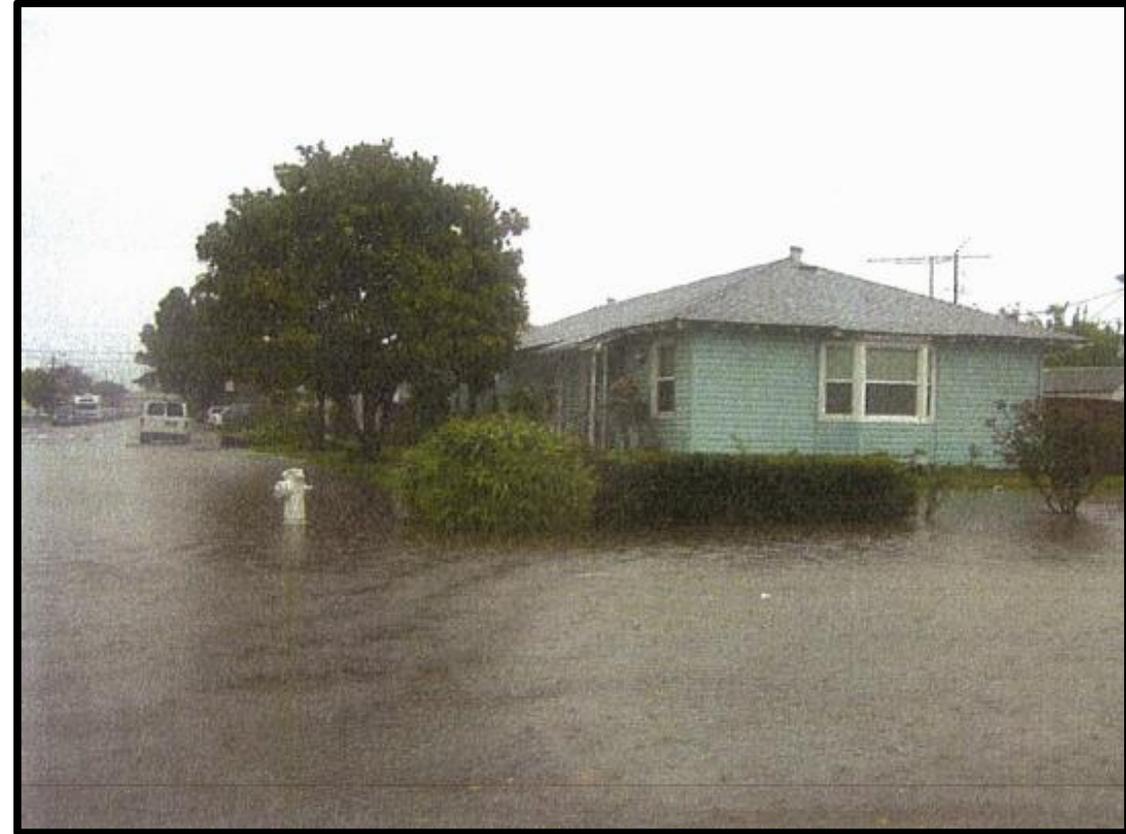
Historic flooding may be related to inoperable:

- Stormdrain systems
- Clogged drainage ditches and channels
- Tide gates blocked by sea water

Sidewalk flooding 1 week after rains

Solution: Operations and Maintenance

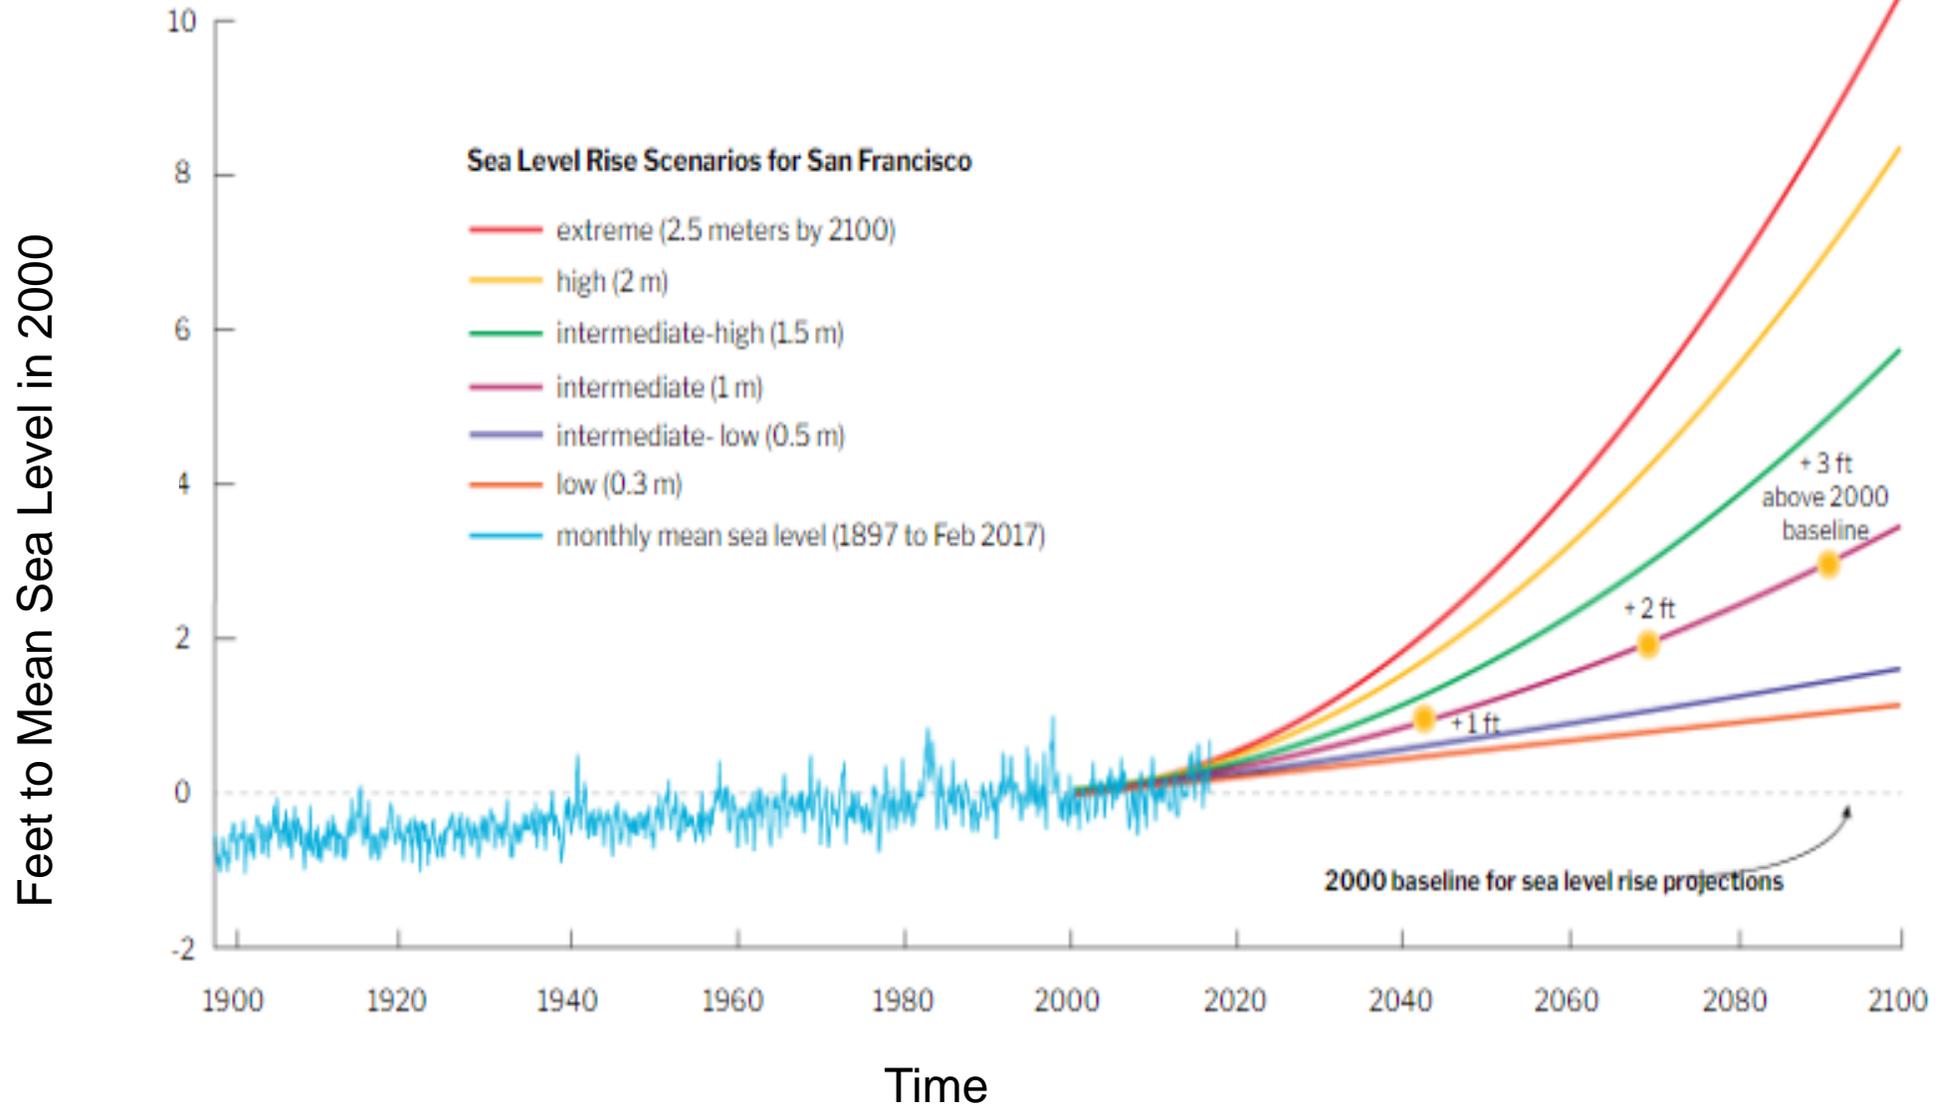
Rising Sea Level (in meters), San Francisco (NOAA data: San Francisco Area, NOAA, 2017)

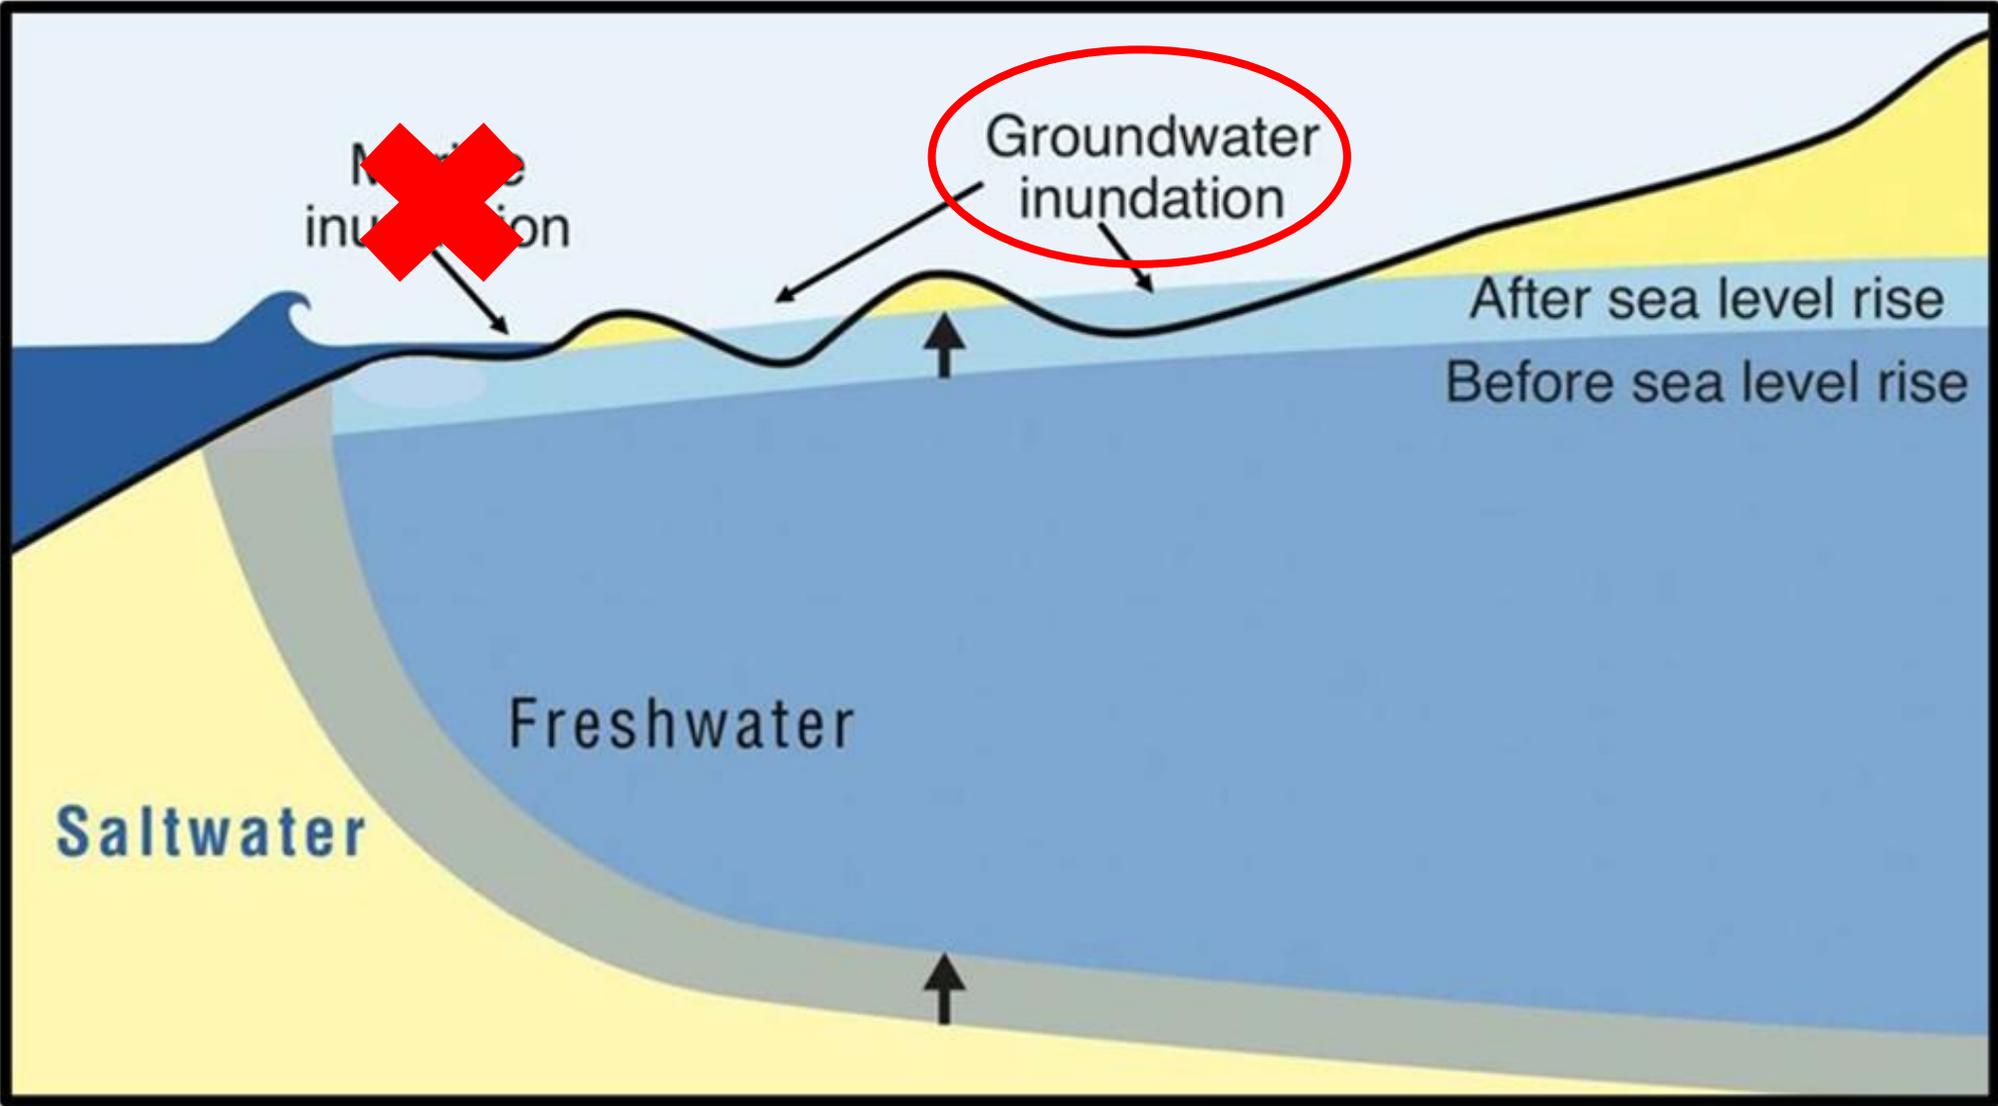
Sea Level Rise: Marine Overtopping or Groundwater Inundation (Emerging Groundwater)

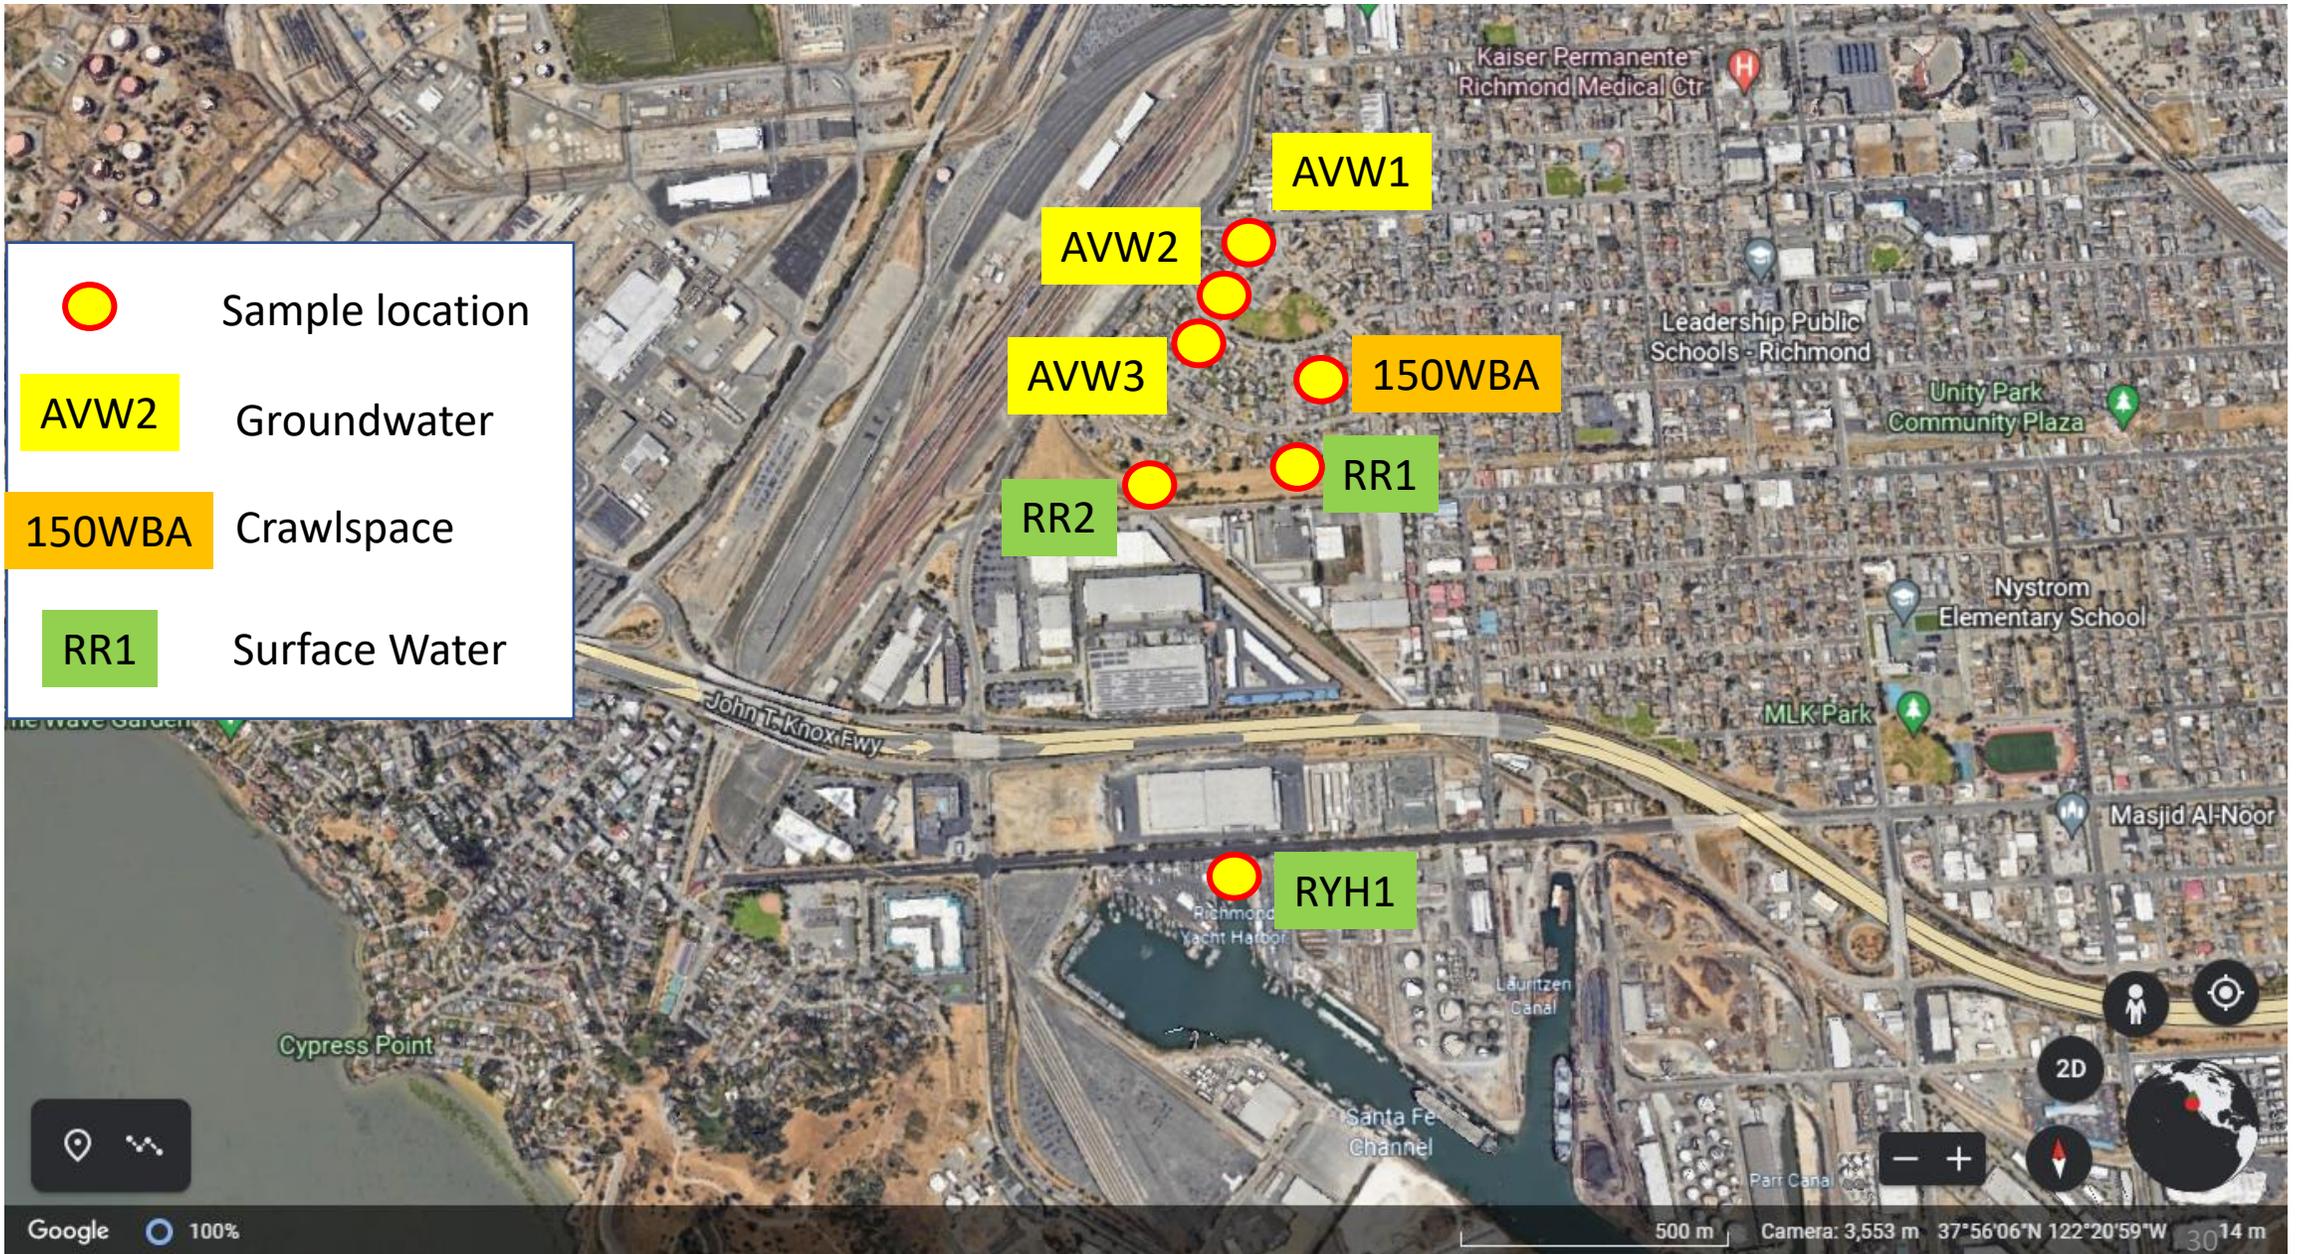
Atchison Village – 0.5 Miles from Santa Fe Channel; 12-15 feet above sea level

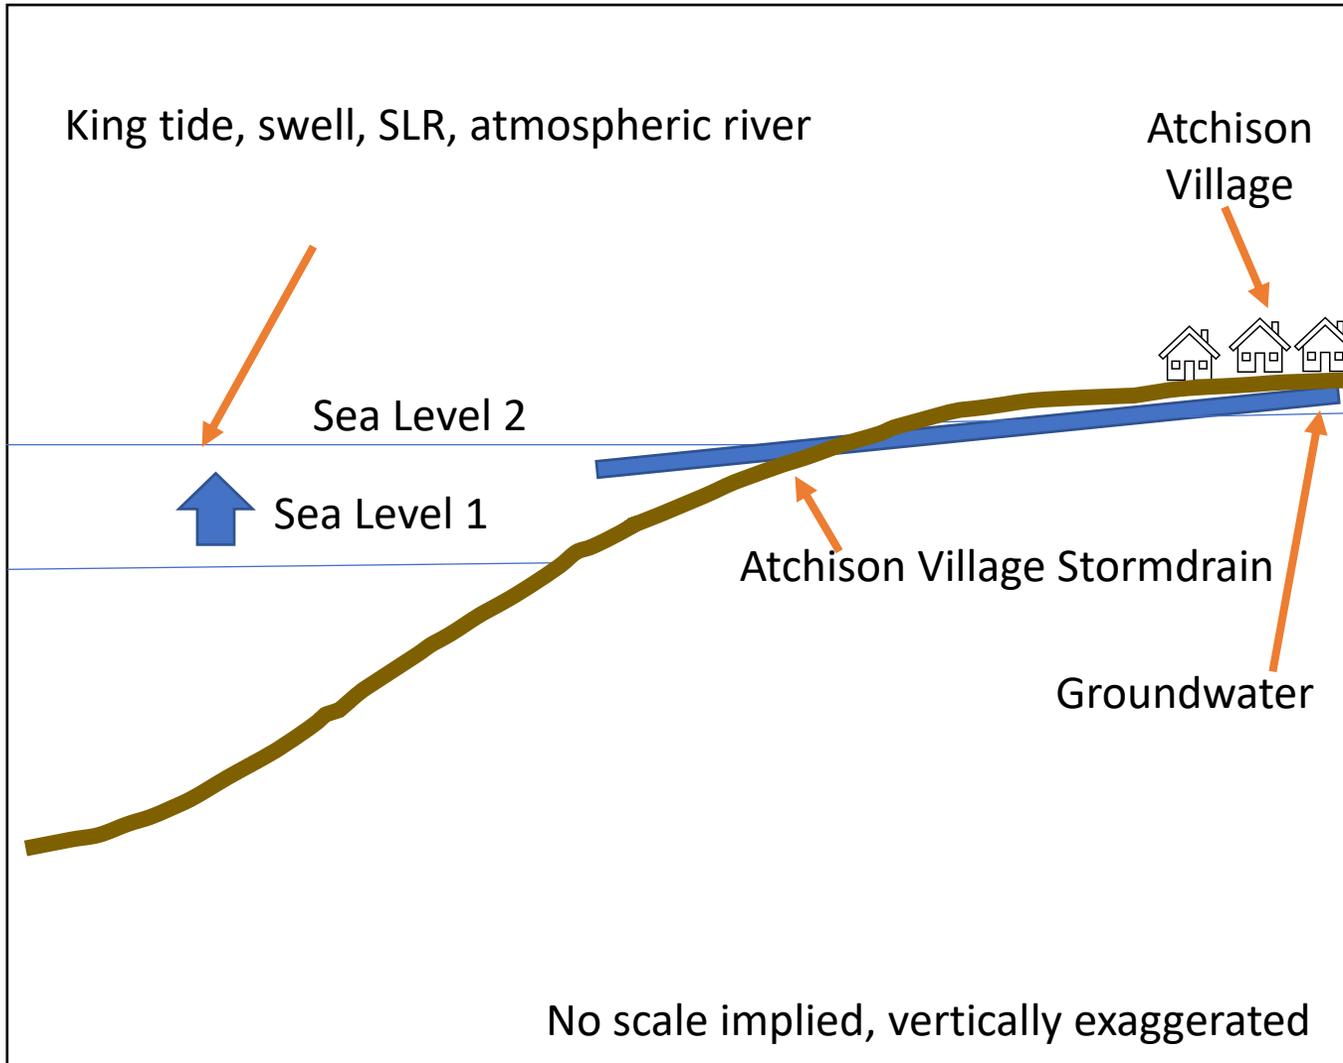
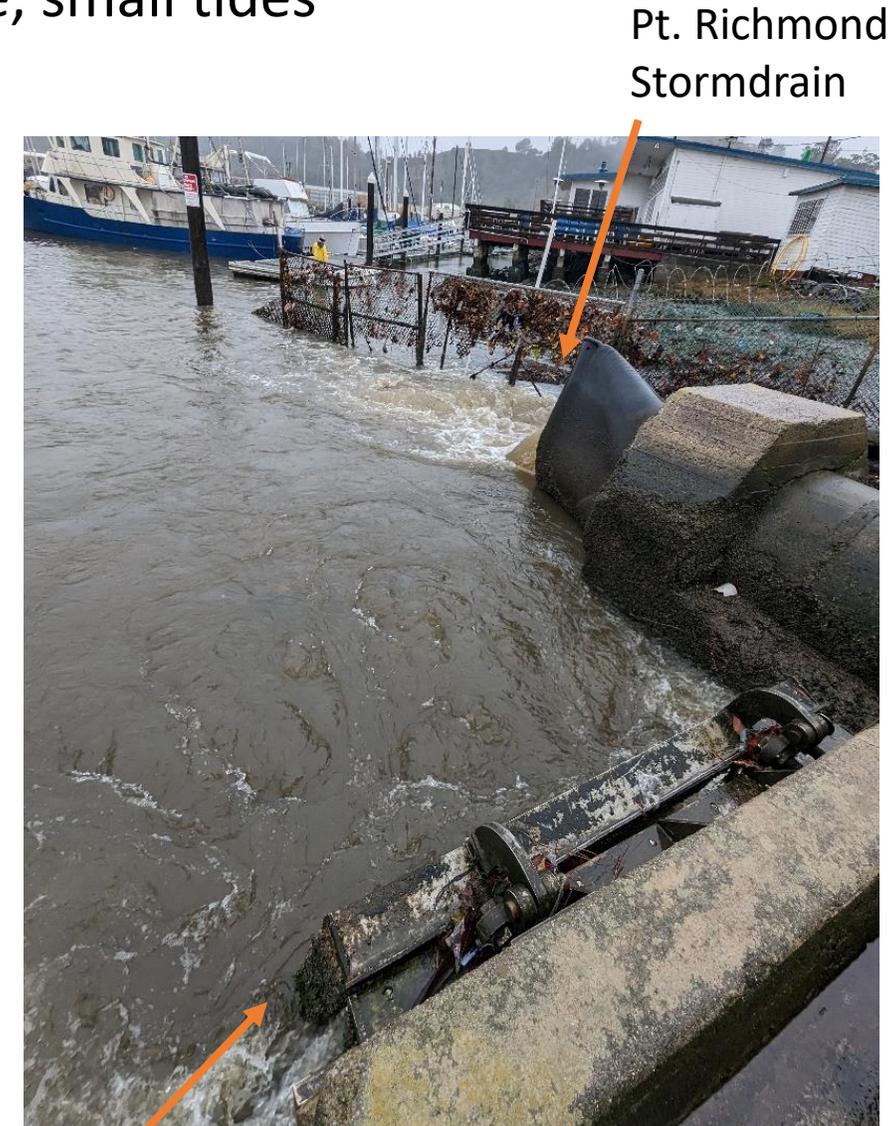
Lack of discharge elevation – king tides, SLR, storm surge, small tides

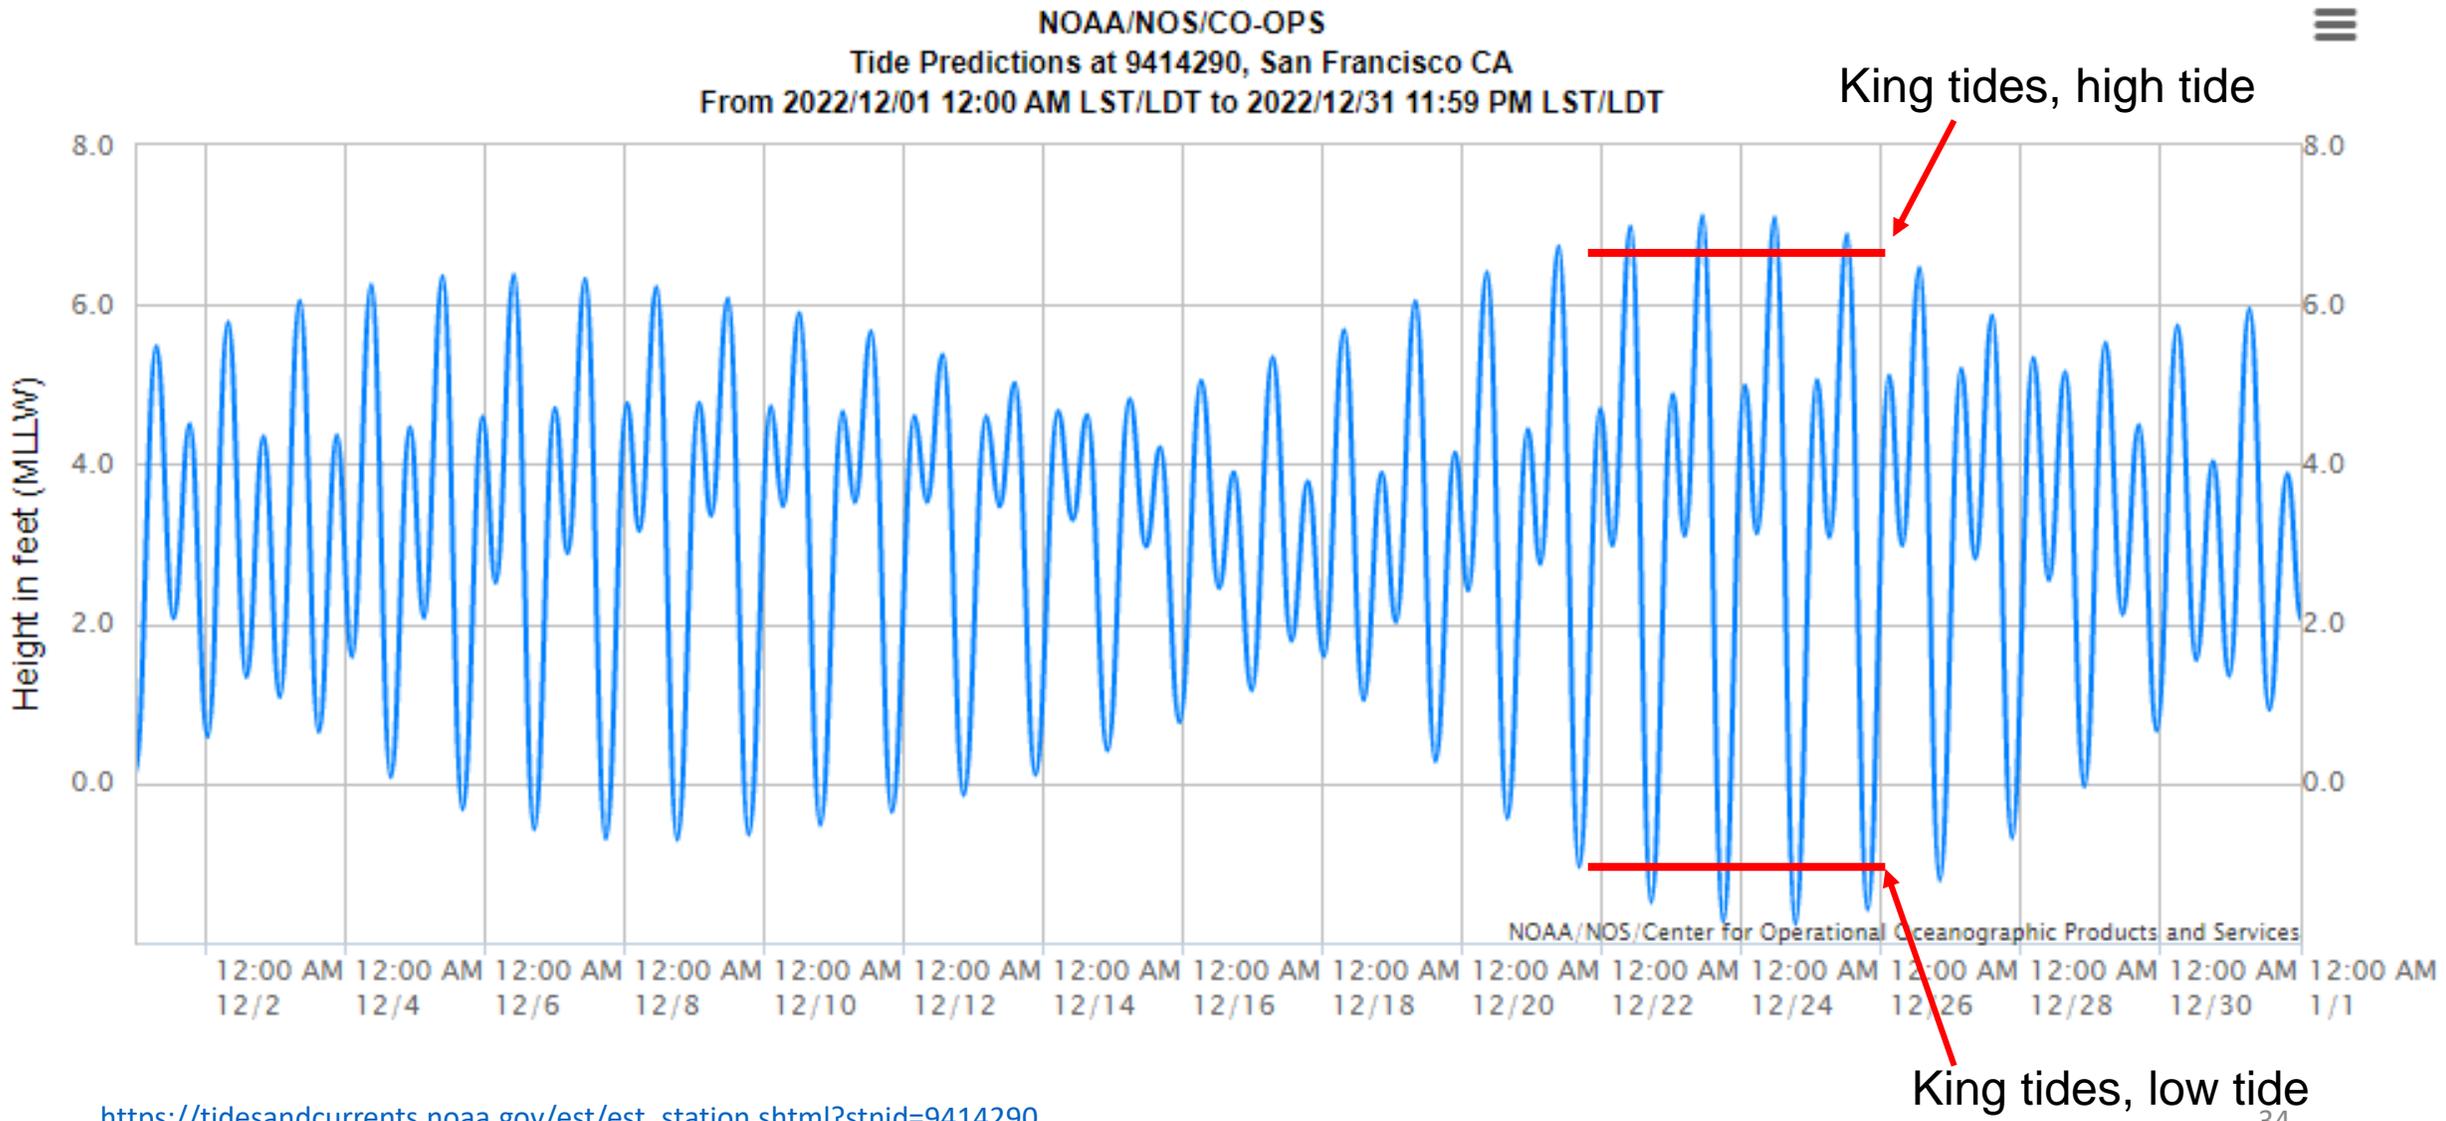
San Francisco; 12/1/22 to 12/31/22 (NOAA data) highest monthly tides from 12/22/22 to 12/24/22; rainless; Question: With sea level rise, can king tides be a proxy for future average tides?

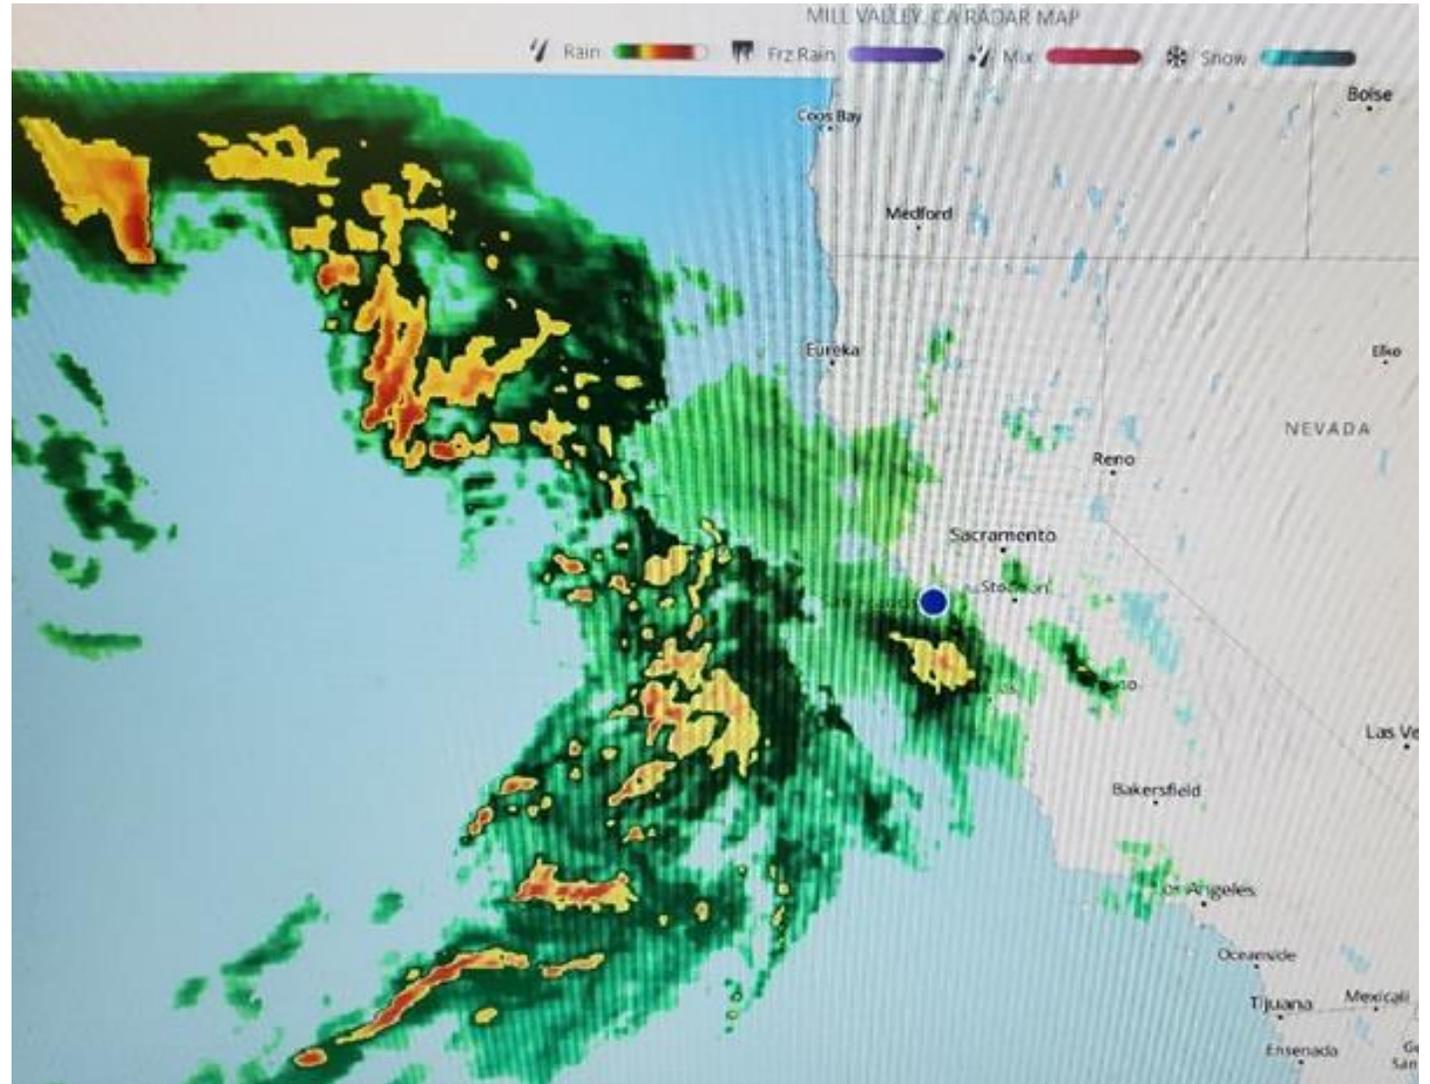
Atmospheric River
Condition (ARC)

Radar graphic from January 8, 2023 of an atmospheric river condition (ARC) which produced 0.72-inches of rain in Richmond, California on that date and 0.85-inches on 1/9/23

Similar concept for
43-day ARC in
1861 and great
flood of 1862

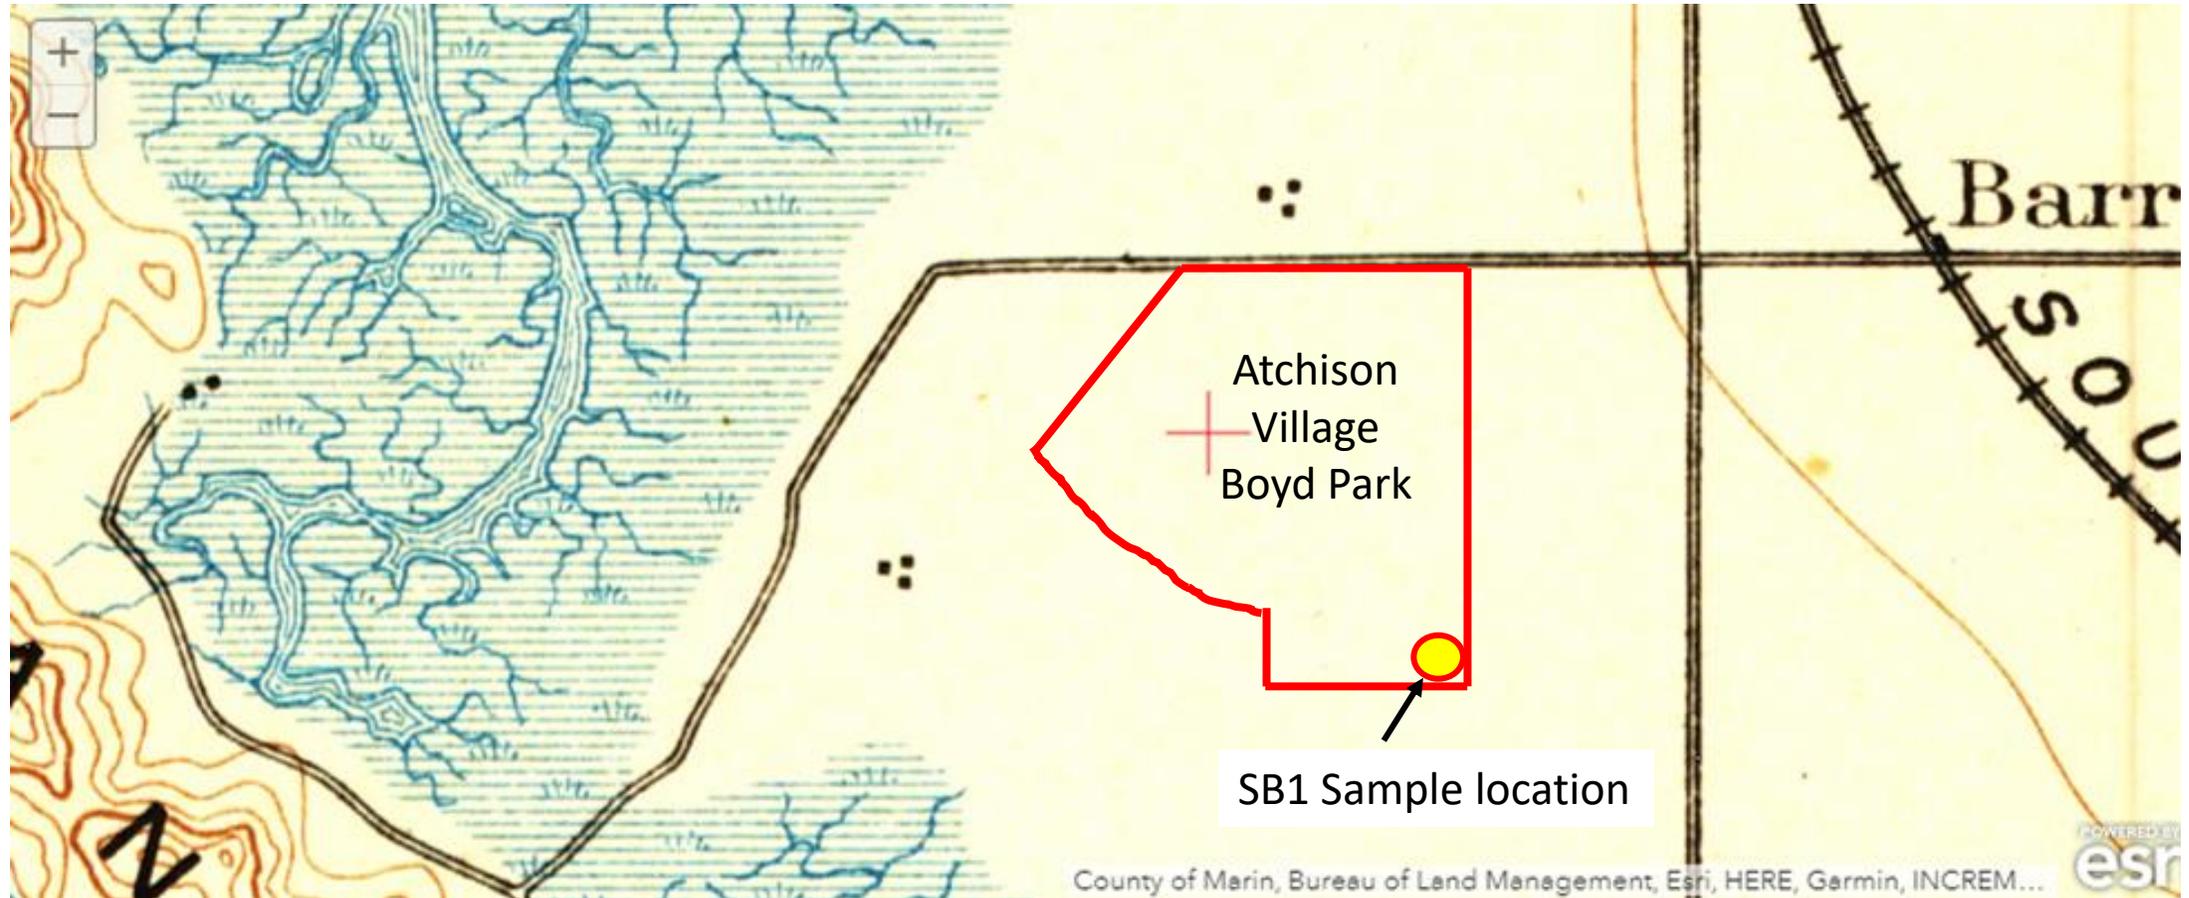
Atchison Village – flood plain adjacent to historic wetlands; plastic clays at 2.00 ft below ground surface

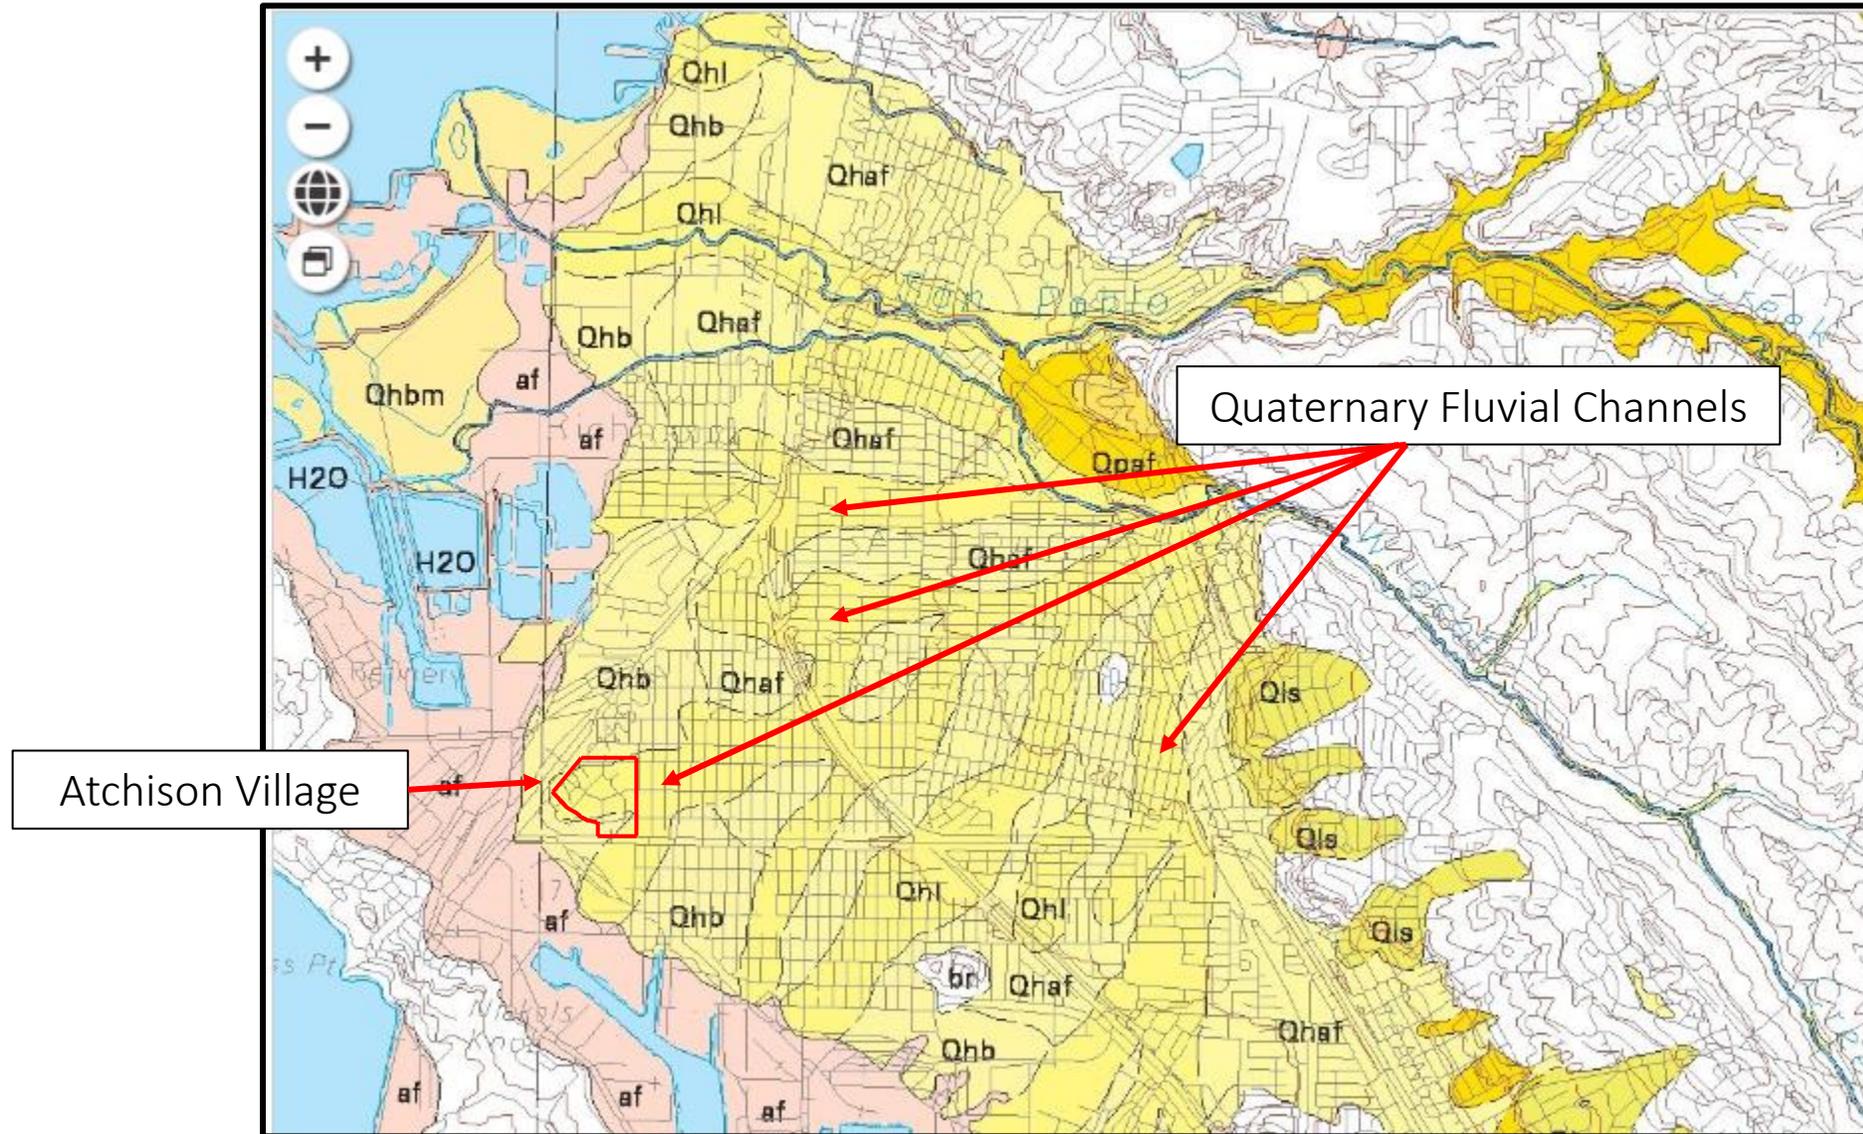
Geology of Richmond, California featuring Quaternary fluvial channels

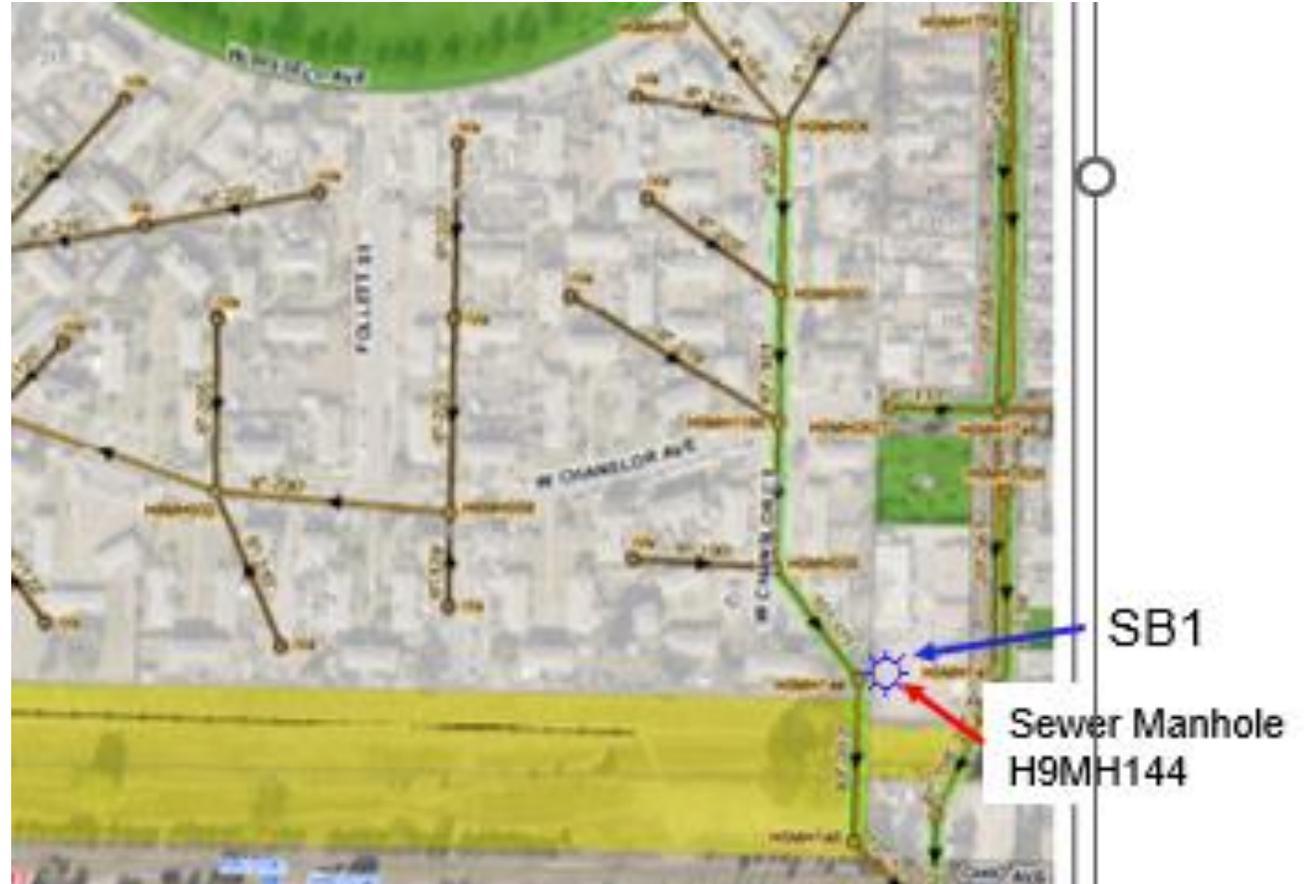
Atchison Village
Soil Boring SB1

SB1 at 12 West Chanslor Ct., within sewer easement – brown gravelly clay (GC) with 1-inch pebbles 0.0 to 2.0 ft

Limited access pilot test: 10/15/22: hand auger to 4.9 ft in 1 hour
