Atchison Village: Groundwater Flooding, Sea Level Rise (SLR), and Atmospheric River Conditions (ARCs)

March 12, 2023 presented to the Atchison Village Community at Atchison Village Hall, live and by Zoom

Atchison Village: Sea Level Rise (SLR), Groundwater Flooding, and Atmospheric River Conditions (ARCs)

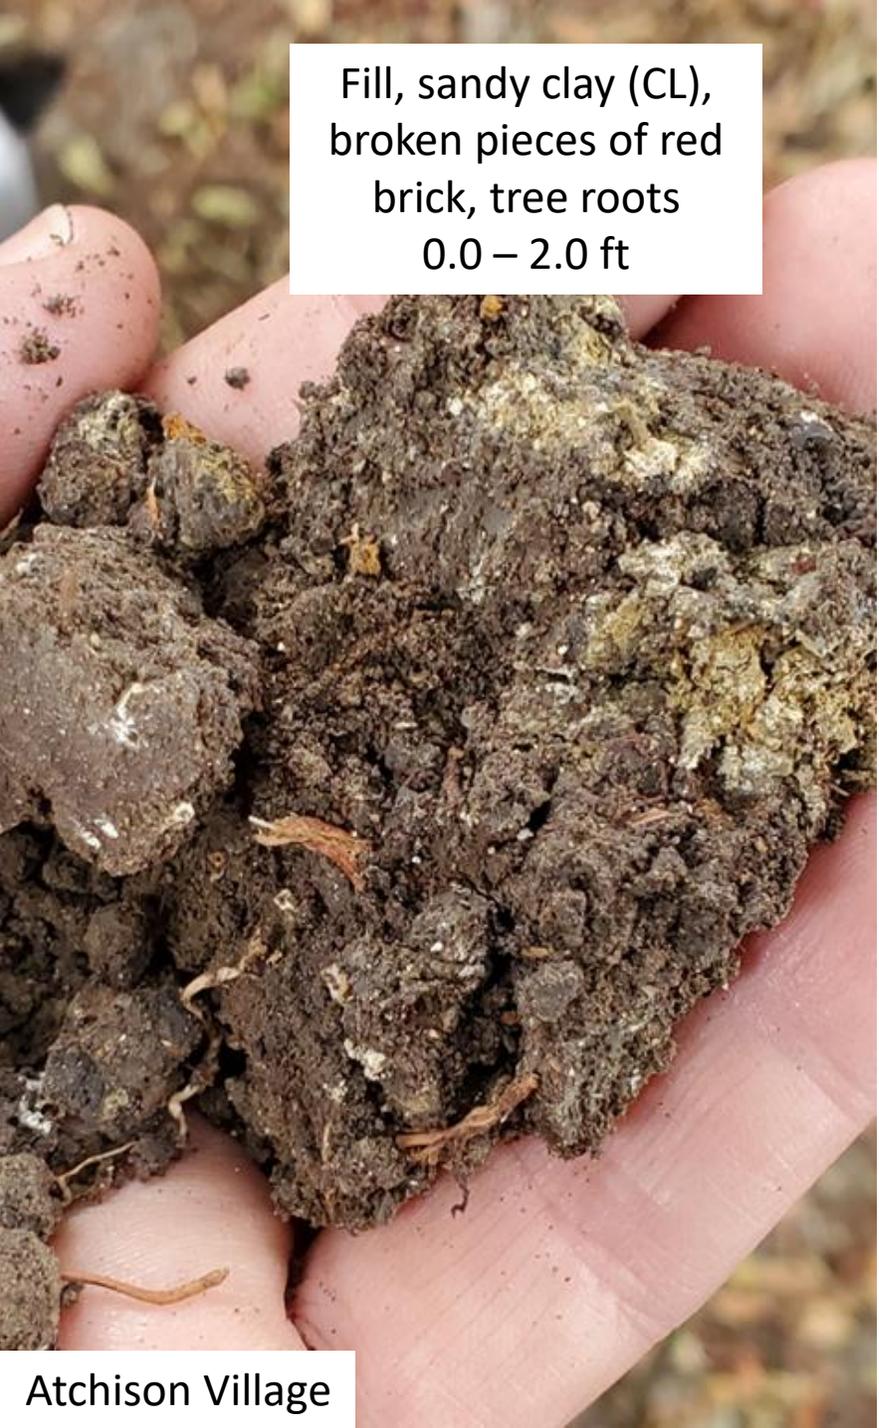
Fill, sandy clay (CL),
broken pieces of red
brick, tree roots
0.0 – 2.0 ft

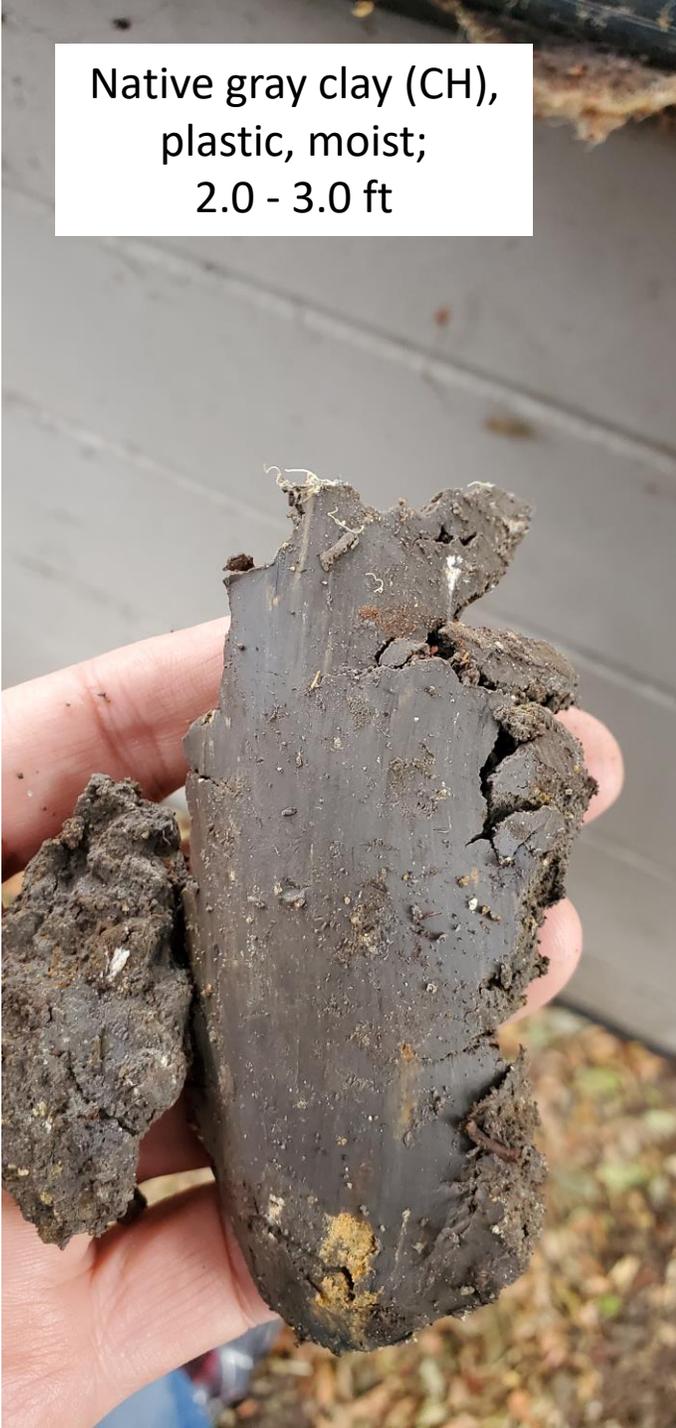
Native gray clay (CH),
plastic, moist;
2.0 - 3.0 ft

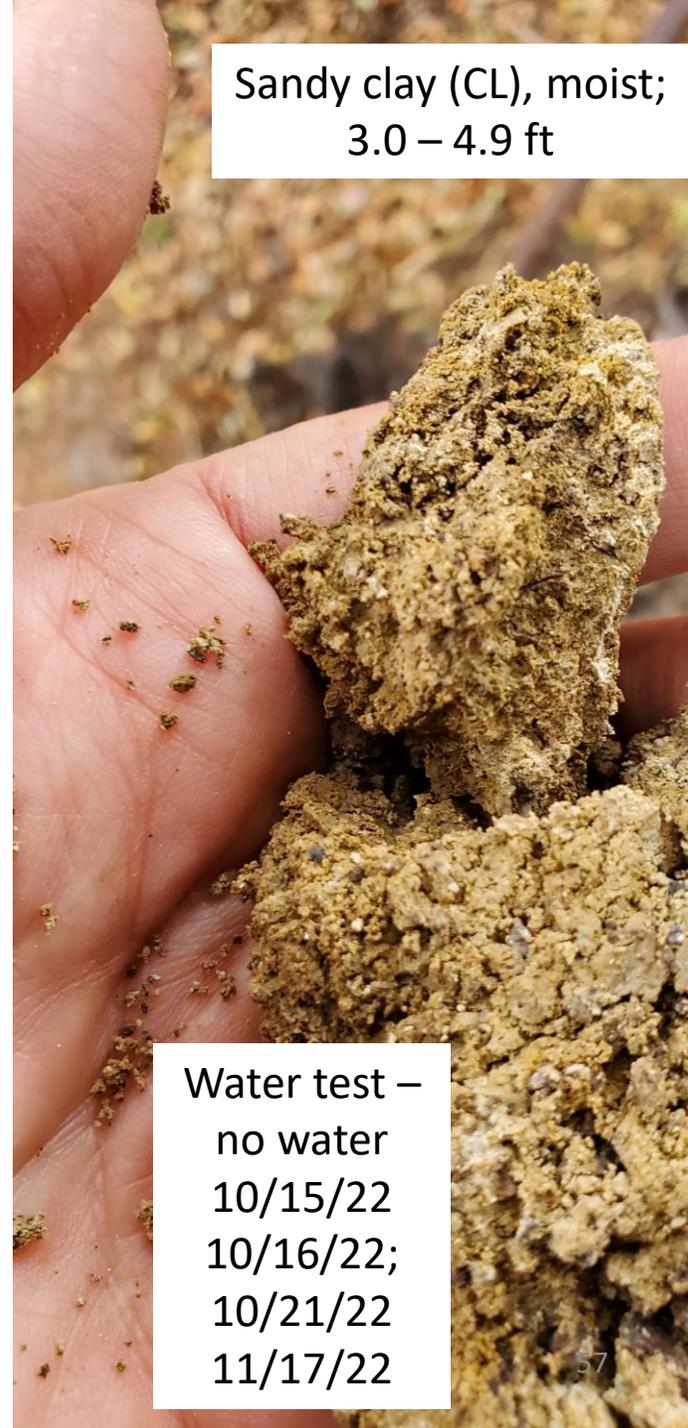
Sandy clay (CL), moist;
3.0 – 4.9 ft

Water test –
no water
10/15/22
10/16/22;
10/21/22
11/17/22

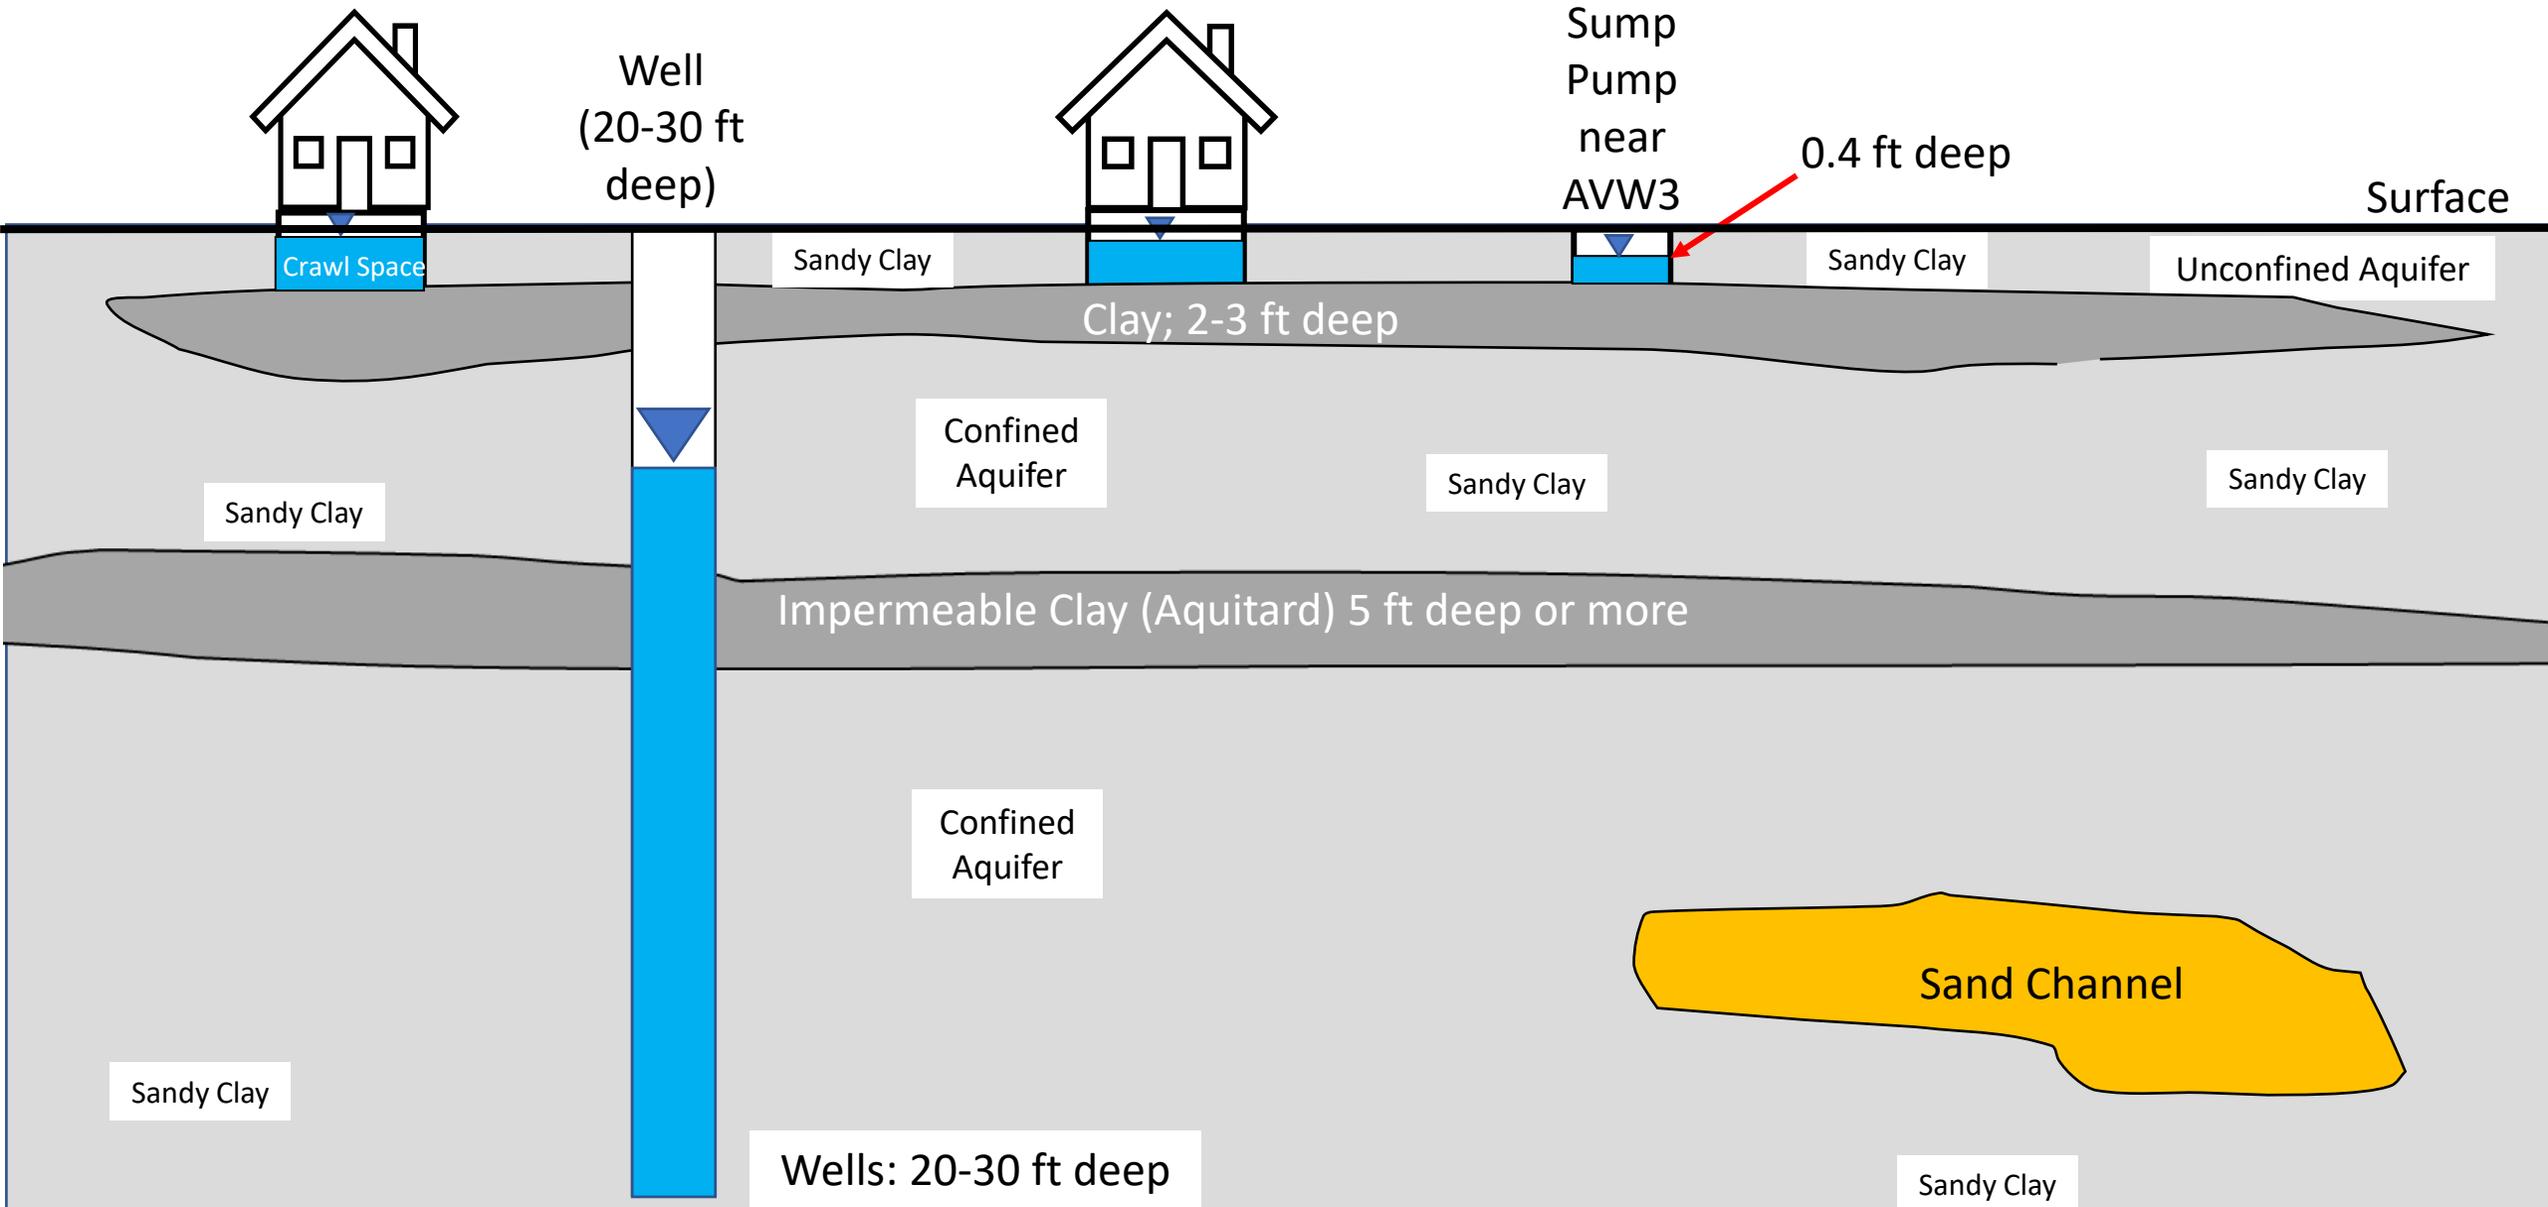
Atchison Village: Concept diagram; clay layers and multiple water table depths (NOT TO SCALE)

Atchison Village: Dynamic environment: deposition, erosion, chemical processes
 Concept diagram; clay layers and multiple water table depths

- Irrigation water
- Sump Discharge
- Groundwater
- Rainwater
- Groundwater Table

Thus, crawl space water = Rain + Groundwater/Trenchwater +
 Irrigation + sump discharge water

NOTES: Sewer laterals and sewer mains were partially upgraded by pipe bursting (2011-2015); original trench backfill from 1941

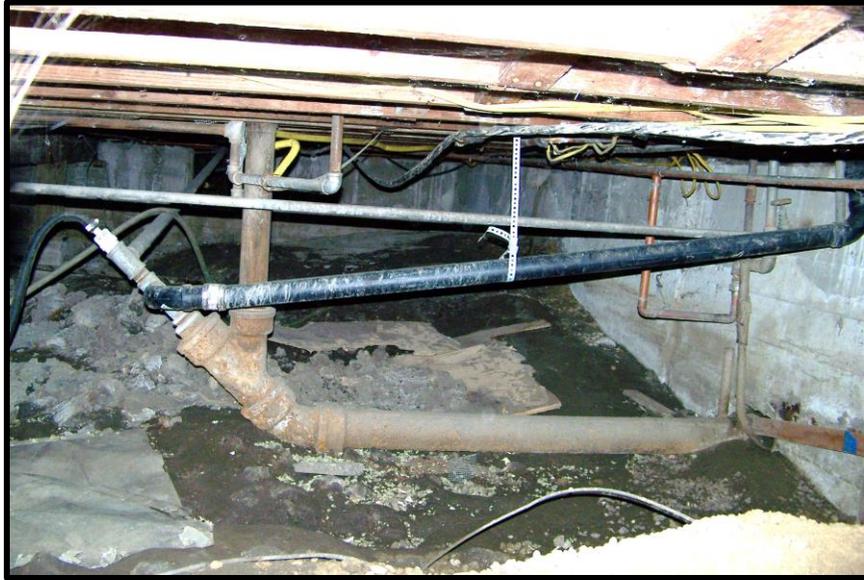
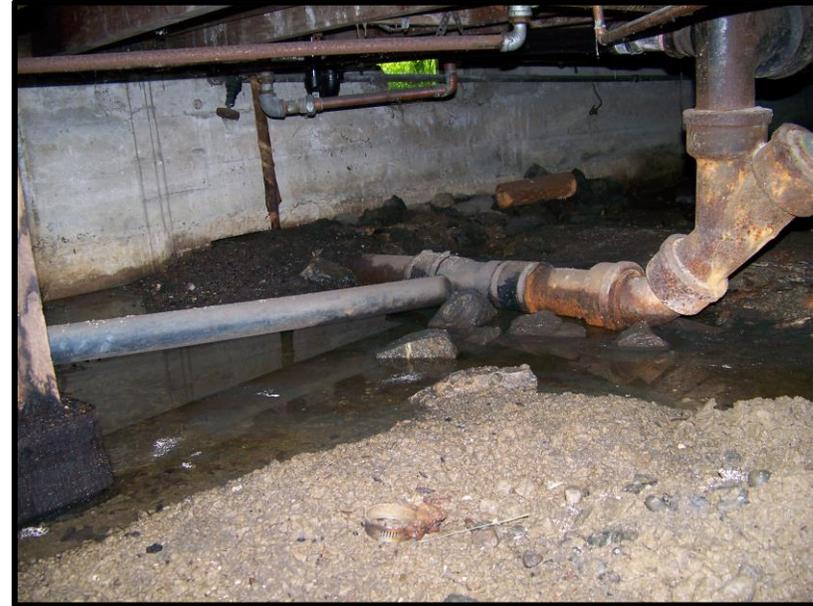
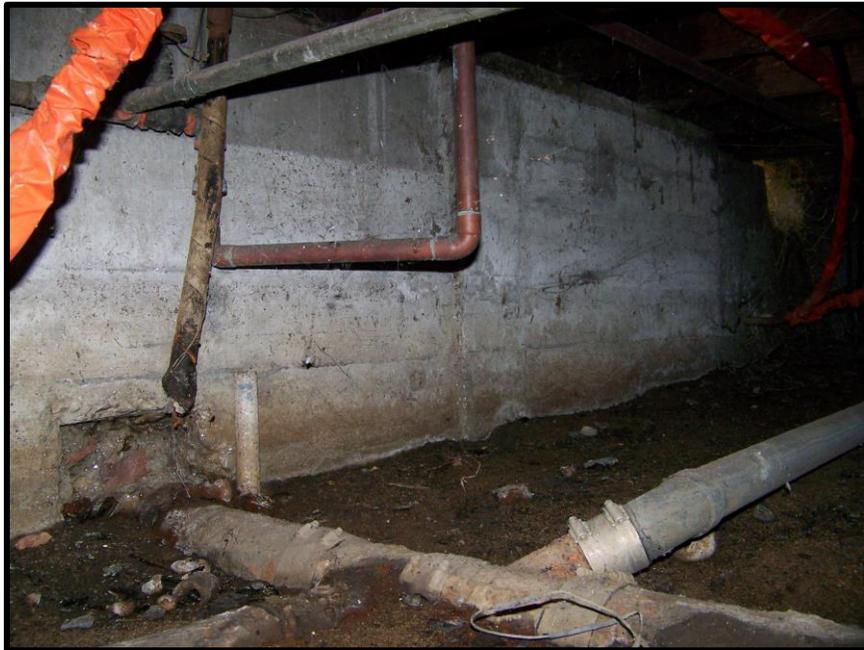
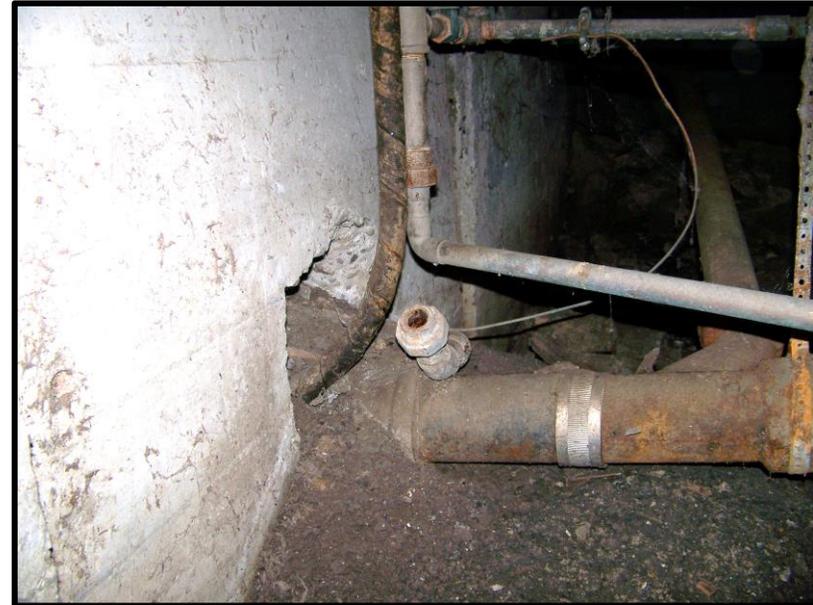
Atchison Village: Crawl spaces and sewer pipe exiting foundation walls (photos by Barbara Postel)

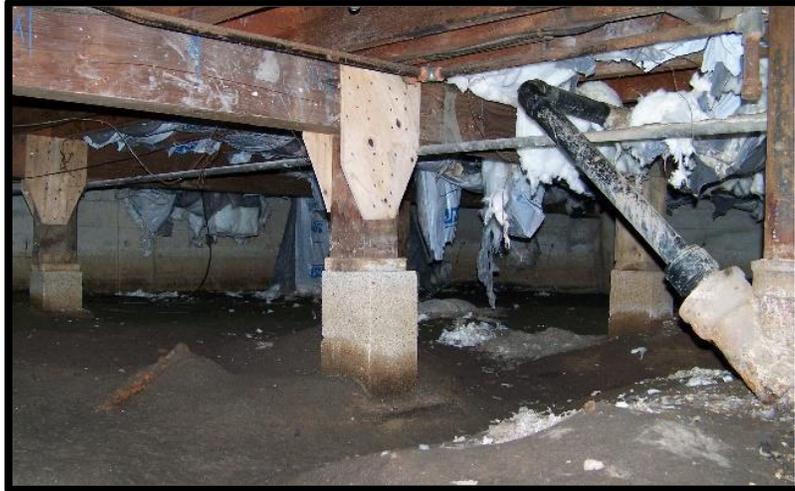
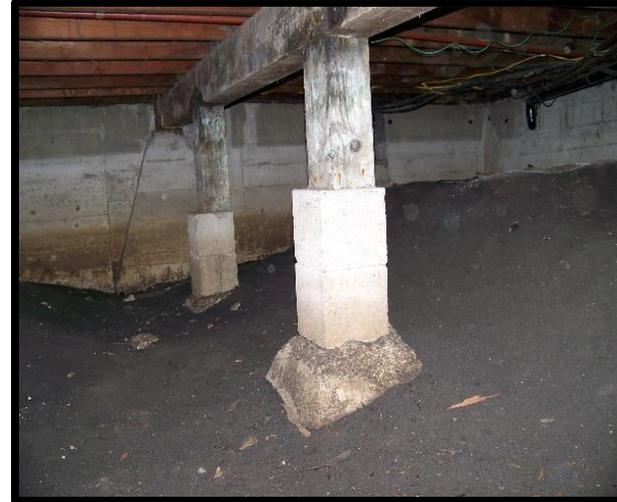
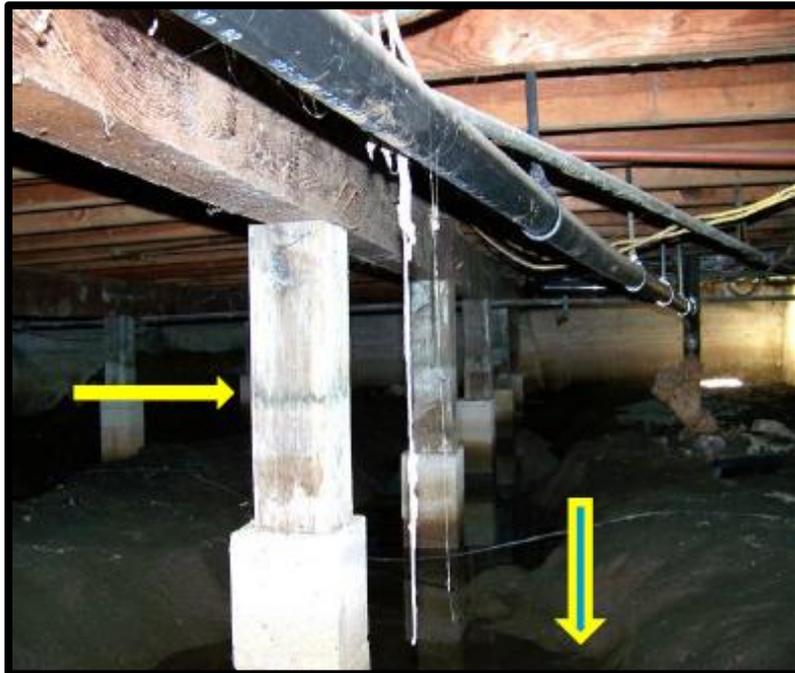
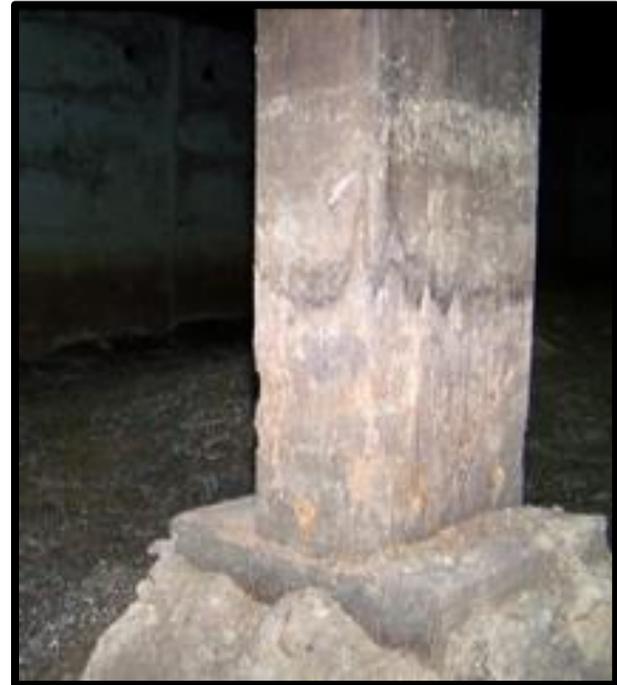
Crawl spaces beneath Atchison Village houses: dynamic environment as evidenced by undulating surfaces

Crawl space left (7/11/17) and right (9/18/14) showing sewer pipes exiting through foundation walls with evidence of sitting water (photos, Barbara Postel)

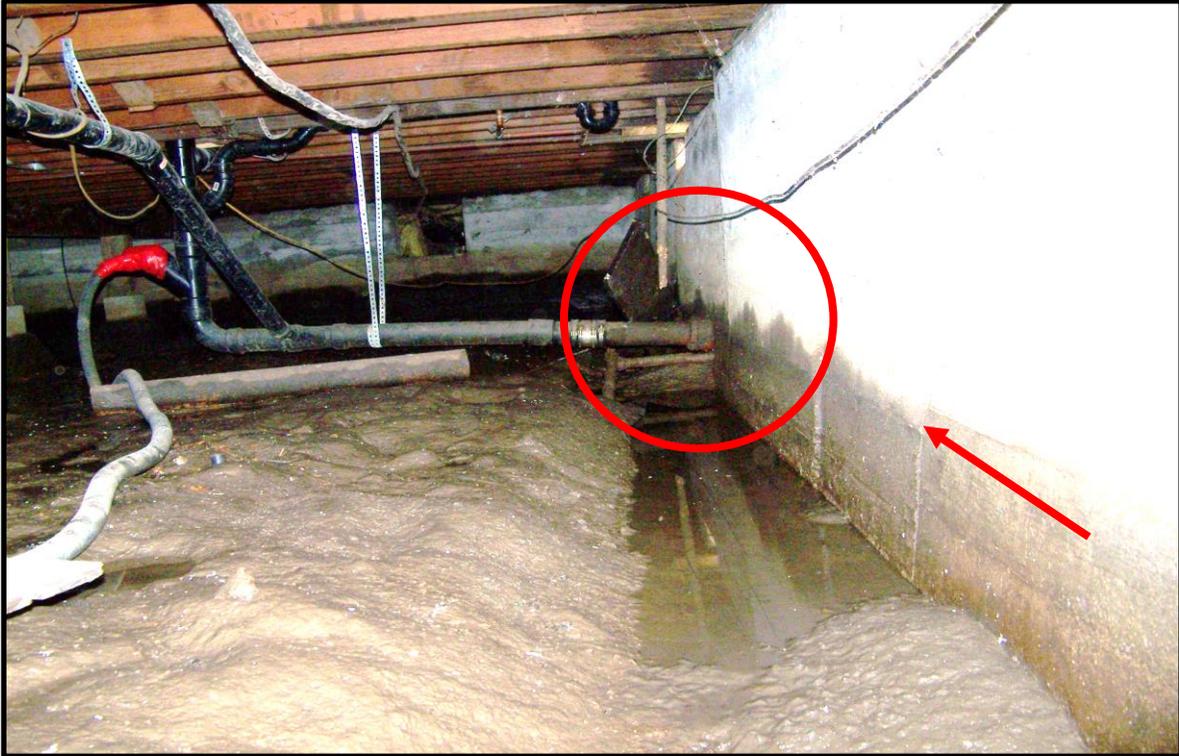
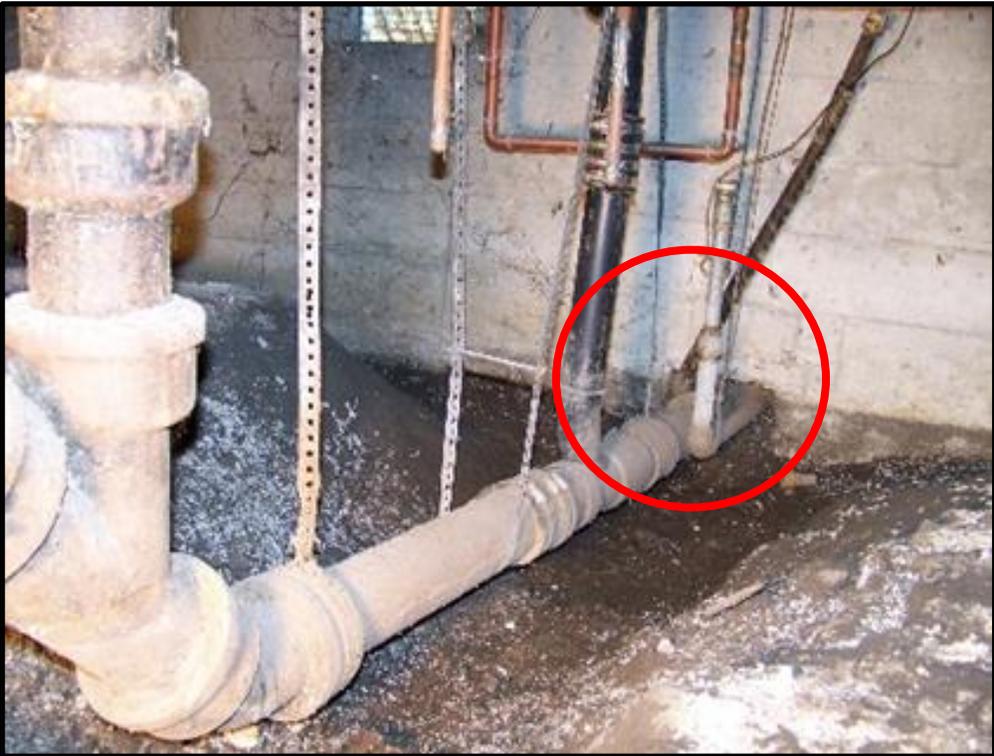
Engineered penetration for sewer line, gas line, and water line through the perimeter foundation wall

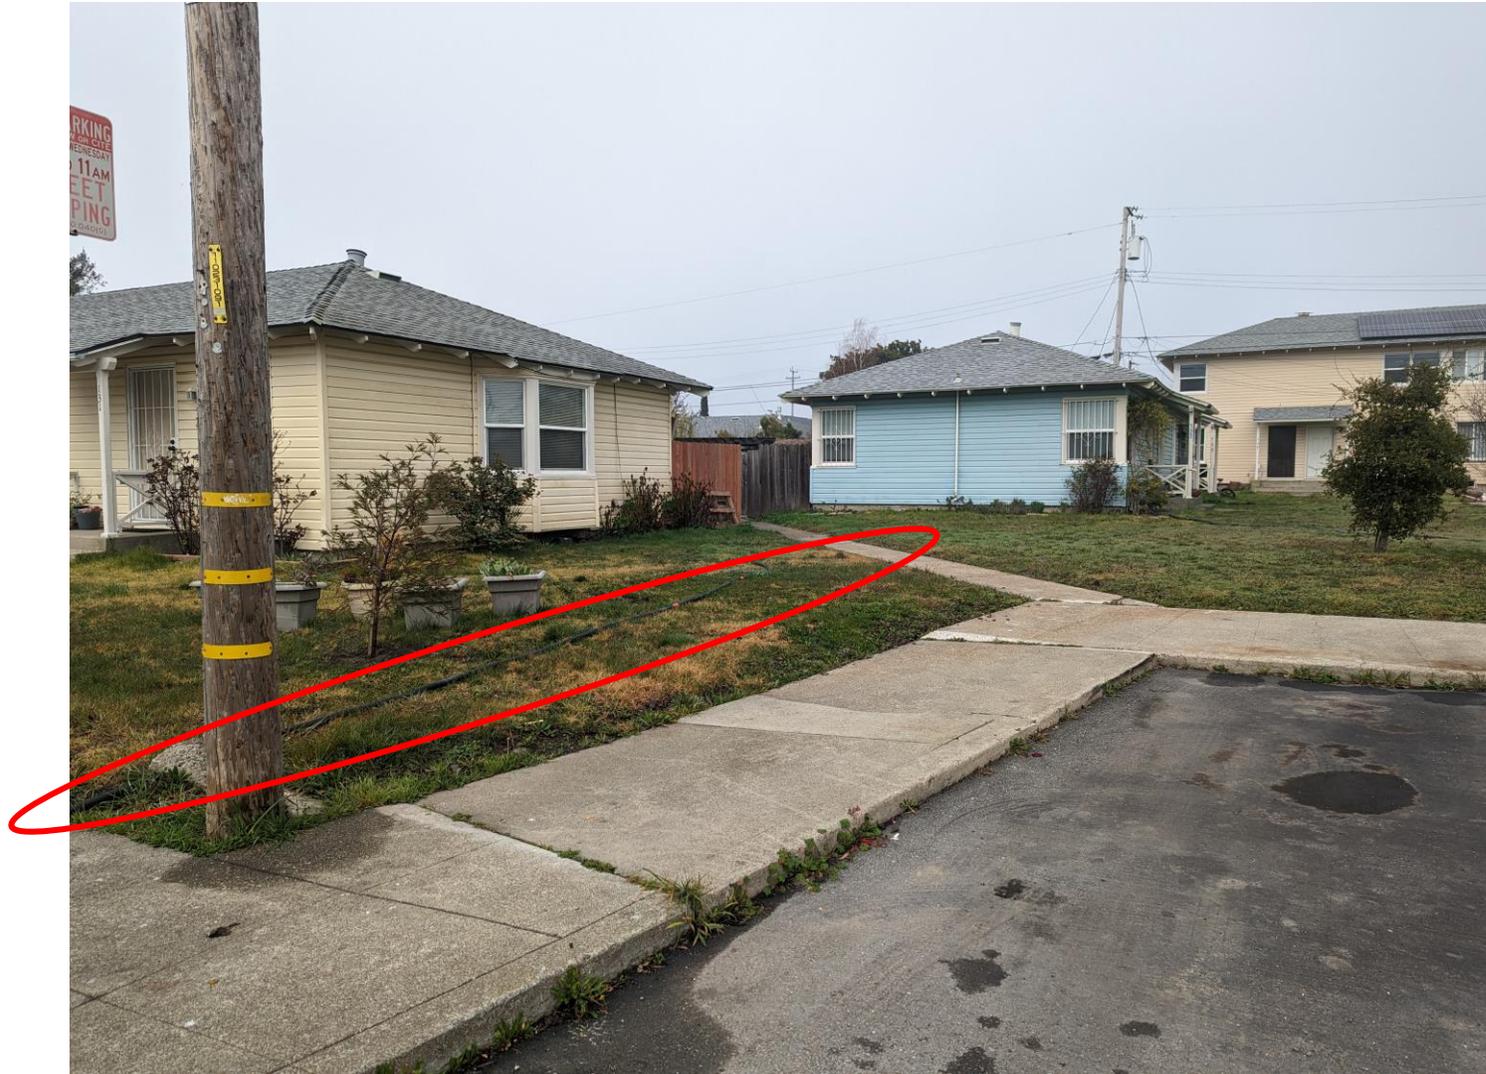
Current discharge of some sump pumps – pumps in almost all of the 163 buildings, all crawl spaces wet to varying degrees

Sump pump hose to lawn

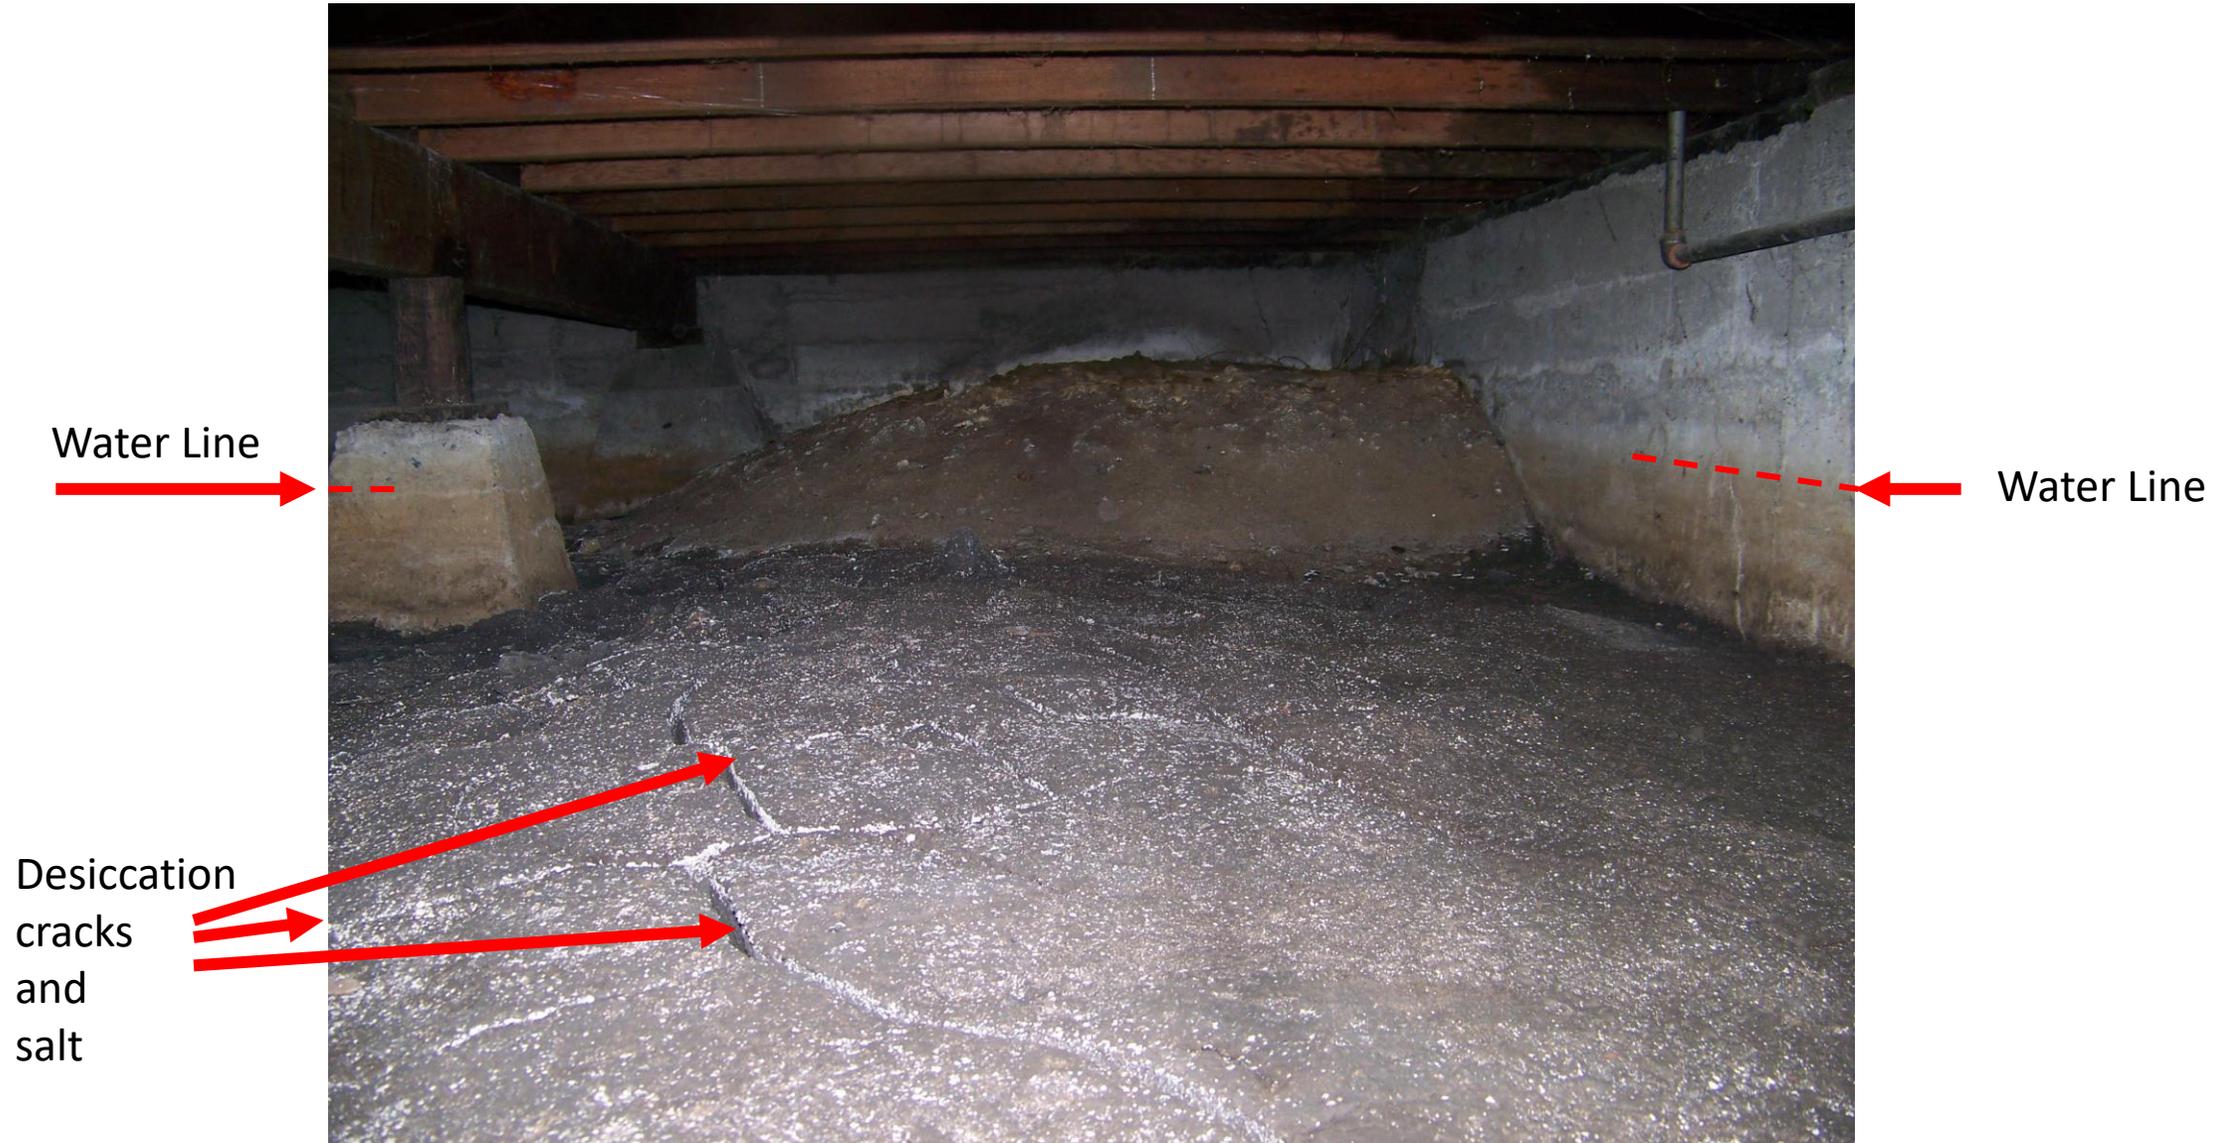
Desiccation cracks and accumulated salts reflect wet and dry periods in crawl spaces. The water lines are clearly visible on the concrete post on the left and side perimeter wall on the right.

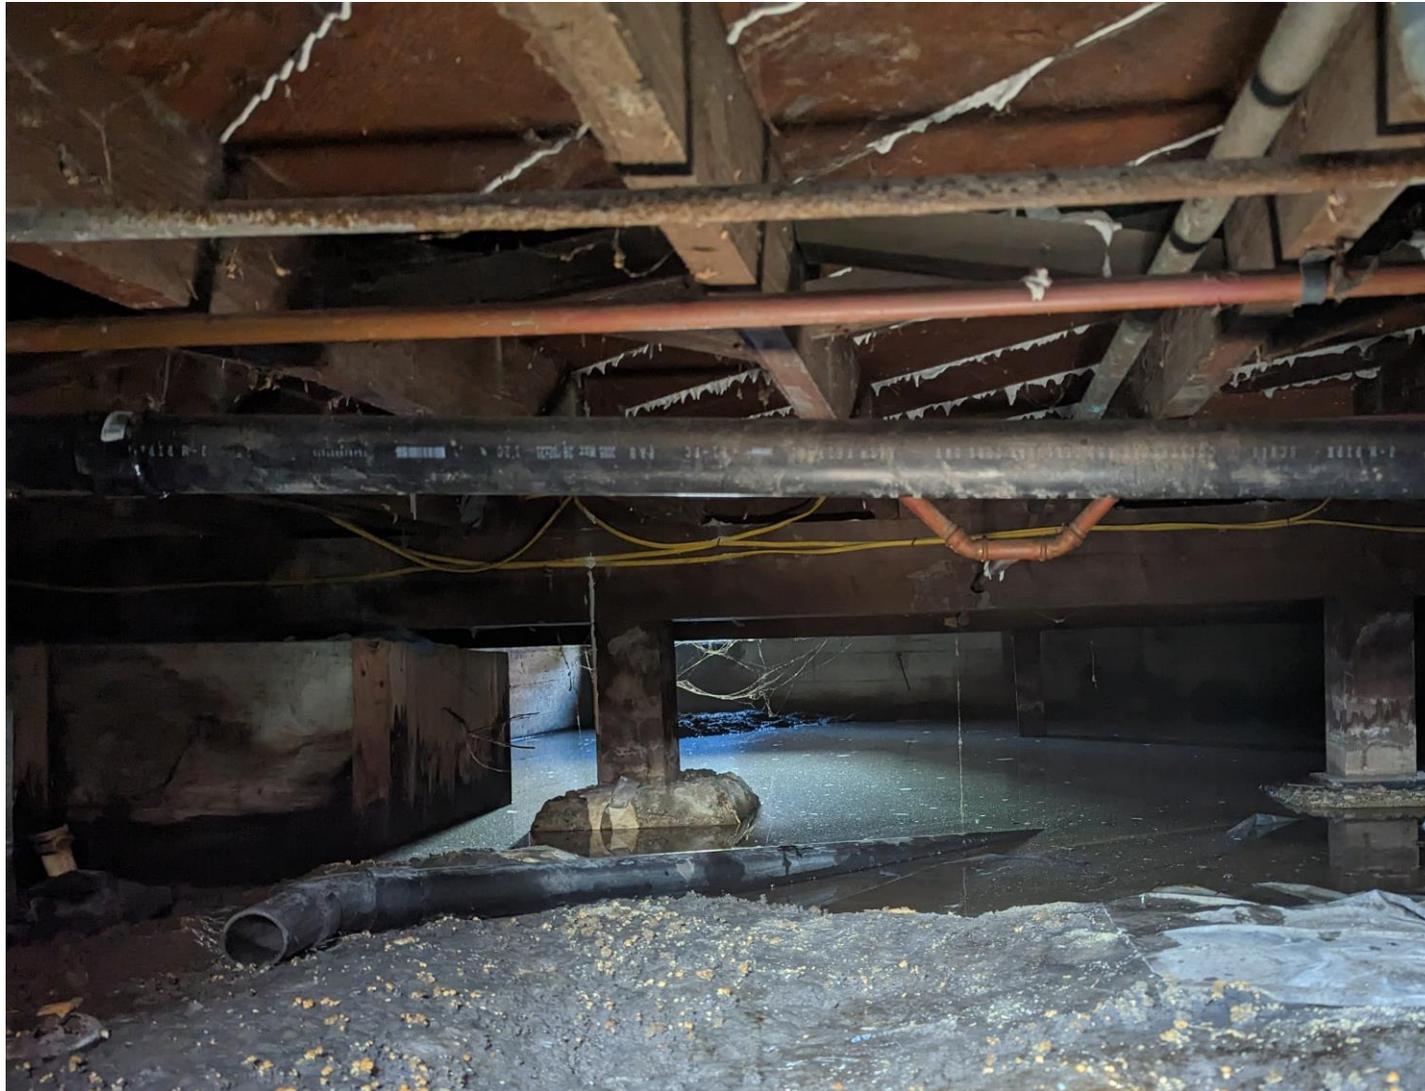
Crawl space beneath in Atchison Village house, Richmond, California; 12/22/22 (king tides); pre-ARC

Question: What is the source of the water in the crawl space?

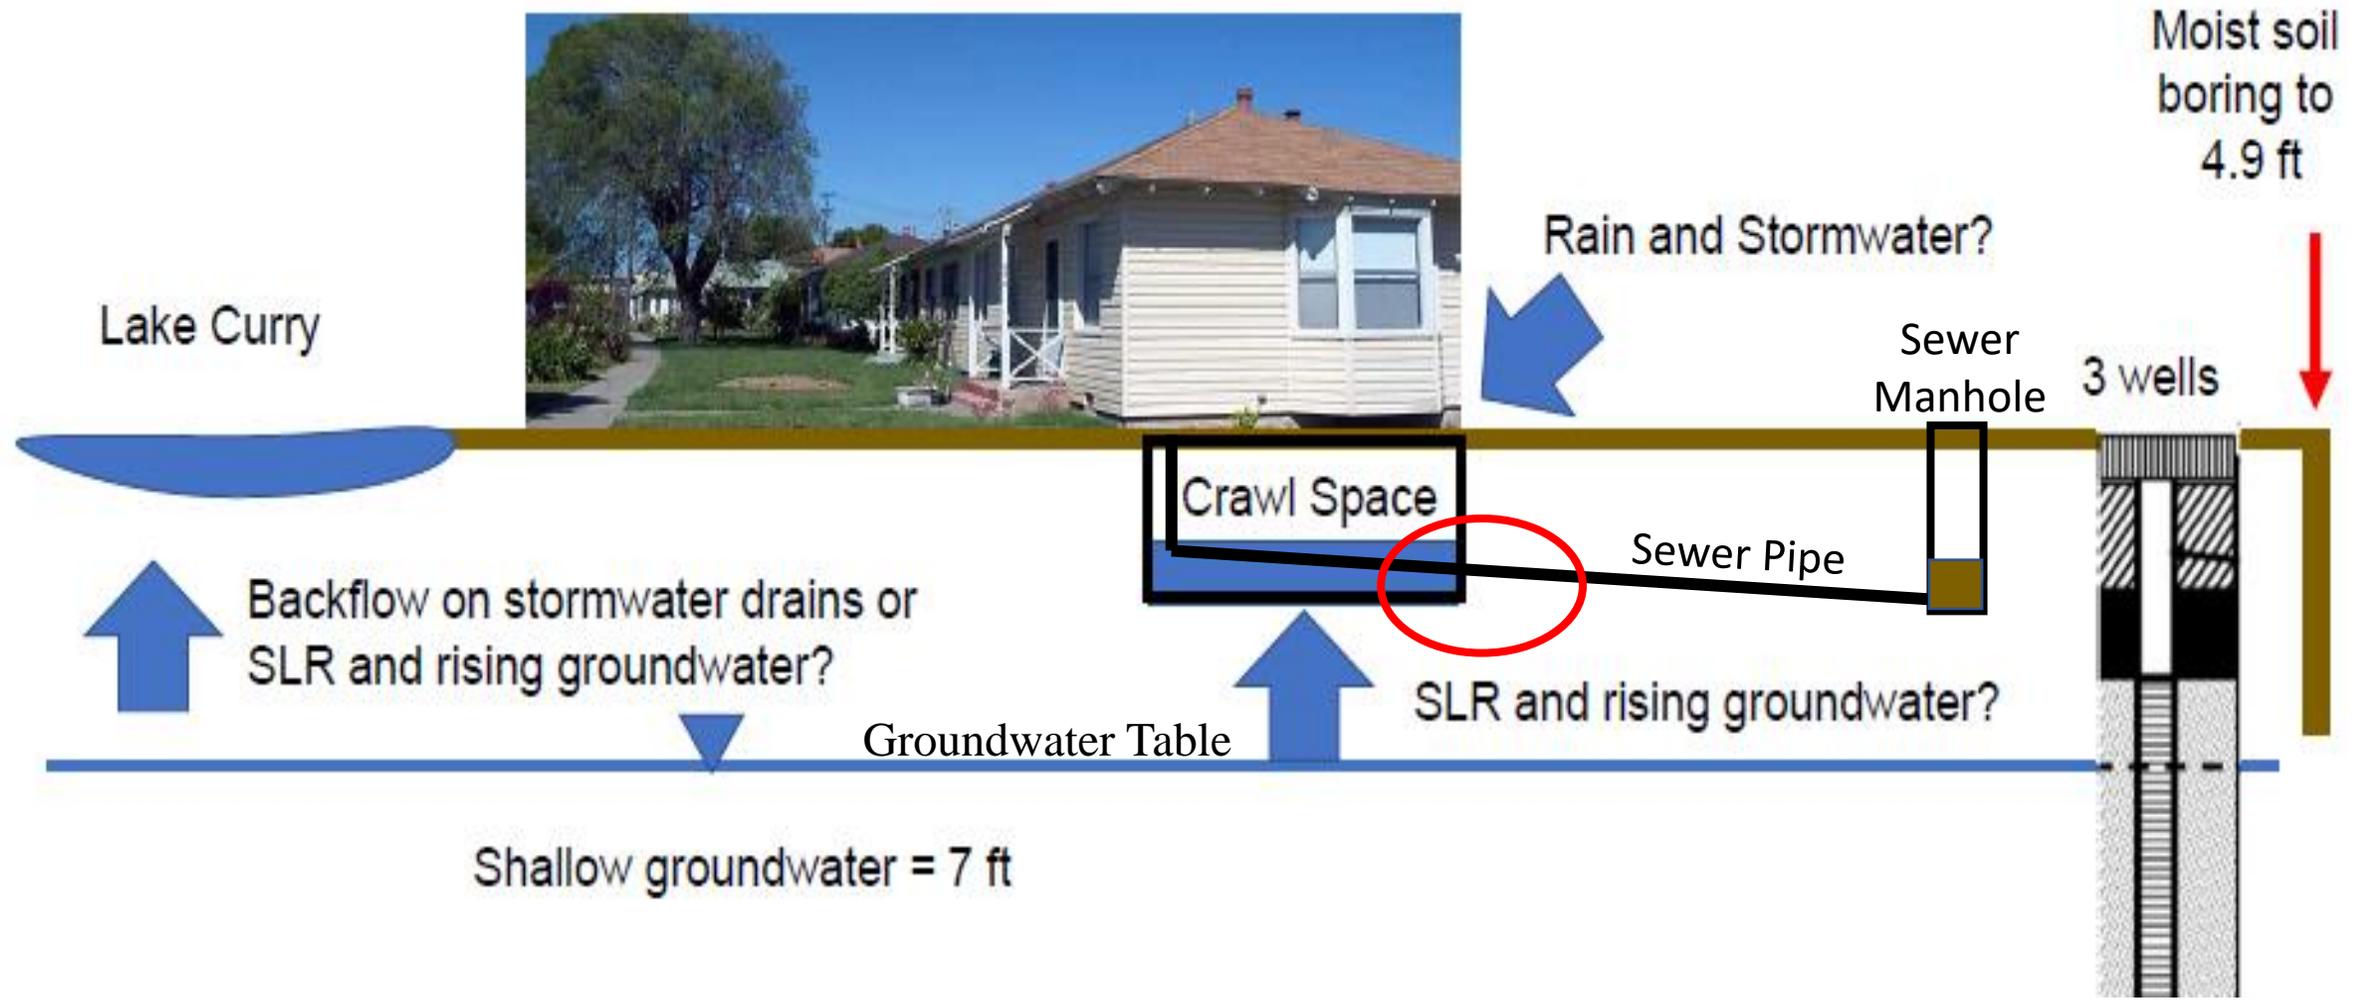
Conceptual model (pre-ARC) for water sources for crawl space flooding, including groundwater, rainwater, irrigation water, sewer water, sewer trench water, and leaky potable water lines.

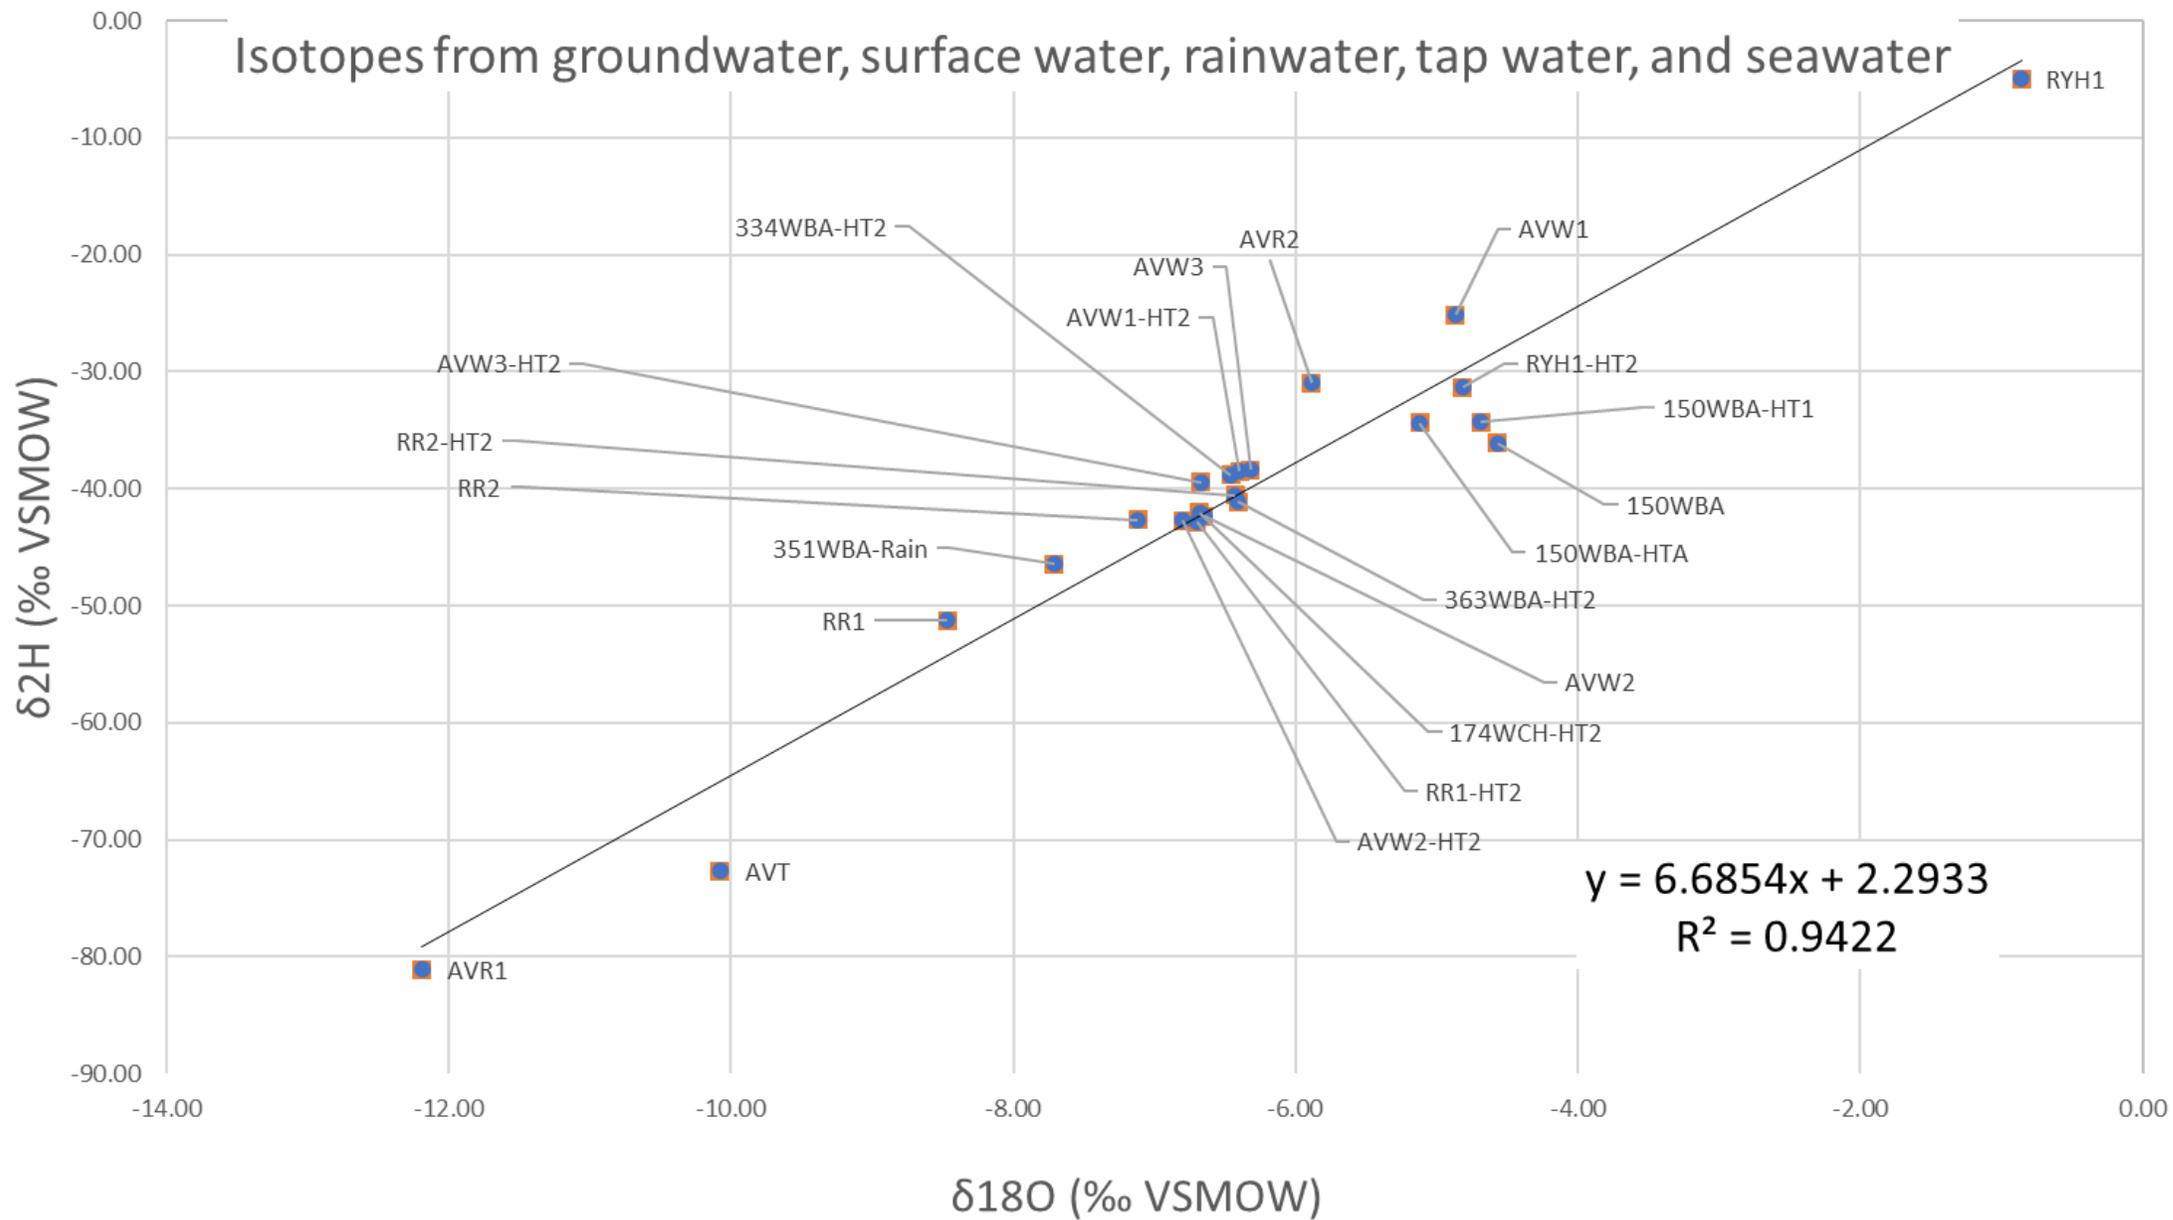
Isotopes from groundwater, surface water, rainwater, tap water, and seawater
