Atchison Village: Groundwater Flooding, Sea Level Rise (SLR), and Atmospheric River Conditions (ARCs)

March 12, 2023 presented to the Atchison Village Community at Atchison Village Hall, live and by Zoom

Atchison Village: Sea Level Rise (SLR), Groundwater Flooding, and Atmospheric River Conditions (ARCs)

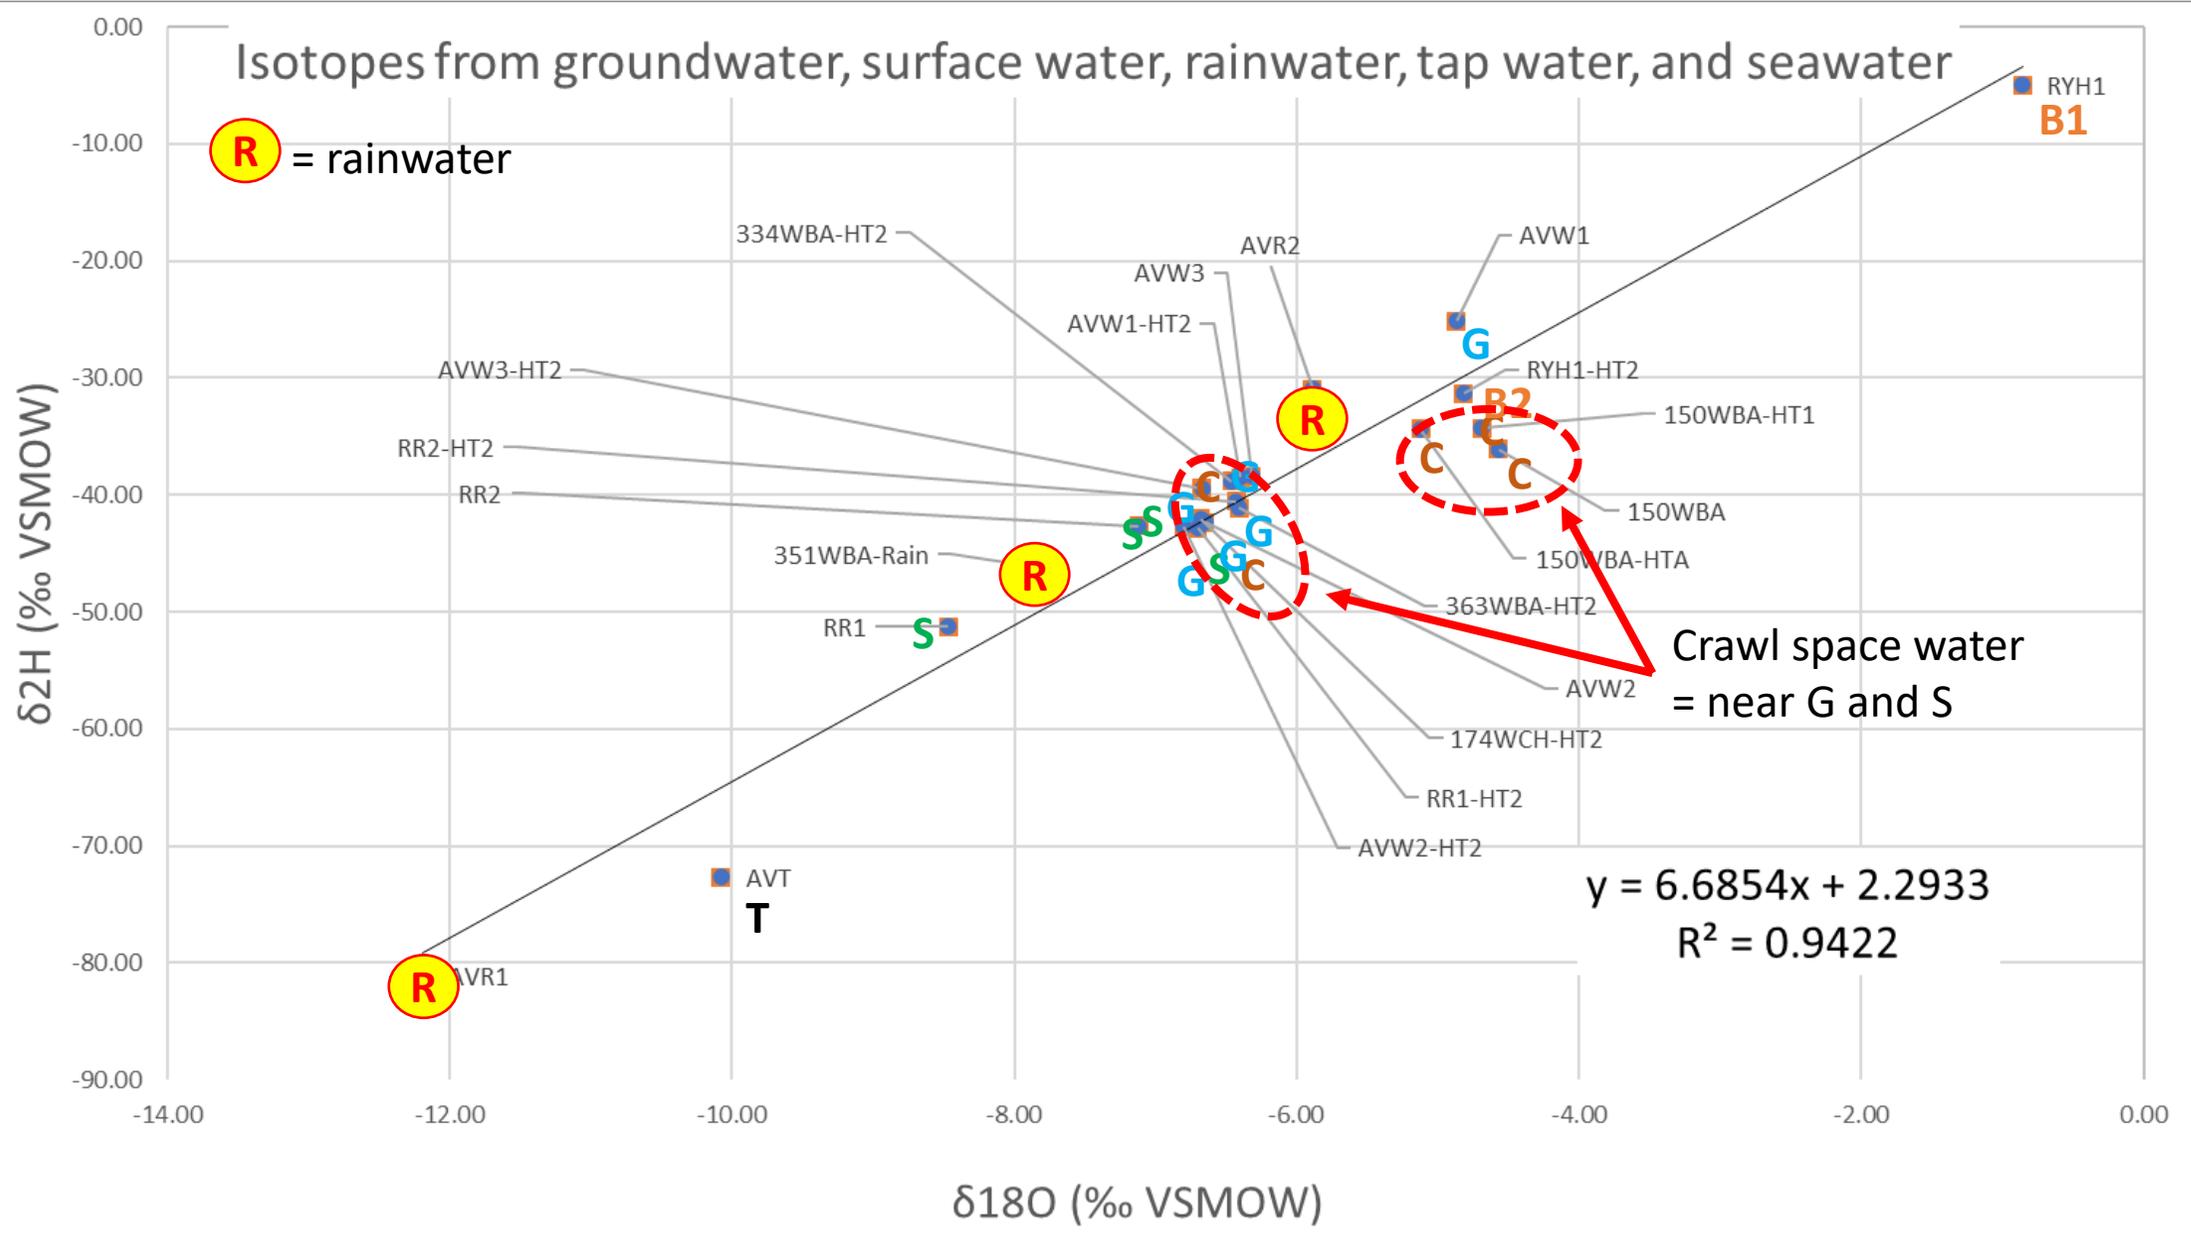
Isotopes from groundwater, surface water, rainwater, tap water, and seawater

R = rainwater

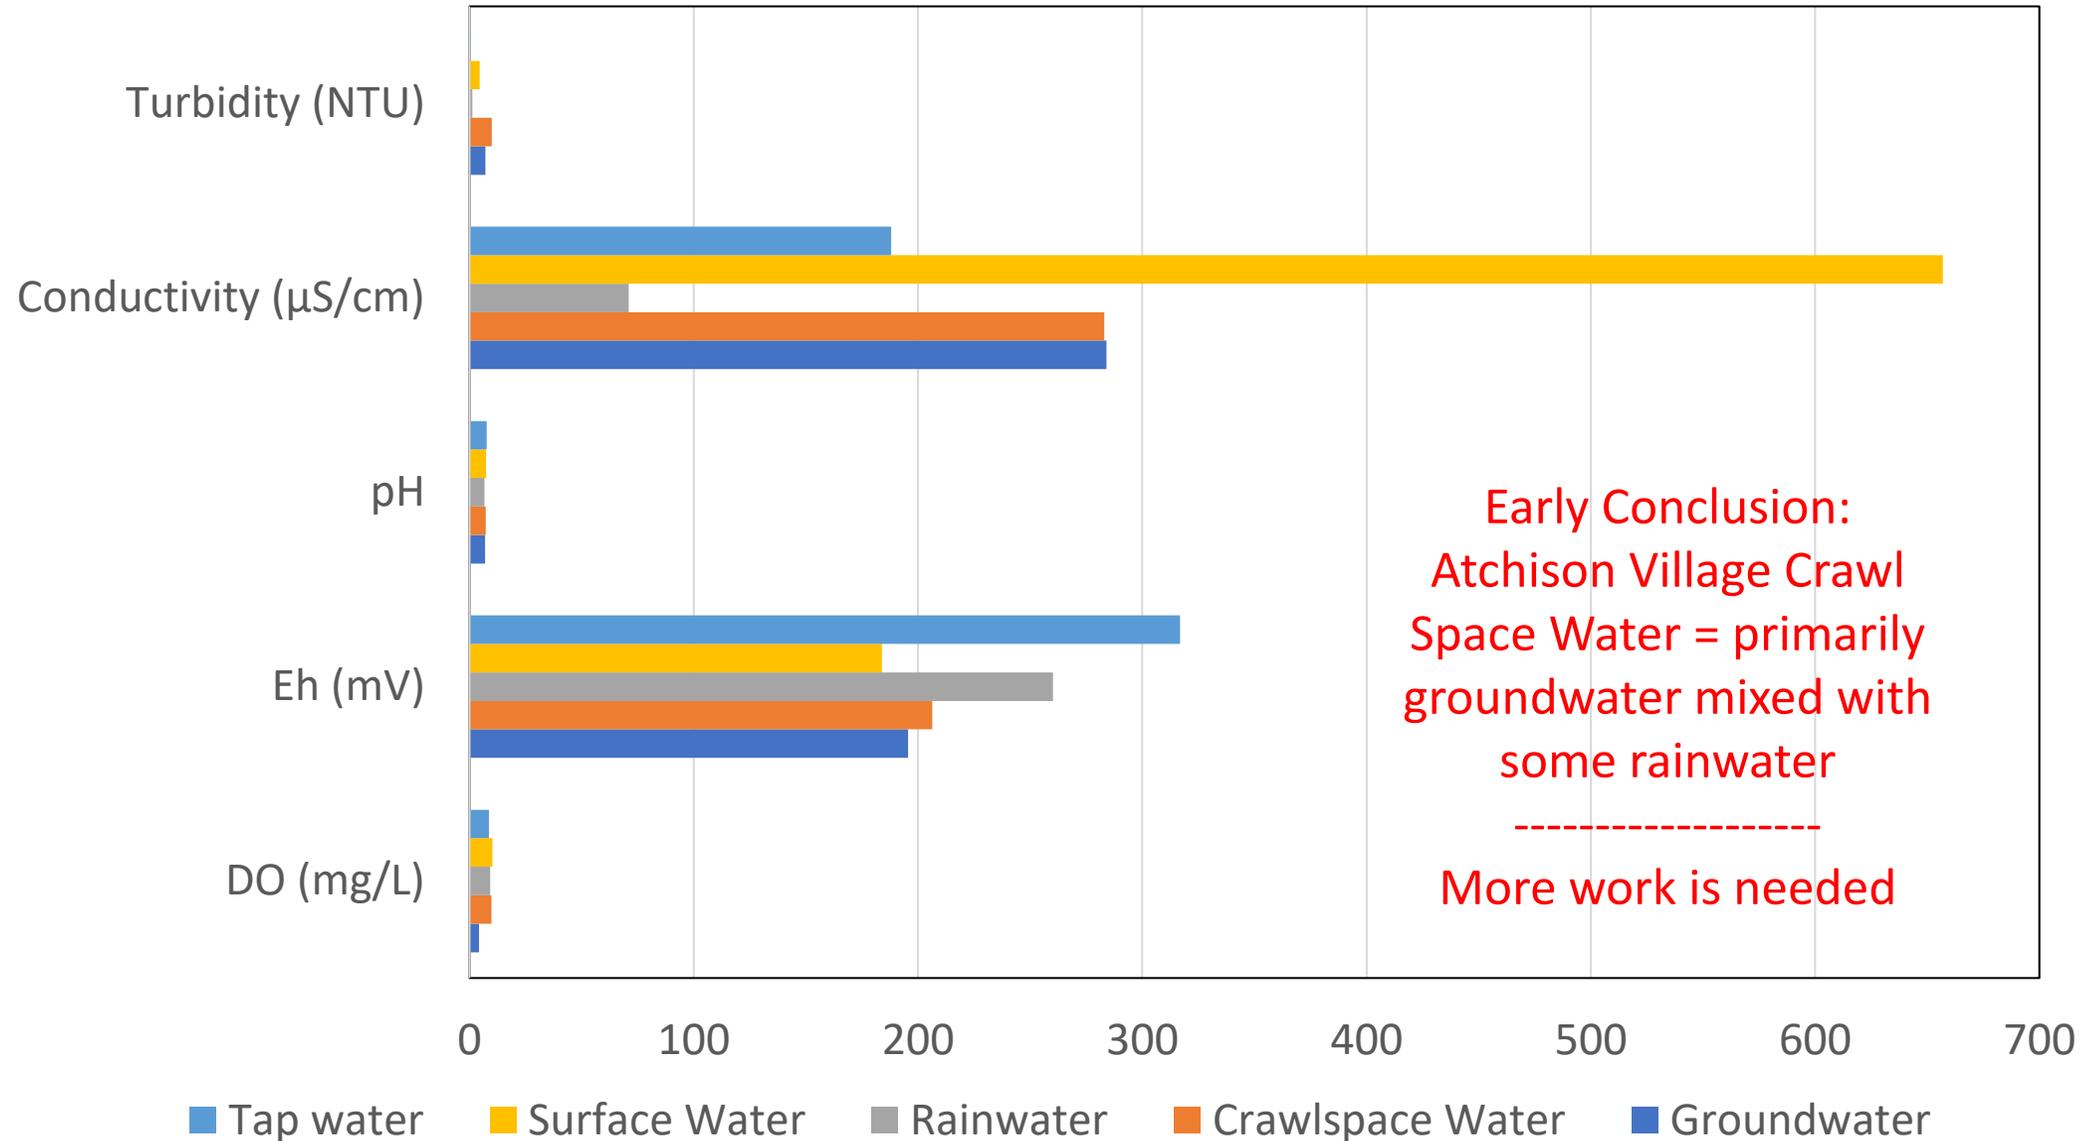
Atchison Village Freshwater (Conductivity < 750 $\mu\text{S}/\text{cm}$) Characteristics: Averaged per Water Source

YSI Meter: DO, ORP (Eh), pH, Conductivity. Hanna Inst. Turbidity Meter: Turbidity; All samples 1/22/23, except (1) tap water and (1) crawlspace, tap water and (1) rainwater (2/3/23); only includes data from <1,000 $\mu\text{S}/\text{cm}$ conductivity.

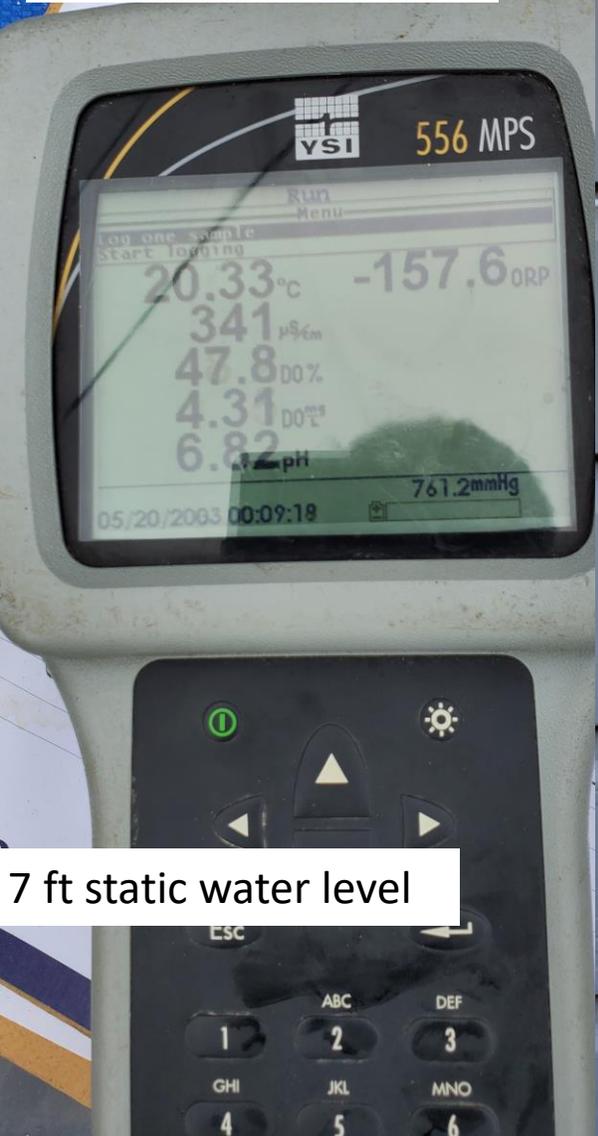
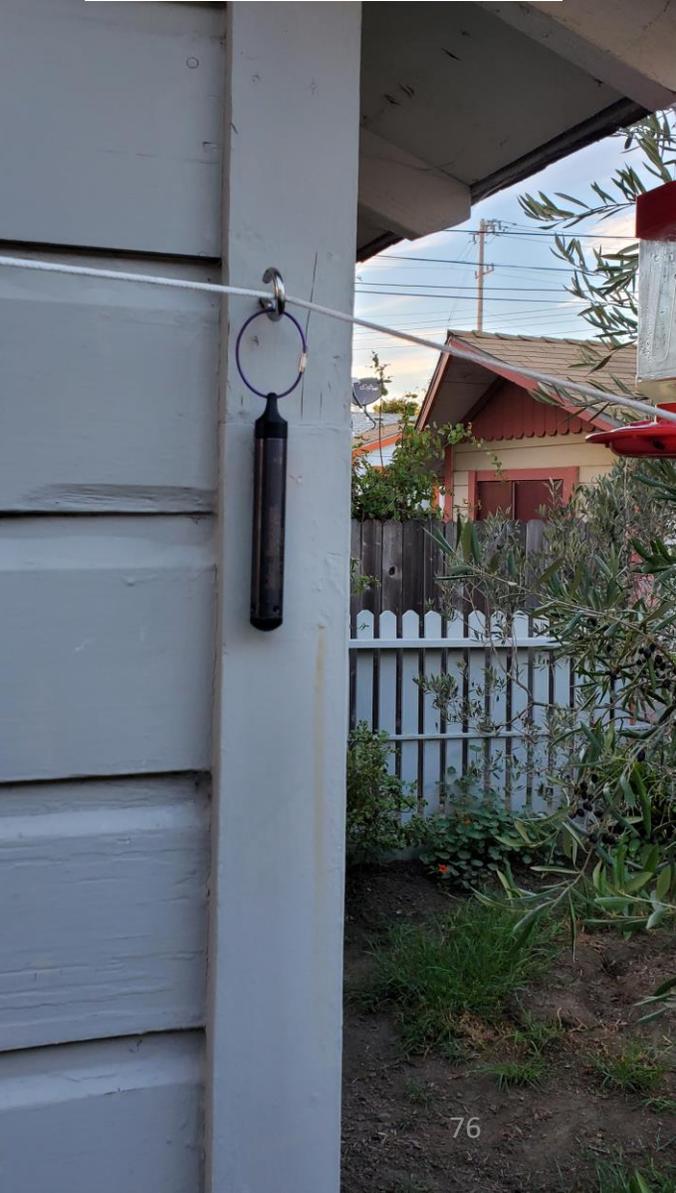
DO = 4.31 mg/L
EC = 343 = fresh water
Temp. = 20.33°C
pH = 6.82

10/16/22: install LTC sensor in well, and baro nearby

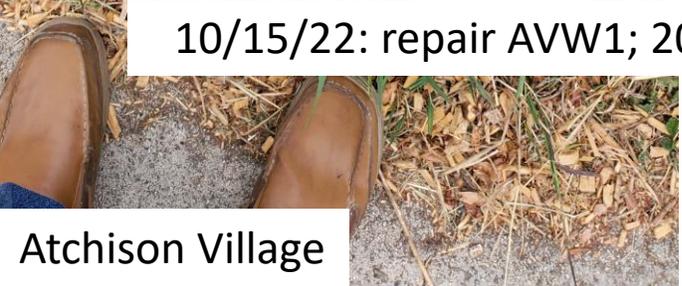
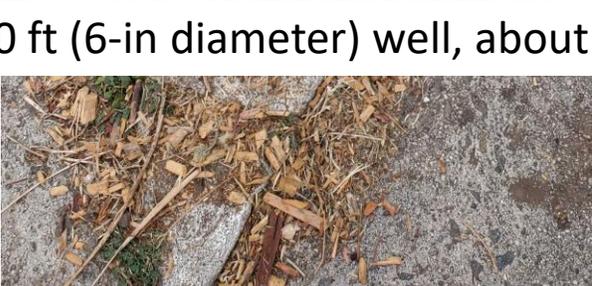
10/15/22: repair AVW1; 20 ft (6-in diameter) well, about 7 ft static water level

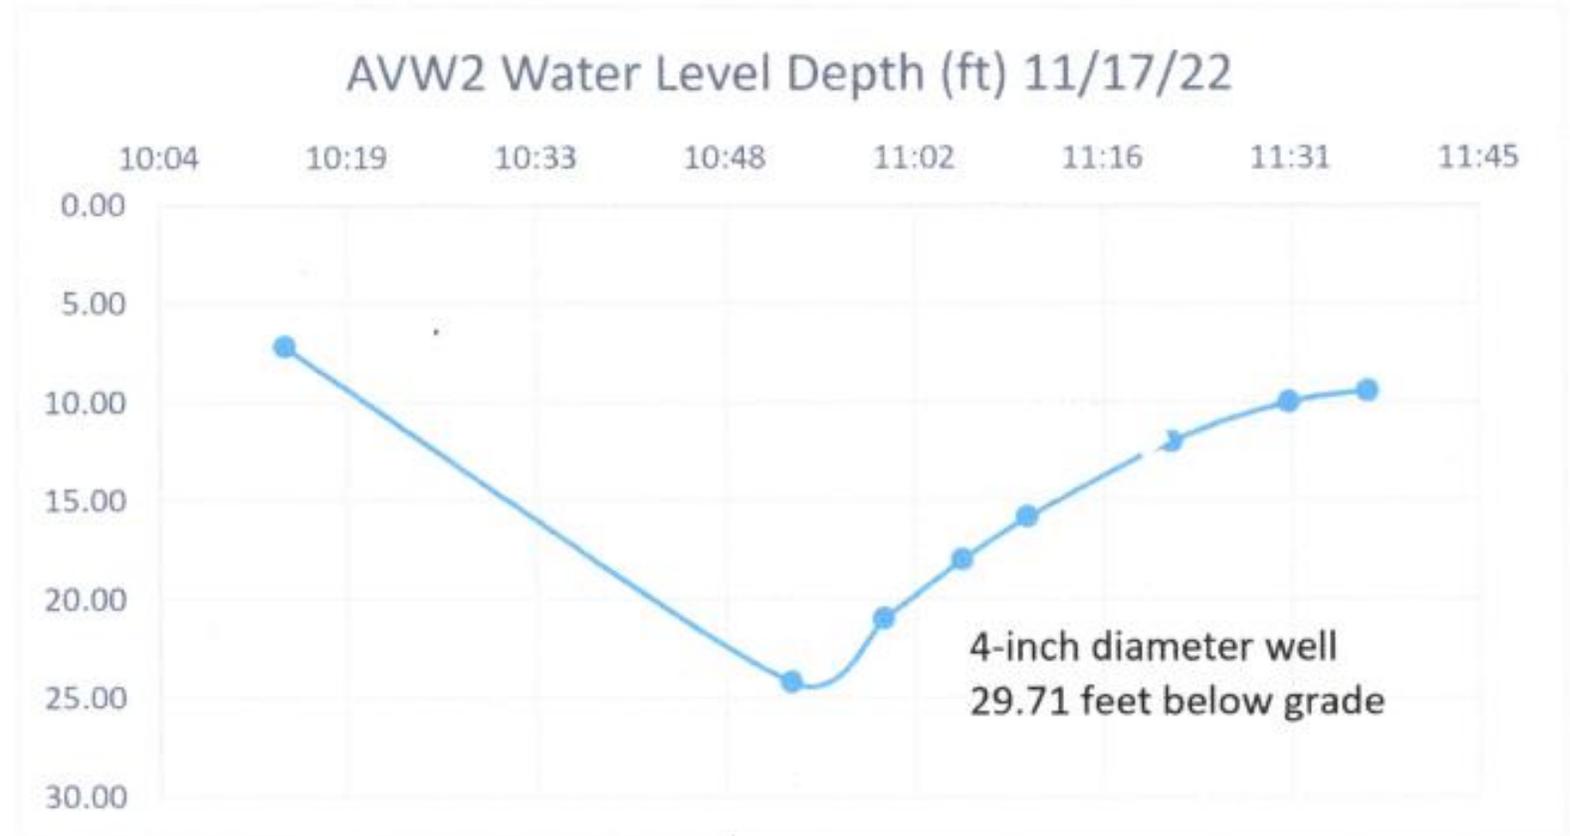
Atchison Village AVW2 – Pump and Recovery Test; Drawdown 17.01 ft; 76% recovery in 83 minutes

Gal Removed	Time	Depth (ft)
0	10:14	7.21
44	10:53	24.22
	11:00	21.00
	11:06	18.00
	11:11	15.87
	11:22	12.00
	11:31	10.00
	11:37	9.45

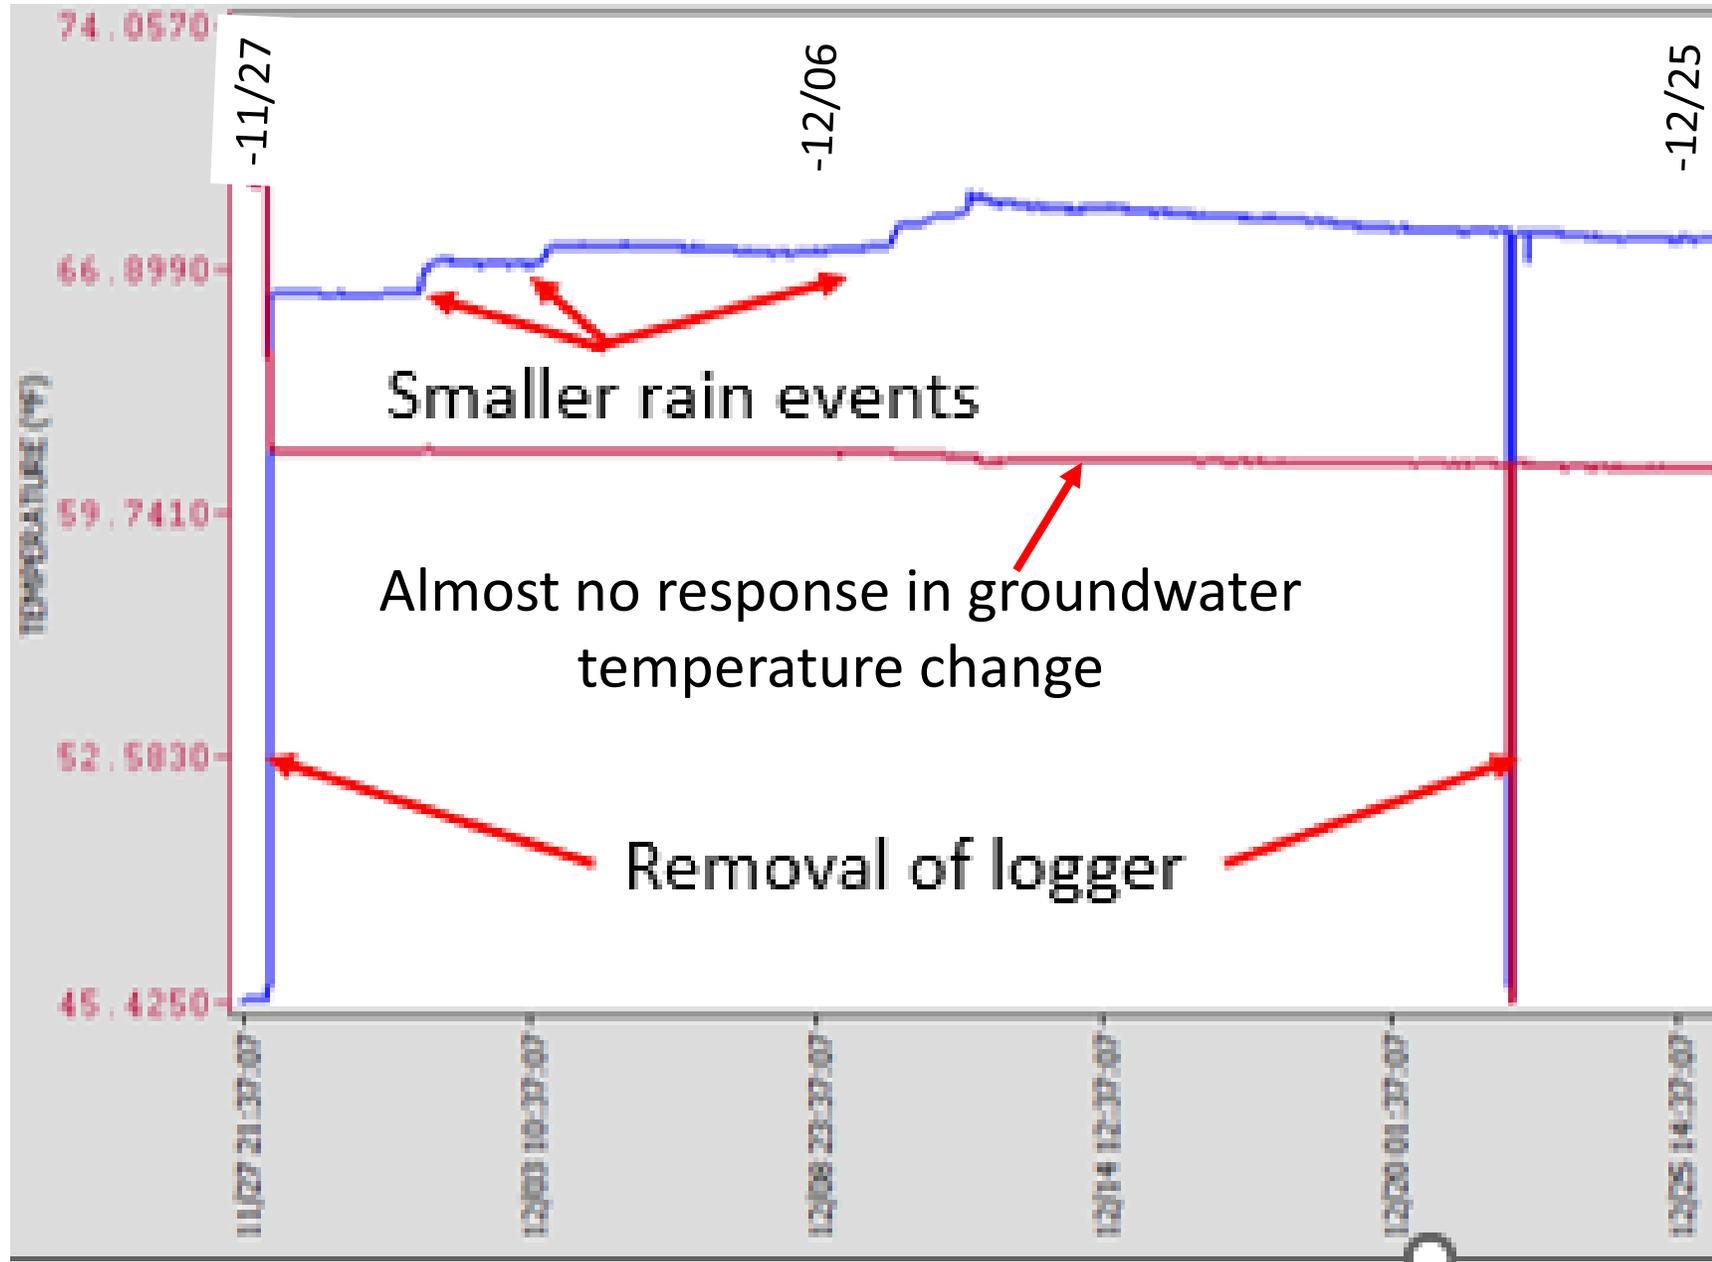
Atchison Village – AVW2 (253 Curry St., Richmond, California); Pre-Atmospheric River Condition

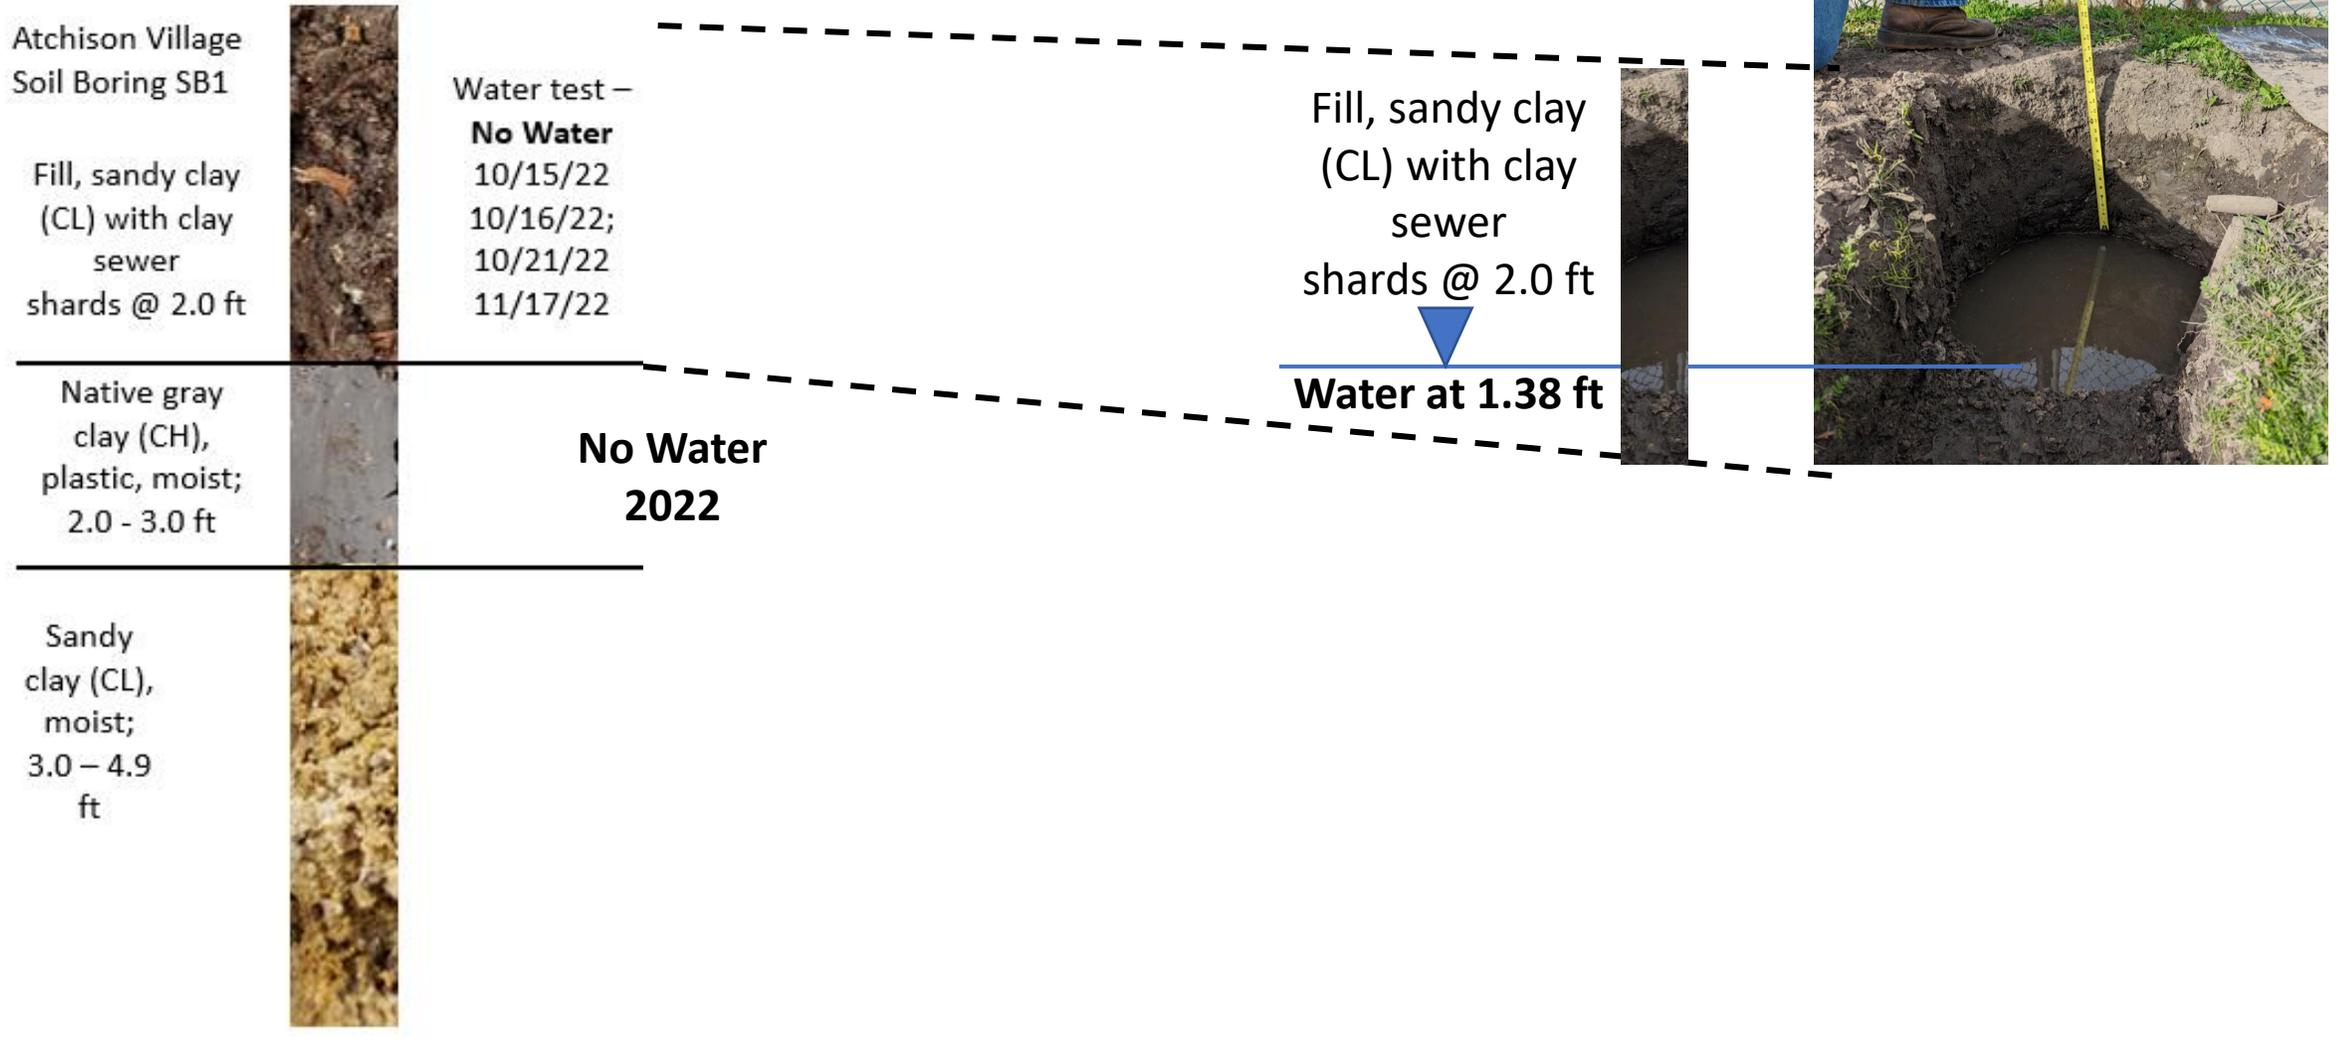
Atchison Village Soil Boring SB1; 10/16/22

Atchison Village Soil Boring SB2; 2/11/23

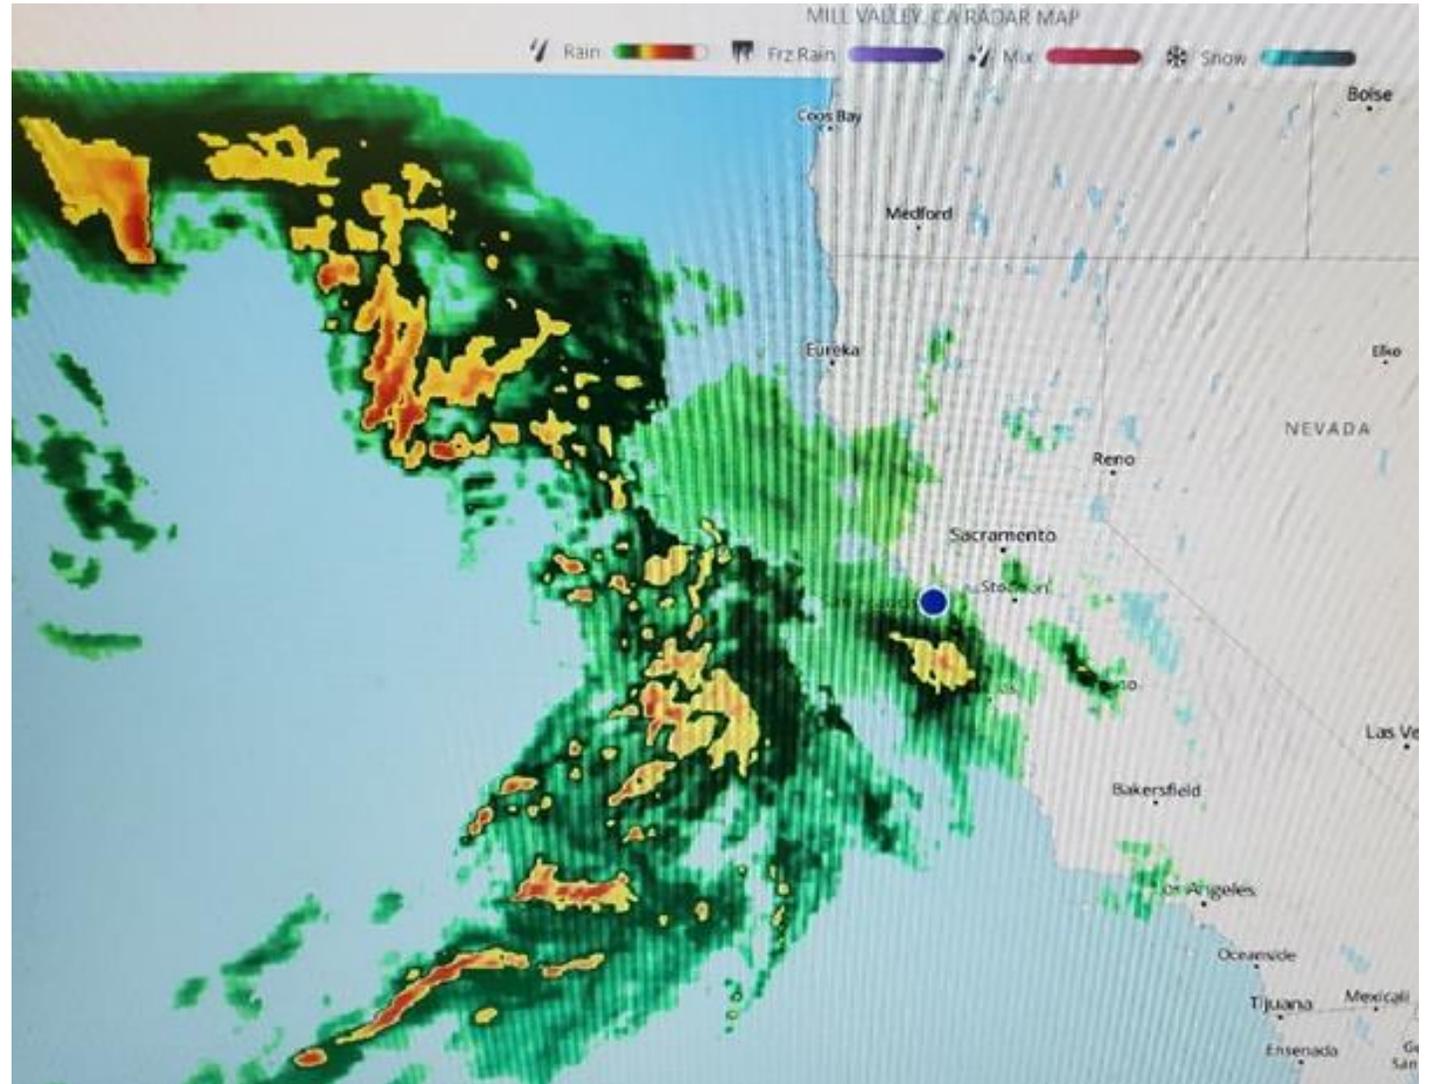
Atmospheric River
Condition (ARC)

Radar graphic from January 8, 2023 of an atmospheric river condition (ARC) which produced 0.72-inches of rain in Richmond, California on that date and 0.85-inches on 1/9/23

Similar concept for
43-day ARC in
1861 and great
flood of 1862

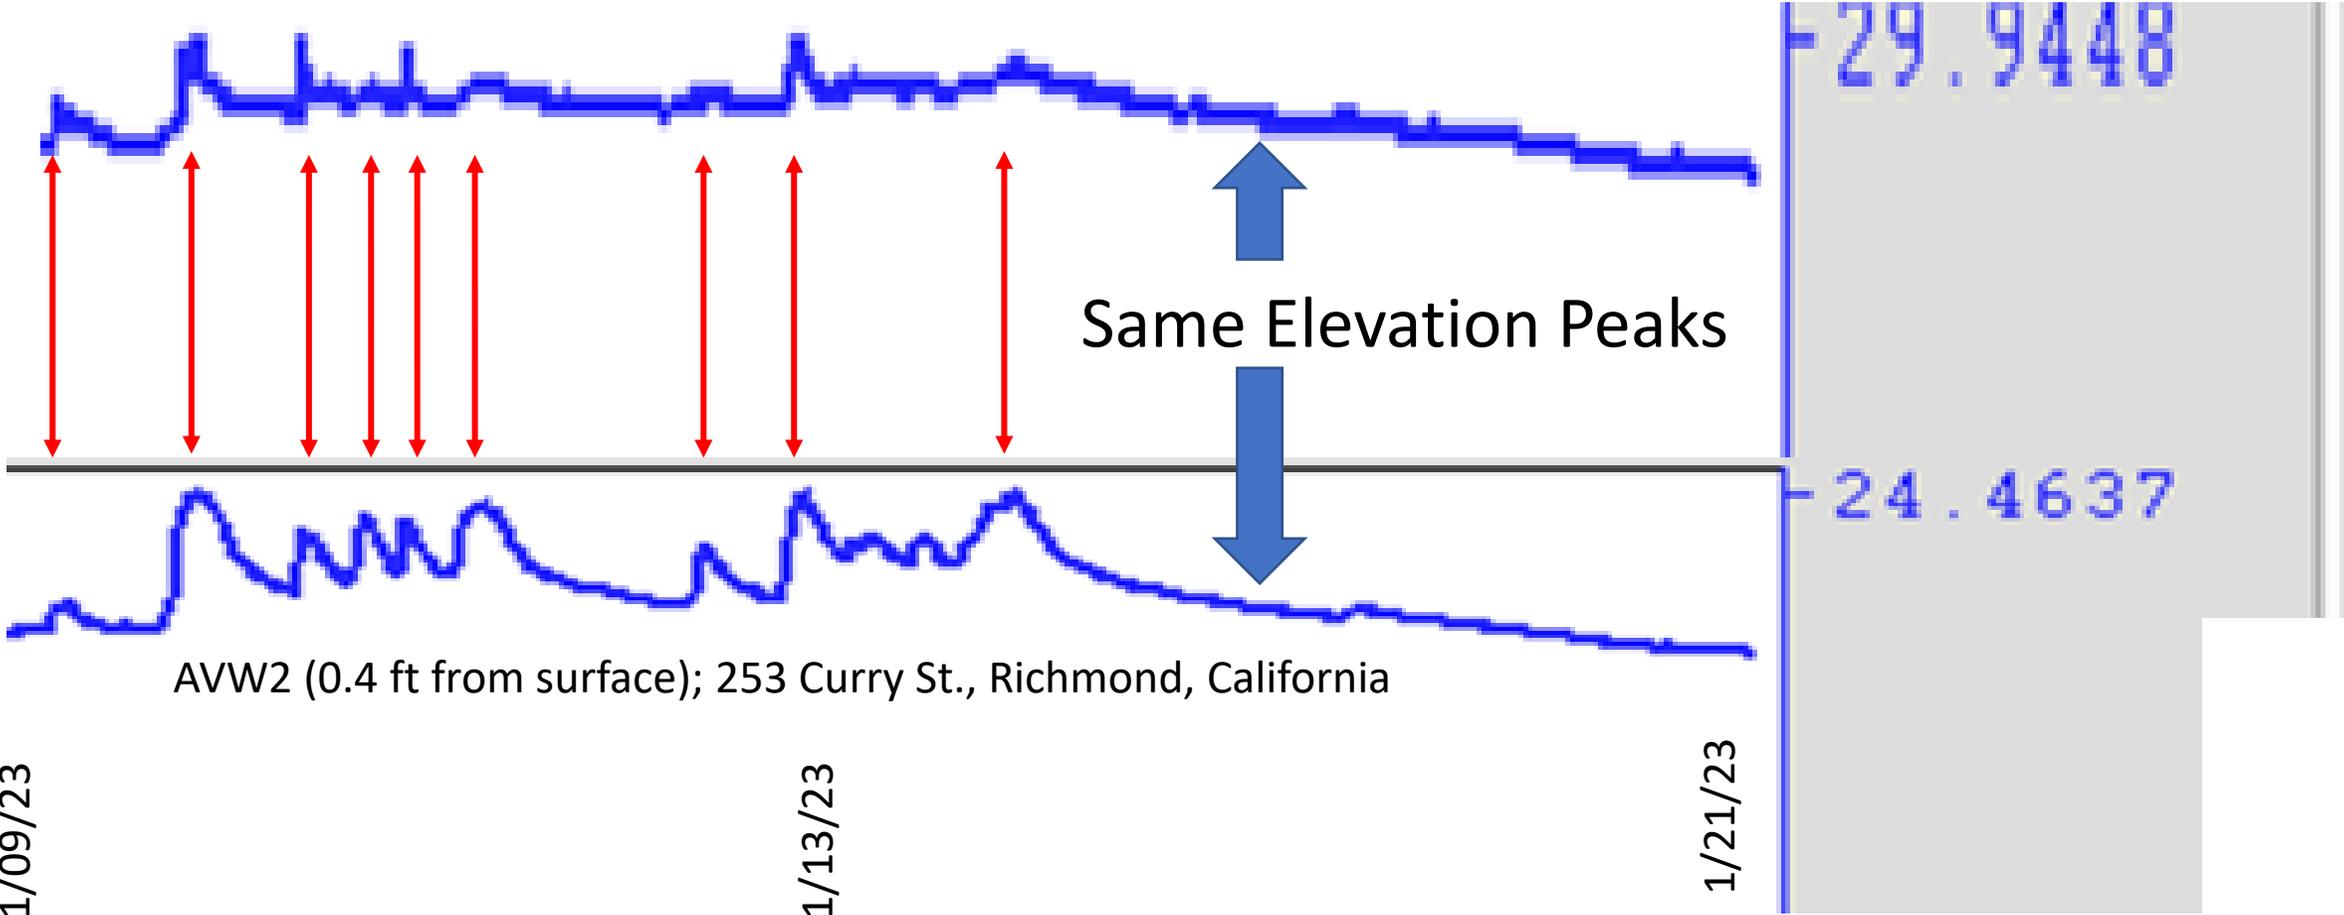
Atchison Village –Differences relate to logger sensitivity (M5 versus M30); AVW2 to AVW3 = 554 ft (169 m)

AVW3; 0.2 ft from surface; 155 Curry St., Richmond, California)

Elevation from bottom of logger to top of water

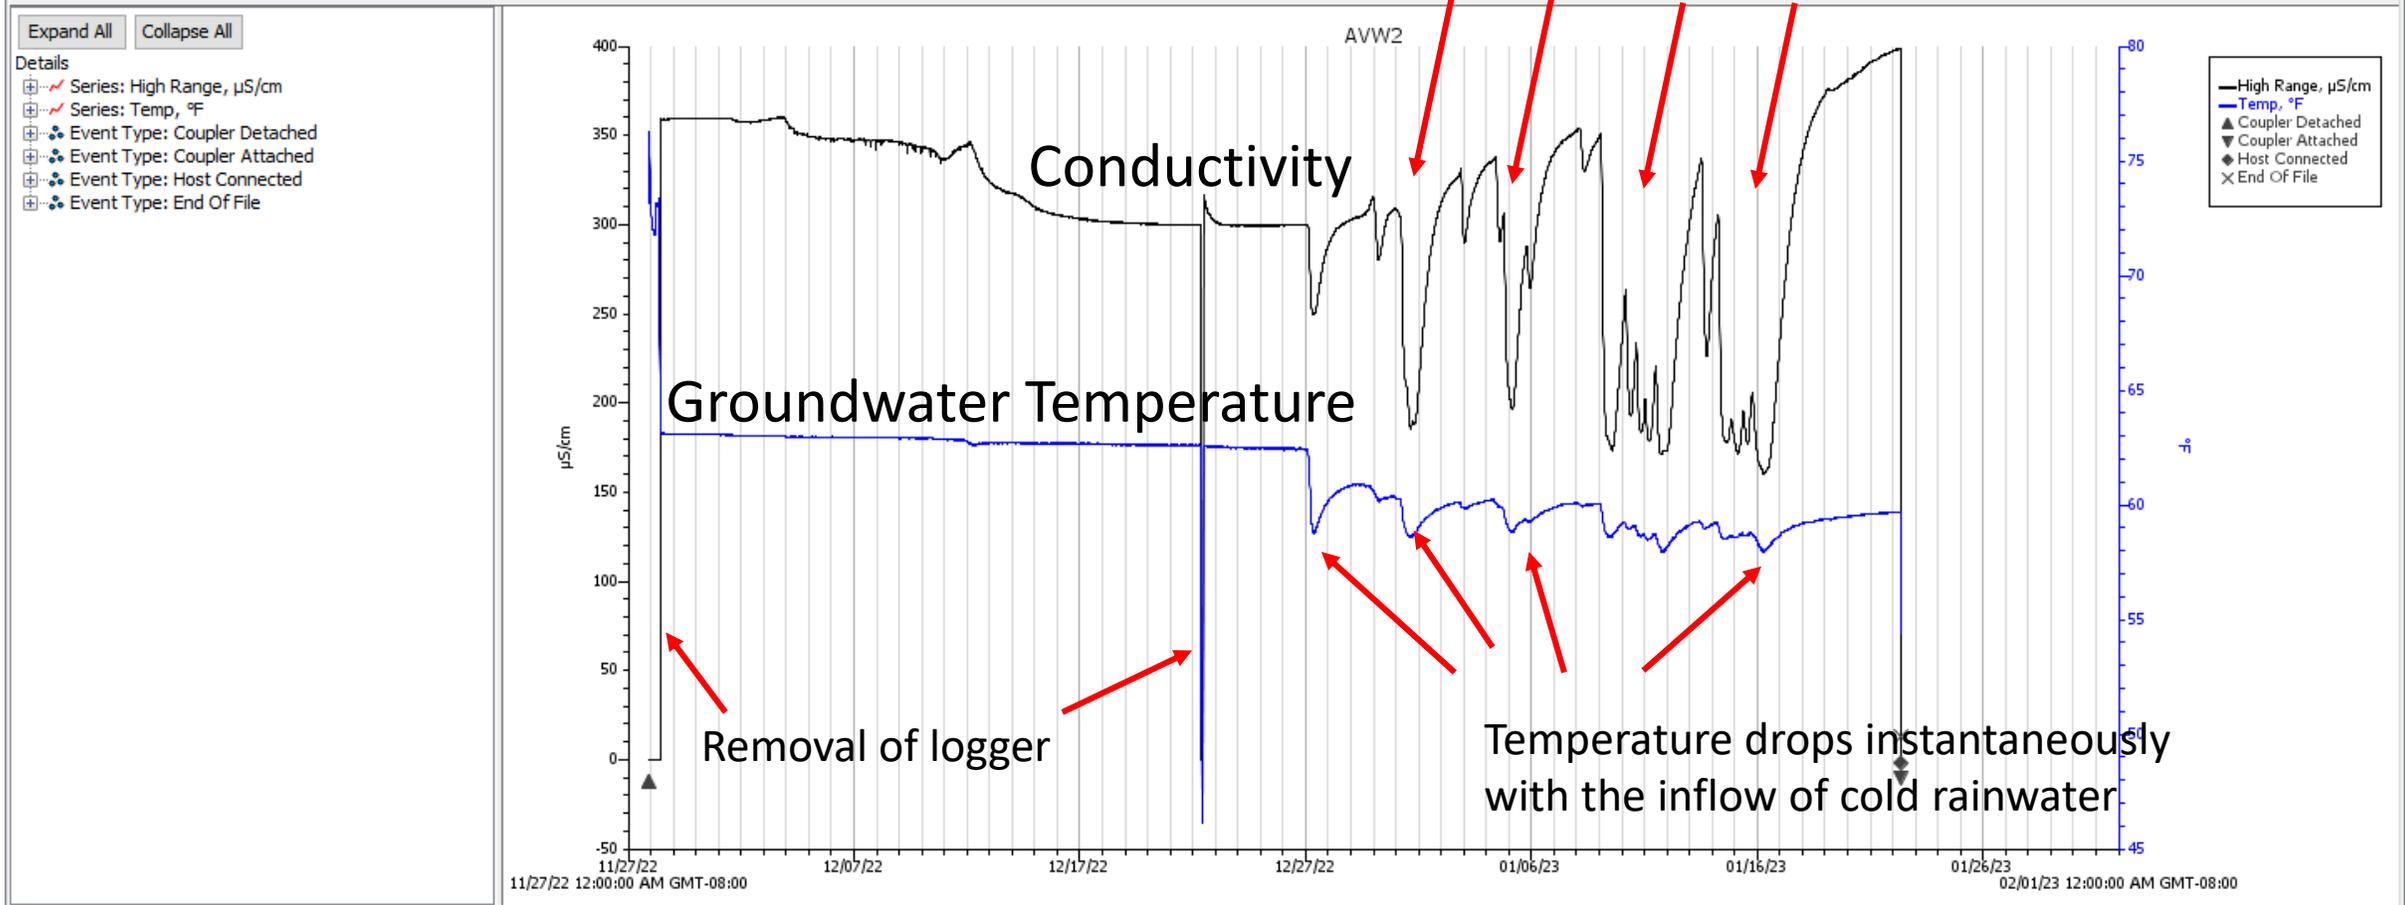
Atchison Village – AVW2 (253 Curry St., Richmond, California)

Water is freshwater, Water depth is 6.5 ft (12/22/22) and 2.4 ft below the top of the well box (1/22/23)

Examples of major rain events; lowering the salt content (conductivity) in the groundwater

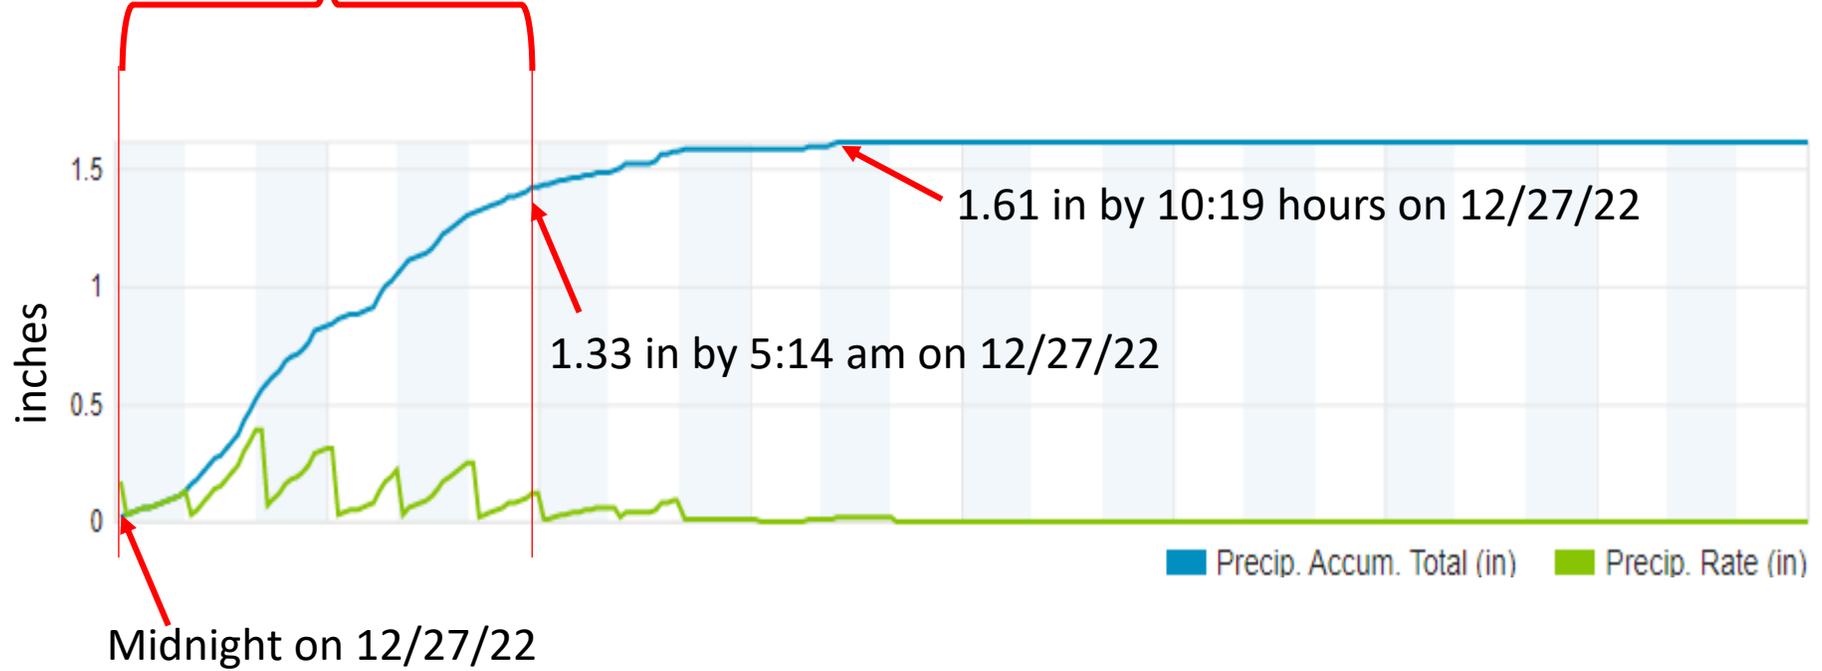
King Tide Influence (Pre-ARC); minor tidal influence (0.12 ft = 1.44 in on 12/24/22) from 9.11 ft of tidal change (king tide)

Richmond Marina Tower Weather Station 12/27/22: 24-hr: 1.61 in of rain

- Sea level rise does impact groundwater at Atchison Village, in a small way; no overtopping
- Atmospheric River Conditions significantly influence groundwater elevation rise (1" rain = 21" groundwater elevation rise)
- An historic ARC occurred in northern California between December 26, 2022 to January 16, 2023
- Early results show isotopes and water characteristics showed crawl space water is mostly groundwater and rain; more research is ongoing
- Community science volunteers have made a meaningful contribution to the study
