Resiprufe waterproof the Univar chemical bunds and sumps

Resiprufe worked with the client to fix problems with 2 small sumps, to protect the floor in the filling shed, to re-line a large sump and to seal and crack bridge the whole bund for an aggressive chemical.

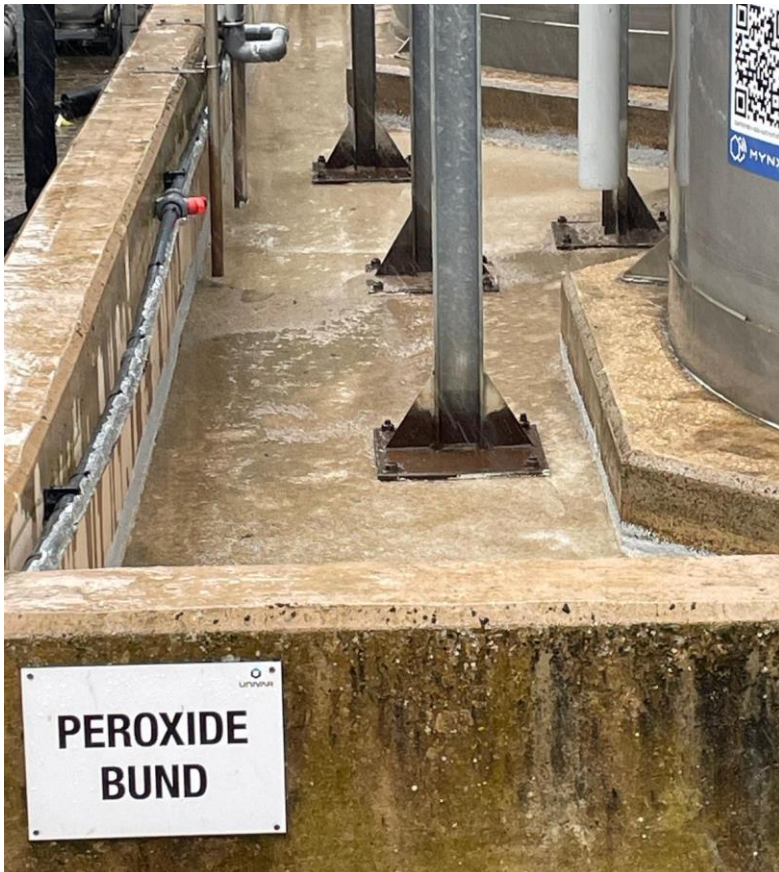
The peroxide bund was built in the case of accidental damage to the bunds that could result in a catastrophic failure and therefore fill the bund. The bund is a concrete structure.

Peroxide is aggressive on bare concrete and could also penetrate through any cracks and seep into the ground water.

The client wanted a solution that would provide a crack bridging base layer combined with a top coat that would resist the Peroxide for a minimum 72 hours – this was determined by the worst case length of time from discovery to emptying.

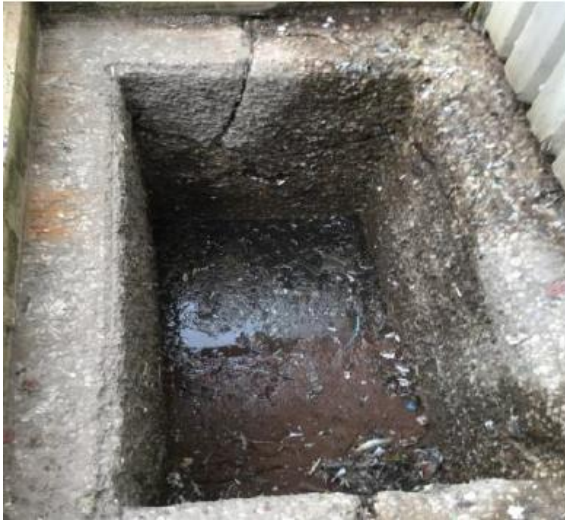
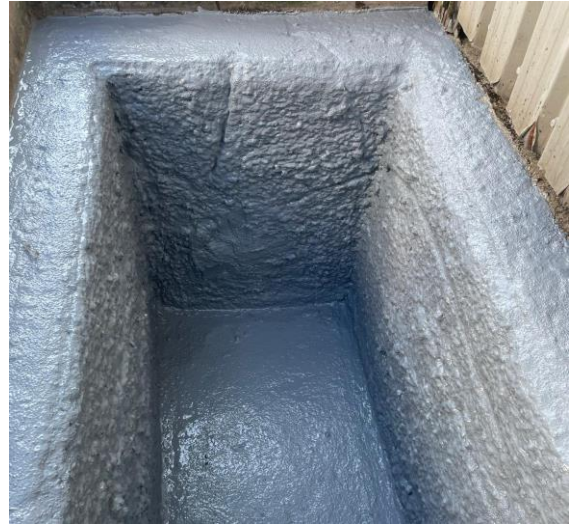
Sump repairs

Sometimes a sump is exposed to chemicals more than the general bund because it's the low point in the bund and also fills up with diluted peroxide after washing the floor. Sometimes we have encountered sumps that have literally dissolved and broken into pieces (see above pictures of before and after). We cleaned out the sump, mechanically prepared to remove loose friable materials and then patched up with PUMA resin tough flexible resin thixotropic to fill in vertical gaps. Finally, the sump was then sealed with the Novolac epoxy top coat.

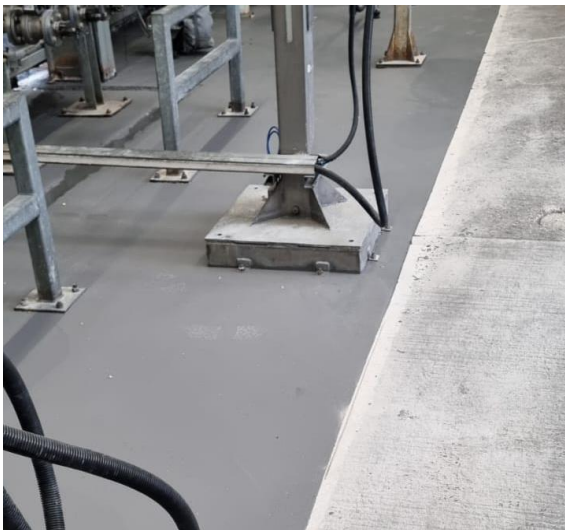
Floor Coating – Filling Room

The filling room was used to fill drums from IBC containers. It is unavoidable to get drips and spills from time to time, and the floor was regularly washed down. Over time the concrete floor had started to be corroded.

Additionally the floor was falling away from the drain. We cut a channel in the centre and also ground the floor to create a fall from the back wall to the drain. We then installed a polyurethane screed which resists peroxide.

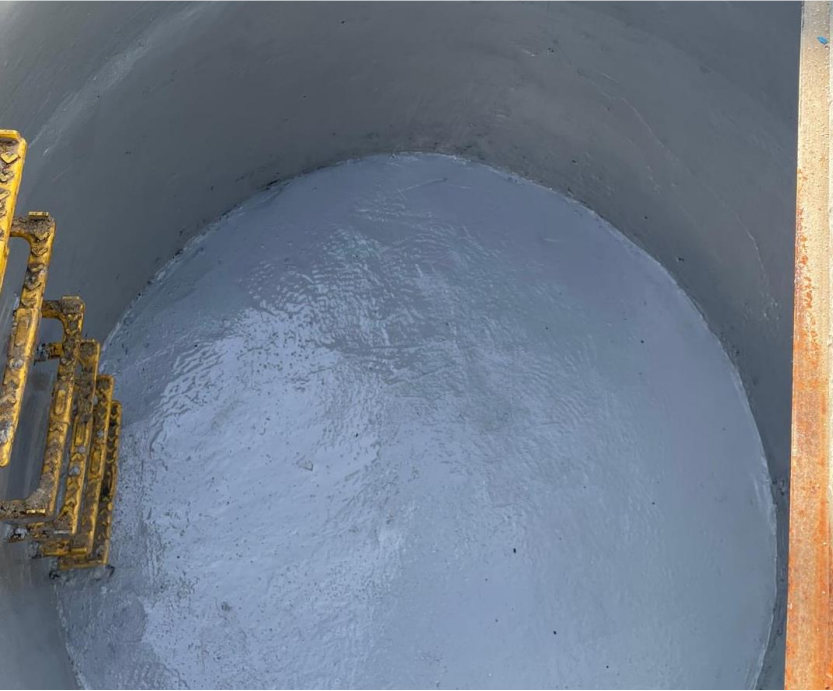
Refurbishing the main sump

The large sump which held the rainwater, washing from the filling room, etc. was constantly exposed to diluted peroxide. Over time the surface wore away exposing large aggregates, slowly destroying the sump. We resurfaced the lining of the sump with Novolac Epoxy Mortar followed by 2 coats of Novolac Epoxy.

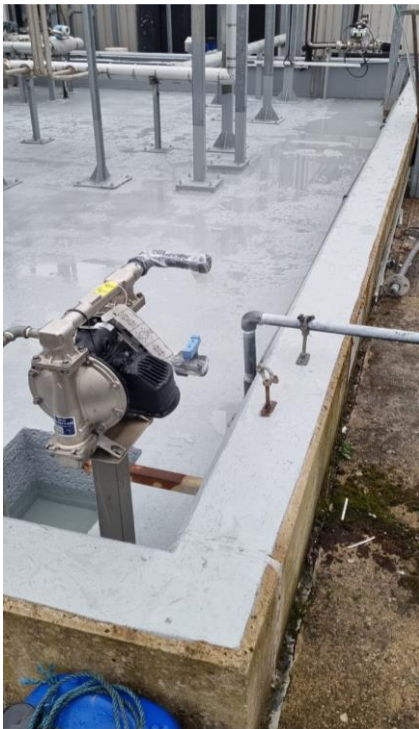
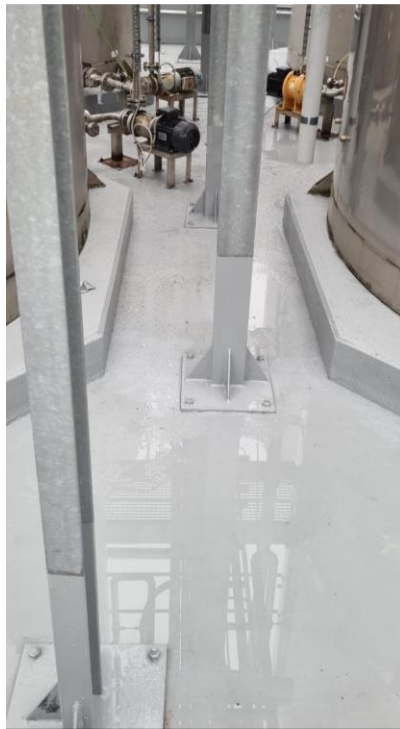
Main Bund

The finished bund certainly looked the part, a fantastic upgrade aesthetically, structurally and most importantly provided the 72 hour chemical resistance needed in the event of a failure.
