# YORK COUNTY REGIONAL CHESAPEAKE BAY POLLUTANT REDUCTION PLAN (2018-2023)

SUBMITTED TO PA DEP SEPTEMBER 15, 2017  
(REVISED AND RESUBMITTED OCTOBER 10, 2017)  
(REVISED AND RESUBMITTED \_\_\_\_\_, 2020)

PREPARED BY THE YORK COUNTY PLANNING COMMISSION IN  
COOPERATION WITH THE YORK COUNTY STORMWATER CONSORTIUM

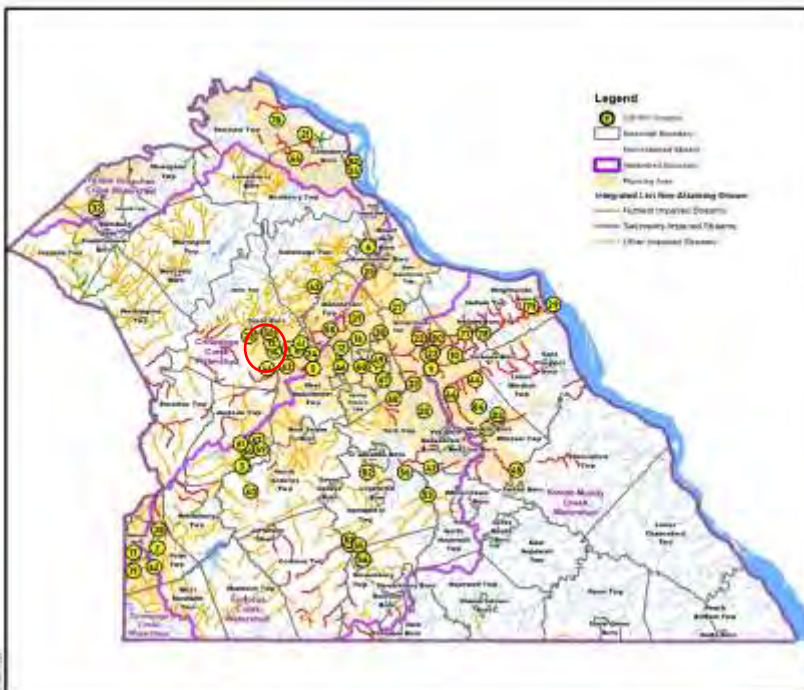
Retrofit of two existing basins at the Dover Township Community Center. The west basin is on parcel ID #24000JG0081D0 and the east basin is on parcel ID #24000300001A0.

Both basin retrofits are located on public land. The west basin is 50'x350' and the east basin is 70'x235' for a combined basin footprint of 33,950 sq. ft. or 0.78 acres.

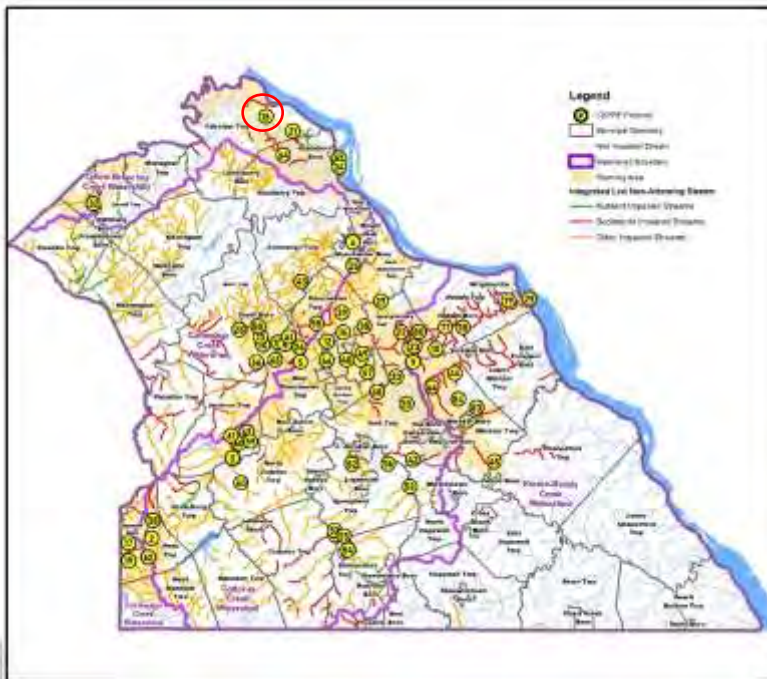
Retrofit a stormwater pond that is the BMP for a small subdivision.

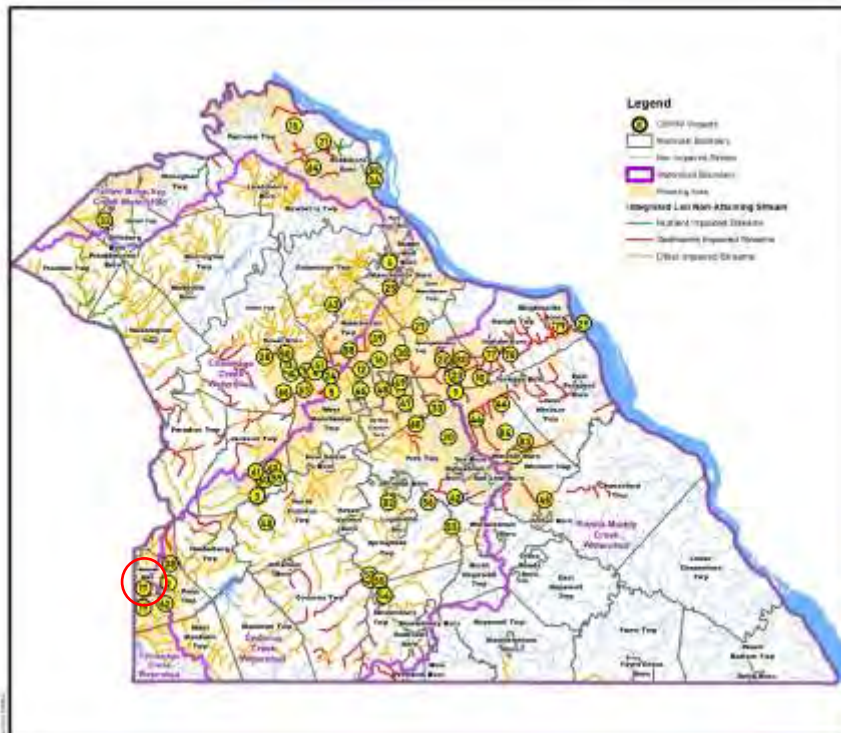
This project will replace an existing swale located alongside a Borough-owned building with an infiltration BMP. The existing swale is undersized to handle the runoff draining to the site. The new infiltration BMP will have an increased storage capacity to alleviate flooding, as well as provide water quality benefits. The BMP location is Parcel ID: 670000901970000000 owned by East Coast Commercial Real Estate LLC.

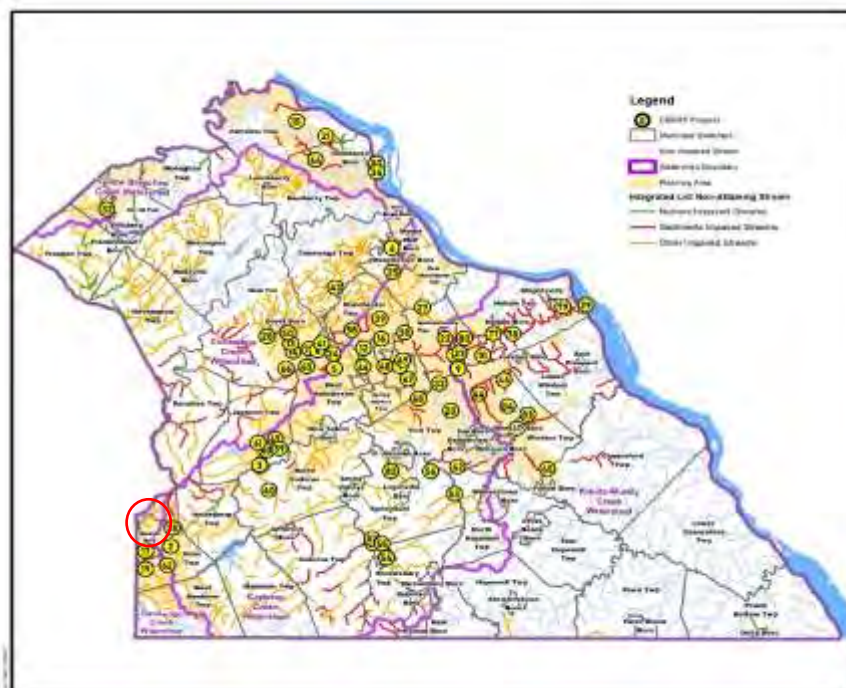
Approximately 1,600 feet of stream restoration on property parcel ID # 44000CD0080A owned by Homewood at Hanover Inc.

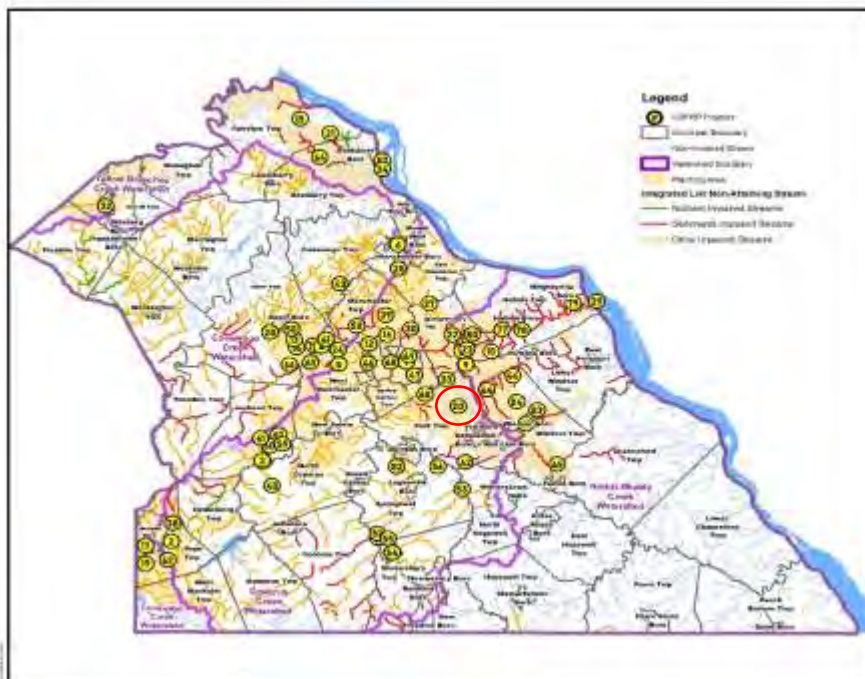
After removal of the dam and stream channel reforming, the wetland areas will be restored.

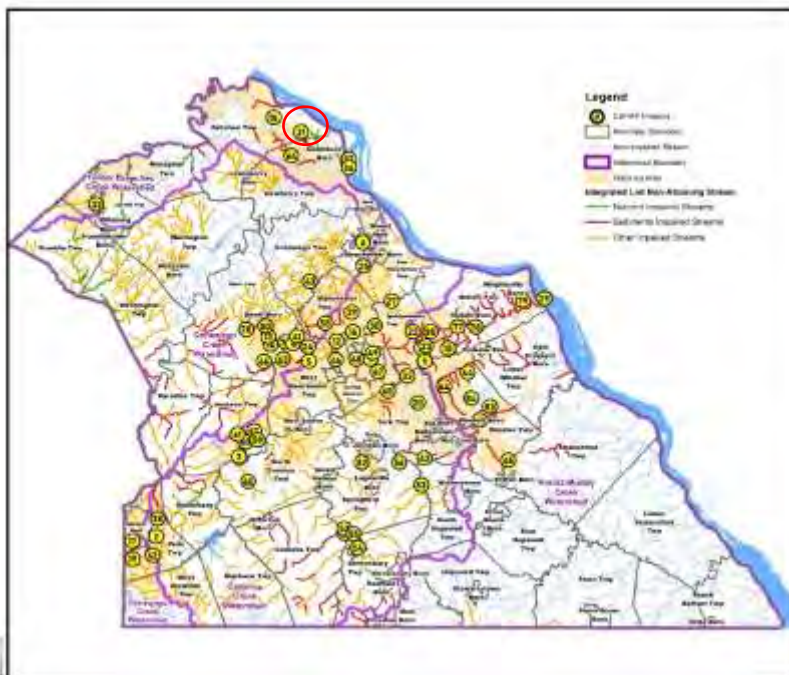
This project includes two (2) sections of stream restoration. The sections of the UNT to Fishing Creek proposed for restoration are not impaired, however the section of the tributary downstream from the project site is impaired for siltation.

The sections of stream proposed for restoration include 1,700 ft of stream at Red Land High School, property parcel number 27000QF0145A000000 owned by the West Shore School District; and 1,200 ft of stream east of Red Land High School within a PA American Water easement near I-83.

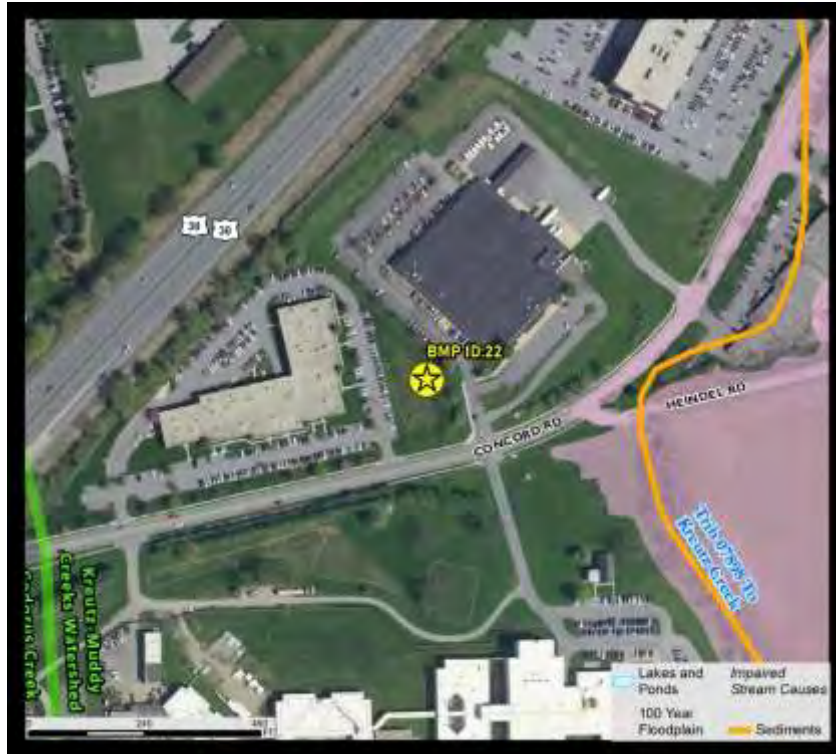
Coordinates are for the east basin shown on the map.

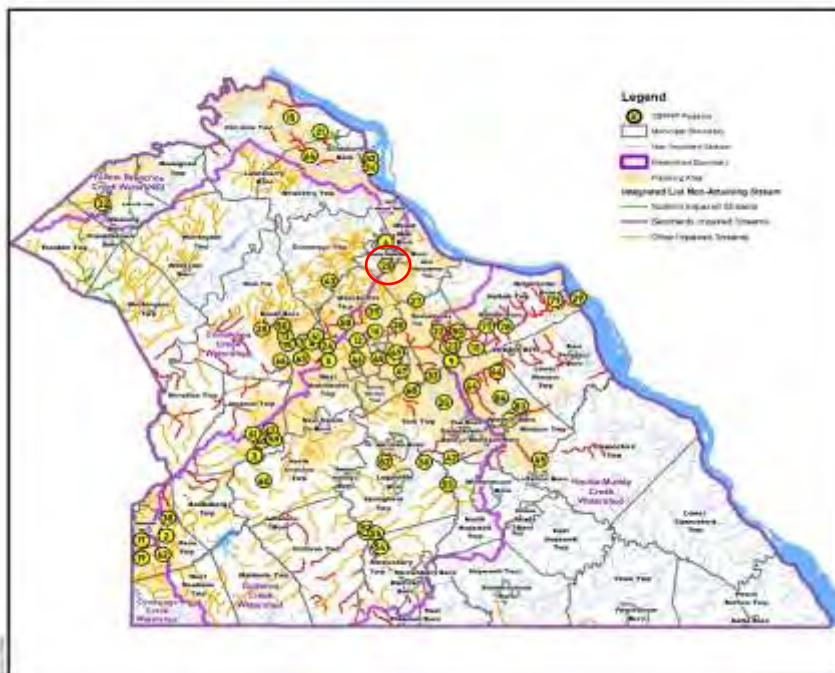
This project will retrofit the existing basin with amended soils and plantings to provide additional water quality benefits.

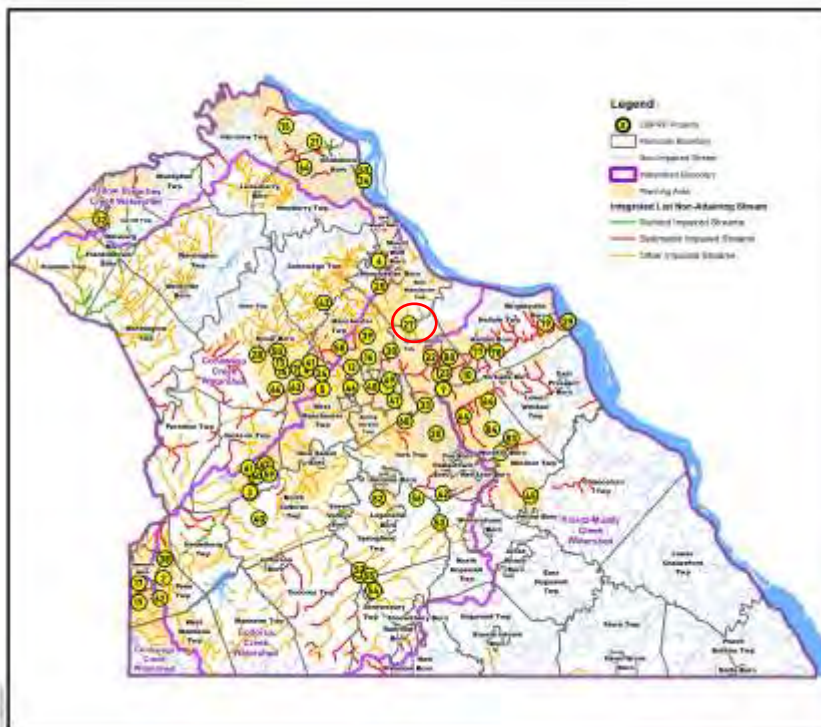
This project seeks to stabilize actively eroding banks along approximately 2,896 LF of stream bank using proven naturalistic techniques including vegetative bank stabilization, strategically placed bio-engineered toe protection, bank grading, targeted floodplain restoration, and a 35 foot riparian corridor restoration using native tree and shrub plantings.

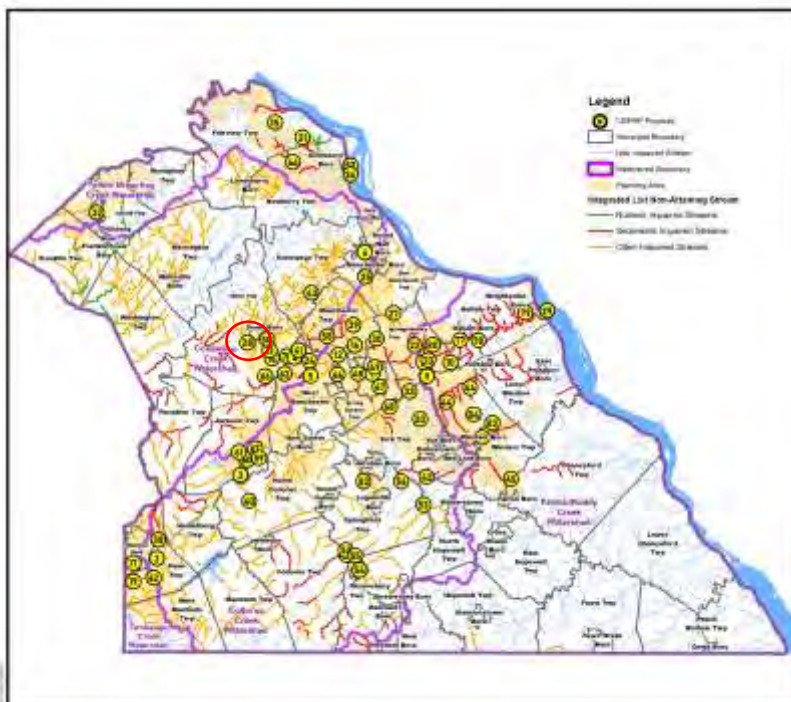
Bioretention/raingardens on site of new public works facility.

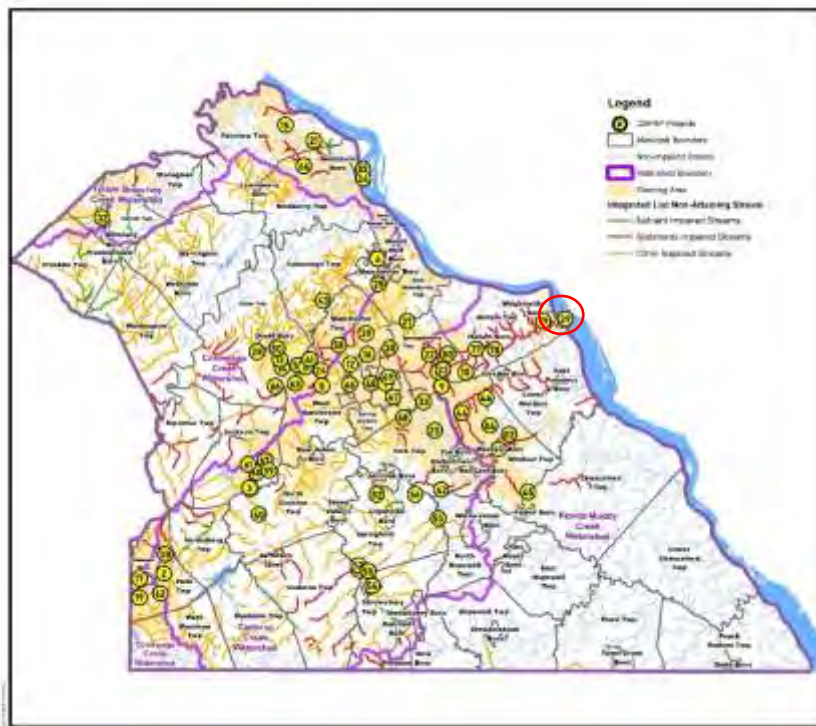
Implementation of a bioretention facility in Riverfront Park to control flooding.

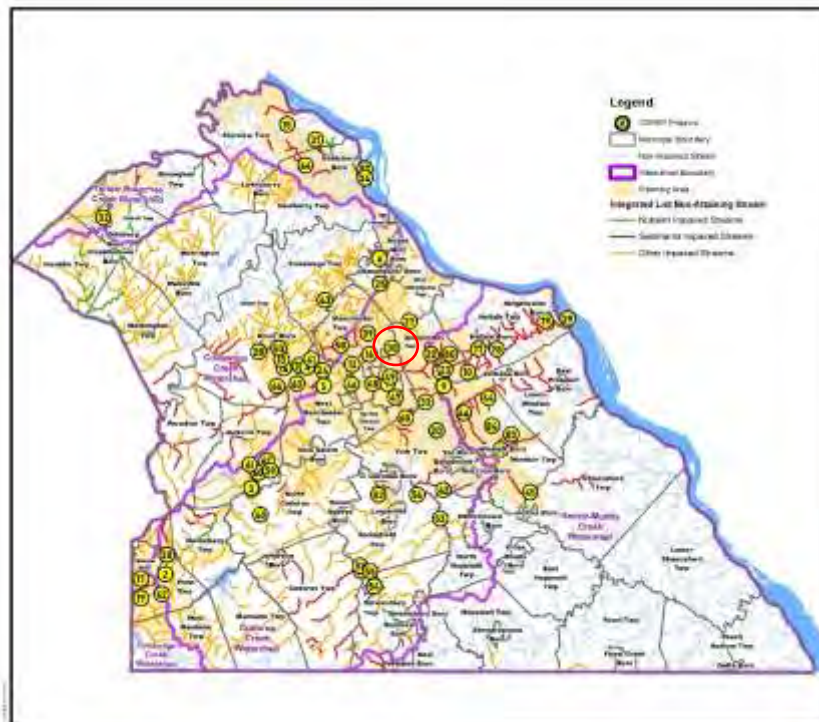
Water re-use operations installed during the planned expansion of the York County Solid Waste and Refuse Center will result in reduced stormwater runoff volume and a reduction in TSS load.

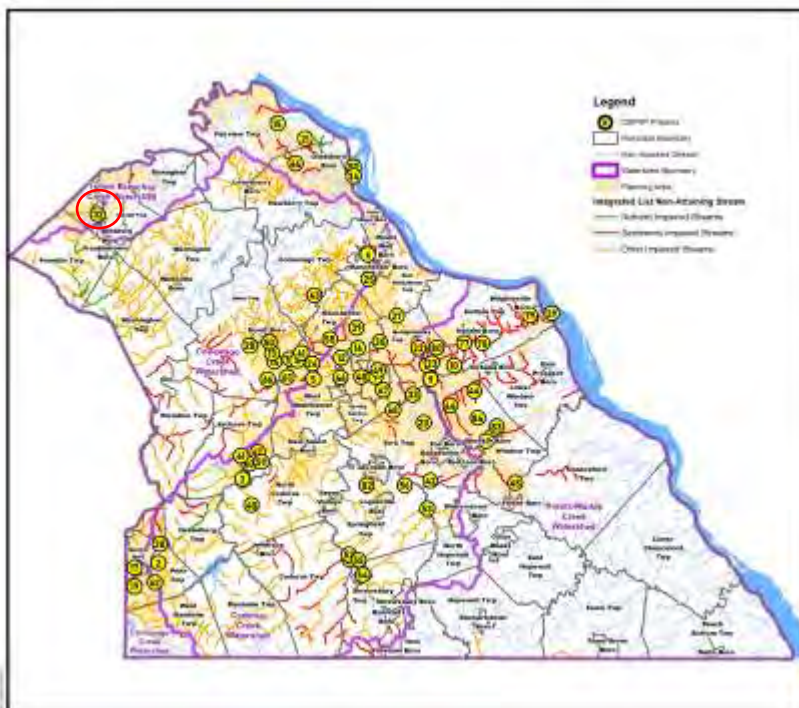
Project is part of an existing E & S basin to SW conversion. Enhancements include naturalization, infiltration, and filtration.

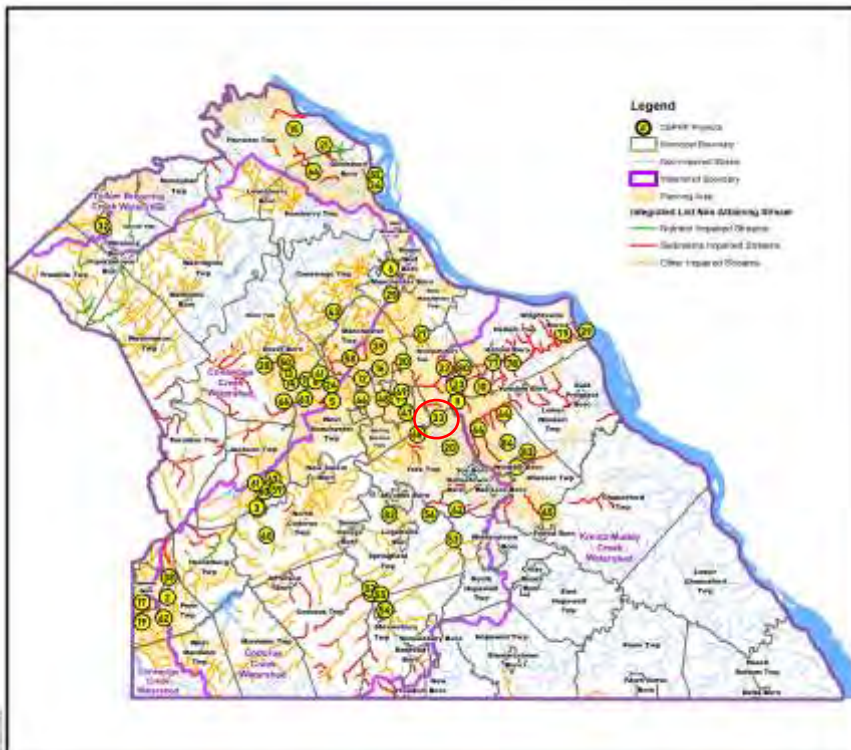
This stream restoration included reconnection to the floodplain, but data was not available to calculate sediment reduction for that component.

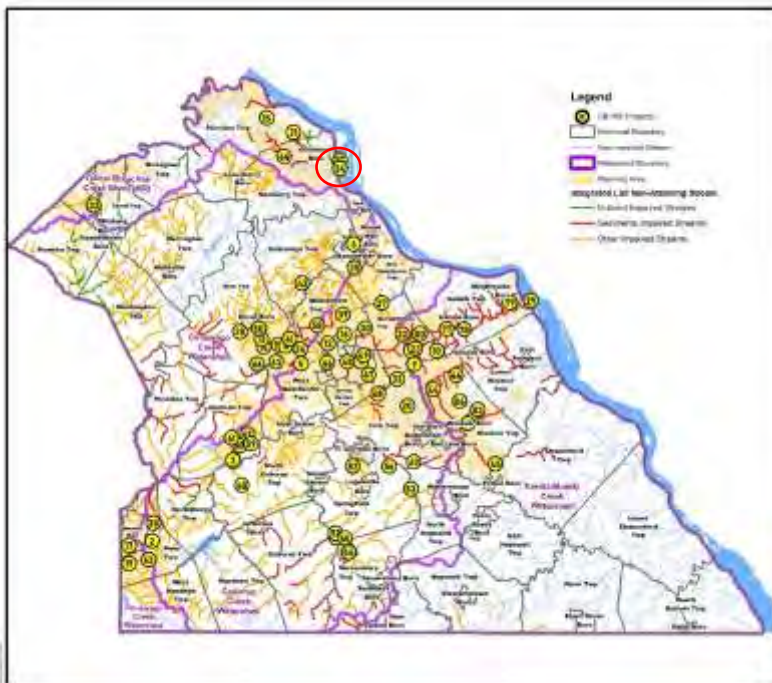
Restoration of Fishing Creek from Borough Park to the River. Will include a riparian buffer. This project is an extension of Project #57.

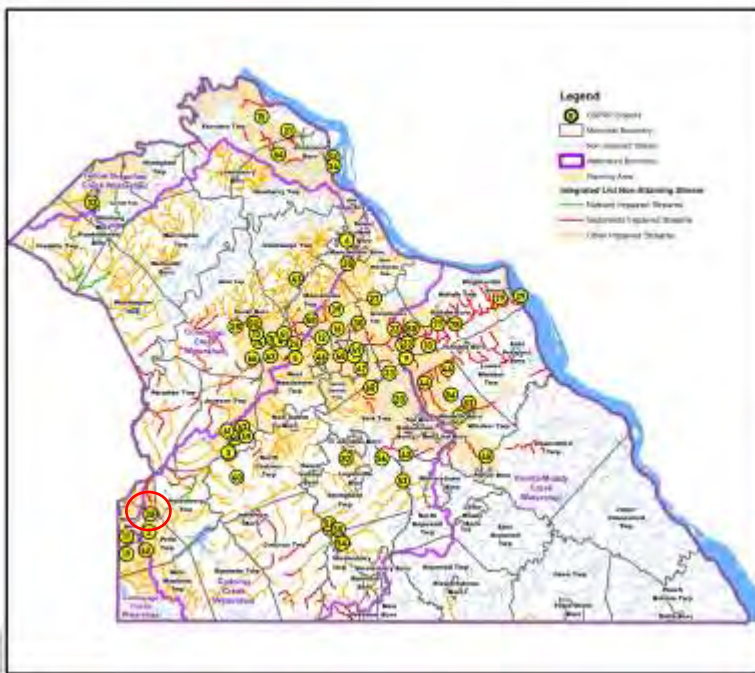
A SWM Plan is being prepared for the 65 acre School District property. This project is a SWM demonstration project associated with the Plan. It also includes continuous monitoring after construction is completed.

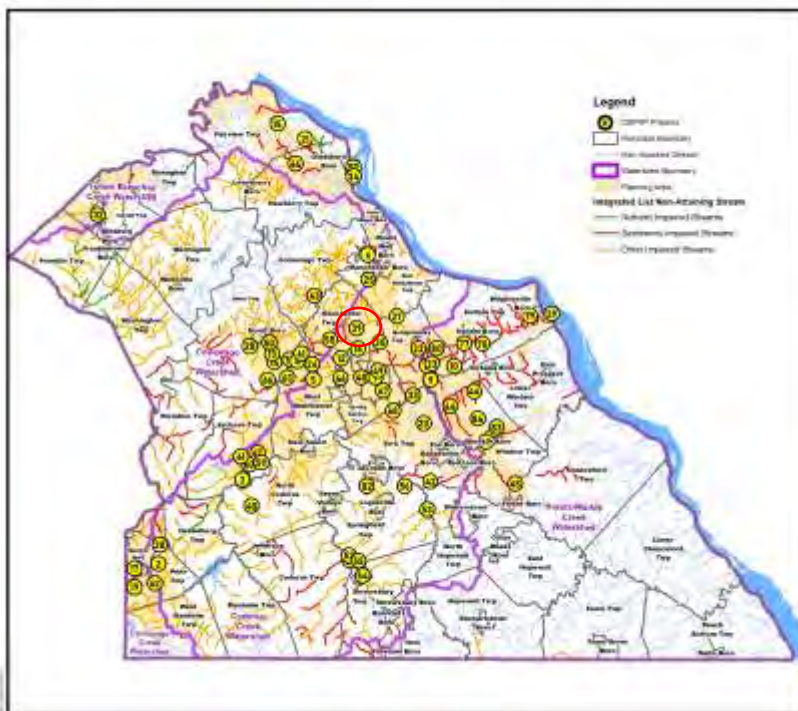
This stream restoration project was completed 12/6/2019. It included a buffer and reconnection to the floodplain. Anticipate higher sediment reduction with PCSM analysis.

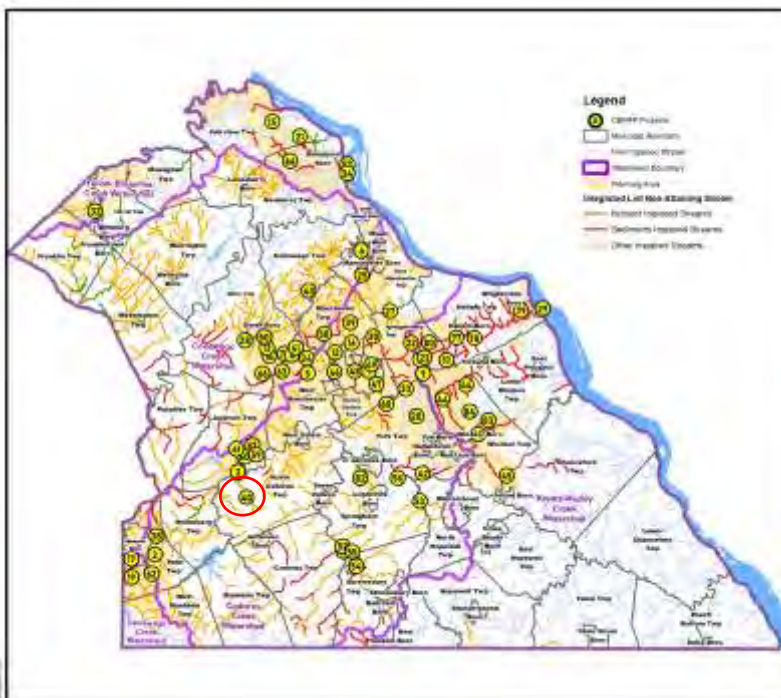
This project includes stream restoration with reconnection to the floodplain and a riparian buffer. Is located outside the Planning Area, but drains to it.

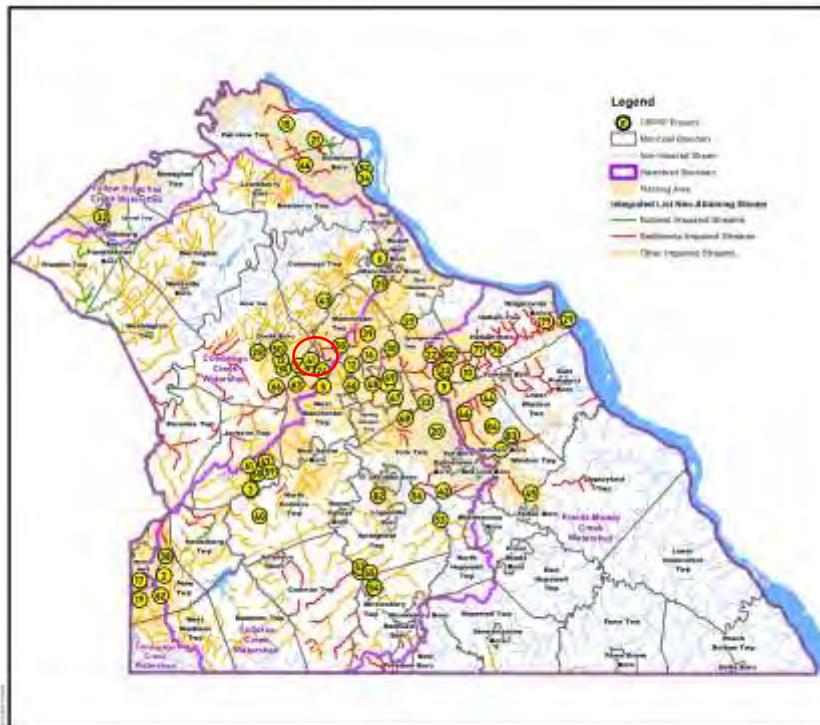
This project includes stream restoration with reconnection to the floodplain and a riparian buffer. Project is on Grandview Golf Course.

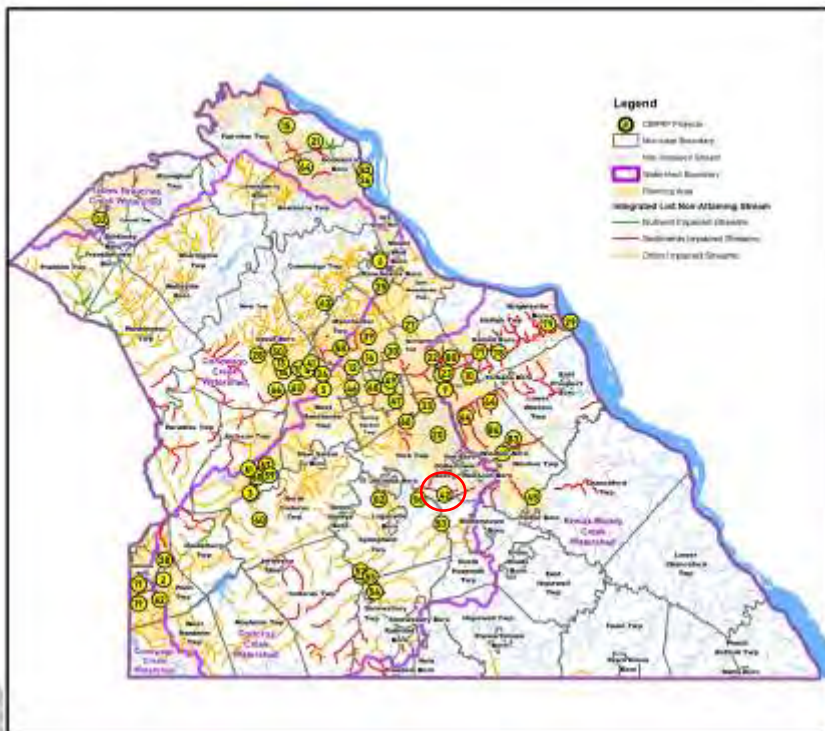
This project includes stream restoration with reconnection to the floodplain and a riparian buffer. Project is shovel ready.

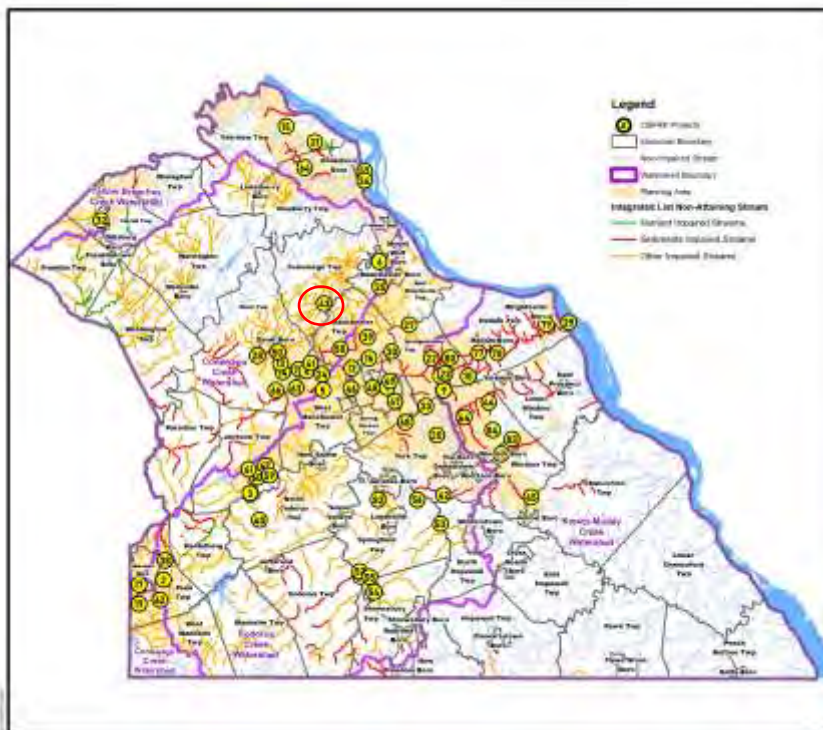
Stream restoration with reconnection to the floodplain and a riparian buffer.

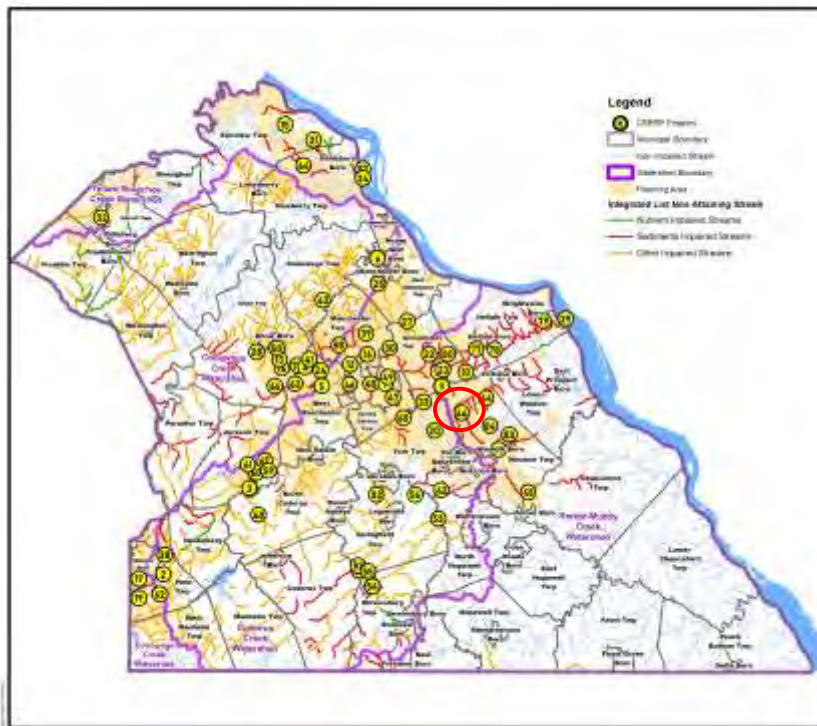
This project includes stream restoration with reconnection to the floodplain and a riparian buffer.

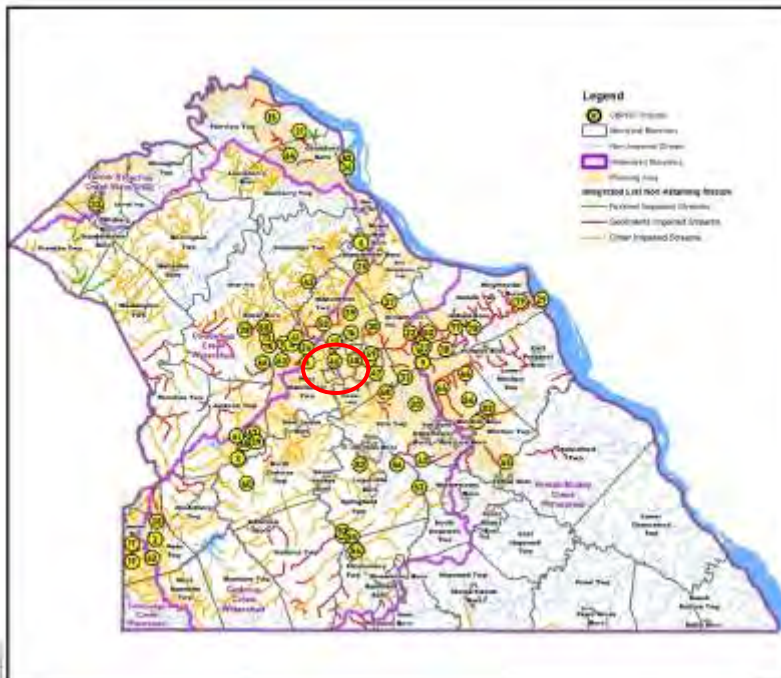
Stream restoration and floodplain restoration within Lincoln Park.

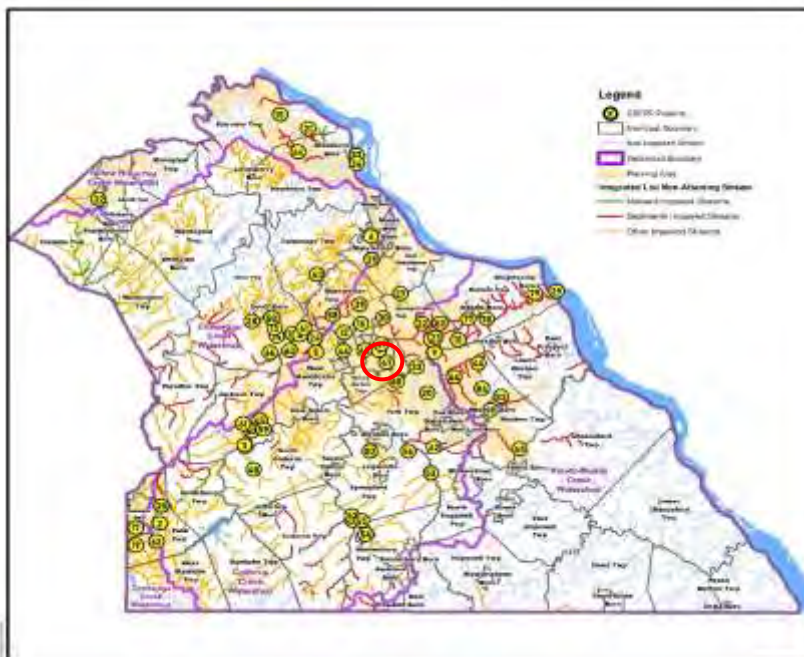
Stream restoration and floodplain management of the stream running through Memorial Park in the City.

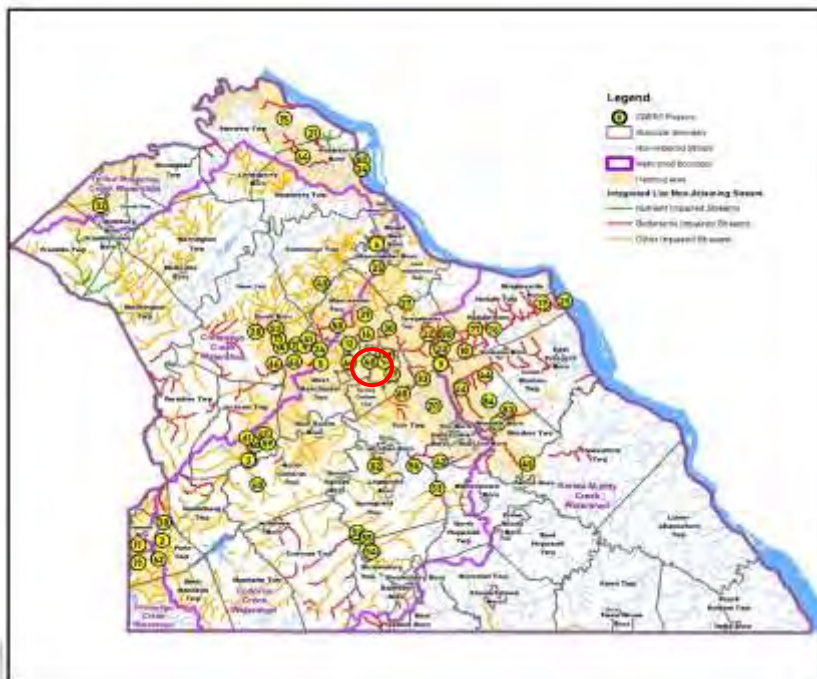
Reconnection of the groundwater table with the highly urbanized channel carrying Willis Run towards the Codorus Creek.

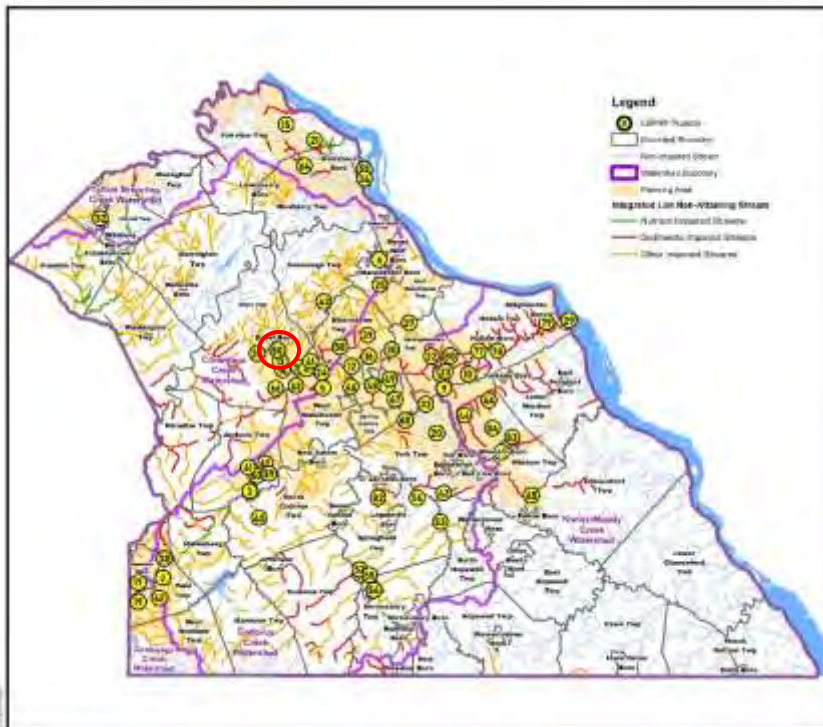
Stream and floodplain restoration on a former golf course property along Fox Run and an unnamed tributary to Fox Run. Site is now a Township park.

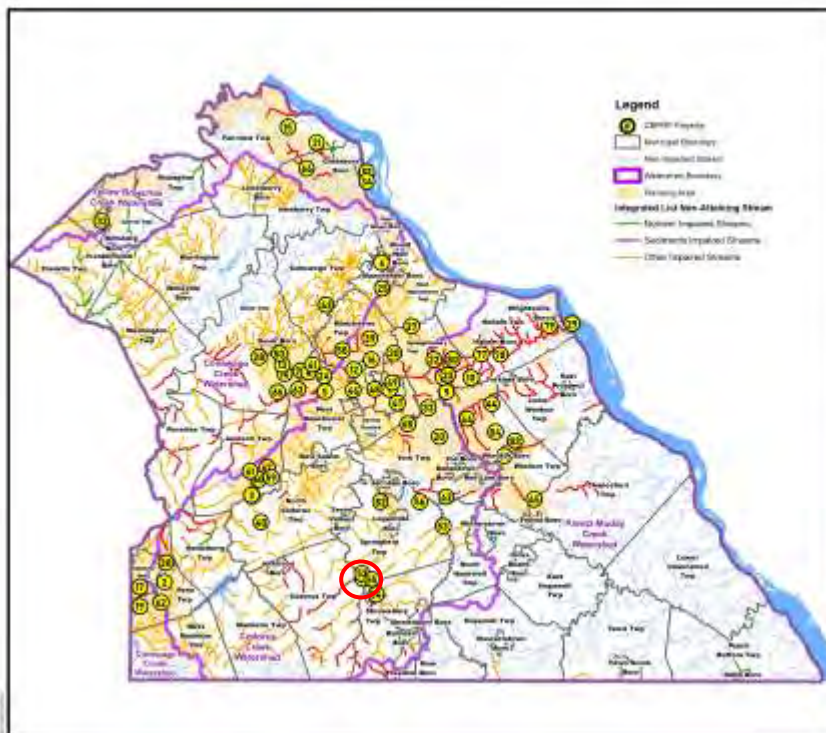
This stream restoration project also includes reconnection to the floodplain and a riparian buffer. Design is complete and permits are in hand. It is shovel ready.

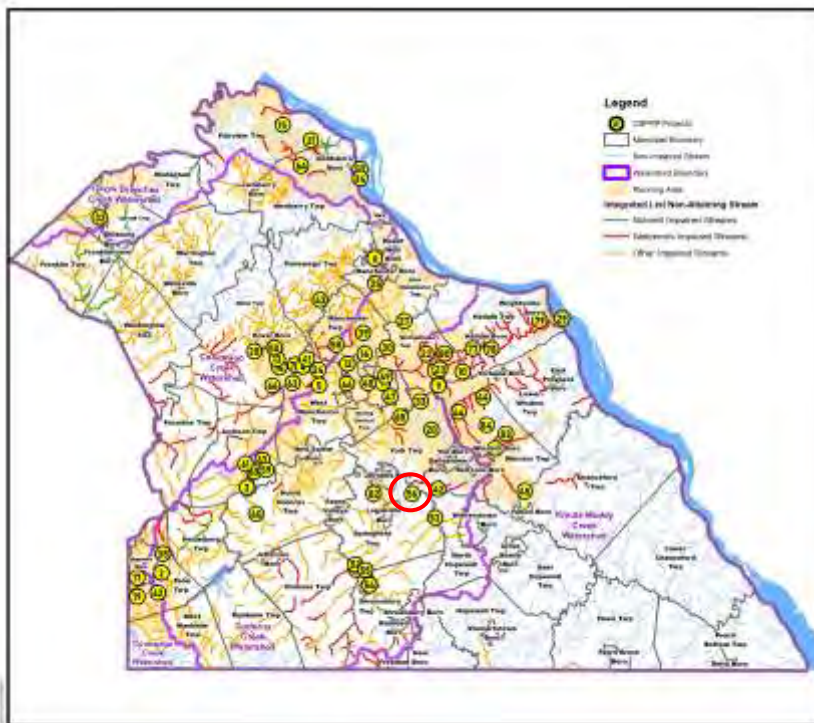
Stream assessment and conceptual design is complete. It will include reconnection to the floodplain and a riparian buffer.

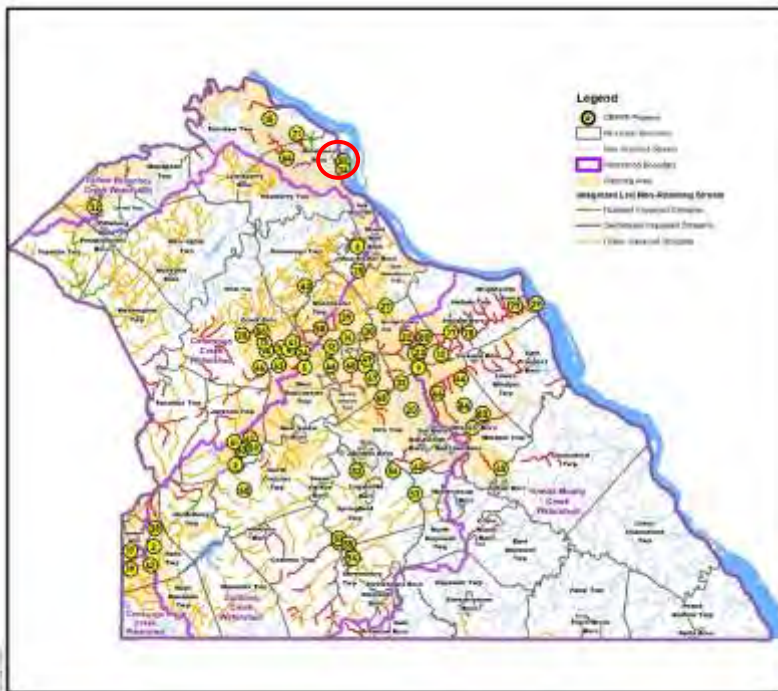
Stream Restoration of Fishing Creek in Goldsboro Borough Park.

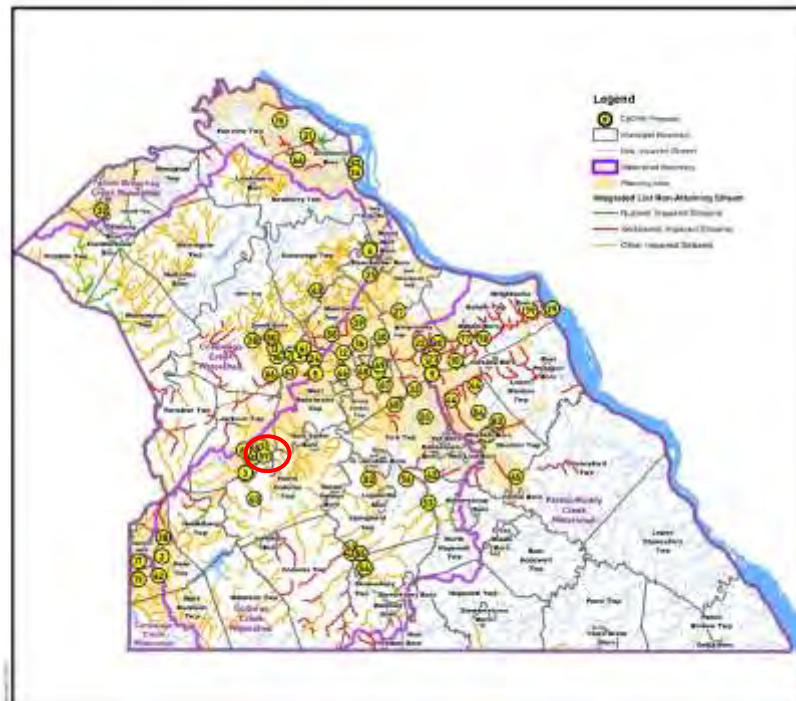
Restoration of Little Creek in Township park. Will include reconnection to floodplain and riparian buffer.

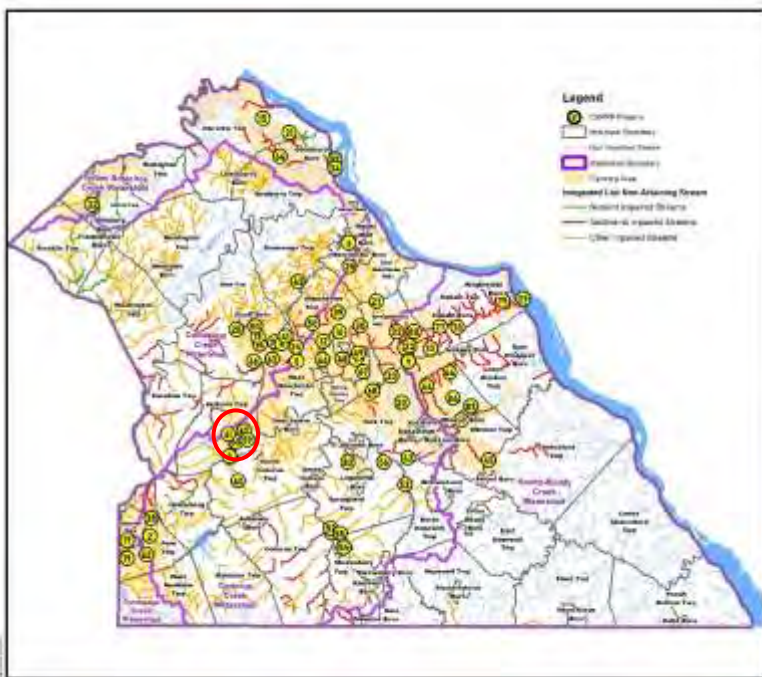
Restoration of a UNT to West Branch  
Codorus Creek with reconnection to  
floodplain and riparian buffer.

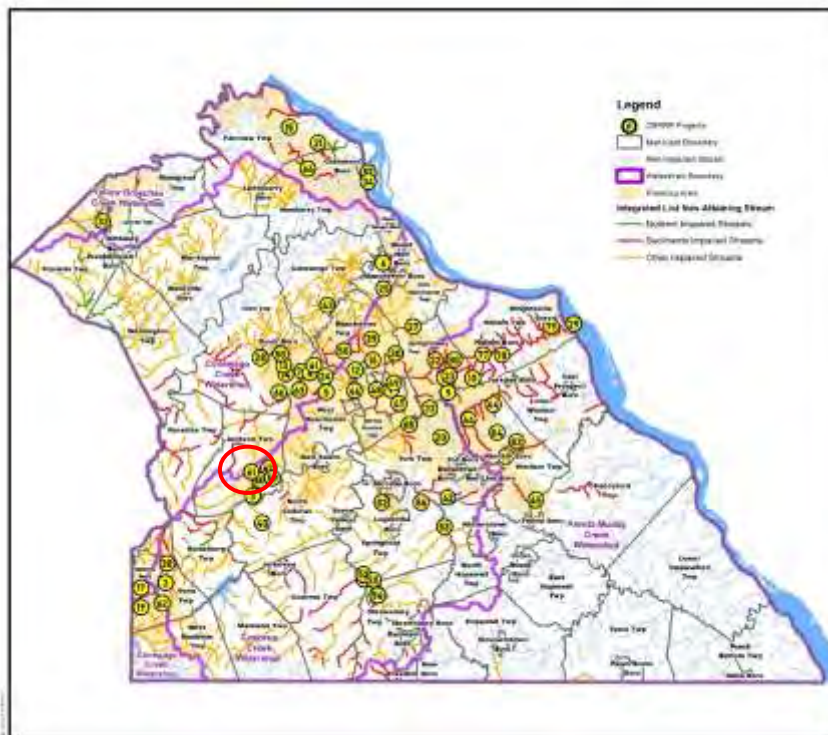
This project includes restoration of Little Creek with reconnection to the floodplain and a riparian buffer.

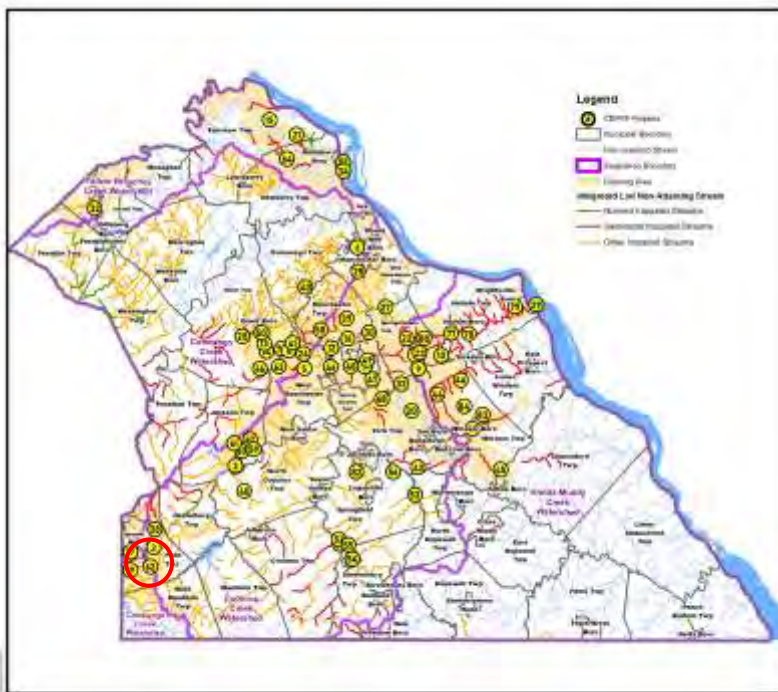
Stream assessment and conceptual design is complete. It will include reconnection to the floodplain and a riparian buffer.

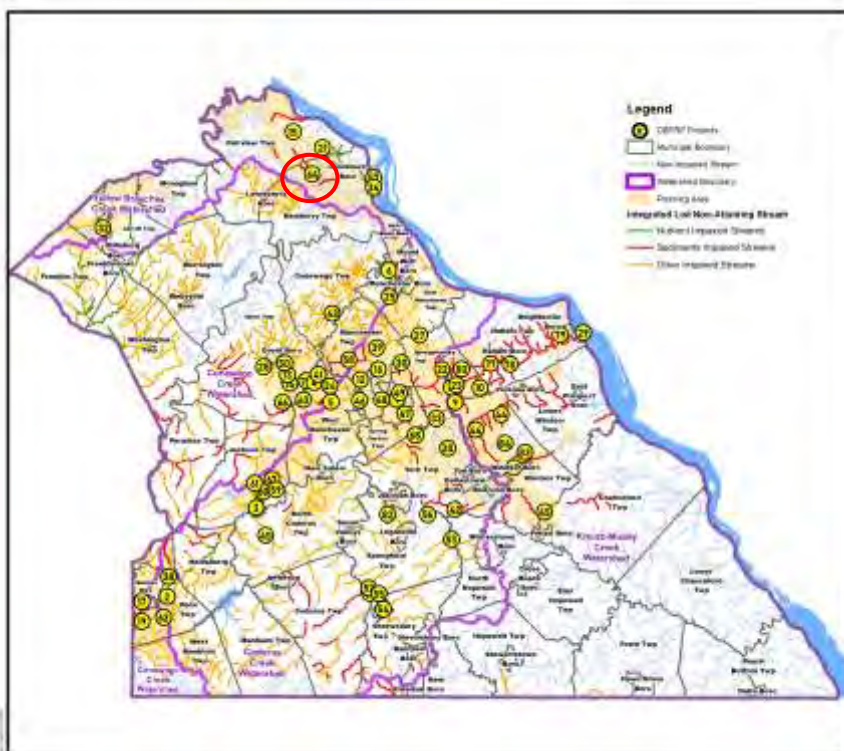
Retrofit of an existing basin on Walmart property to add water quality improvements that will increase infiltration. Basin assessment is complete.

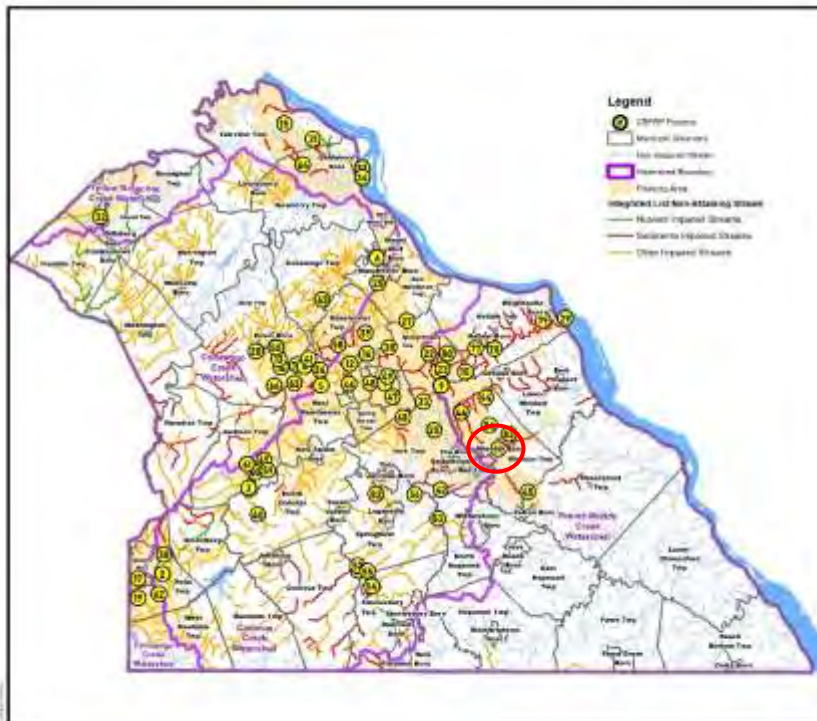
Improvements to Fishing Creek through the entire Borough (approx. 6,700 LF), including planting buffers, filtering practices, and stream stabilization measures.

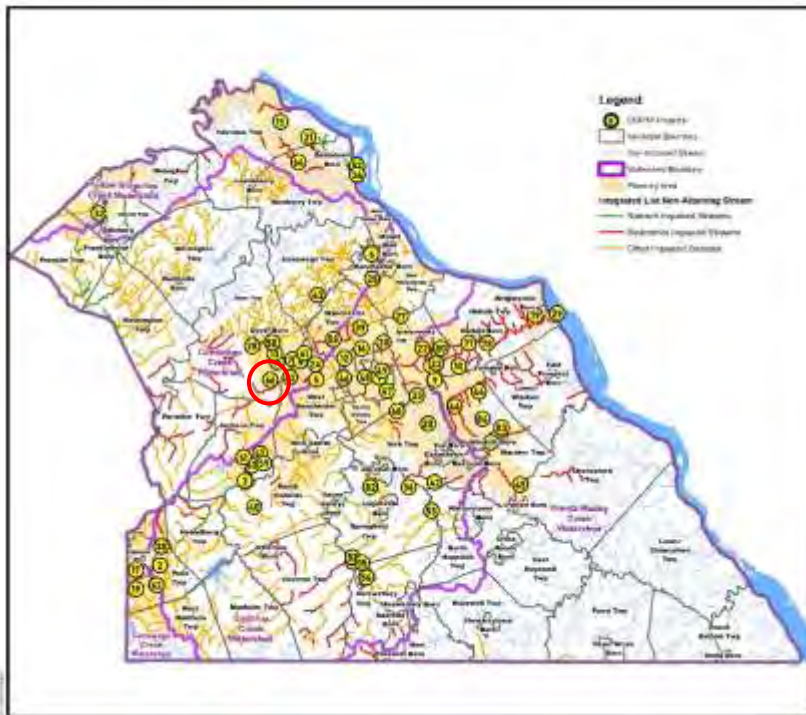
This Project includes a riparian buffer and a bioretention facility utilizing a series of berms to encourage infiltration and minimize runoff.

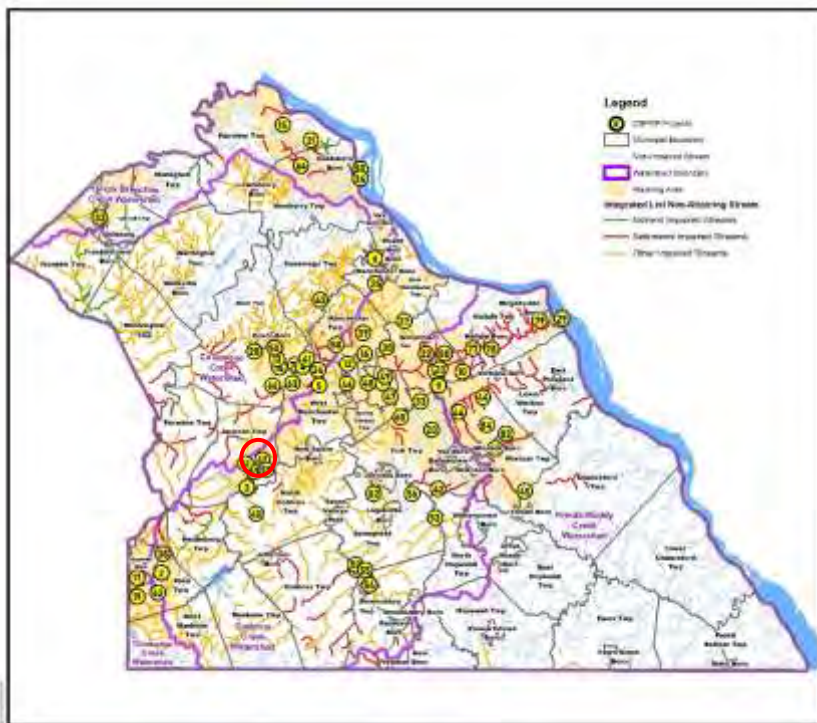
This Project includes a 2.67 acre riparian forest buffer planted along Little Creek in the Little Creek Park. It also includes converting 0.55 acres of lawn to meadow habitat and conversion of 0.54 acres of lawn to a “food forest” consisting of fruit/nut trees and shrubs.
