# YORK COUNTY REGIONAL CHESAPEAKE BAY POLLUTANT REDUCTION PLAN (2018-2023)

SUBMITTED TO PA DEP SEPTEMBER 15, 2017  
(REVISED AND RESUBMITTED OCTOBER 10, 2017)  
(REVISED AND RESUBMITTED \_\_\_\_\_, 2020)

PREPARED BY THE YORK COUNTY PLANNING COMMISSION IN  
COOPERATION WITH THE YORK COUNTY STORMWATER CONSORTIUM

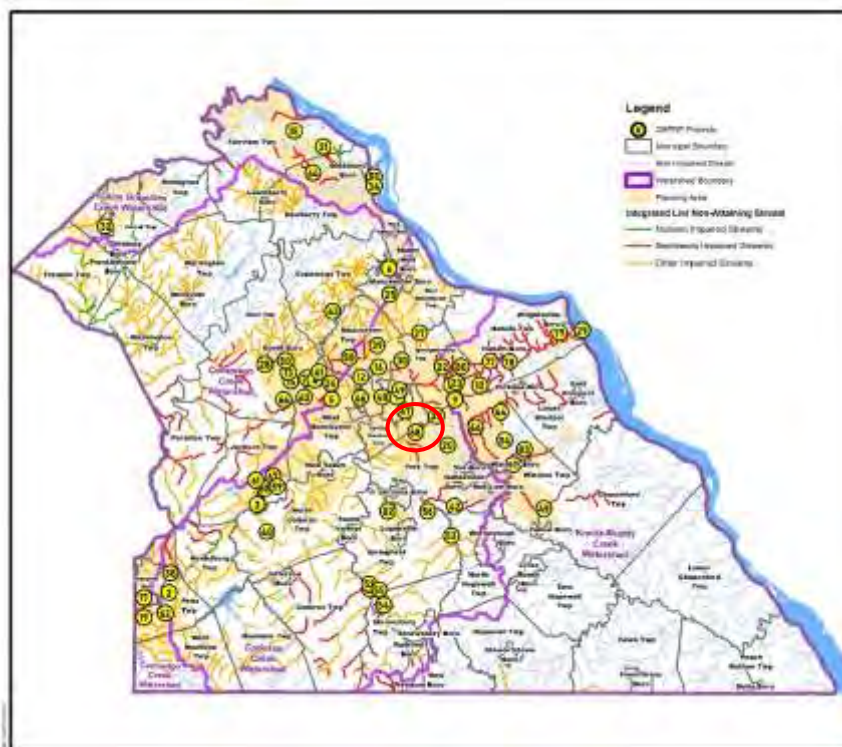
Stream restoration involves approximately 1,100 ft along an impaired tributary to Mill Creek in York Township. This tributary receives stormwater runoff from a large drainage area that includes a significant amount of impervious area from the Queenswoods Shopping Plaza. Multiple segments of highly-eroded streambank were observed during a field visit to the site. The stream is contained within a sanitary sewer easement and is therefore relatively easily accessible.

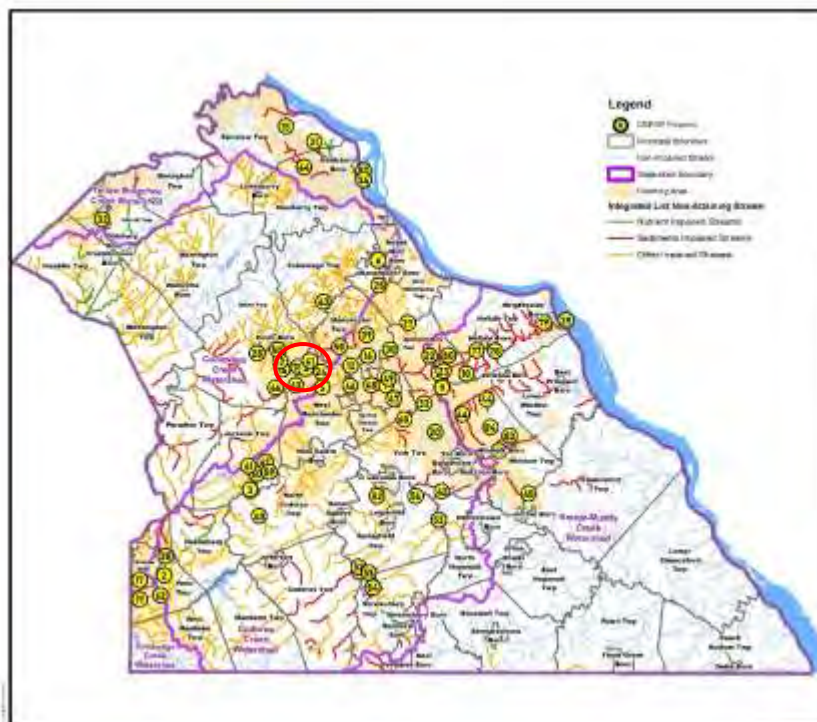
Restoration of 800 feet of stream within a residential development.

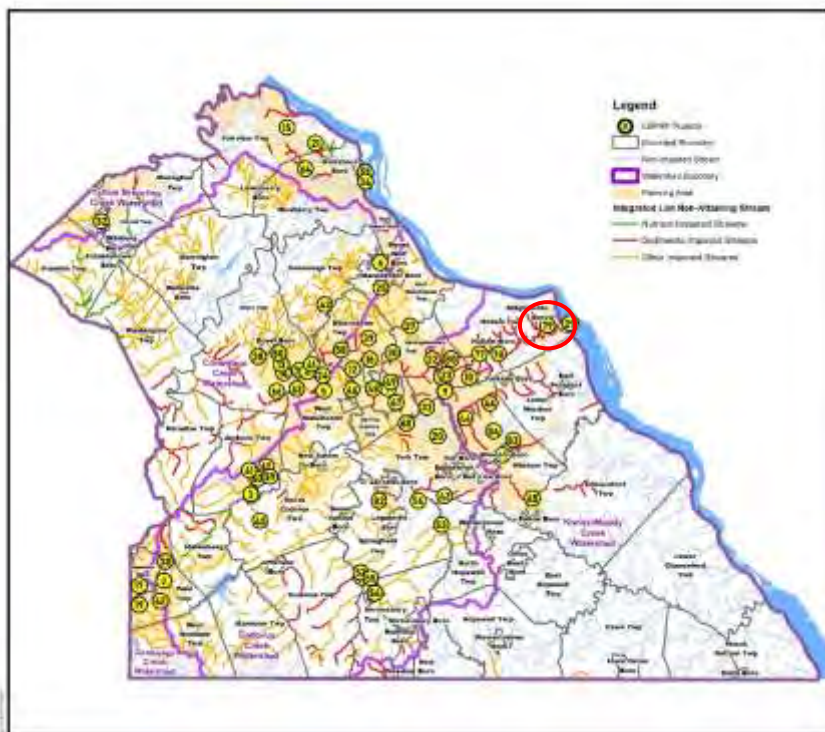
This project includes construction of Basin #2 and Bioswale #2. Improvements include amended soils and planting of native trees, shrubs, and seeding.

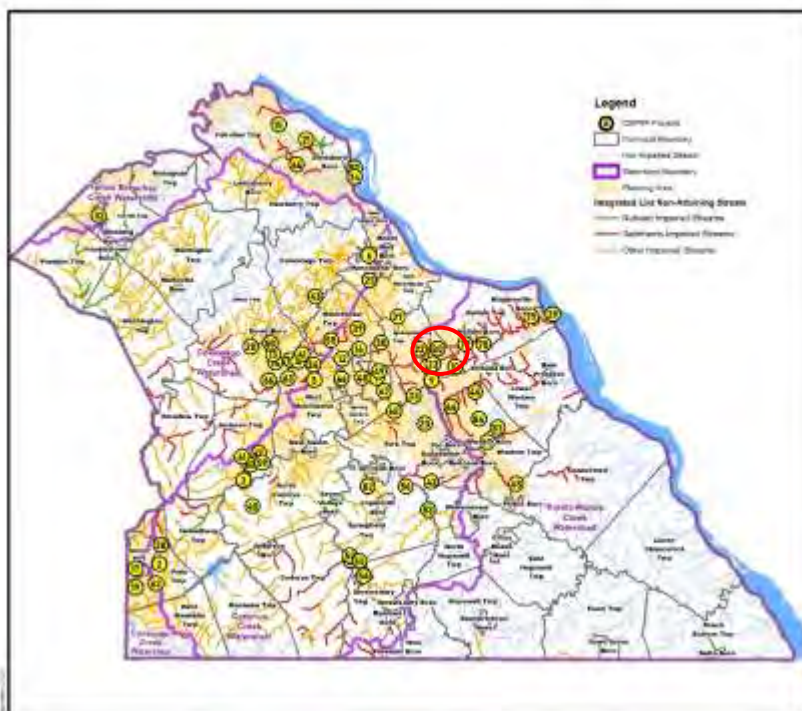
Three (3) stormwater basin retrofits, with removal of concrete low flow channels, installation of level spreader, and modification of existing eroded swale. Areas planted with a wetland mix.

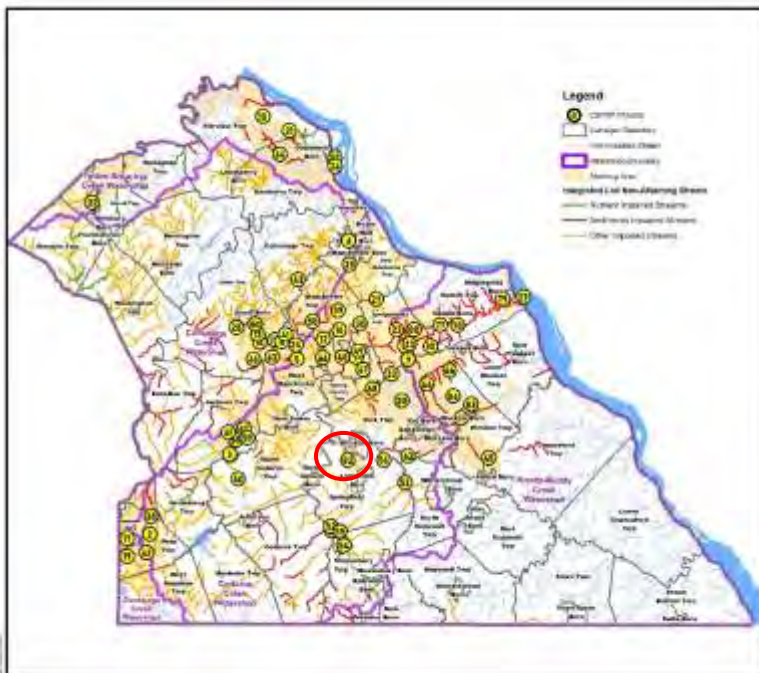
This project involves the stabilization of a severely eroded swale in Springfield Township. As was common in the 1960s and 70s, the entire development drains to a few inlets, which discharge directly to this swale. No stormwater basin or other control facility was installed to manage this flow.

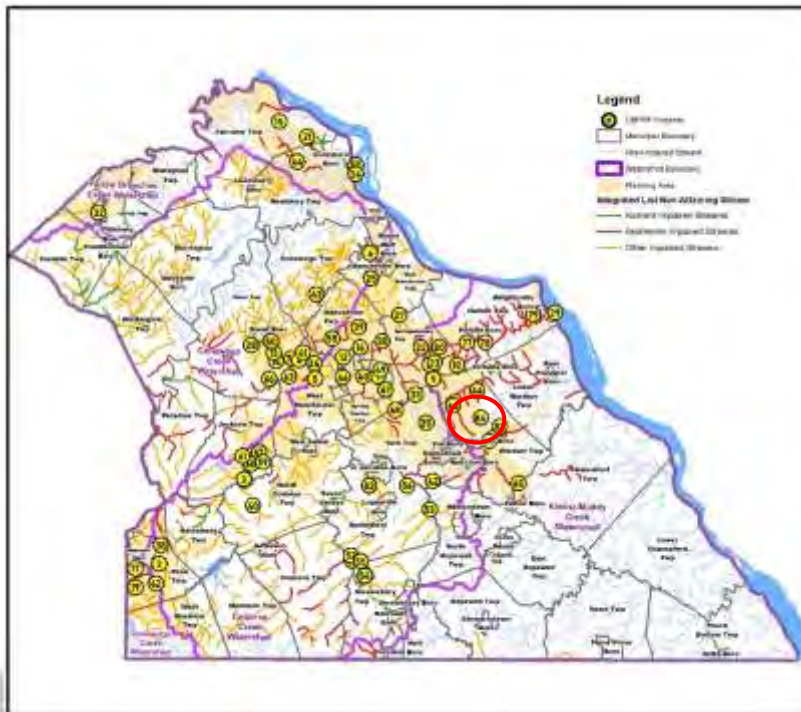
This is a retrofit of an old stormwater basin located within the Milner Heights Development in Windsor Township. The project will add native plantings and sediment forebay for water quality improvements.
