Physical Inspection Report

LOCATED AT:
1234 Any Street
Any City, CA 12345

INSPECTED ON:
Friday, April 10, 2020 at 8:00 AM

Inspector, James Wall
Lugar Inspection Services
(310) 798-2411

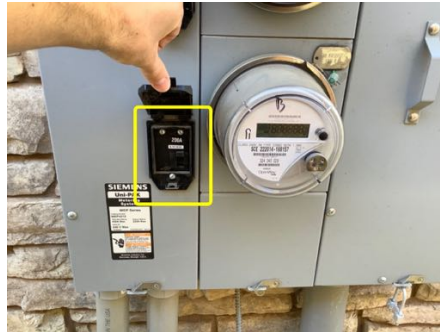
The main electrical shutoff breaker was located at the left of the building.

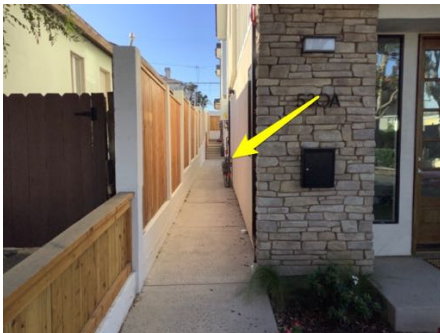
The main gas shutoff valve was located at the left of Unit A.

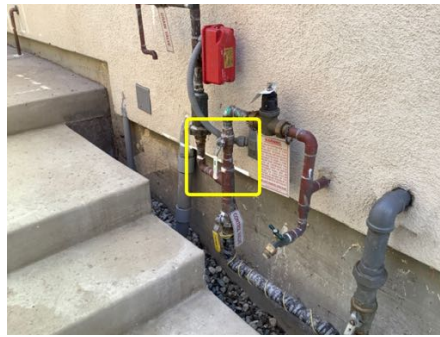
The main water shutoff valve was located at the front left of the building.

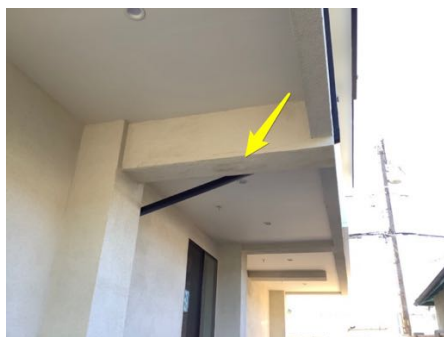
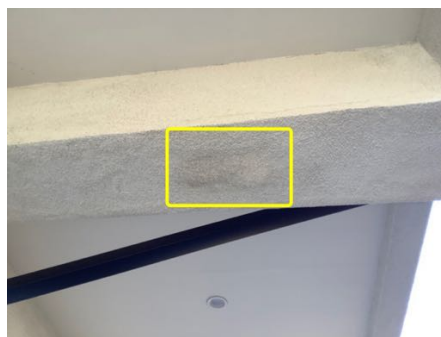
FE Past repairs were noted on the stucco siding (driveway overhang). We recommend inquiring with the Sellers about the conditions noted.

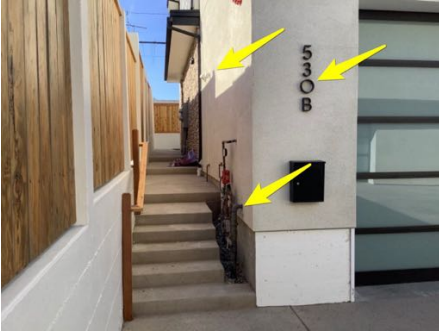
FE CR There were gaps between the stucco siding, house numbers and pipe penetrations. These conditions are conducive to moisture intrusion/deterioration. We recommend correcting the conditions noted.

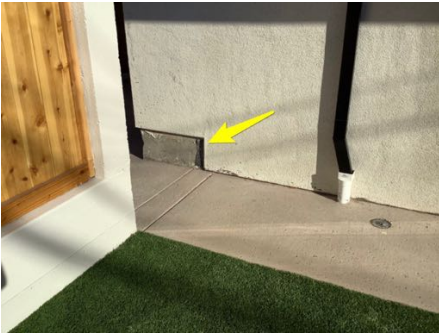
CR The membrane behind the stucco was exposed to the elements in areas. We recommend correcting the condition noted.

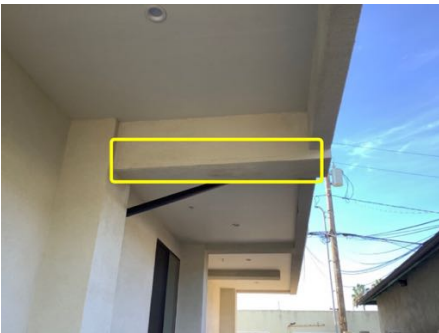
FE CR There were cracks in the stucco siding in areas, most notably at the driveway overhang. We recommend further evaluation of source and corrections by a specialist in the appropriate trade.

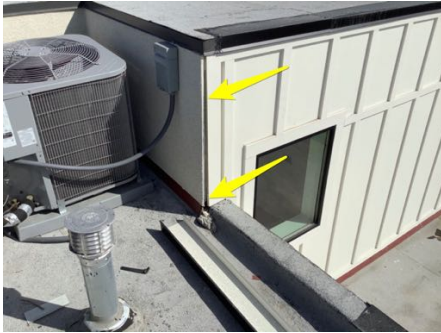
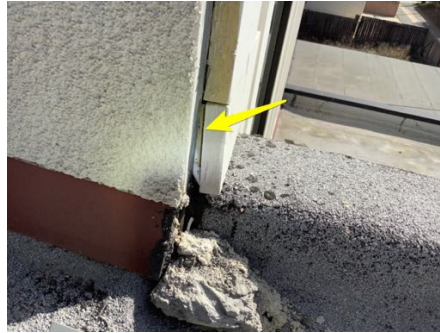
CR There were gaps between the wood siding and adjacent materials at the rear roof area. These conditions are conducive to moisture intrusion/deterioration. We recommend further evaluation of all siding and corrections by a specialist in an appropriate trade.

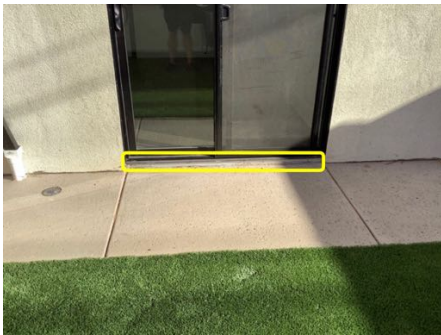
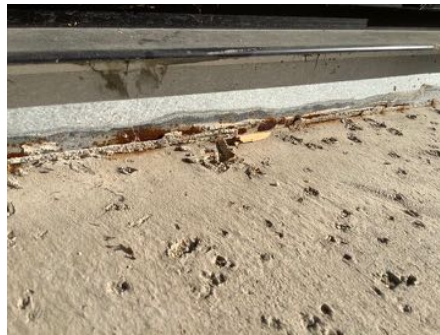
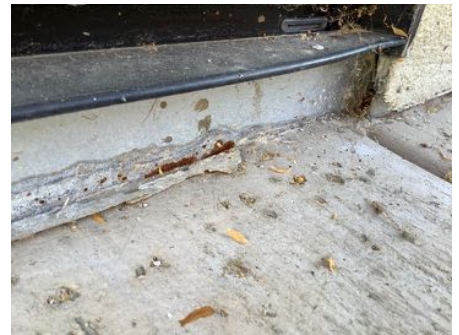
CR The flashing below the sliding door on the rear was rusted. We recommend further evaluation of the source and corrections by a specialist in an appropriate trade.

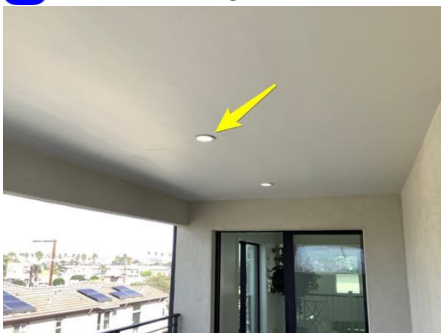
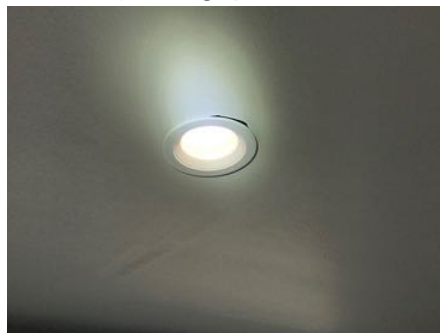
CR An exterior light fixture at the loft balcony had gaps. We recommend correcting the condition noted.

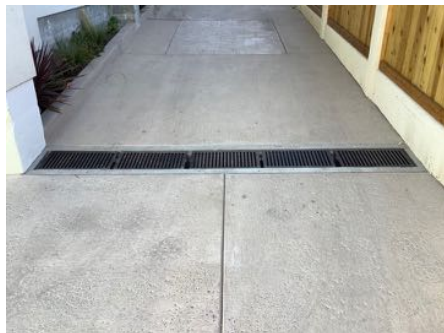
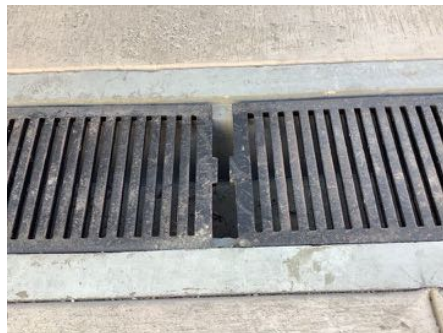
SC FE Uneven sections were noted in the driveway surface (drainage grate designed feature). This condition is a potential trip hazard. We recommend correcting any trip hazard conditions.

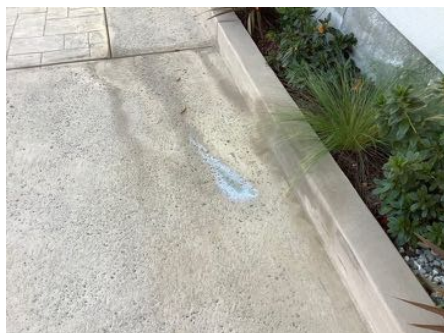
FE CR There was discoloration/staining on the driveway. We recommend further evaluation of the source and corrections by a specialist in an appropriate trade. We also recommend inquiring with the Seller on conditions known.

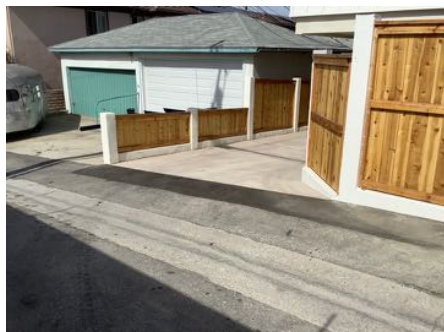
FE CR The angle of the driveway opening when coming from the west side of the alley may impede parking. We recommend further evaluation and corrections by a specialist in an appropriate trade.

Note: Please drive your vehicles into the driveway and see how they fit.

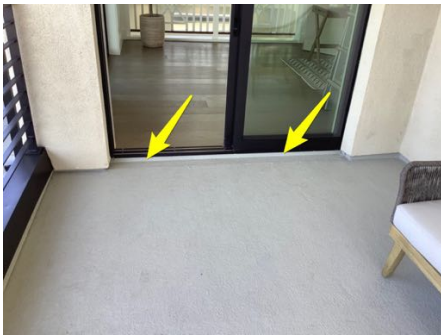
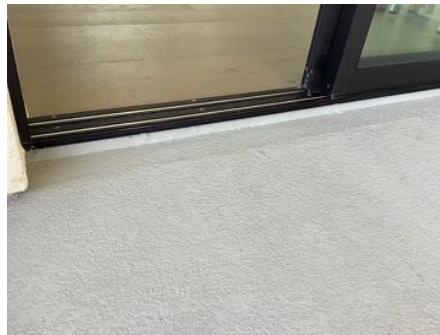
FE CR A section of the loft balcony near the sliding door was not sloped towards the drain. We recommend correcting the condition noted.

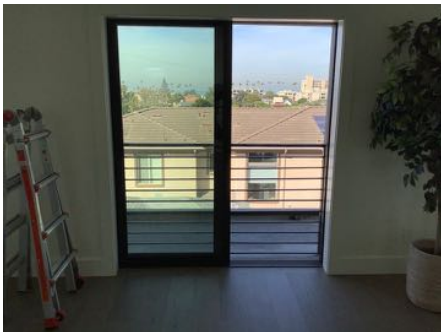
The guard rails were built in a horizontal fashion, these conditions are a potential safety hazard due to they are climbable for children. We are noting this potential issue to educate the Client of the potential hazard although appears to be installed as per "building code".

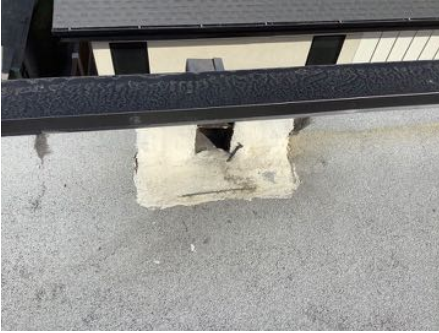
FE CR The roofing had been patched near the drains in areas. We recommend inquiring with the Seller on conditions known.

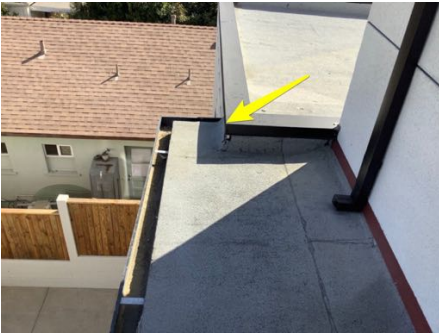
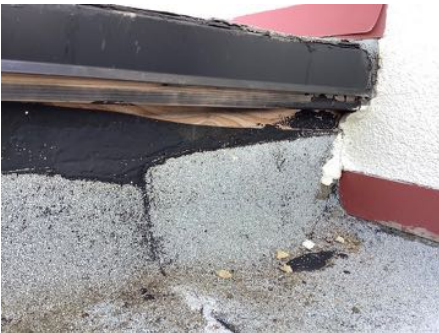
FE CR The roofing installation was substandard in areas (wood framing exposed). These conditions are conducive to moisture intrusion and deterioration. We recommend further evaluation of the entire roof and corrections by a specialist in the appropriate trade.

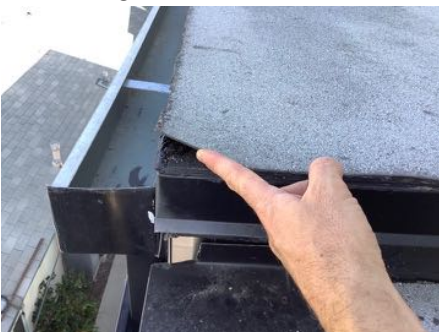
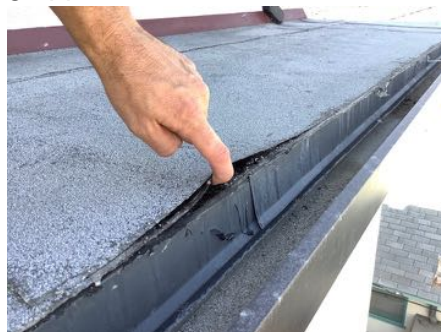
CR There were areas of the roof that require maintenance (loose/delaminated at the perimeter edge metal in areas), These conditions are conducive to moisture intrusion and deterioration. We recommend correcting the conditions noted using approved methods.

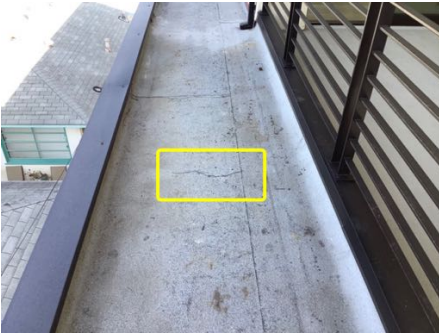
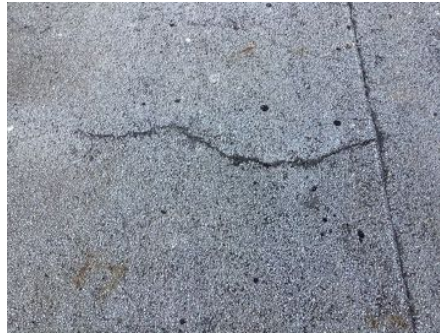
CR The roofing material was cracked/damaged in areas. We recommend further evaluation of the entire roof and corrections by a specialist in the appropriate trade.

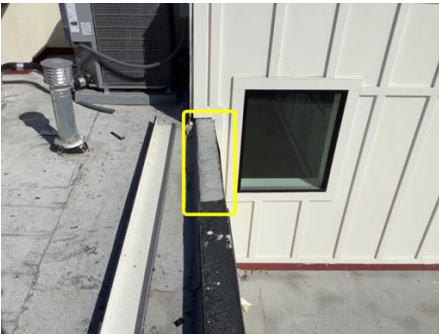
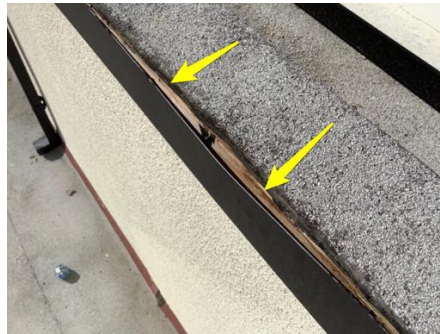
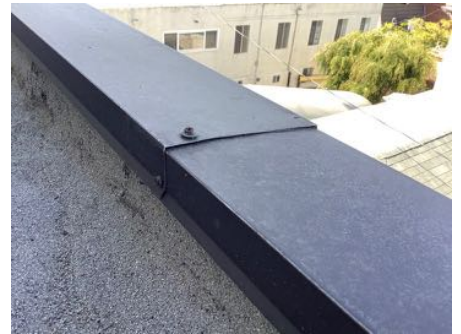
CR The metal parapet cap laps were missing/open in areas (wood framing exposed), this condition is conducive to leakage. We recommend further evaluation and corrections by a specialist in the appropriate trade.

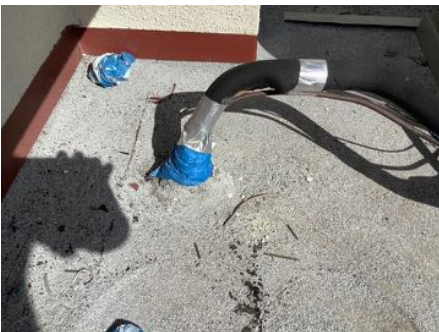
CR There was a substandard sealant (tape) at the penetration for the refrigerant lines on the rear. We recommend correcting the conditions noted.

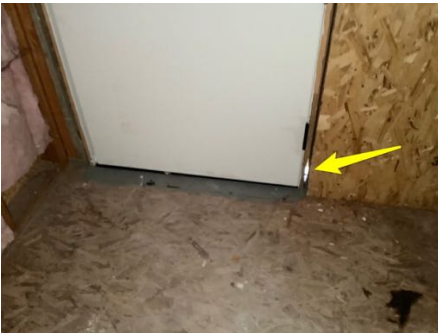
FE CR Day light visible under/around the door, weatherstripping was damaged/missing. We recommend correcting the condition noted.

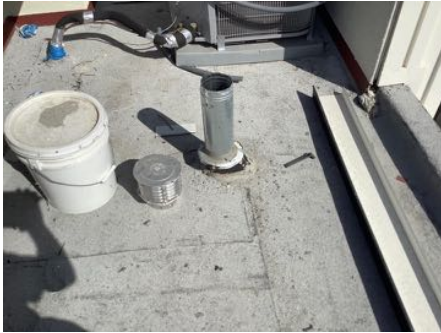
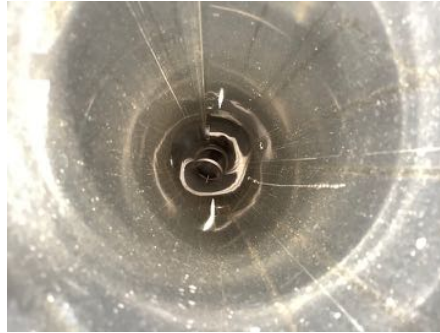
CR The flue vent pipe has screws penetrating the inner pipe. We recommend the pipe should be replaced.

Looking down into pipe

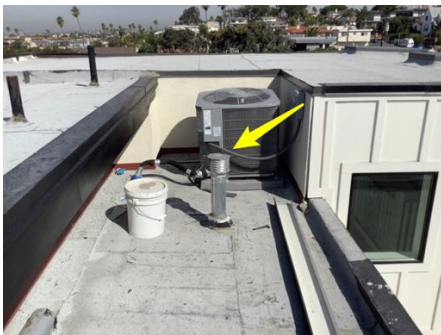
CR The flue vent pipe was too short and terminated improperly. We recommend correcting the condition noted.

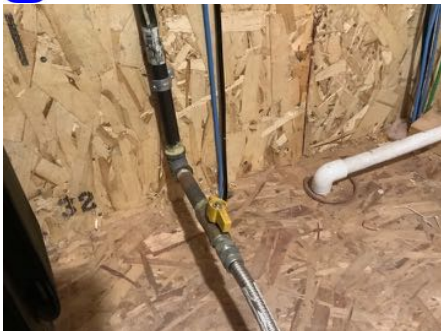
CR The gas pipe sediment trap was missing. We recommend correcting the condition noted.

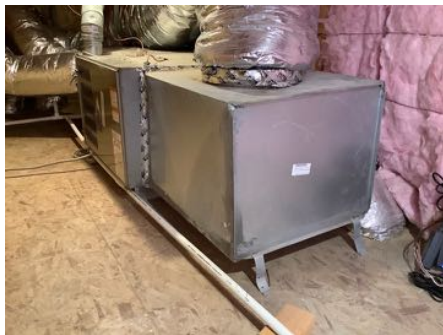
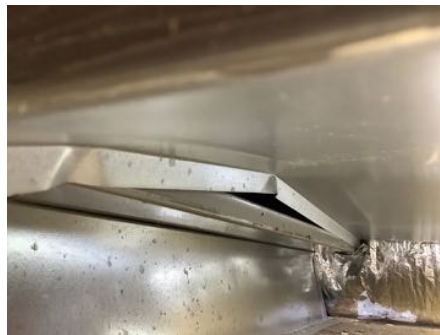
SC **CR** There were air leaks in the return air plenum at the furnace connection. We recommend correcting the condition noted.

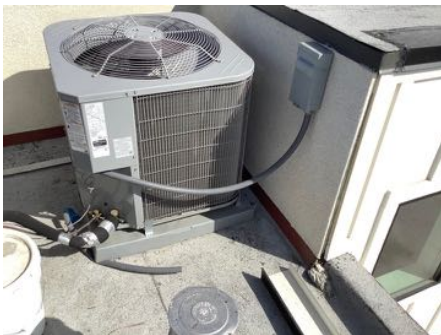
CR The wiring entering/exiting the electrical disconnect was not properly secured. We recommend correcting the condition noted.

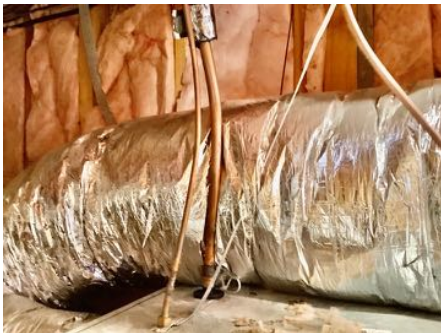
CR The insulation on the coolant lines was damaged/missing in the attic near the evaporator coil. We recommend correcting the condition noted.

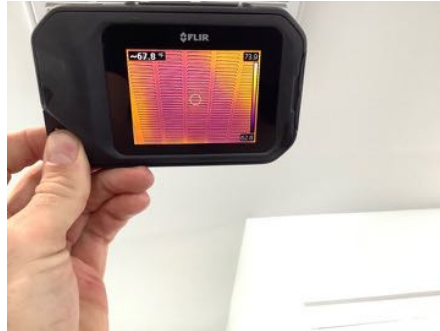
The system responded to normal operating controls and a temperature differential between the supply and return air grills was within the normal range.

Note: Supply was 68 degrees and Return was 52 degrees after the unit was operating over 20 minutes.

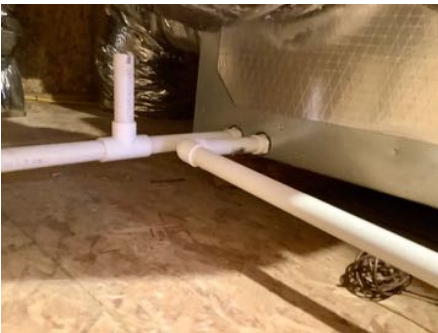
CR There was no vent/trap in the condensate drain line at the evaporative coil unit. We recommend correcting the condition noted.

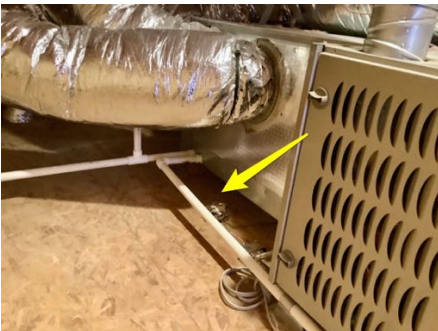
CR The attic installation of the cooling system had no secondary condensation pan/drain line to the exterior. We recommend correcting the condition noted.

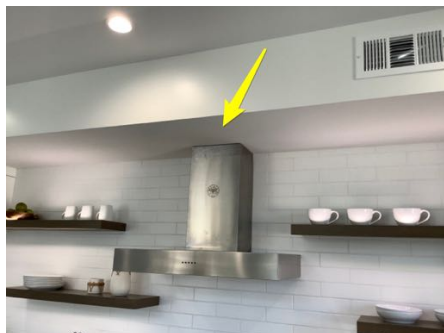
FE Past repairs were noted on the ceiling near the exhaust hood. We recommend inquiring with the Seller about the condition noted.

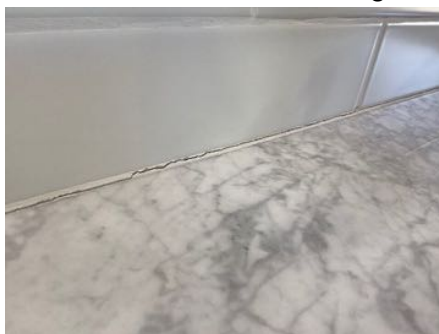
CR The grout/caulking was cracked. We recommend correcting the condition noted.

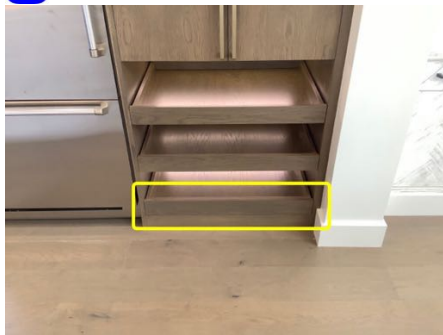
CR The lower drawer did not close properly. We recommend correcting the condition noted.

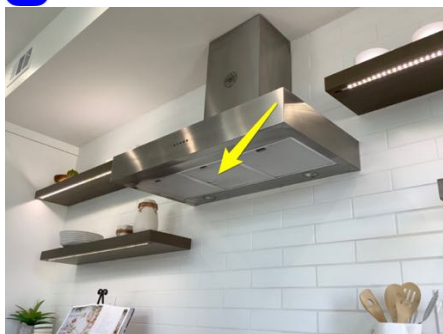
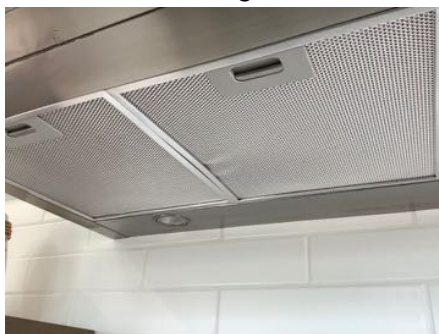
CR There was a bent filter. We recommend correcting the condition noted.

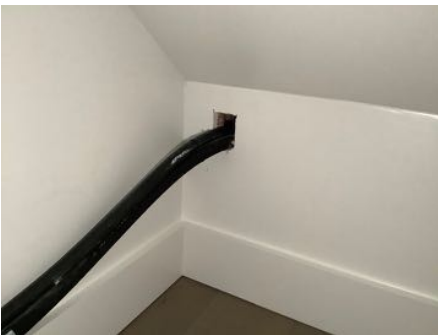
CR There was a hole in the wall where the elevator wiring passes through. We recommend correcting the condition noted.

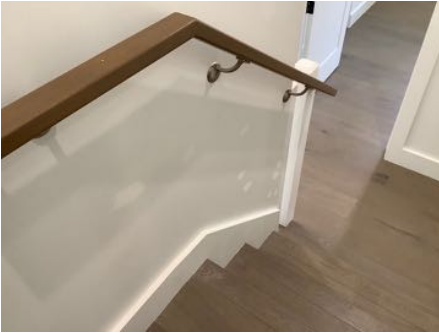
FE **CR** The paint was unfinished in areas. We recommend further evaluation and corrections by a specialist in an appropriate trade.

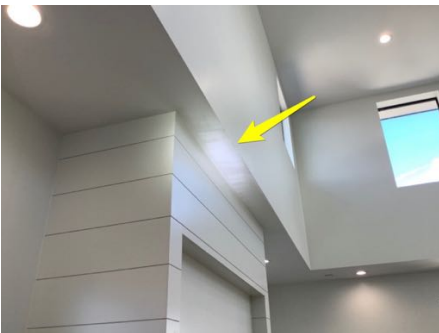
FE **CR** The paint was unfinished above the fireplace. We recommend further evaluation and corrections by a specialist in an appropriate trade.

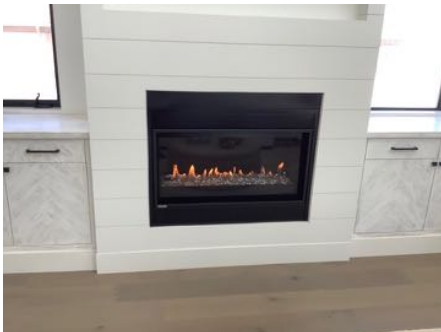
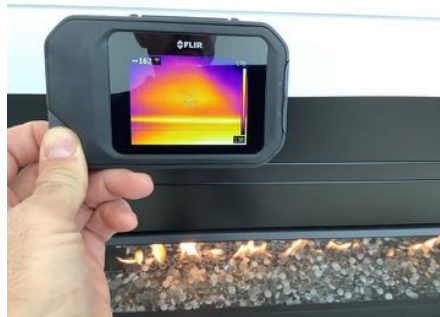
SC FE The wood surround at the firebox appeared to be too close to the fireplace opening (tested at 162°F after operating for 20 minutes). This condition may be a potential fire hazard. We recommend further evaluation and corrections by a specialist in an appropriate trade. We also recommend inquiring with the fireplace Manufacturer on this installation.

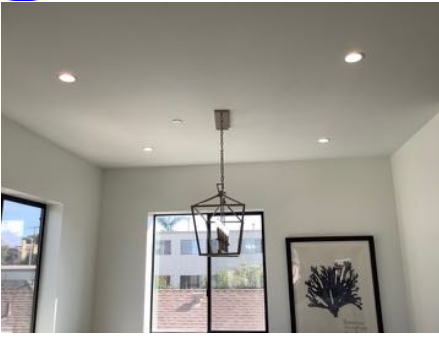
CR The light fixture was crooked. We recommend correcting the condition noted.

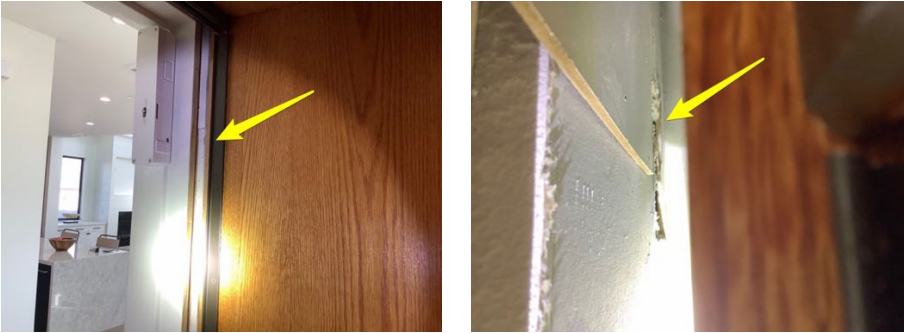
SC There were holes in the fire resistive wall between the elevator shaft and living space. We recommend correcting the condition noted.

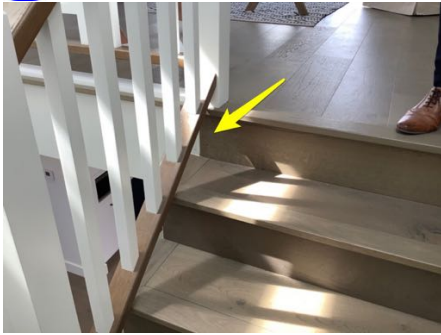
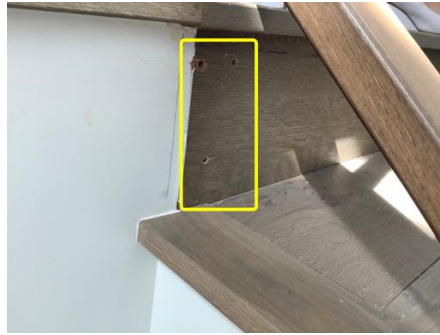
CR The stairs at the top of the stairway had holes. We recommend correcting the condition noted.

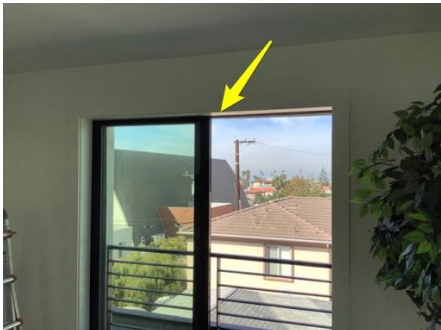
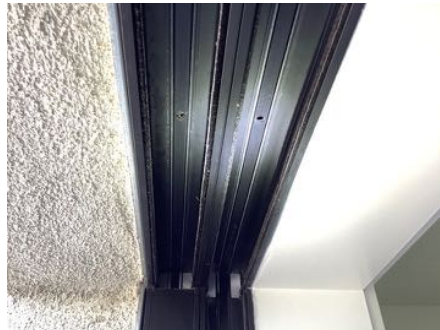
CR The upper portion of the sliding door frames had missing screws. We recommend correcting the conditions noted.

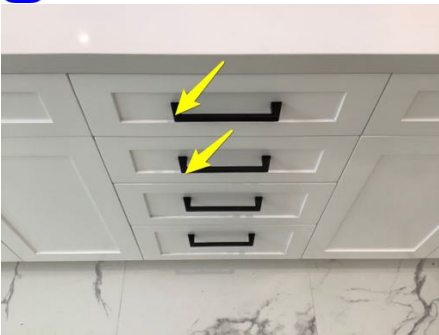
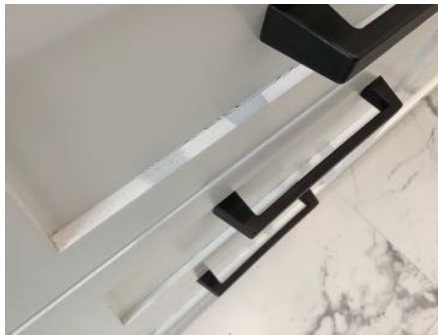
CR The drawer finish was cracked/damaged. We recommend correcting the conditions noted.

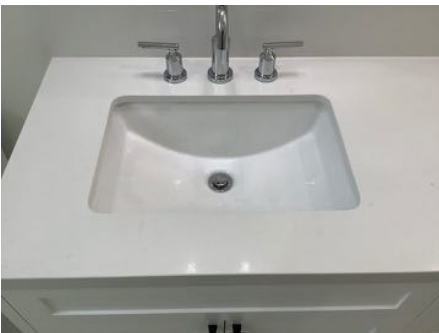
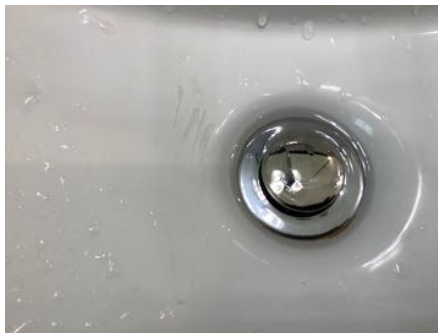
FE CR The left sink surface was scratched near the drain. We recommend correcting the condition noted.

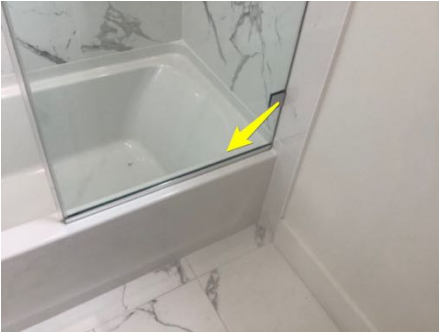
CR There were visible cracks noted in the shower/tub. We recommend correcting this condition to prevent moisture intrusion into concealed spaces.

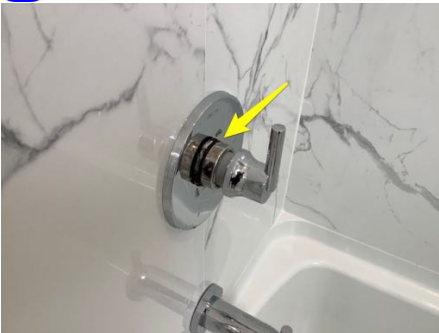
CR The faucet handle was missing the trim cover. We recommend correcting the condition noted.

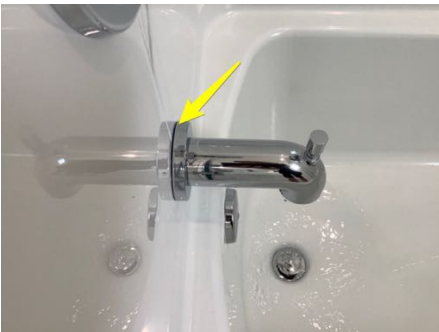
CR The spout was not sealed to the wall, this is a potential leak source. We recommend correcting this condition to prevent moisture intrusion into concealed spaces.

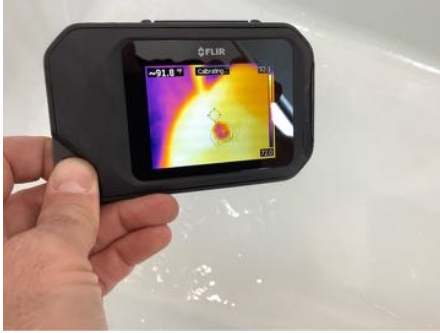
91°F

FE CR The hot water flow from the mixer valve was minimal (adjustment needed). We recommend correcting the condition noted.

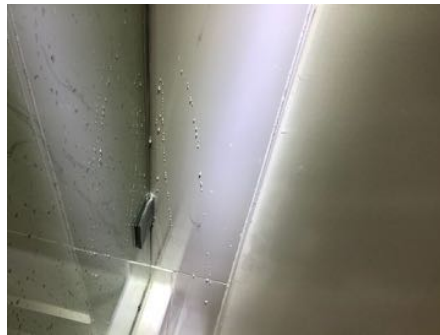
FE CR There was leakage from the shower enclosure. We recommend correcting the condition noted.

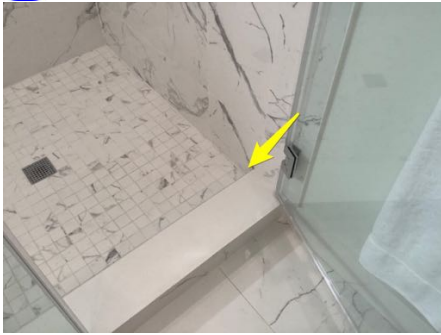
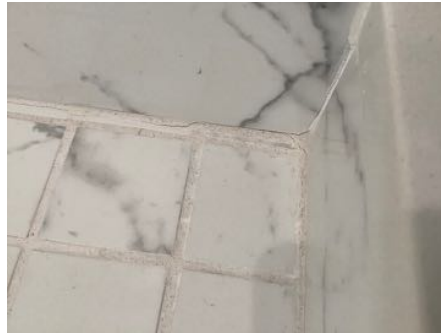
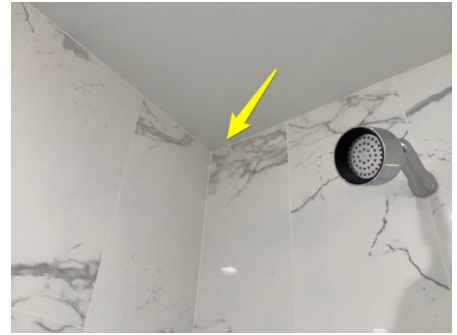
CR The grout/caulking was cracked. We recommend correcting the condition noted.

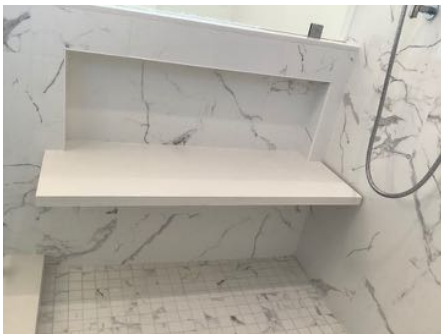
FE CR There bench seat was improperly sloped (holding water). We recommend further evaluation and corrections by a specialist in the appropriate trade.

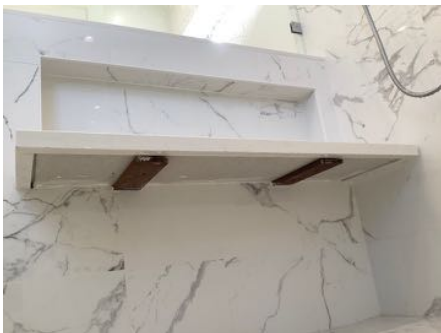
FE CR The underside of the bench seat was unfinished. Caulking was missing and the metal supports were exposed. We recommend corrections by a specialist in an appropriate trade.

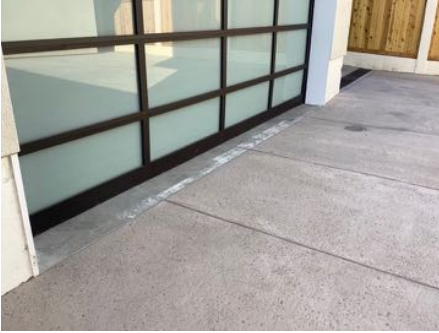
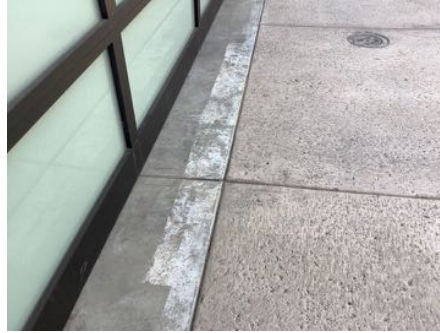
CR The exterior portion of the garage slab was discolored. We recommend correcting the condition noted.

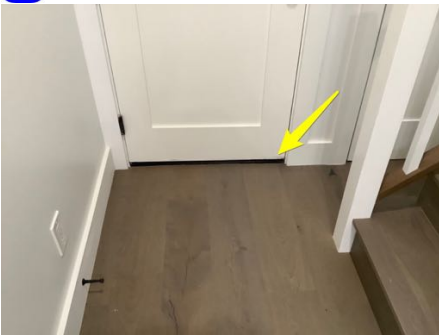
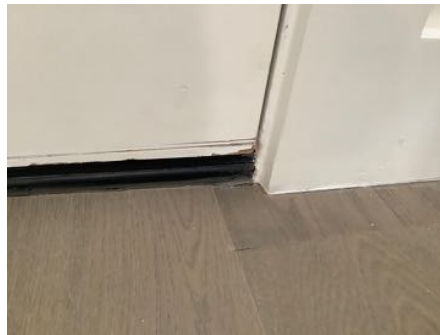
CR The fire door between the garage and living space appeared to be of fire resistive construction. The automatic self closing hinges was were disabled. We recommend correcting the condition noted.

CR The fire door finish was damaged/flaking. We recommend correcting the condition noted.

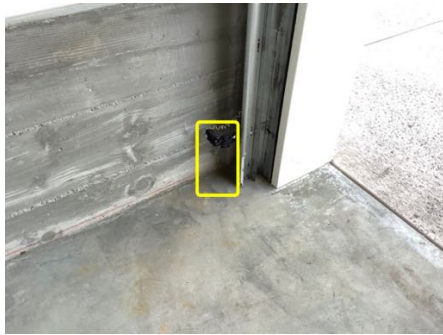
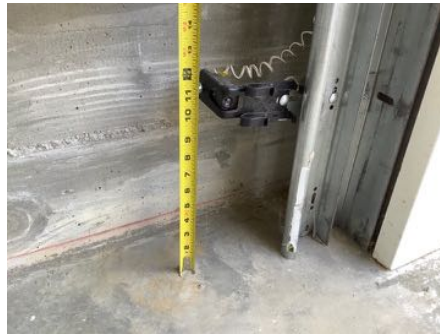
SC The secondary safety system (electric eyes) were mounted higher than the manufacturer's recommendation of 4" to 6" above the floor. We recommend correcting the condition noted.
