## Three failing systems traced before a purchase

Three-storey residential property · Purchase due diligence · 6 days from flight to report

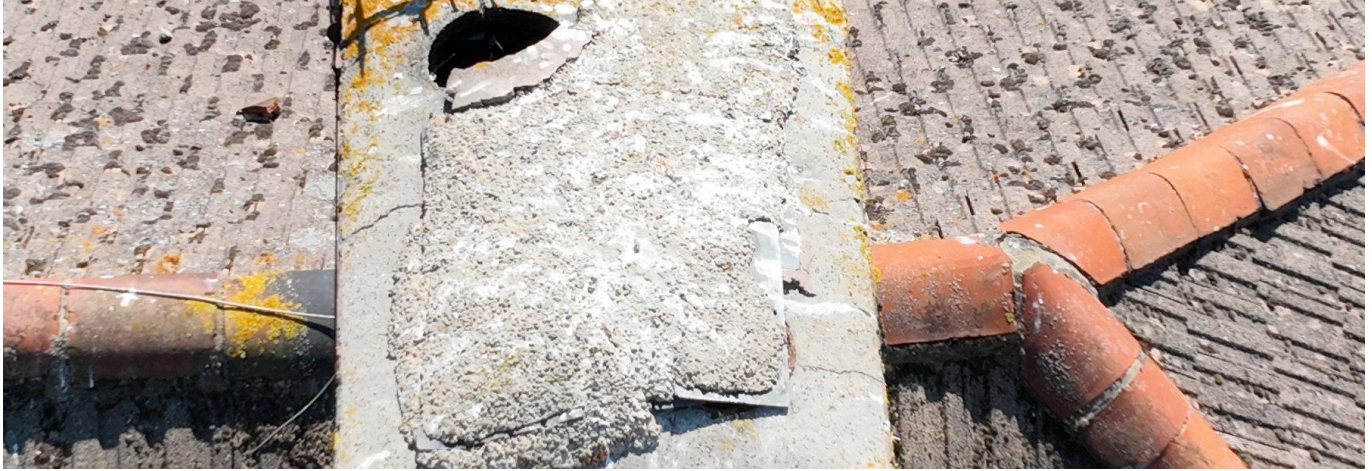
Chimney cap holed, cracked and previously patched: one of three failing systems traced (inspection photo).

The survey found 21 defects, none urgent, but the pattern mattered more than the count. Rooted plants in the gutters on three sides, and moss on the outside of a downpipe, showed the rainwater system had been overflowing for years, not months. An open flue and a holed, previously patched chimney cap were letting water into the stack, with spalled brick and a damp band below. And the roof covering had failed where water concentrates: an open void at the hip apex, four cracked hip tiles and torn underlay at the eaves.

**The insight that mattered:** these were three failing systems, not 21 separate jobs. The report grouped them that way and named the most valuable next step for a buyer: have a roofer open up the chimney and the hip apex, before exchange, to see what years of water had done to the hidden timbers.
