Correlation of Bendix® Data Recorder (BDR) versus Engine Control Module (ECM) Data

Numerous research papers, articles and publications have been written to validate the data within Engine Control Modules, specifically pertaining to the application of this data in relation to traffic crash investigation. This paper outlines the correlation of the data found within the Bendix® Data Recorder (BDR) and compares it against the data within Electronic Control Modules (ECM).

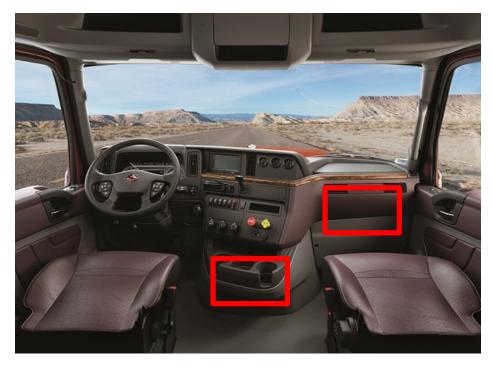
Figure 1.1 – International Lone Star Tractor - typical mounting locations

Bendix® EC80 controllers are cab-mounted and vary in their mounting location. Typically, they are found in the center stack area and/or passenger side front dash (see red rectangles below).

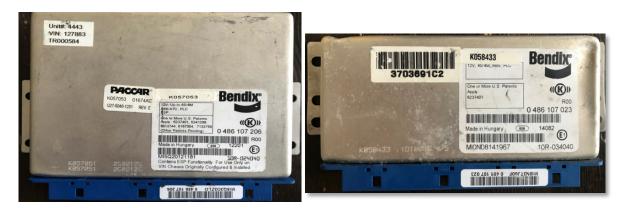
Figure 1.2 – (Left) EC80, (Right) EC60

The two ECU's pictured above are the EC80 (left) and the EC60 (right). The EC80 is distinguishable by the module being deeper than the EC60. The EC80 is the latest ECU from Bendix® and is currently associated with the Bendix® Wingman/Fusion systems.

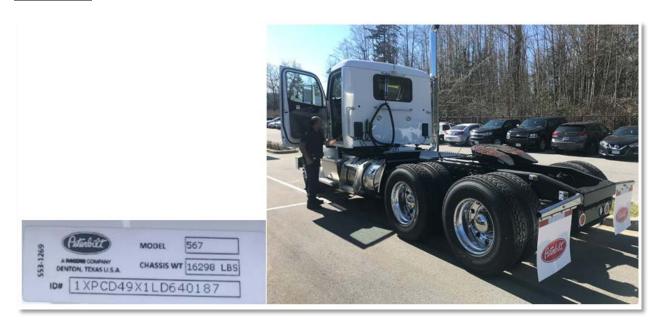
Figure 1.7 – 2019 Peterbilt 3 axle tractor

The vehicle used for the testing was a three axle day cab tractor, featuring a Cummins engine and ECM.

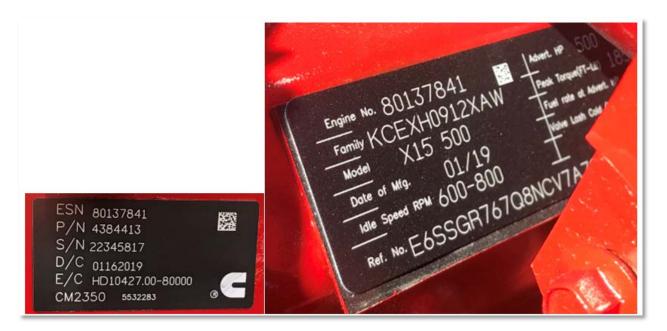
Figure 1.9 – 2019 Peterbilt Engine/ECM Identifiers

The 2019 Peterbilt was virtually brand new with 62.6 km (38.9 miles) on the dash.

The 2019 Peterbilt was equipped with a Bendix® EC80 ESP 6S/6M system. There were no active DTC's within the pre-testing download.
