# **HOME INSPECTION REPORT**

123 Test St  
Wilmington , NC 12345

Inspected by:  
Michael Harmon  
Harmon Home Inspections

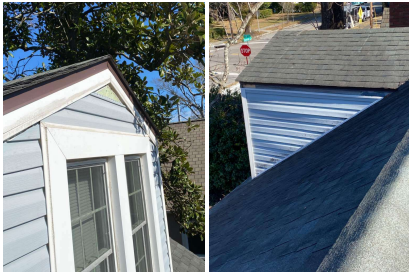
1. ☐☐☐☐☒ **TYPE:** VINYL SIDING - MISSING SIDING PANELS AND WARPED PANELS CAN INDICATE WATER PENETRATION BEHIND AS WELL AS PROVIDE DIRECT ACCESS FOR WATER TO DAMAGE THE STRUCTURE OF THE HOME. HAVE A LICENSED CONTRACTOR EVALUATE FULLY AND REPAIR OR REPLACE AS NEEDED

7. **ENTIRE PROPERTY EXTERIOR SURFACE TYPE:** VINYL SIDING - MISSING SIDING PANELS AND WARPED PANELS CAN INDICATE WATER PENETRATION BEHIND AS WELL AS PROVIDE DIRECT ACCESS FOR WATER TO DAMAGE THE STRUCTURE OF THE HOME. HAVE A LICENSED CONTRACTOR EVALUATE FULLY AND REPAIR OR REPLACE AS NEEDED

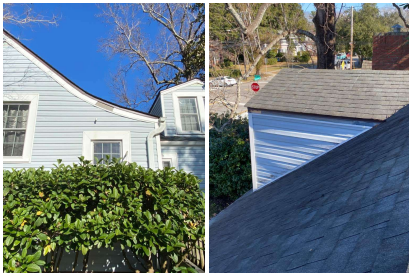
3. ☐☐☐☐☒ **FASCIA:** VINYL - MISSING FASCIA PANELS CAN PROVIDE ACCESS FOR WATER TO PENETRATE THE FRAMING STRUCTURE. A LICENSED CONTRACTOR IS RECOMMENDED TO EVALUATE AND MAKE NECESSARY REPAIRS

8. **FASCIA:** VINYL - MISSING FASCIA PANELS CAN PROVIDE ACCESS FOR WATER TO PENETRATE THE FRAMING STRUCTURE. A LICENSED CONTRACTOR IS RECOMMENDED TO EVALUATE AND MAKE NECESSARY REPAIRS

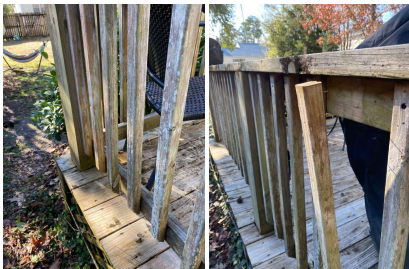
4. ☒ ☐ ☐ ☐ ☐ **PORCH:** BRICK  
5. ☐ ☐ ☐ ☐ ☒ **DECK:** TREATED WOOD - LOOSE PICKETS ON THE GUARD RAIL AROUND THE DECK AREA, THIS COULD PRESENT A SAFETY CONCERN FOR ANYONE ON THE DECK. A QUALIFIED CONTRACTOR IS RECOMMENDED TO EVALUATE AND MAKE NECESSARY REPAIRS

- 11. DECK:** TREATED WOOD - LOOSE PICKETS ON THE GUARD RAIL AROUND THE DECK AREA, THIS COULD PRESENT A SAFETY CONCERN FOR ANYONE ON THE DECK. A QUALIFIED CONTRACTOR IS RECOMMENDED TO EVALUATE AND MAKE NECESSARY REPAIRS

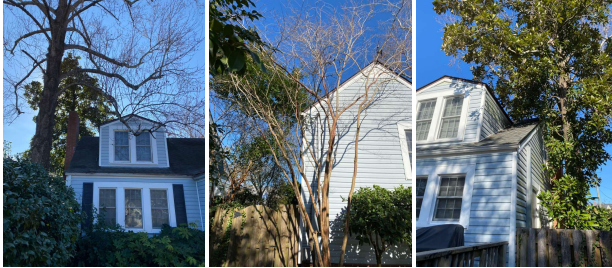
7. ☐☐☐☐☒ **VEGETATION:** TREES - TREE LIMBS OVER HANG THE ROOF AND SHOULD BE CUT BACK, TREE PLANTED TOO NEAR THE FOUNDATION AND ROOTS MAY CAUSE DAMAGE TO THE FOUNDATION, AN EVALUATION BY A QUALIFIED ARBORIST IS RECOMMENDED TO ESTIMATE SERVICES REQUIRED TO REPAIR THIS PROBLEM

- 12. VEGETATION:** TREES - TREE LIMBS OVER HANG THE ROOF AND SHOULD BE CUT BACK, TREE PLANTED TOO NEAR THE FOUNDATION AND ROOTS MAY CAUSE DAMAGE TO THE FOUNDATION, AN EVALUATION BY A QUALIFIED ARBORIST IS RECOMMENDED TO ESTIMATE SERVICES REQUIRED TO REPAIR THIS PROBLEM

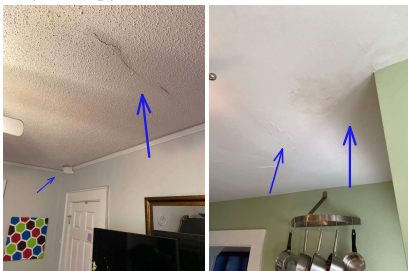
1. ☐ ☐ ☐ ☐ ☒ **CEILING:** POPCORN CEILING, PAINT - LOOSE OR PEELING PAINT, EVIDENCE OF PAST OR PRESENT WATER STAINING, MOISTURE OR WATER PENETRATION CAN CAUSE THE DETERIORATION IN THE CEILING MATERIAL. A QUALIFIED CONTRACTOR IS RECOMMENDED TO EVALUATE AND MAKE NECESSARY REPAIRS.

- 15. FAMILY ROOM, BOTH BEDROOMS LIVING SPACE CEILING:** POPCORN CEILING, PAINT - LOOSE OR PEELING PAINT, EVIDENCE OF PAST OR PRESENT WATER STAINING, MOISTURE OR WATER PENETRATION CAN CAUSE THE DETERIORATION IN THE CEILING MATERIAL. A QUALIFIED CONTRACTOR IS RECOMMENDED TO EVALUATE AND MAKE NECESSARY REPAIRS.
