# PREVENTION OF PLASTIC CONTAMINATION WHEN HANDLING COTTON MODULES

*John Wanjura & Mathew Pelletier, USDA-ARS  
Jason Ward, N.C. State University  
Bobby Hardin, Texas A&M University  
Ed Barnes, Cotton Incorporated*

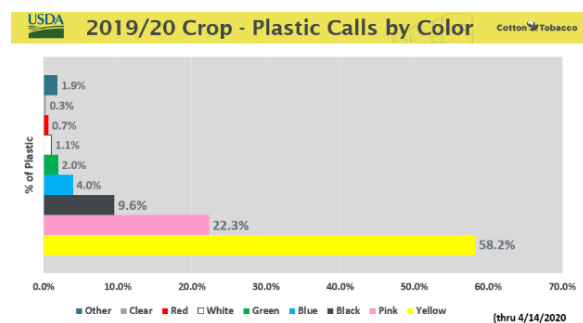
Figure 1. 2019/20 cotton crop plastic calls by color (chart complements of USDA-AMS).

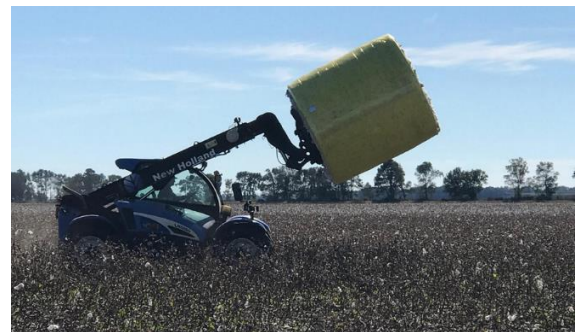
Figure 2. One of the in-field module handlers observed in this study.

During the 2018 and 2019 growing seasons, images were collected from a video camera mounted on two different types of module handlers as they staged modules in North Carolina fields. A similar system was developed

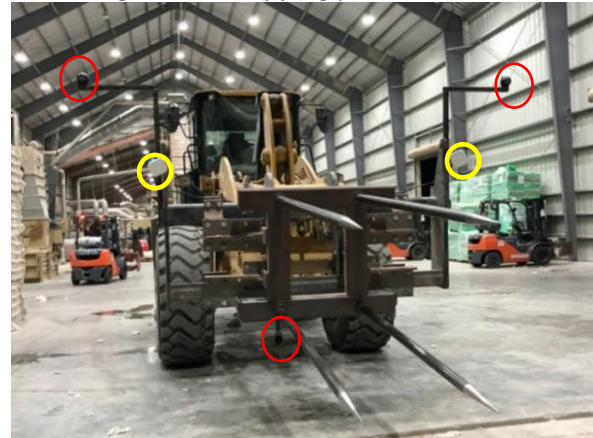
Figure 3. System used at gin yards for two of the Texas gins. Camera locations shown inside red circles and RFID antennas shown inside yellow circles.

In Texas, the system used at two gins consisted of RFID antennas, an embedded RFID module, GPS receiver, and outdoor security cameras connected to a single-board computer (Raspberry Pi 3B+). The system was designed to be capable of installation on any machinery used to handle modules. The system was installed on wheel loaders used to unload trailers at both gins and at the module truck used to move modules to the feeder at one of the gins. Images are captured when a module is detected and the vehicle comes to a stop, for more details, see Wang et al. (2020).

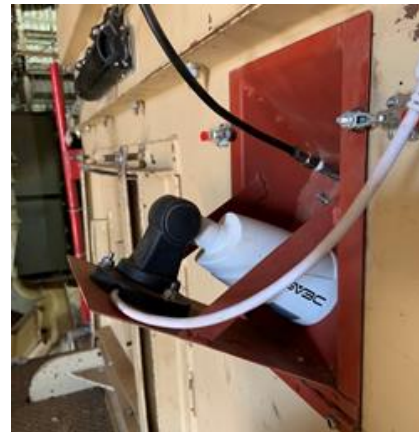
Figure 4. Network camera mounted to the back wall of the module feeder dispersing cabinet at 3<sup>rd</sup> Texas gin.

The system used to collect images and video of modules at the third Texas gin location consisted of an IP camera inspection system mounted in the module feeder dispersing cabinet (Pelletier et al., 2020) and an RFID scanning bridge (Wanjura et al., 2020) collocated with network-video-recorder (NVR) cameras at the intake end of the module feeder. The camera system mounted in the module feeder dispersing cabinet captured images of the dispersing cylinders when the module feeder floor was briefly paused, and a clear image of the rotating cylinders was available. Manual inspection of the still images of the dispersing rollers was conducted to determine if plastic material had accumulated on the cylinders since the last feeder bed pause event. Each time plastic was detected on the cylinders, the gin crew quickly removed it. In some cases, the plastic wrap contained an RFID tag or readable tag showing the module identification number making it a simple task to go back in the RFID scan log from the RFID bridge at the intake of the feeder to determine when the corresponding module was placed on the feeder and unwrapped. The RFID scan timestamp was used review the NVR video log and extract video footage showing the handling and unwrapping of the module that led

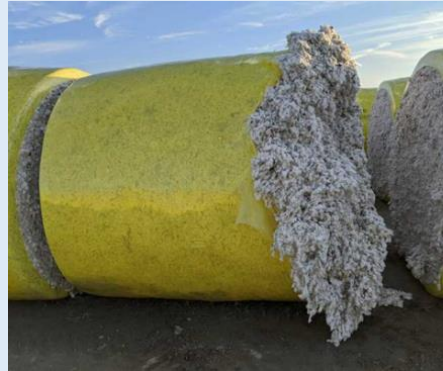
**Source:** Clipped by the handler on the harvester, module mover, or tail of the module truck.

**Preventative Steps:** Do not turn the harvester sharply or raise the handler before the module is away from the handler. Also, make sure module truck backs into modules with bed tilted completely and avoid sharp turns when moving into the loading position. Take care to make sure module moving equipment is clear of the modules before turning.

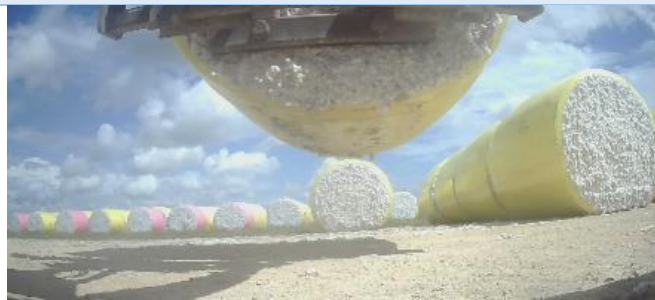
**Source:** Cotton stalk damage from staging modules on cut stalks.

**Preventative Steps:** Unload modules in turnrows or grass borders.

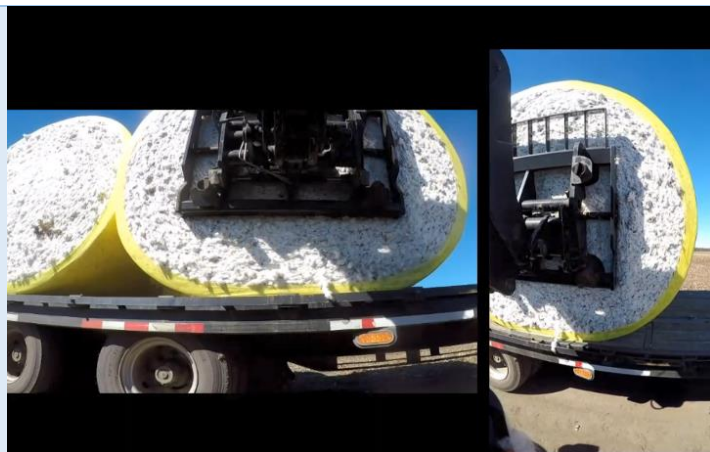
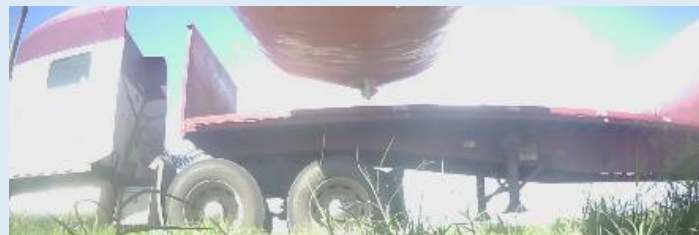
**Source:** When loading modules, in this case on a flat bed, modules can be pushed on the decking. Screws or damaged wood can damage the wrap.

**Preventative Steps:** Inspect the truck bed regularly. Repair or replace damaged decking or connectors.

Avoid sliding module on decking.

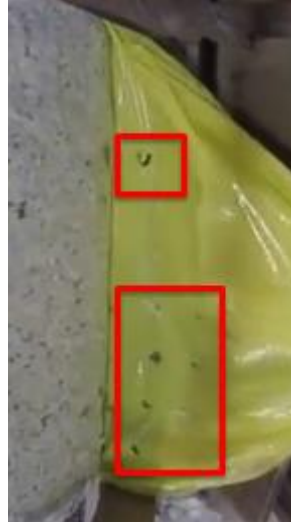
**Source:** Punctures in plastic wrap. Could push fragments of the wrap into the seed cotton.

**Preventative Steps:** Use proper chains on module trucks with smooth lugs and adjust chain speed to match ground speed. Prevent wrap puncture on sharp objects in the field and gin yard.

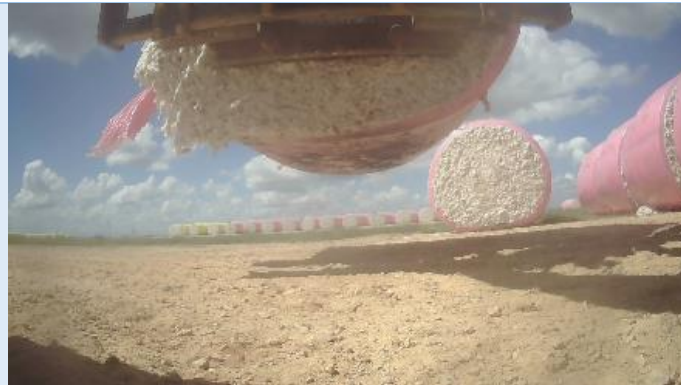
**Source:** Damage on side at end of module that may have been punctured by spear when staging adjacent modules in the field.

**Preventative Steps:** Be aware of adjacent modules when staging.

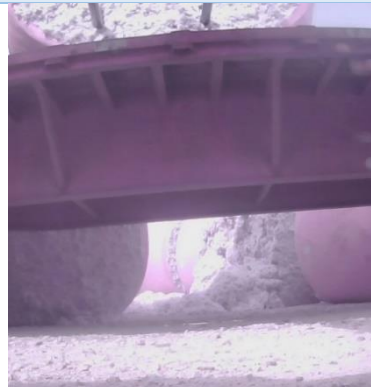
**Source:** Damage to module wrap resulted in complete module failure at the gin yard.

**Preventative Steps:** Cuts to module wrap can result in additional tearing – repair immediately.

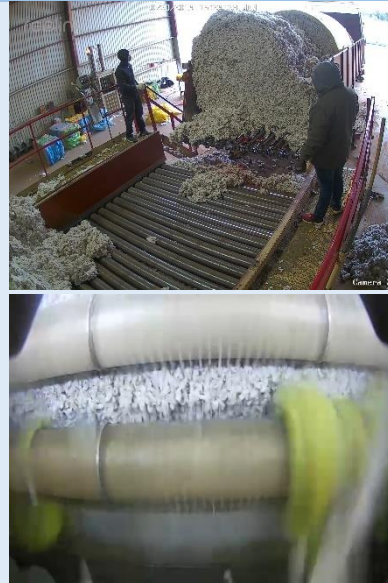
**Source:** Wrap condition - module wrap was damaged in the field. Broken module was loaded with plastic imbedded inside seed cotton, resulting in plastic entering the module feeder and becoming impaled on one of the dispersing cylinders. Once on the dispersing cylinder, it does not take long for significant shedding of plastic into the cotton stream to occur

**Preventative Steps:** Repair wrap damage as soon as it is detected. Consider processing all broken modules at one time at the end of the season.

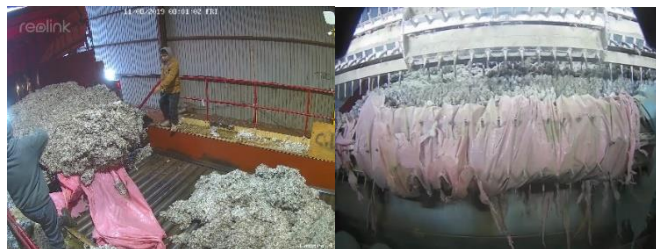
**Source:** Wrap Condition: Broken module with pink wrap underneath cotton.

**Preventative Steps:** Repair wrap damage as soon as it is detected. Consider processing all broken modules at one time at the end of the season.

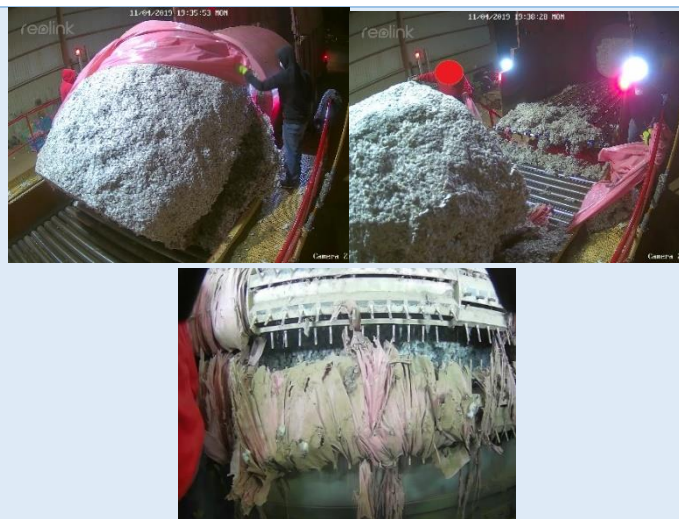
**Source:** Full-size module not unloaded on to flat end. Plastic was visible in the cotton. The portion that could be pulled out was removed. The module could not be repositioned to remove remaining trapped plastic.

**Preventative Steps:** Use proper unloading height of module truck above feeder bed to properly flip module onto its flat end. Use secondary equipment (loader or telehandler) to reposition module.

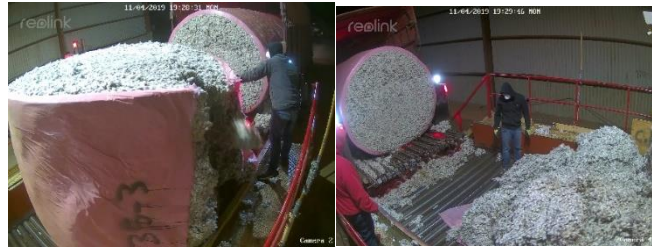
**Source:** Unwrapping technique - module wrap cut too high, not leaving sufficient material to restrain cotton. Module broke wrap and trapped plastic under cotton.

Plastic was visible in the cotton, and only the portion that could be pulled out was removed. Plastic trapped between fallen cotton and module feeder bed remained and was subsequently transported into the gin.

**Preventative Steps:** Leave the wrap uncut at the top 2 ft of the module to restrain cotton until complete wrap removal.

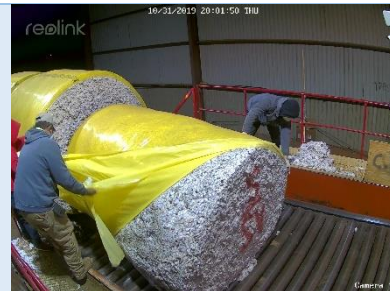
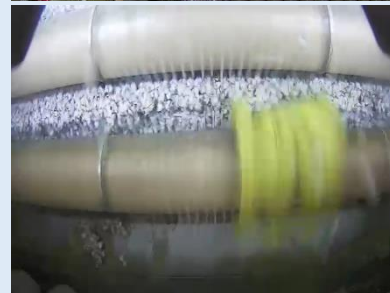
**Source:** Module Diameter  
Small module not unloaded onto flat end.

Plastic was visible in the cotton but could not reposition the module to remove completely.

**Preventative Steps:** Use secondary equipment (loader or telehandler) to reposition module onto flat end once unloaded from the truck.
