Characterisation of the Ross River Dam Foundations

Deryk Forster¹ and Manoj Laxman²

ABSTRACT

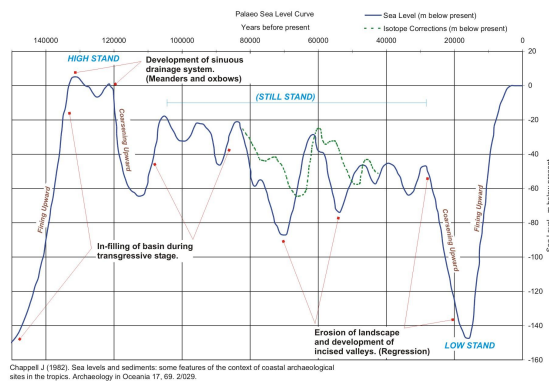
Figure 1 Palaeo Sea Level Fluctuation

The historical sea level curve is illustrated in Figure 1.

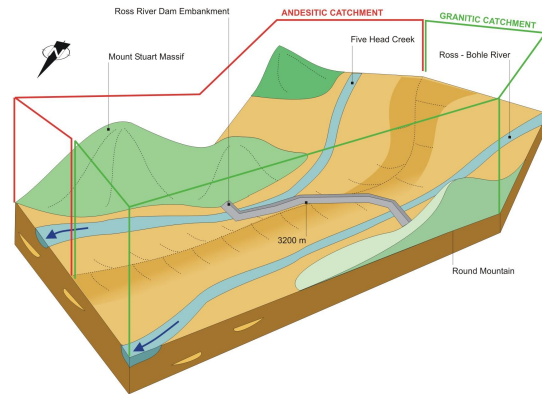
Figure 5 Distribution of andesitic and granitic clays based on stream catchments.

As illustrated in Figure 5, the andesitic sediments would have drained along the eastern side of the catchment, with the granitic sediments draining to the west. It is likely that a low watershed would have divided the valley in much the same way that the Ross and Bohle River catchments are separated today.

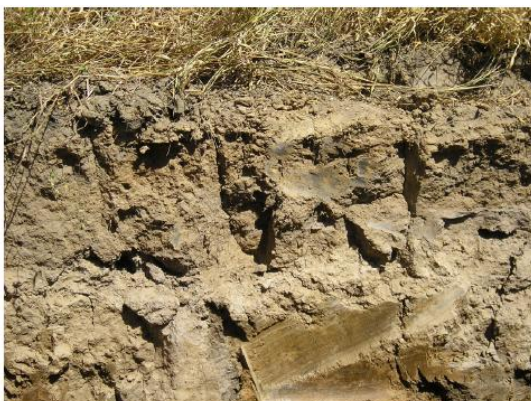
Figure 8 Type A Fissure

Type A defects are present in the upper 600 to 700 mm of the soil profile and appear to have developed as a result of wetting and drying (desiccation) of the soil profile. Typically, they are rough and irregular and are likely to reseal upon wetting of the soil profile. They were observed in all the soils, especially the granitic clays.

Where other material has in-filled these cracks, probably deposited during the first flush following a dry period, sub-vertical to 45° shears have developed as the soil has not been allowed to re-swell unimpeded along the original defect.

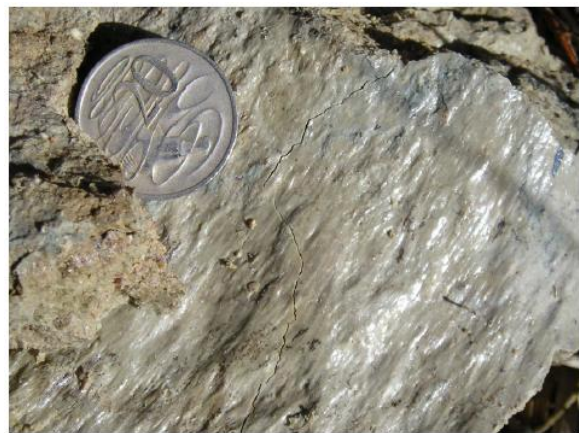
Figure 9 Type B Fissure

The most well developed Type B fissures were identified within the greenish-grey coloured clays intersected around chainage 4100 m, generally lying below 3.0 m. The fissures in this material were typically highly polished and glassy, and severely slickensided. Upon separation of intact fissures, droplets of free moisture were identifiable although the surrounding material was dry to moist. Most fissures were stained, in part (FeO or MnO), indicating the fissures are able to conduct groundwater.

The orientation varies, ranging from sub-horizontal, through 45°, to sub-vertical. These fissures persist for at least 150 mm.

Type B fissures were also identified in the granitic and andesitic clays, however do not always display well developed slickensides or highly polished glassy surfaces. Within these soils, however, there is a significant sand component, appearing to have an effect on the ability of the clay to develop polished and glassy fissures.

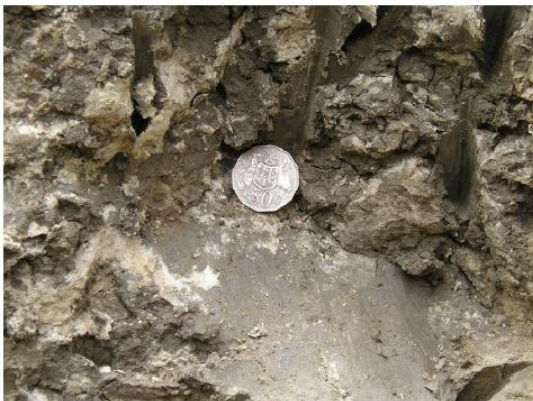
Figure 10 Type C Fissure

The majority of Type C fissures occur in the northern section of the embankment alignment, between chainage 1000 m and 3000 m. Although they display some slickensiding, they are generally smooth and planar to slightly undulating. Unlike the other fissures identified, Type C fissures tend to occur at low angles, generally being sub-horizontal to < 30° (to 45°).

Where identified, the clay within which they occur is somewhat softer than fissure-bearing materials elsewhere on site, reporting a strength of approximately 550 kPa . This style of fissuring was targeted for removal in the early 1980's. Type C fissures appear to swarm, with several fissures coalescing to form larger, semi-continuous planes.

Individually, they average approximately 0.5 m in length, however several fissures were observed to coalesce resulting in a continuous, though undulating, surface over 1.0 m in length.

Laboratory testing of these materials indicated a peak strength of 29° and residual strength of 10°.

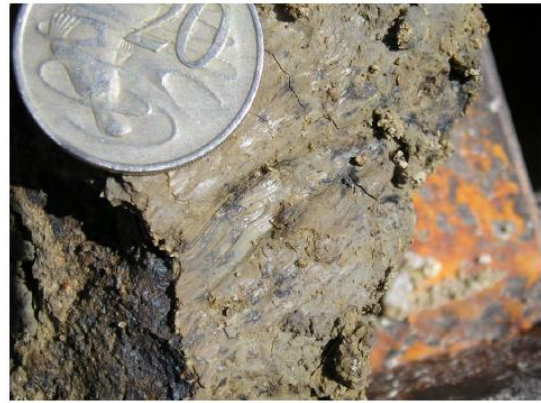
Figure 11 Type D Fissure.

Type D fissures are those fissures typically occurring deeper than 4 m below ground level. These tend to be present in materials with significant sand content, with the fissures being short (< 20 mm in length) and rough. The material excavates as a blocky, hard clay. Some evidence of slickensiding and striation development has been noted. Iron and manganese oxide staining is common in this material.

It appears the presence of sand within the material has assisted in preventing the development of the more planar and pervasive fissures classified as Type B and Type C.

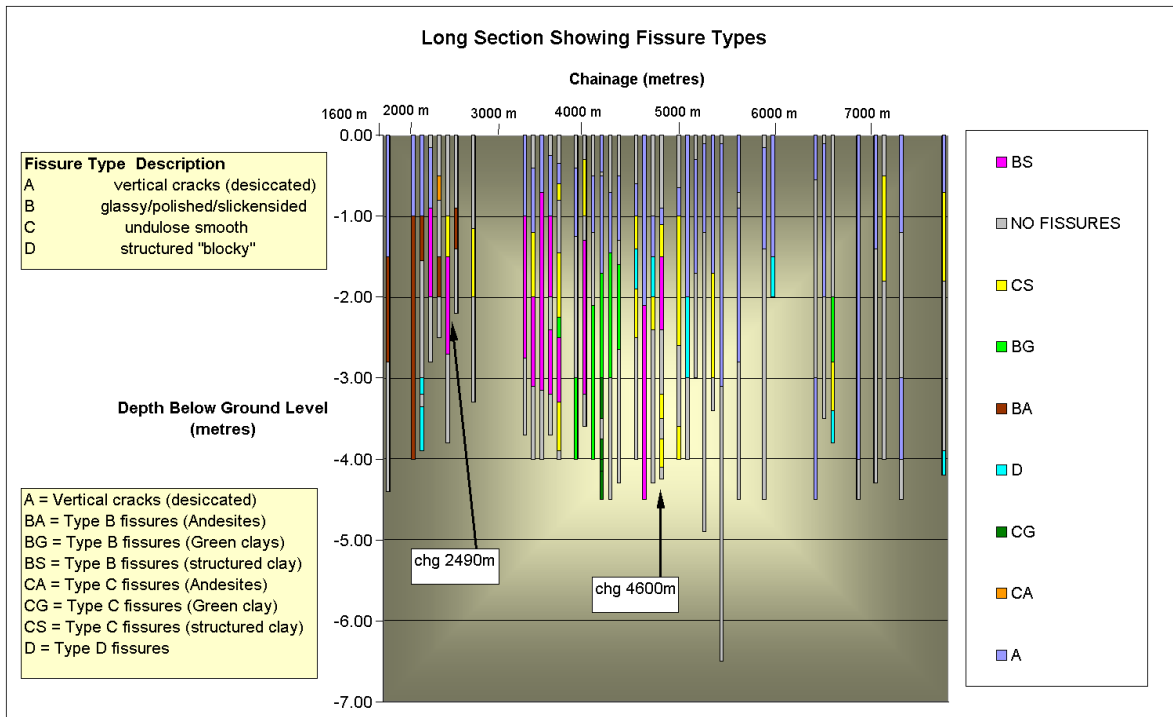
Figure 14: Fissure Variation along embankment.

The extent of the presence of the fissures in the dam foundations and the variation of the types

of fissured and the geological orientation of the foundation clays are indicated in the fissure model in Figure 14.

The fissure model provides a useful tool in determining the shear strengths of the fissured clays for various chainages along the embankment and for various depths.
