LABORATORY TEST REPORT

RE: Laboratory Test Report for Water Resistant Flooring Test Services

BMI-Assigned Lab Number:	2021-0496
Product Name/Description:	Water -Proof Laminate Flooring 7x48-10mm-AC4
Product Code/SKU:	Not Specified (N/S)
Manufacturer Name:	BBL Floor
Supplier Name (if different from manufacturer):	N/A
Lot/Batch Number:	N/S
Production Date:	N/S
Sample Collection Date:	March 31, 2021
Other Information:	N/A

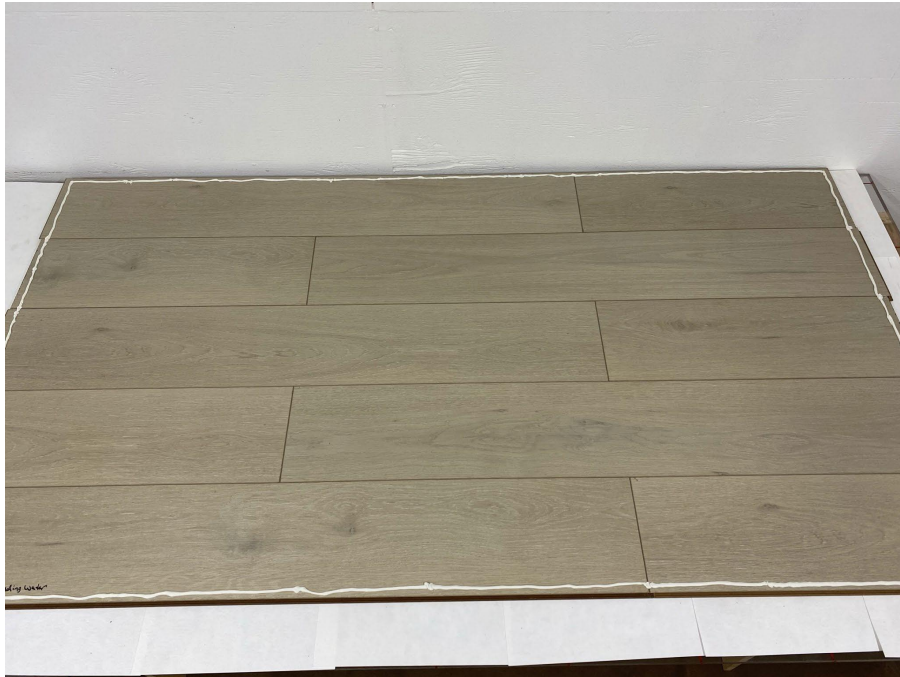
Figure 1: 30-Hour Standing Water Test Assembly prior to addition of water

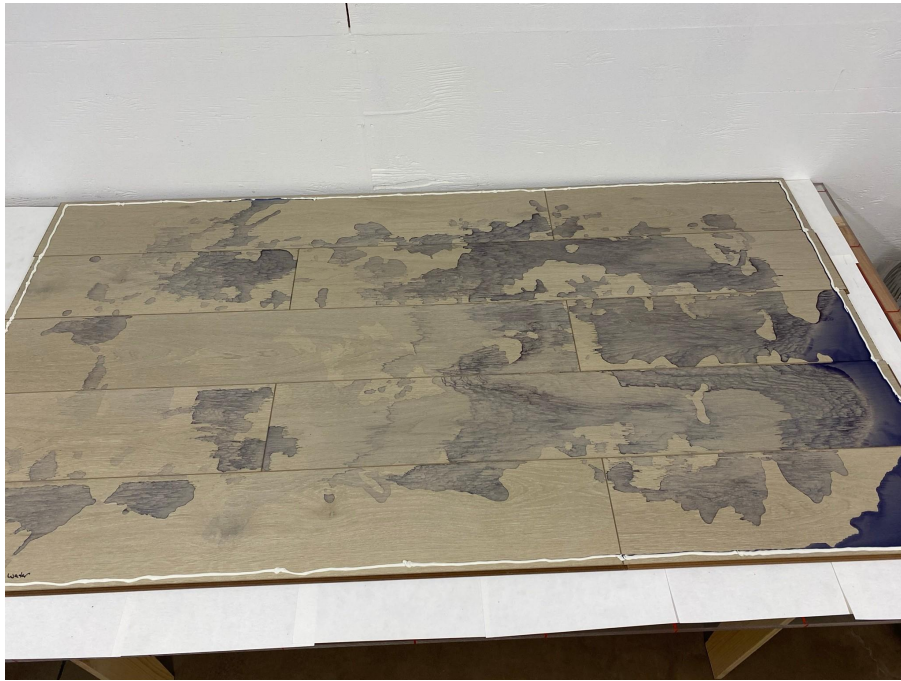
Figure 9: 30-Hour Standing Water Test Assembly at the 24-hour mark

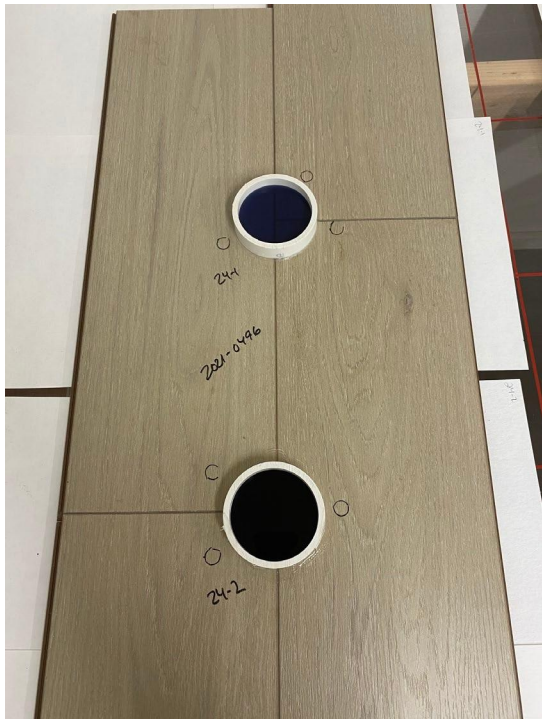
Figure 12: 24-Hour T-Seam at commencement of test

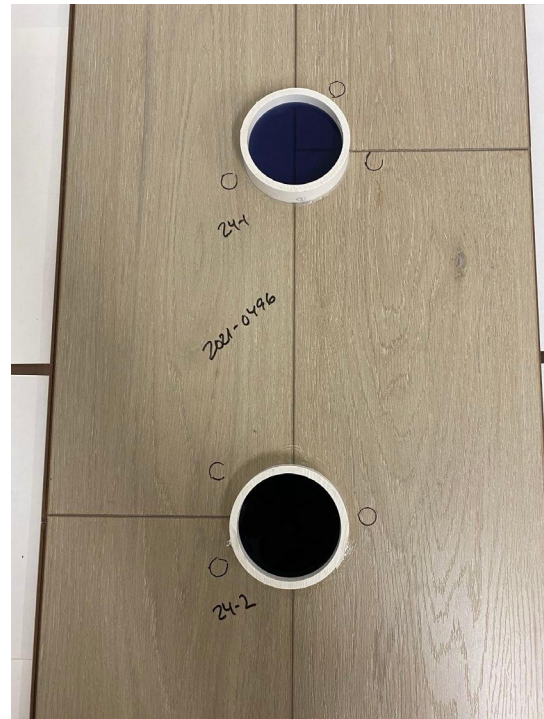
Figure 13: 24-Hour T-Seam at 30-minute mark

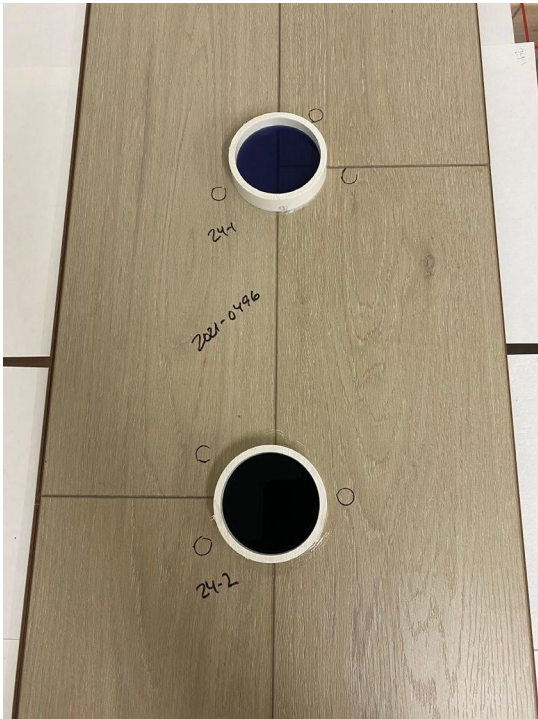
Figure 14: 24-Hour T-Seam at one-hour mark

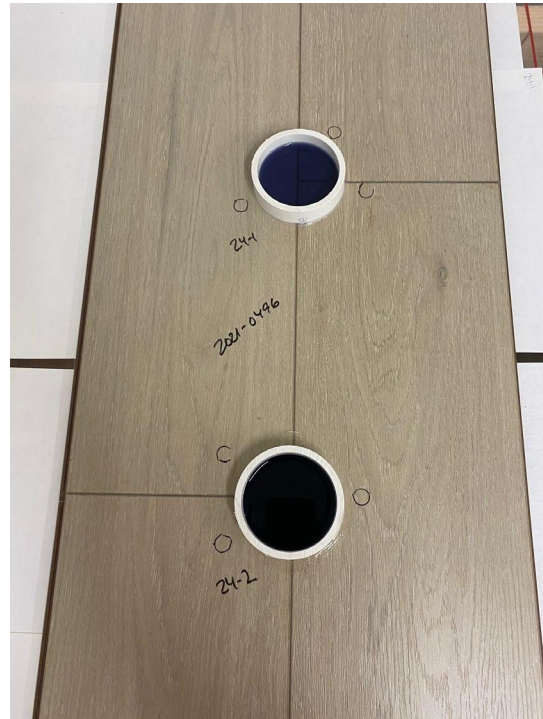
Figure 15: 24-Hour T-Seam at two-hour mark

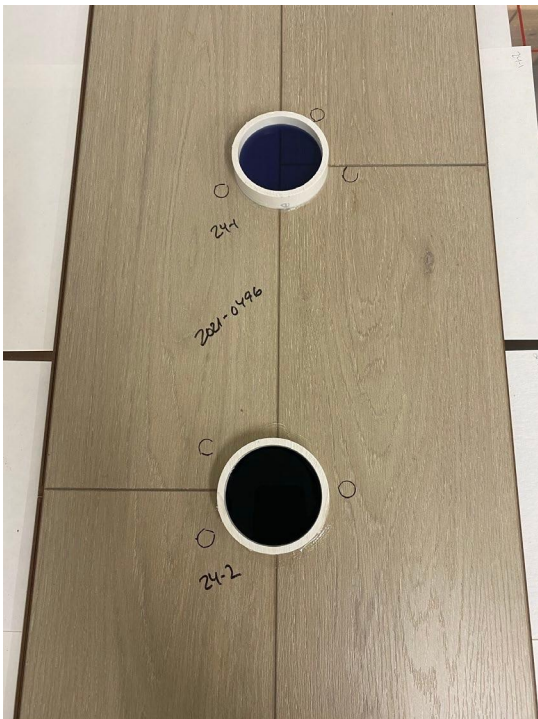
Figure 16: 24-Hour T-Seam at four-hour mark

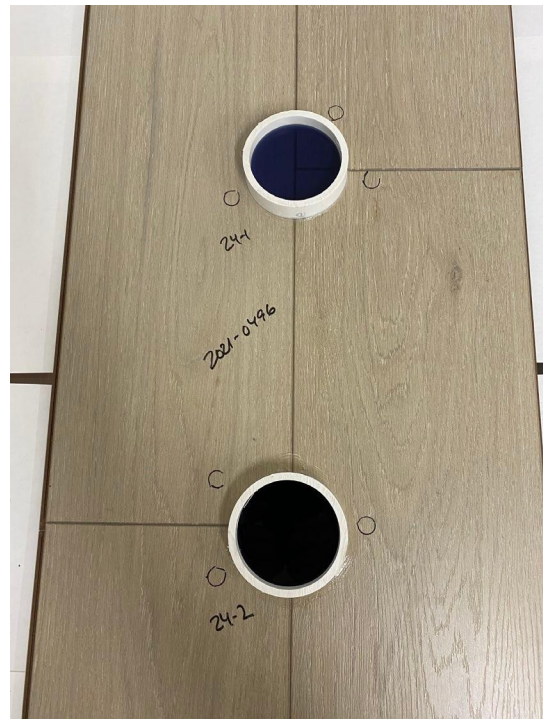
Figure 17: 24-Hour T-Seam at six-hour mark

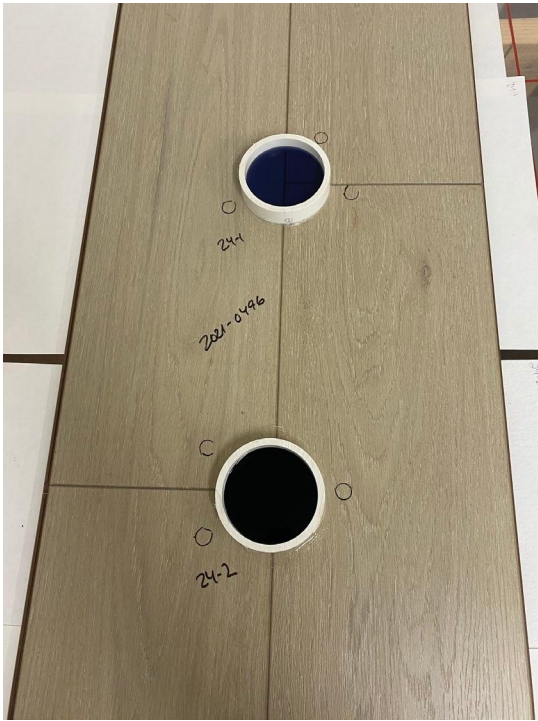
Figure 18: 24-Hour T-Seam at eight-hour mark

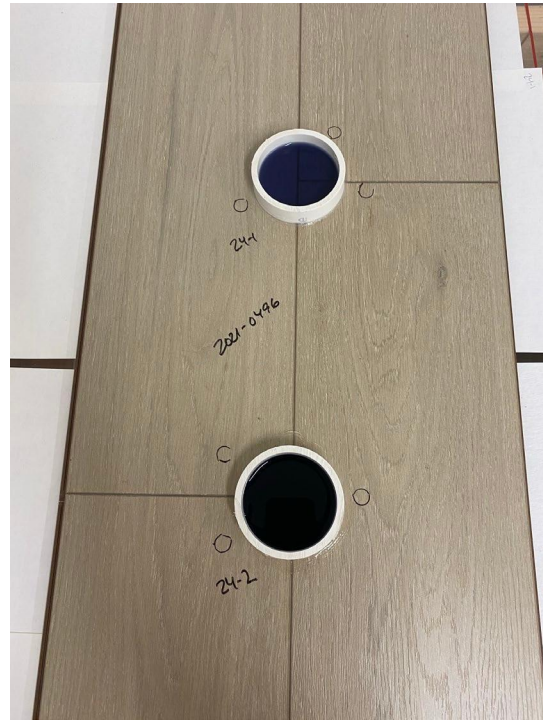
Figure 19: 24-Hour T-Seam at 24-hour mark

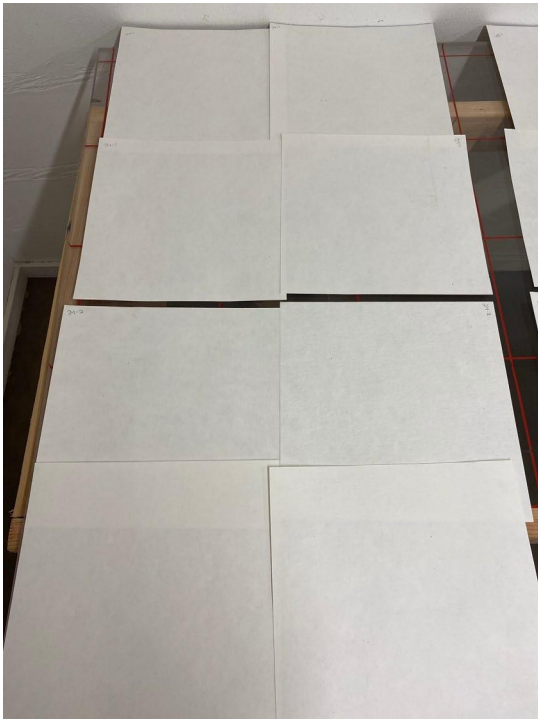
Figure 20: Blotter papers, 24-Hour T-Seam, at endpoint

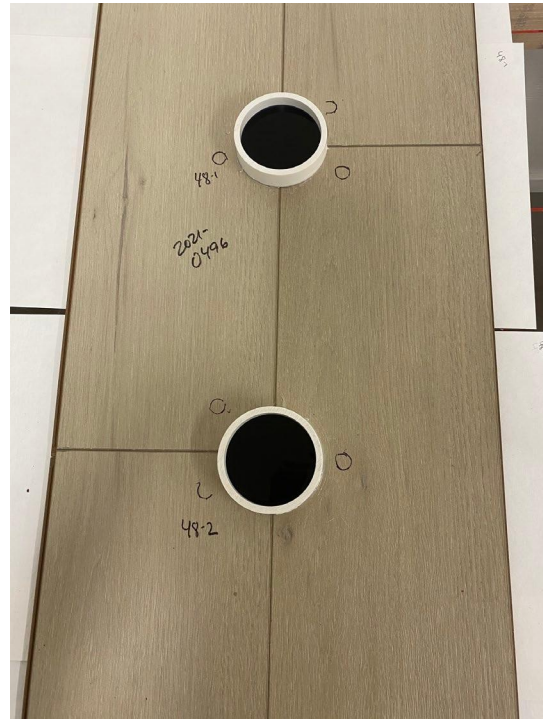
Figure 21: 48-Hour T-Seam at commencement of test

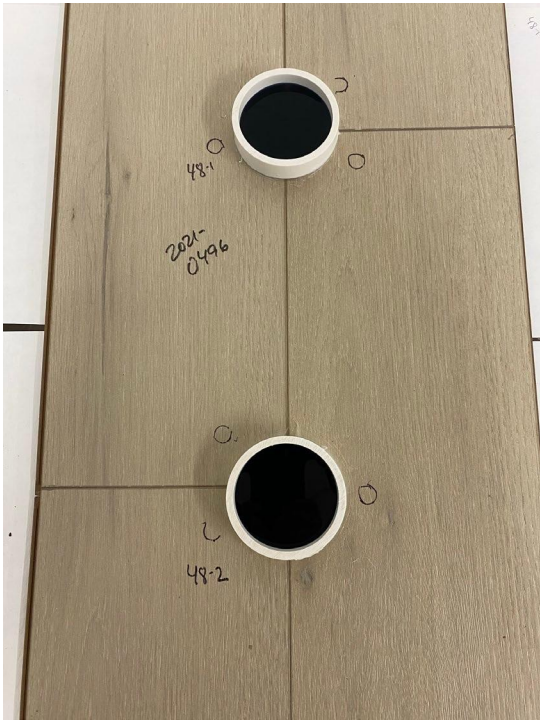
Figure 22: 48-Hour T-Seam at 30-minute mark

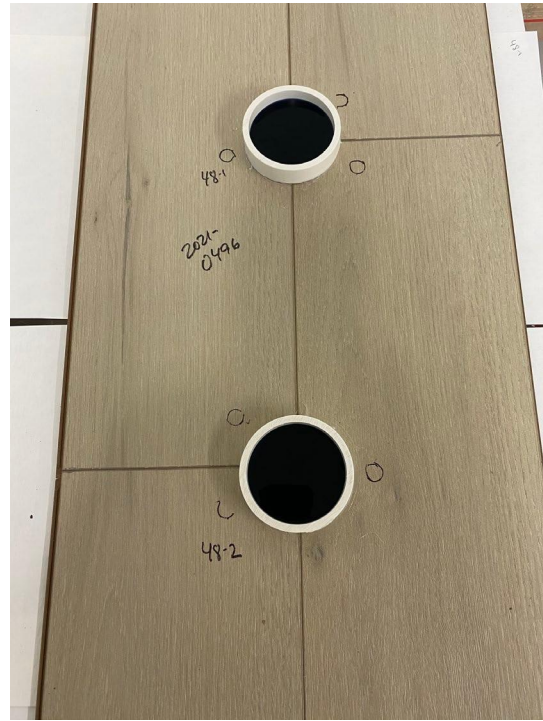
Figure 23: 48-Hour T-Seam at one-hour mark

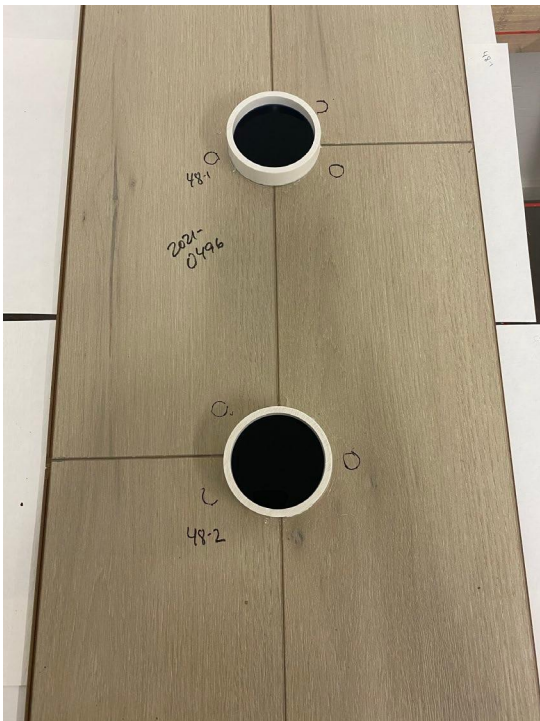
Figure 24: 48-Hour T-Seam at two-hour mark

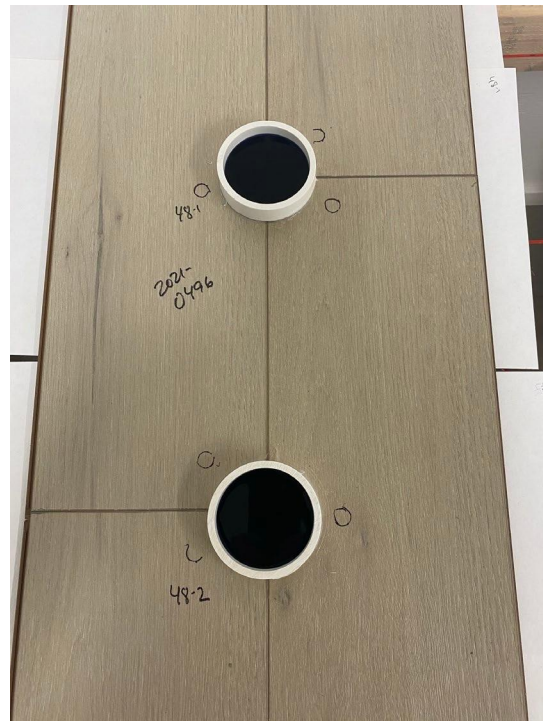
Figure 25: 48-Hour T-Seam at four-hour mark

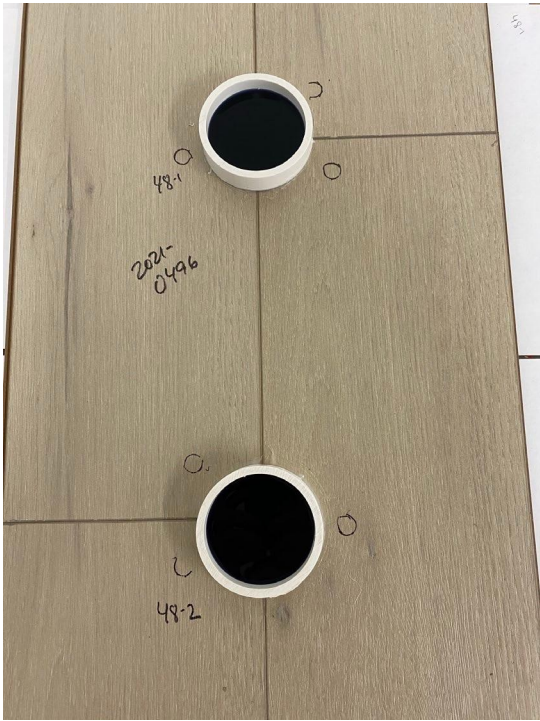
Figure 26: 48-Hour T-Seam at six-hour mark

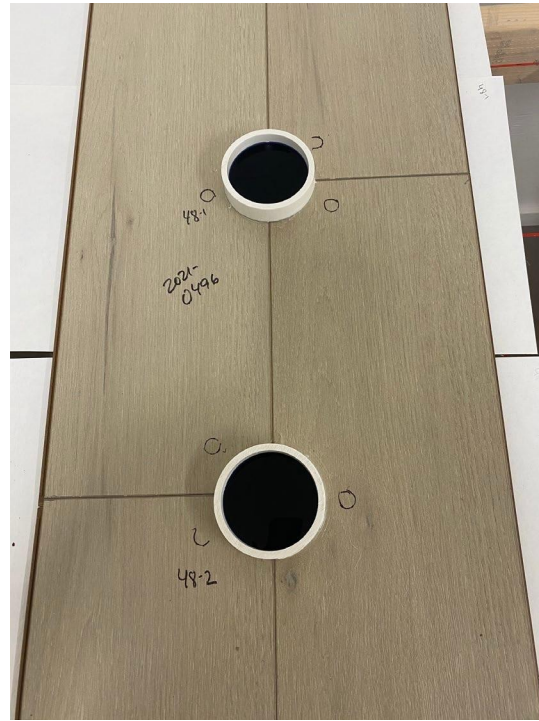
Figure 27: 48-Hour T-Seam at eight-hour mark

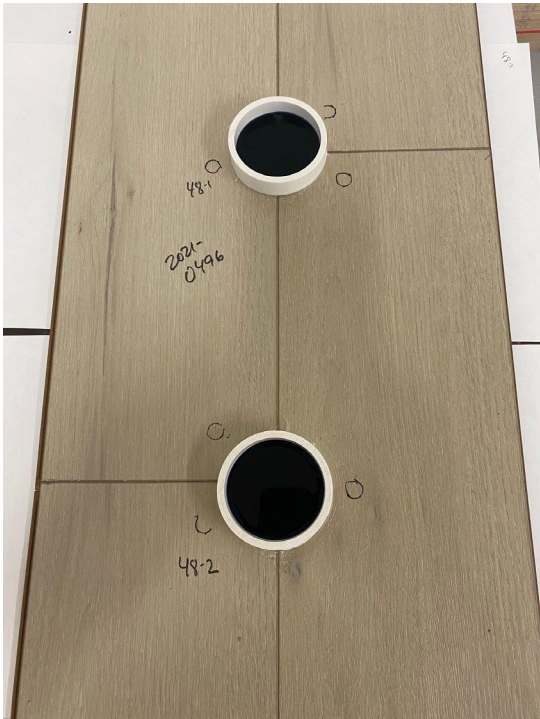
Figure 28: 48-Hour T-Seam at 24-hour mark

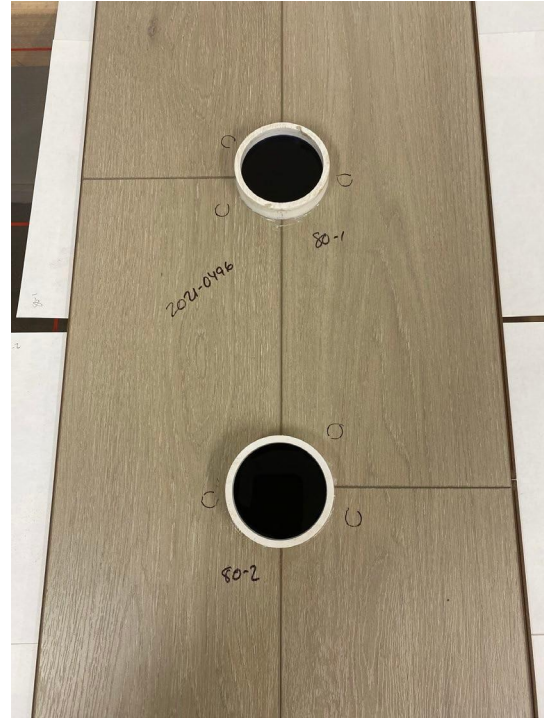
Figure 31: 80-Hour T-Seam at commencement of test

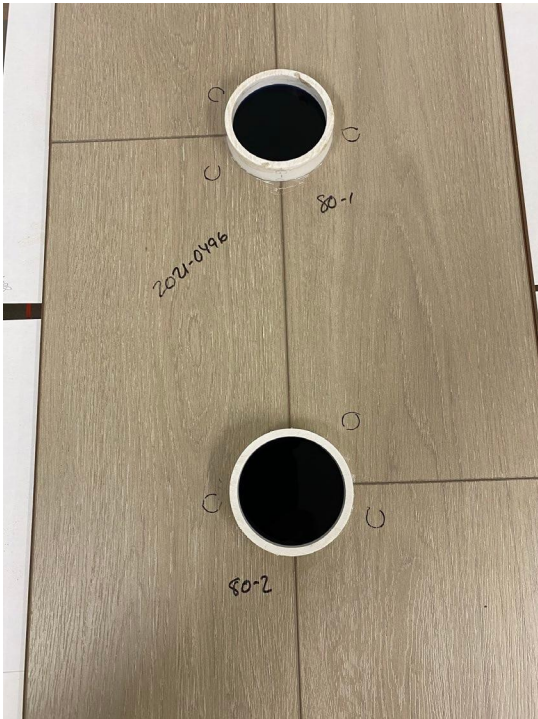
Figure 32: 80-Hour T-Seam at 30-minute mark

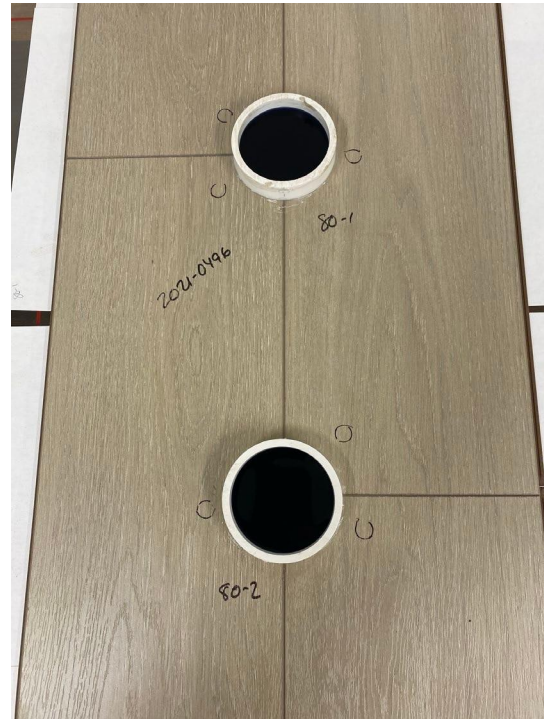
Figure 33: 80-Hour T-Seam at one-hour mark

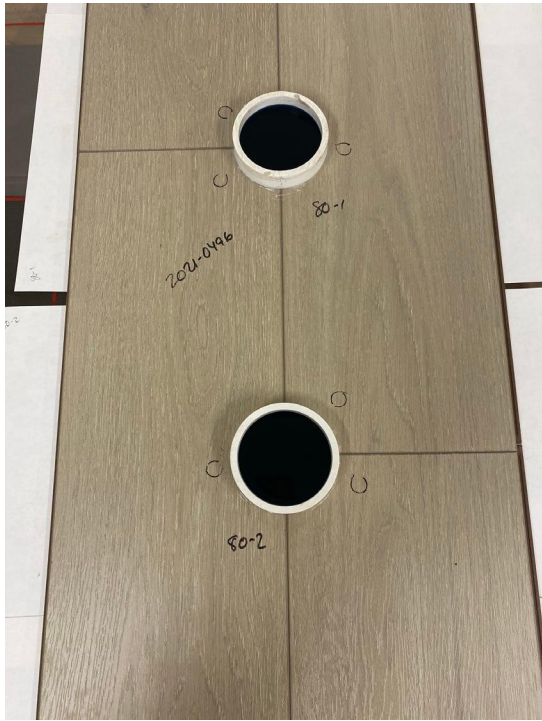
Figure 34: 80-Hour T-Seam at two-hour mark

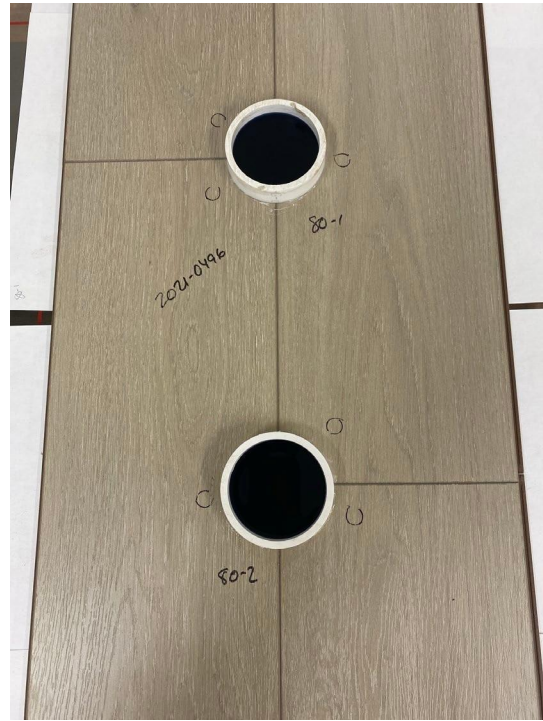
Figure 35: 80-Hour T-Seam at four-hour mark

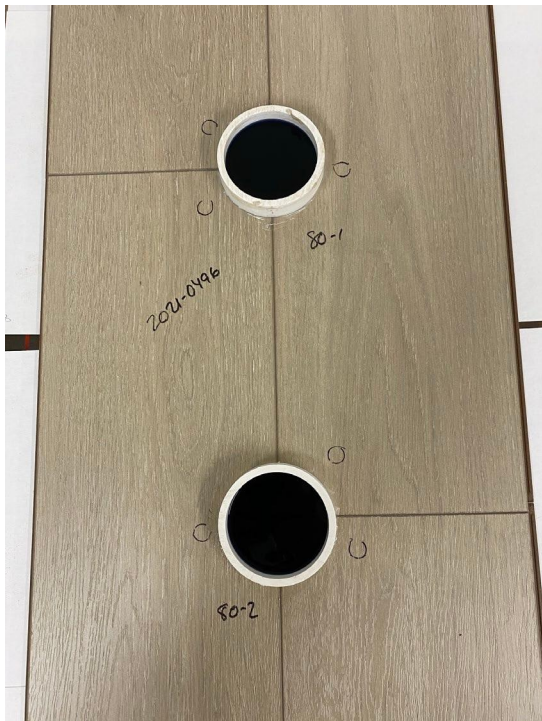
Figure 36: 80-Hour T-Seam at six-hour mark

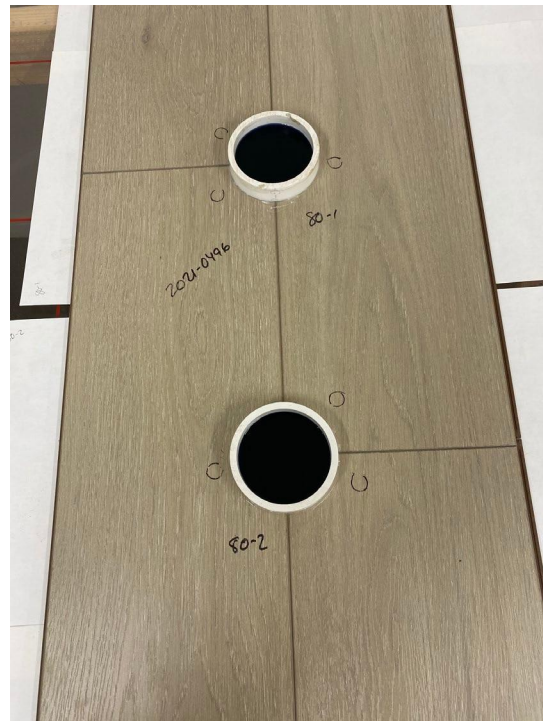
Figure 37: 80-Hour T-Seam at eight-hour mark

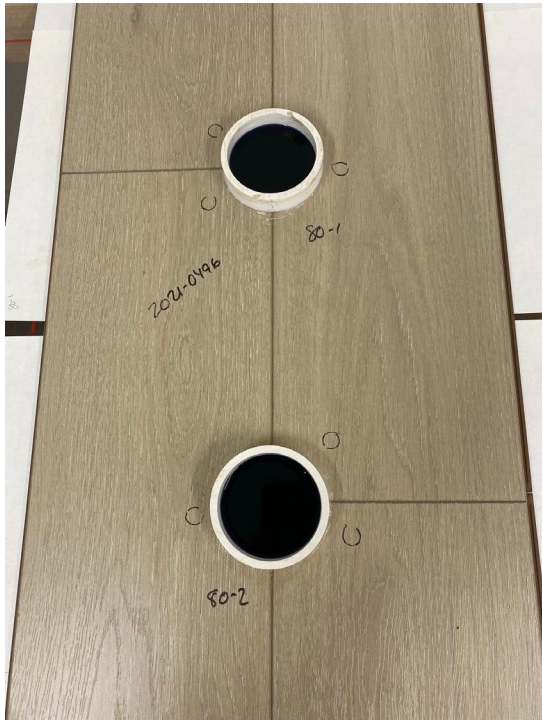
Figure 38: 80-Hour T-Seam at 24-hour mark

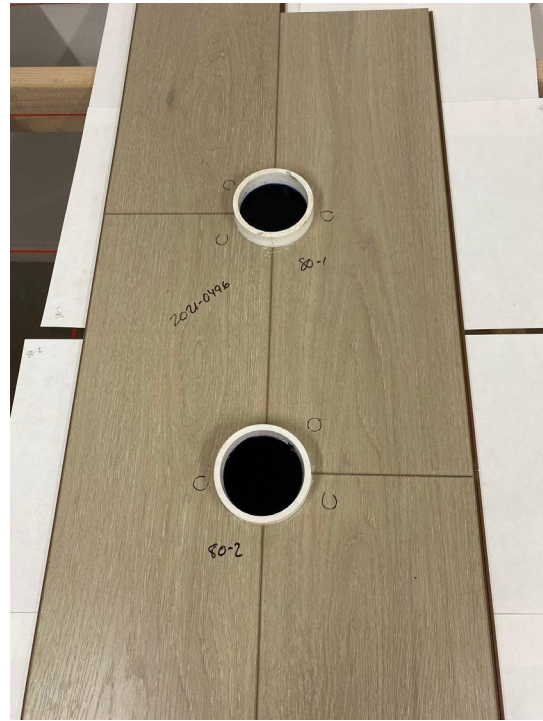
Figure 39: 80-Hour T-Seam at 48-hour mark

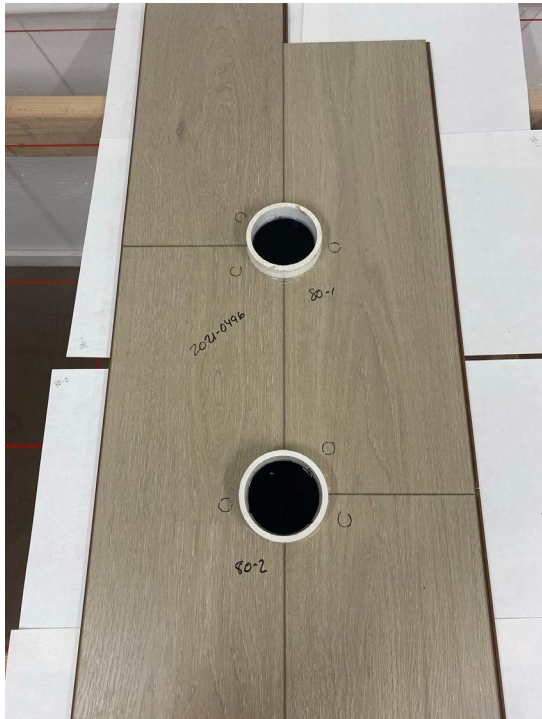
Figure 40: 80-Hour T-Seam at 72-hour mark
