**Subject:**  
GLT Fiber Optic System Status,  
Thule Air Base

**Date:**  
2017-Dec-12  
DK006-2017

**From:**  
Derek Kubo

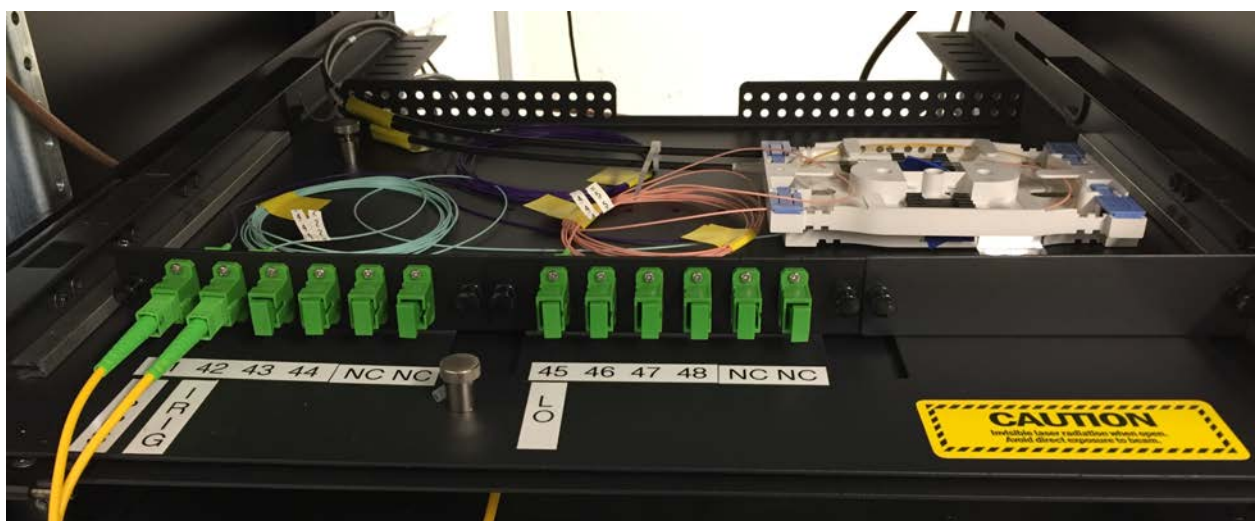
Figure 2. Maser house splice chassis for W11 to RSC and W12 to Rx Cabin

The physical partitioning of the fiber optic system is described in Table I. The design was originally to have a single large control module for summit station but was partitioned to consist of a separate control container, VLBI container, and maser container for the interim location at Thule Air Base. The 12 cables were pulled from the 3 containers and installed into the telescope by ICP/ASIAA in September. Peter Oshiro arrived in Thule on September 14 and began preparation for fusion splicing of the SC/APC pigtail fibers onto the ends of the AFL cable. Due to problems encountered during parts procurement and shipping, we were missing some key items including the 900-um fiber holders, thermal stripper, and fusion splice chassis. Peter accommodated the first two items with work around solutions but as a result was only able to finish 7 of the 12 cables. I arrived in Thule on November 16 about 2 weeks after arrival of the rack mount fusion splice chassis and proceeded to install the cables and fusion splice trays into the racks. Figures 2-8 illustrate the 7 completed rack mount chassis with SC/APC panel mount connectors.

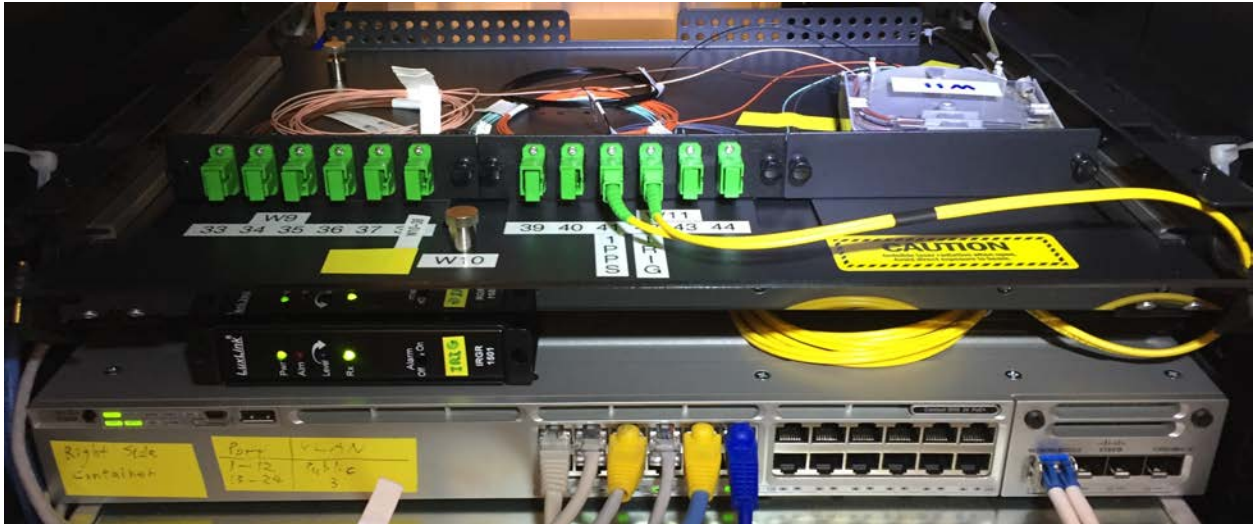
Figure 3. RSC splice chassis for W9 and W10 from control room, and W11 from maser house

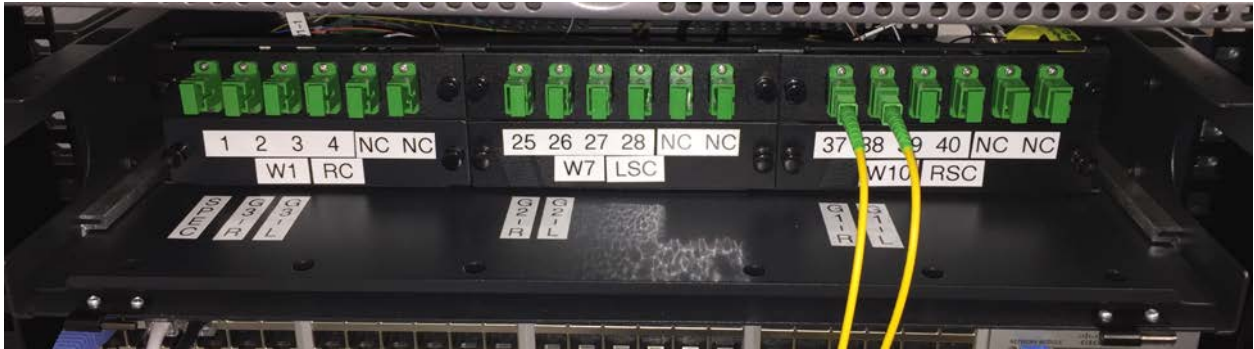
Figure 4. Control container splice chassis for W1 to Rx cabin, W7 to LSC, and W10 to RSC
