# RESIDENTIAL MOLD ASSESSMENT

Project: 171221A

Address: 1234 Happy Lane, Fun City, TX 77777

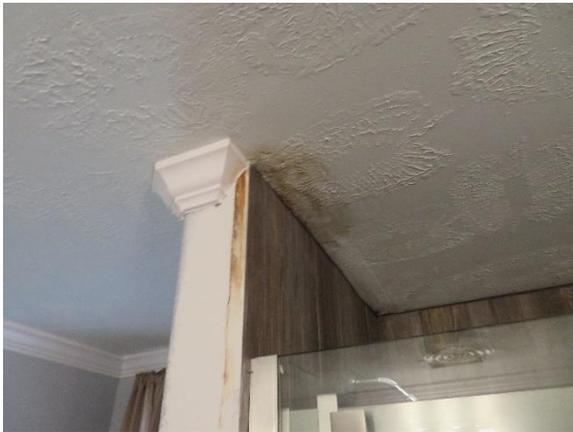
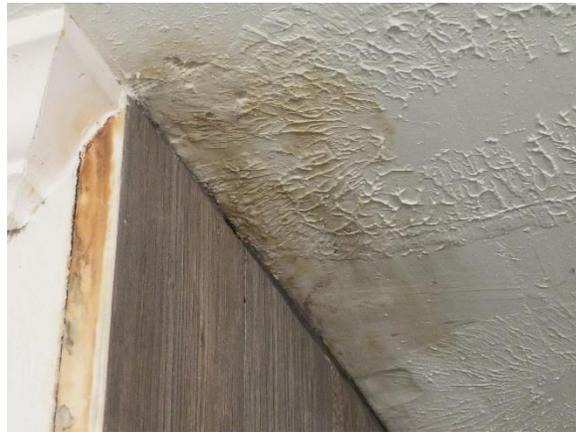
**Moisture Intrusion:** Areas of moisture intrusion were observed on the master bathroom ceiling and wall.

**All conducive conditions should be corrected to reduce the risk of moisture intrusion and subsequent mold growth. Removal of mold without controlling and correcting the conducive condition can cause mold to regrow and reappear on the affected areas.**

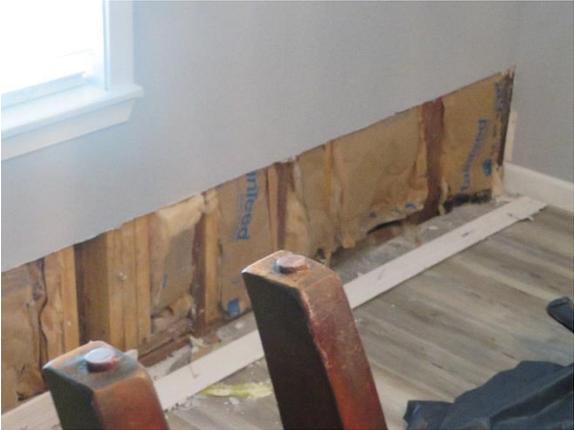
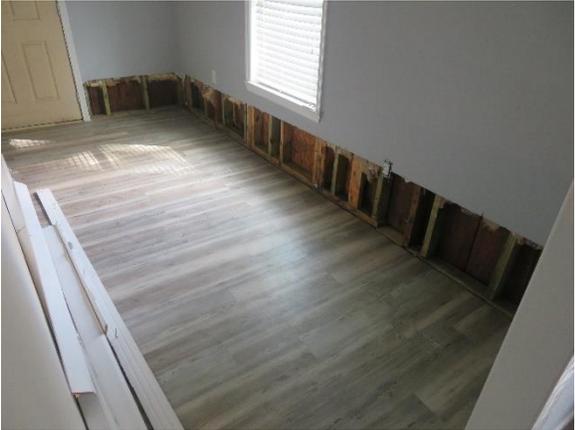
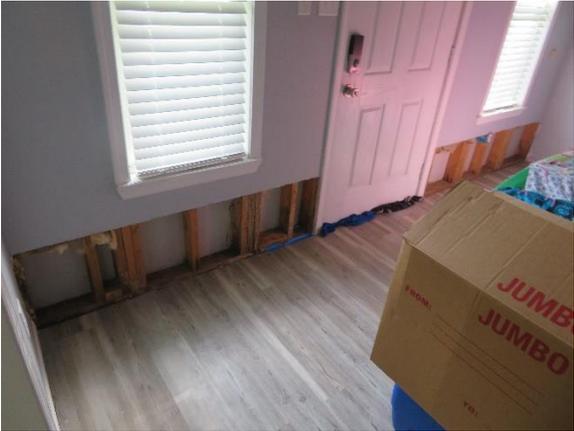
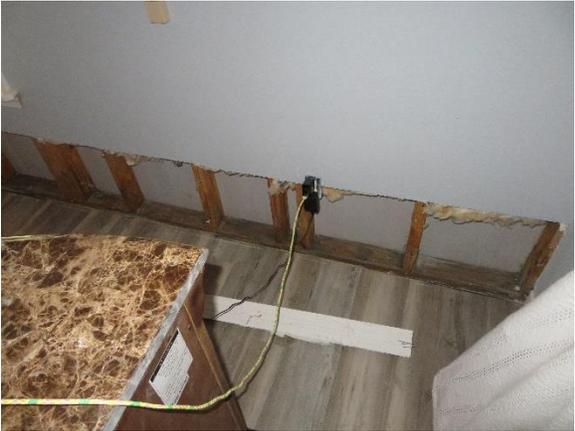
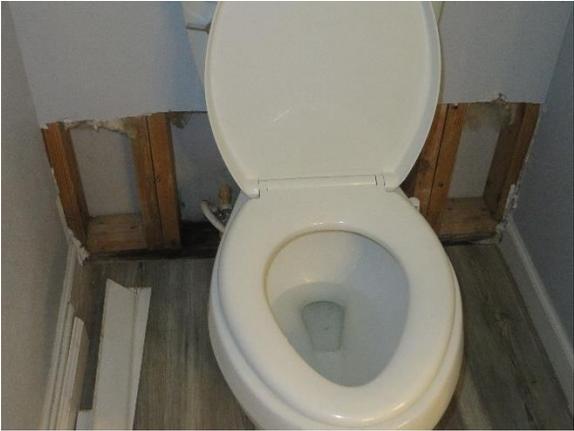
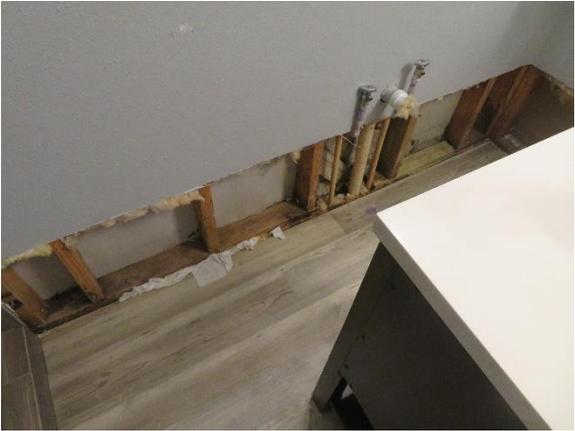
**Water Damage:** Water damage was observed in multiple rooms in the property.

Intrusive investigation should be performed in areas with water damage and/or elevated moisture content to identify the full extent of areas requiring remedial treatment.

Building materials that have been water damaged to the point that drying and cleaning will not restore them to their pre-water exposure condition or have sustained loss of integrity should be removed and discarded, whether there is visible evidence of fungal growth or not.

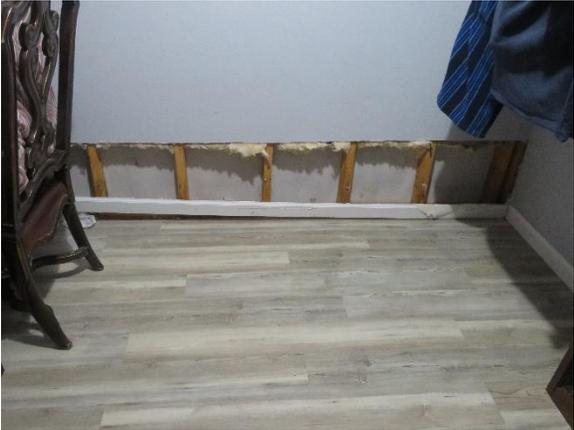
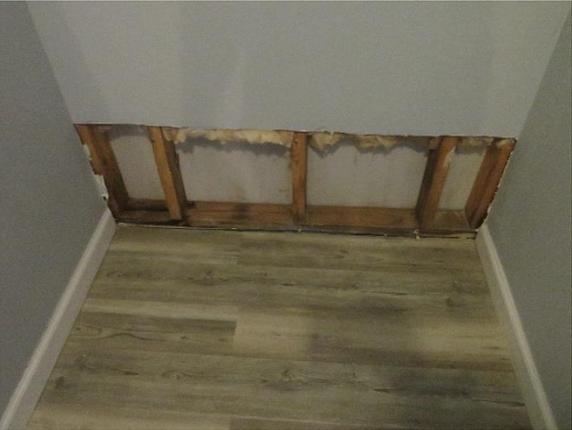
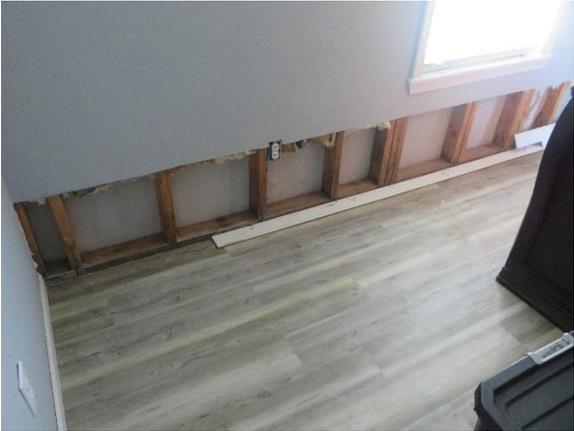
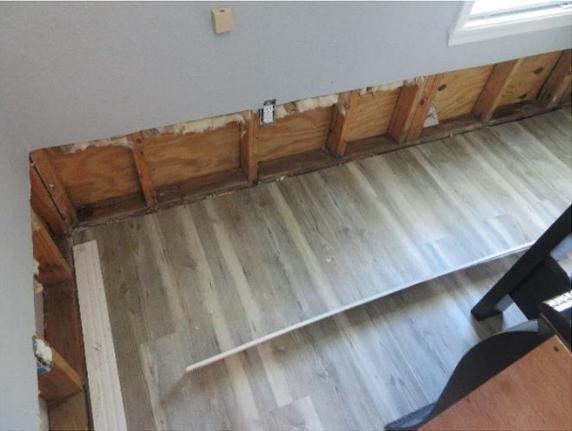
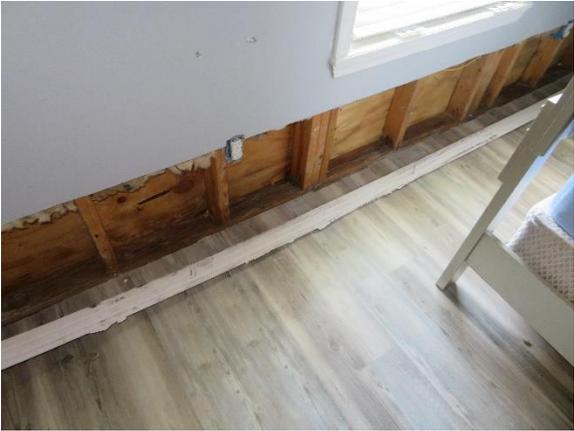
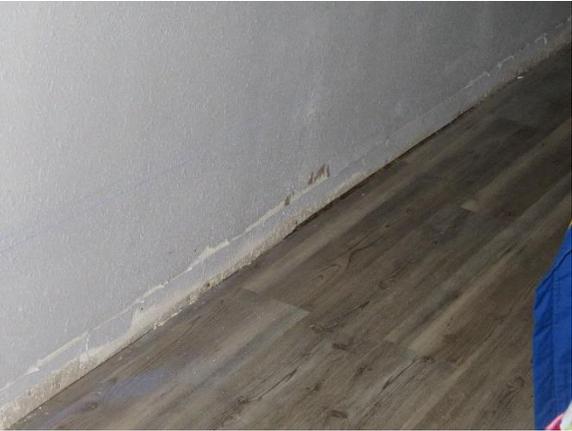
Water Damage (cont.): Water damage was observed in multiple rooms in the property.

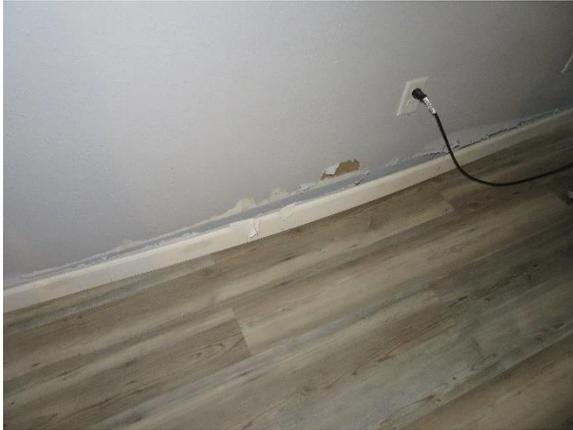
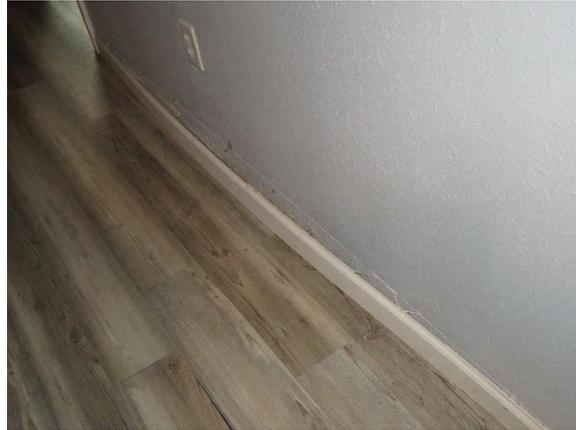
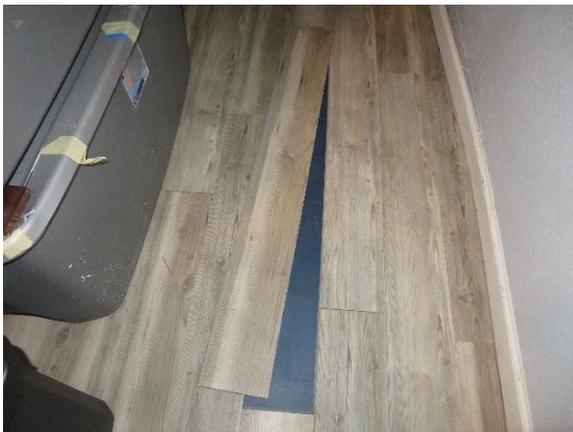
Water Damage (cont.): Water damage was observed in multiple rooms in the property.

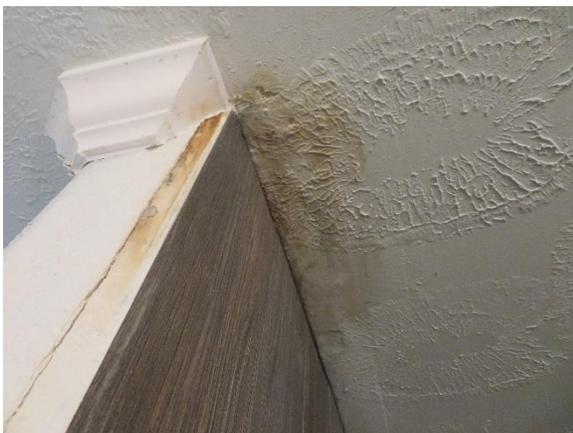
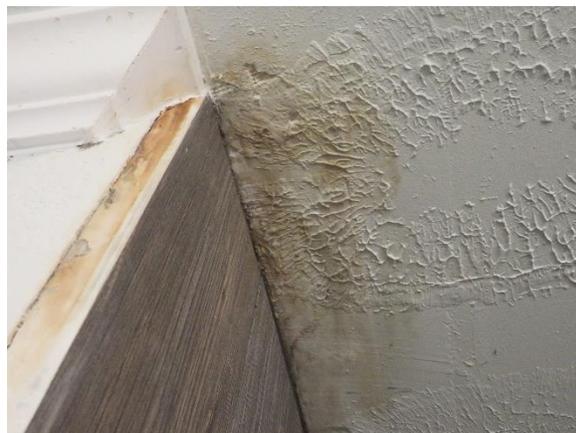
**Apparent Mold Growth:** Evidence of apparent mold growth was observed on the master bathroom ceiling.

**Based on the laboratory analysis and visual inspection, it is the opinion of the inspector that mold remediation is recommended on the subject property.**

The goal of the remediation process is to correct all existing moisture conditions that promote mold growth and to physically remove all mold contaminated/non-restorable materials in accordance with the EPA/OSHA and IICRC S520 mold remediation standards.

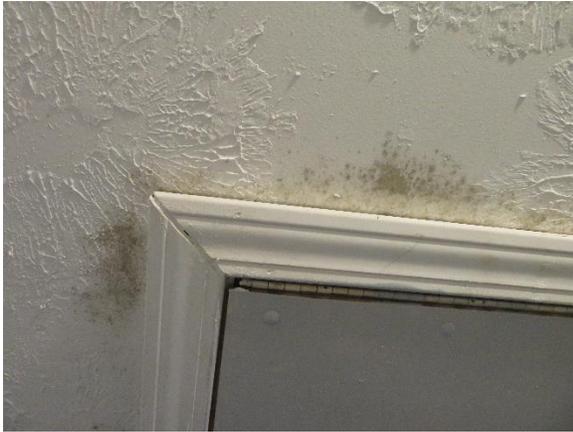
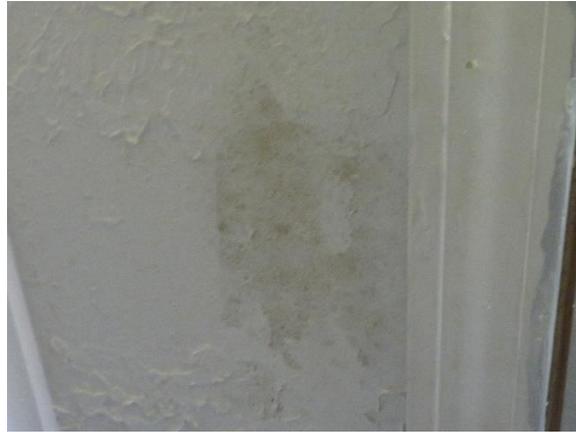
Apparent Mold Growth (cont.): Evidence of apparent mold growth was observed on the hallway ceiling.

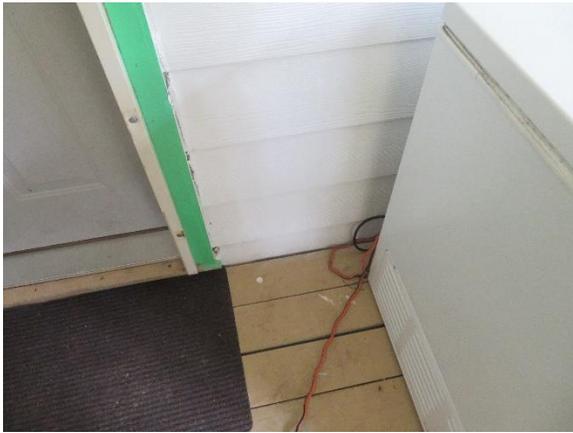
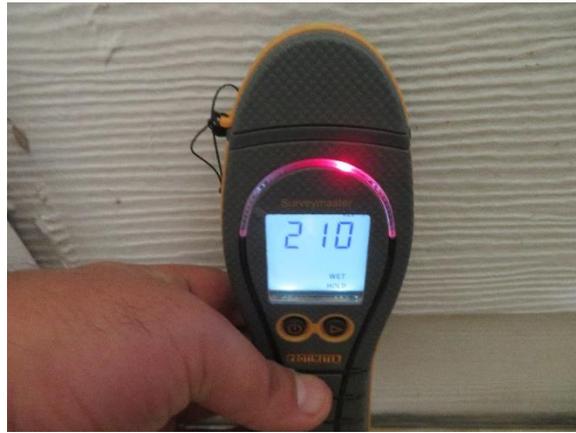
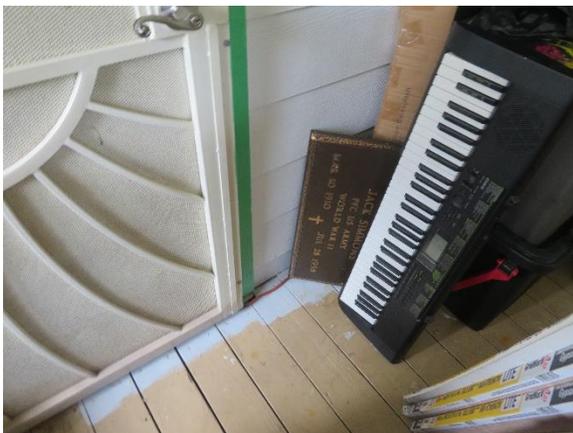
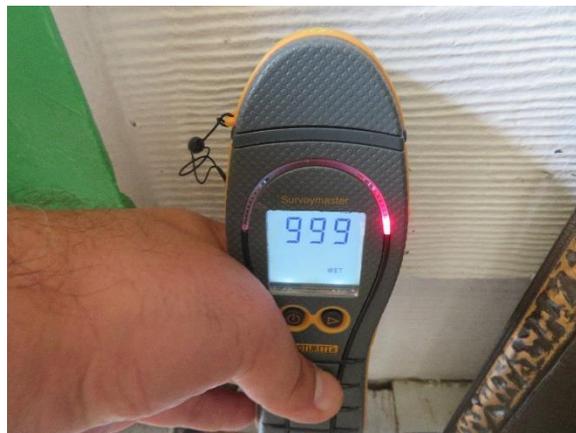
**Conditions Conducive to Mold Growth:**

1. Wet siding: Siding in the porch was observed to be wet when tested with the moisture meter.

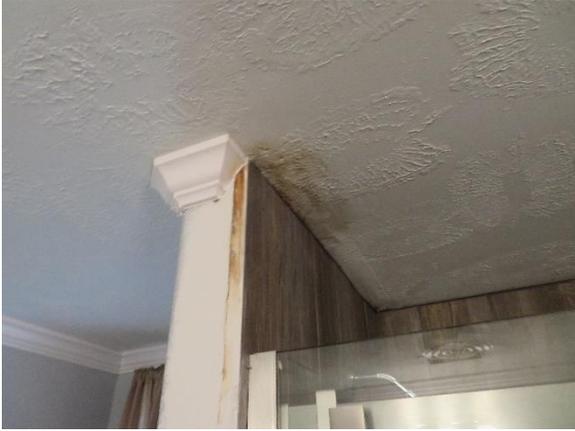
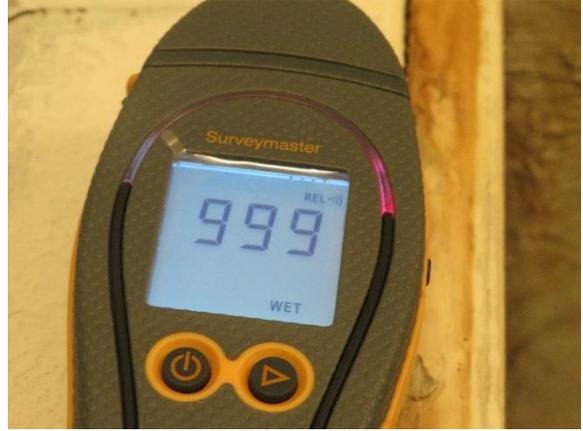
Conditions Conducive to Mold Growth (cont.):

2. Water intrusion: Wall and ceiling in the master bathroom was observed to have wet areas when tested with a moisture meter.

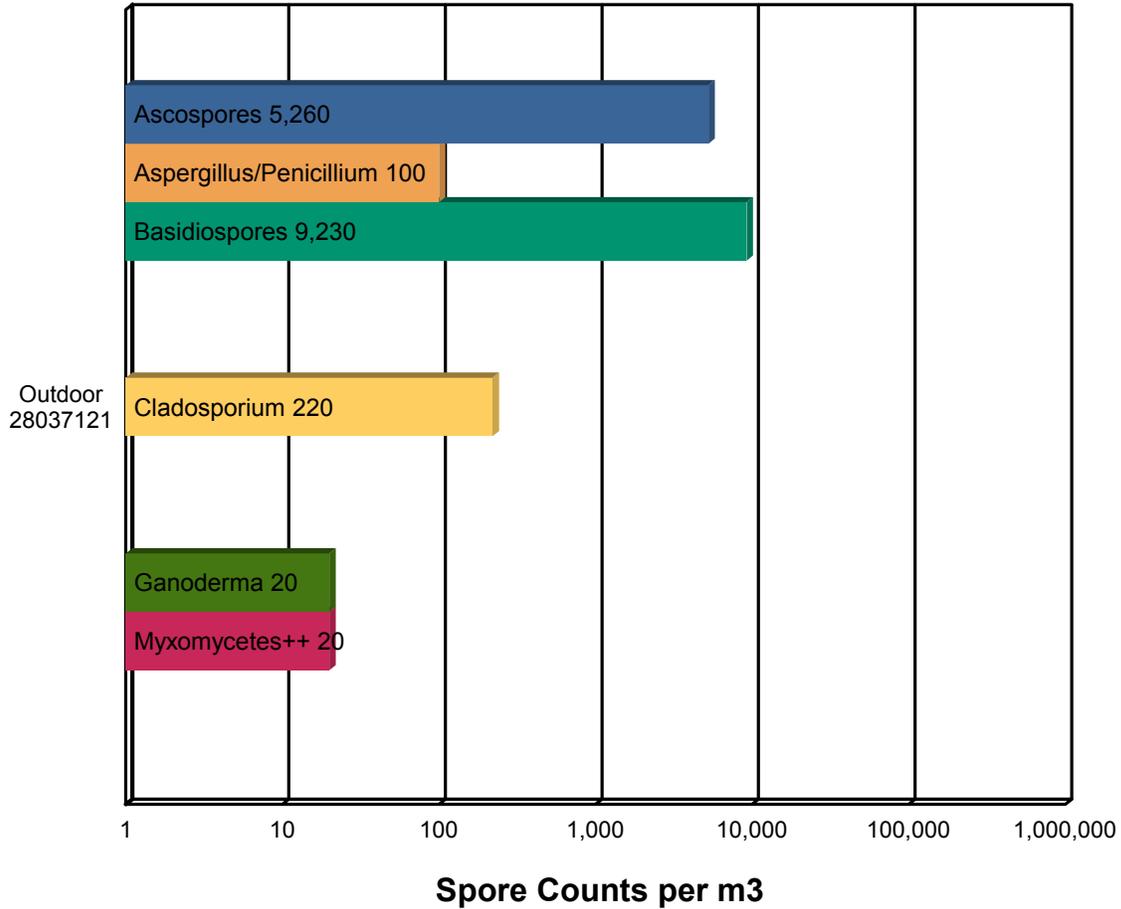
## Spore Trap Report: Total Counts

\* The chart is displayed using a logarithmic scale. Bar size is not directly proportional to the number of spores.

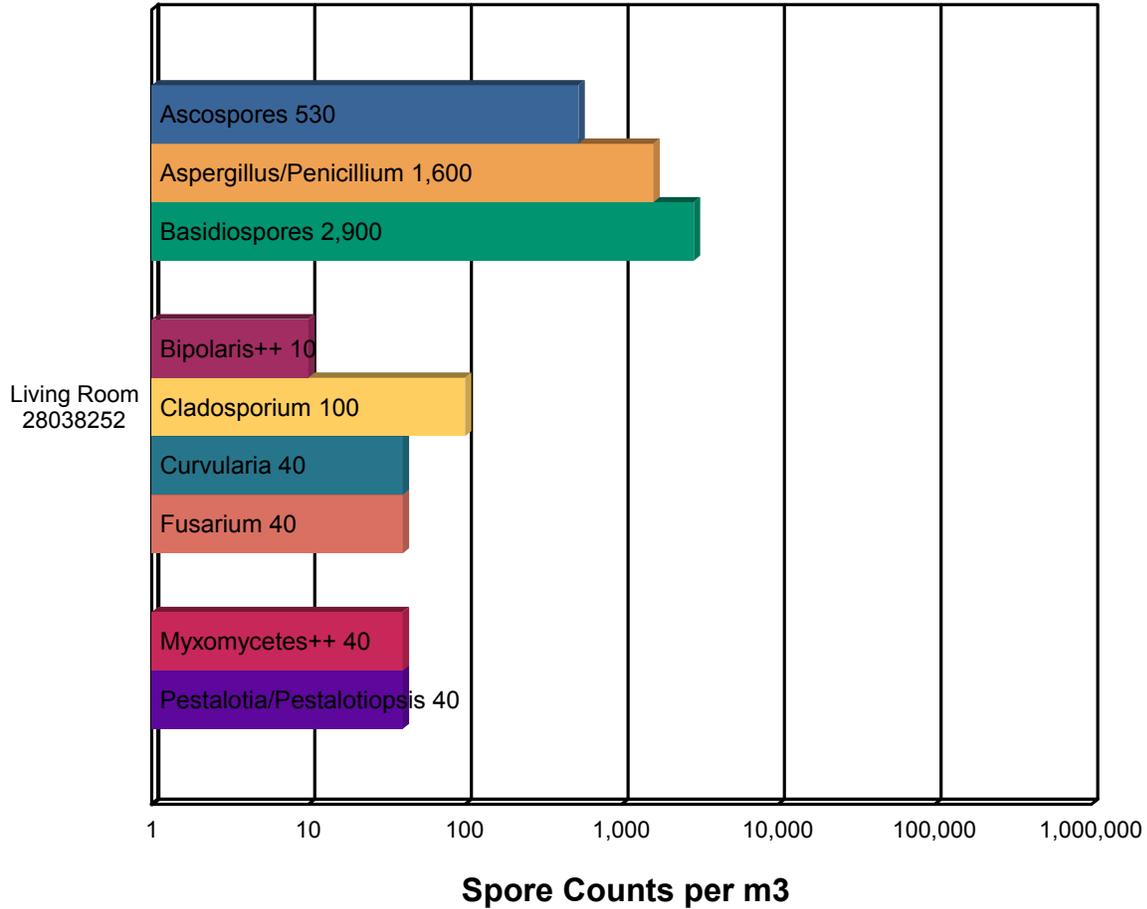
## Spore Trap Report: Total Counts

\* The chart is displayed using a logarithmic scale. Bar size is not directly proportional to the number of spores.

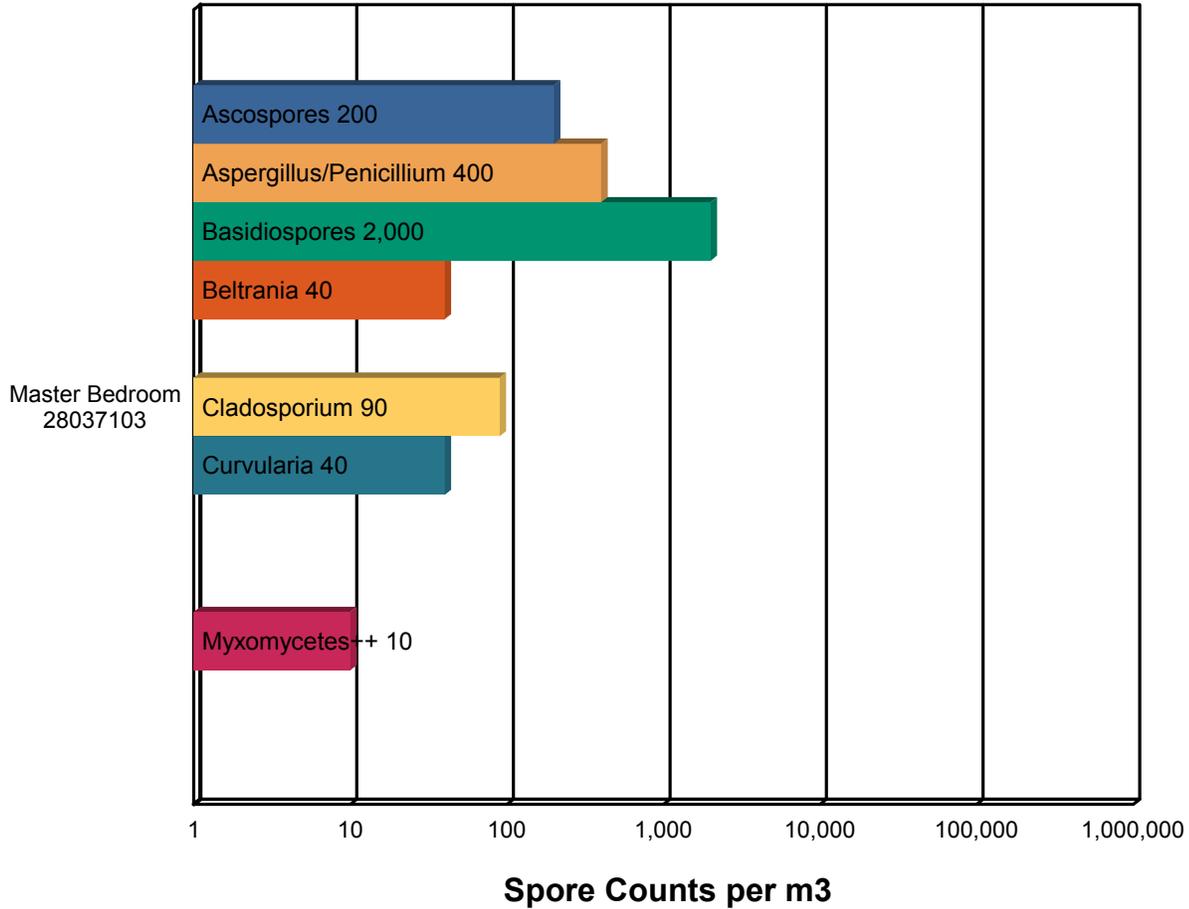
## Spore Trap Report: Total Counts

\* The chart is displayed using a logarithmic scale. Bar size is not directly proportional to the number of spores.

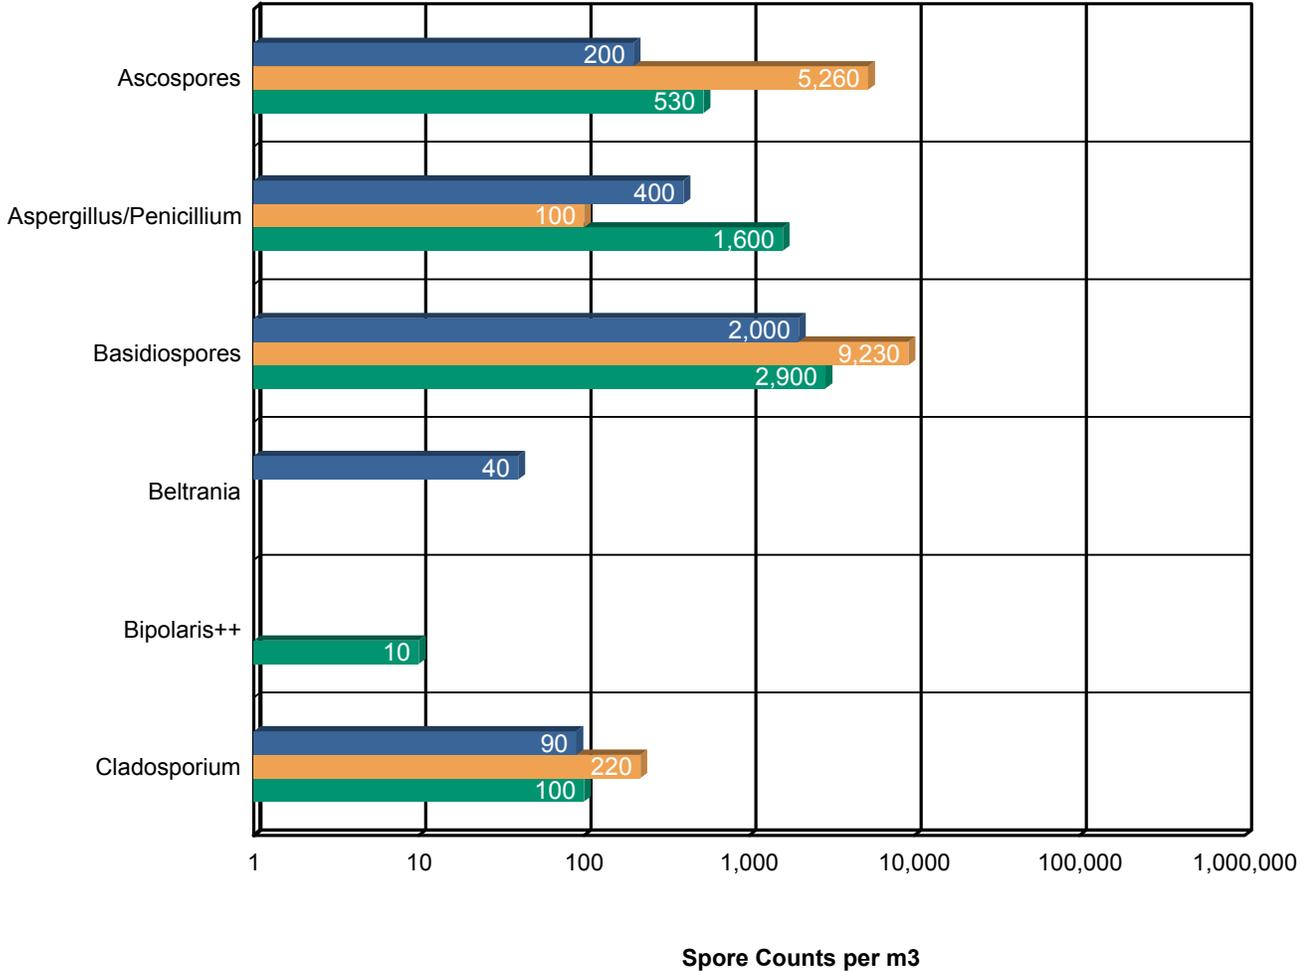
## Background Comparison Chart

\* The chart is displayed using a logarithmic scale. The bar size is not directly proportional to the number of spores.

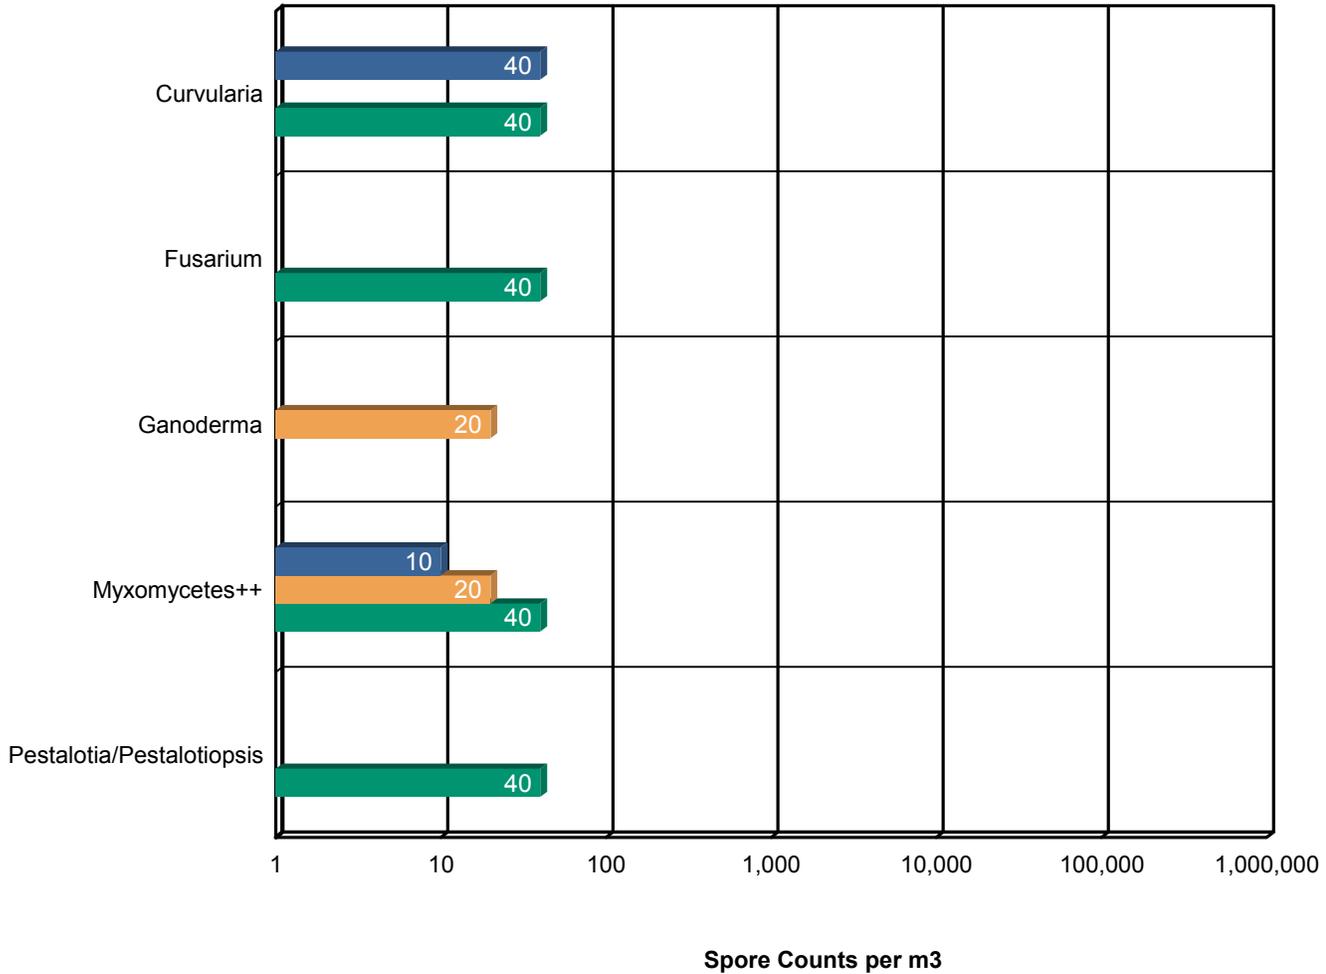
## Background Comparison Chart

\* The chart is displayed using a logarithmic scale. The bar size is not directly proportional to the number of spores.
