## TEST REPORT

No. : XMIN2211009396CM

Sample Name : SPC6512-3  
Manufacturer : EVERLASTING BASE SDN BHD  
Material and Mark : SPC

Summary of Results:

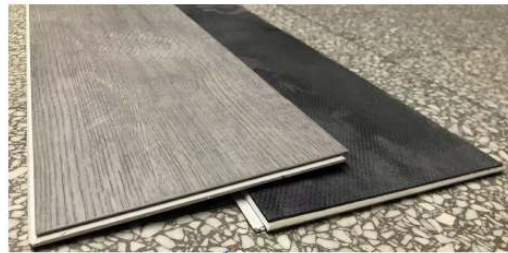
## Schematic Diagram:

- Sample Description : 7(5.5+1.5) mm flooring, surface density: about 11.5 kg/m<sup>2</sup>, at the bottom of the sample with 1.5mm cushion pad. Total Thickness: 7mm
- Test conducted : ASTM E492-09(2016)<sup>ε1</sup>, ASTM E989-21, ASTM E90-09(2016), ASTM E413-16
- Project description : No decoration on the surface of the sample, sample installation is directly assembled.  
The test specimen was covered on a 150mm concrete floor with a drop ceiling, testing area 11.3m<sup>2</sup>, the drop ceiling construction showed in Schematic Diagram
- Test Equipment : RTA840 system
- Test Environment : Source room volume 125m<sup>3</sup>, receiving room volume 100m<sup>3</sup>, air temperature 20.1 °C, air humidity 32.5%

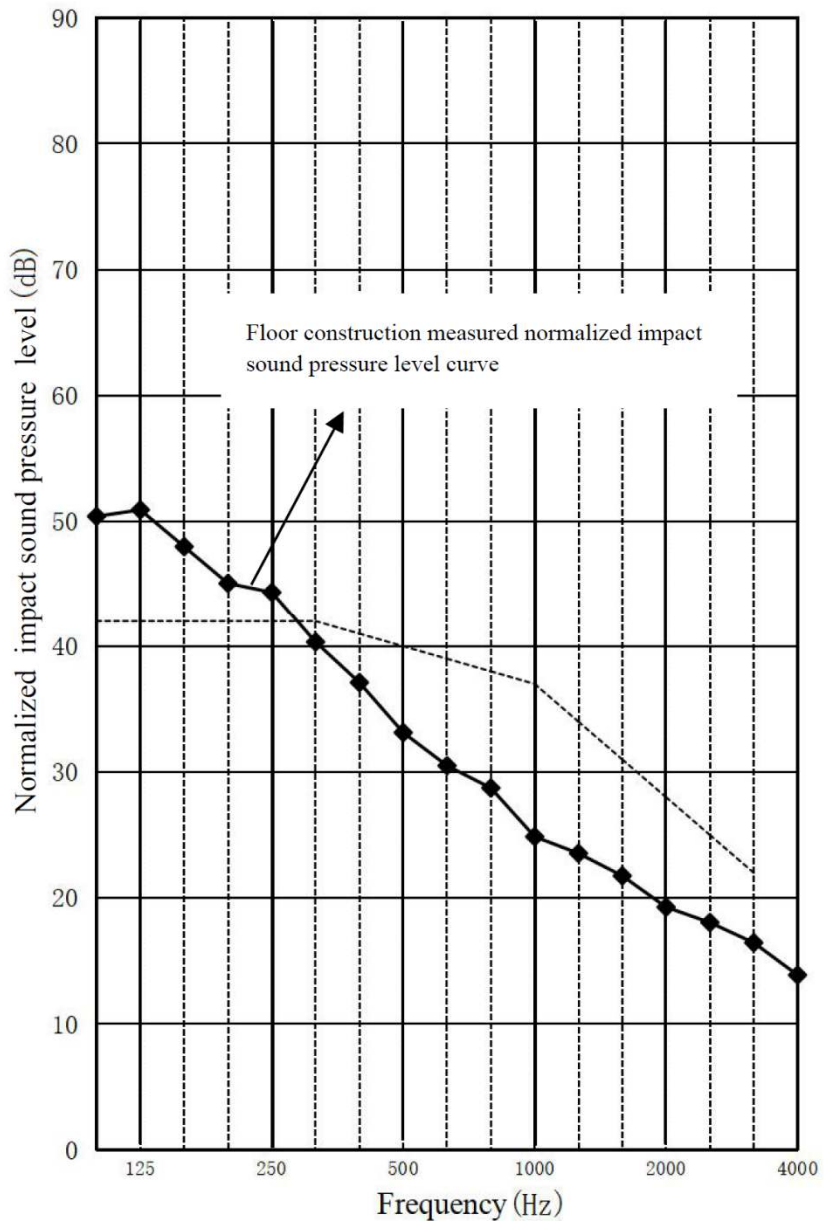
## Frequency spectrum for IIC:

f Hz	Ln dB
100	50.4
125	50.9
160	48.0
200	45.1
250	44.3
315	40.3
400	37.1
500	33.1
630	30.5
800	28.7
1000	24.9
1250	23.5
1600	21.8
2000	19.3
2500	18.0
3150	16.4
4000	13.9
IIC = 69

Remark:  $L_n$  as the weighted normalized impact sound pressure level

No.	Test Item	Test Method	Result
1	Determination of Impact Sound Insulation Class	ASTM E492-09(2016) <sup>E1</sup> ASTM E989-21	<b>IIC = 69</b>
2	Airborne sound transmission loss test and class	ASTM E90-09(2016) ASTM E413-16	<b>STC = 68</b>
