Northeast Aquatic Research

January 21st, 2021

Re: Action Plan for The Management of New Cattail Growth in Robinson Pond

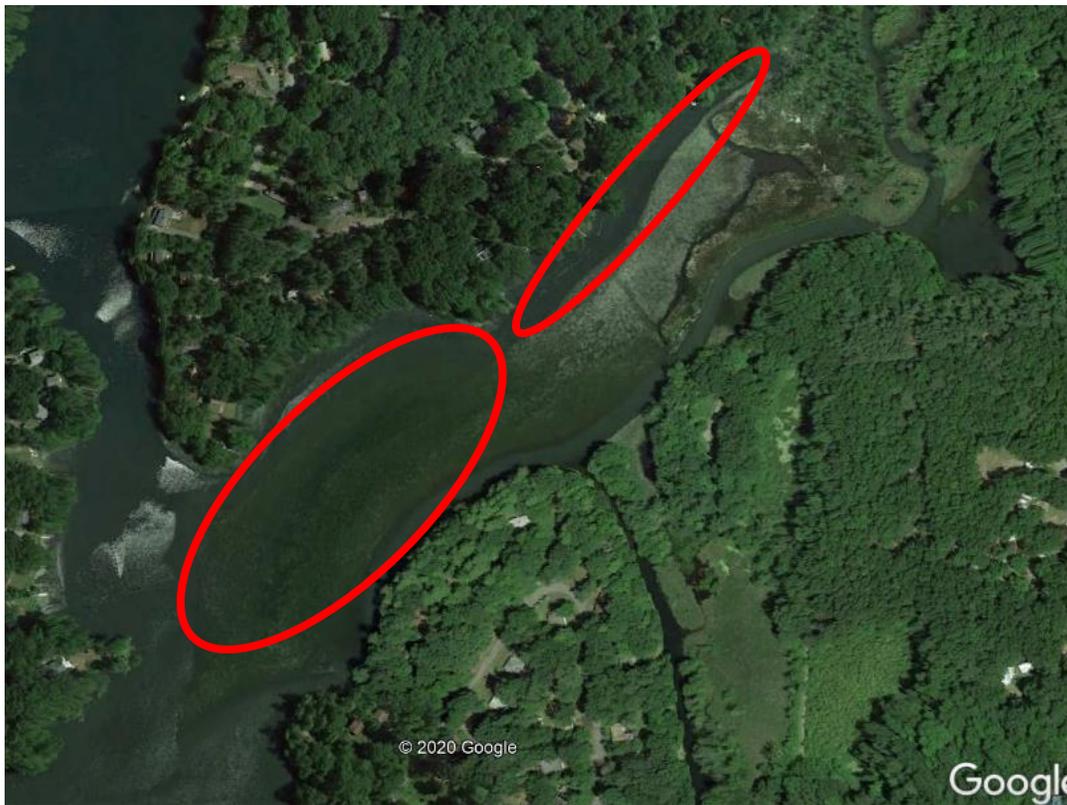
In the summer of 2020, Northeast Aquatic Research (NEAR) was contacted by the Taconic Shores Property Owner's Association to develop a specific action plan for the monitoring and management of new cattail growth that has appeared in the north and northeastern sections of the lake. During the drawdown in the summer of 2020, there was significant expansion of cattails and other emergent plants into the shallow areas in the northern section of the lake adjacent to the Roeliff-Jansen Kill (Figure 1). Access in and out of this area was significantly reduced for boating due to the increased growth.

Figure 1. Area of increased cattail growth in 2020

To control the increased cattail growth, mechanical harvesting should continue in the northeastern section (Zone 6). The goal of harvesting should be to cut the cattails below the waterline to drown out the plants. Harvesting should be done in the middle section of the lake on an “as needed” basis. It is not clear whether the cattails at the southernmost extent of zone 6 will continue to persist when the lake is at full pool. The shallow nature of this area will undoubtedly support future aquatic plant growth. However, it is unclear whether or not cattails can persist in these areas under normal water levels. A hydro raking operation may be needed in future years if certain areas have persistent cattail growth after the pond returns to full pool.

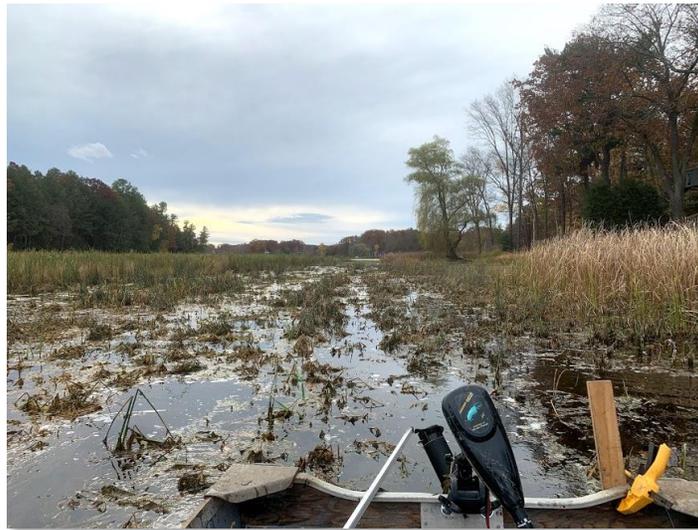
NEAR inspected the entire pond with a special focus on the emergent growth in the northeastern section. In this section, we used a combination of field notes, GPS waypoints and photos to develop an acreage estimate for the emergent area. We estimated that there were ~14 acres of new emergent plant growth in this section (Figure 4). This may be an underestimate, as there was extensive management of this area via mechanical harvesting, which can make it more difficult to spot underwater stems. The densest and most recreation-impacting section of growth was along the shore of the northeastern section of Zone 6 (Figure 2; Zone map in appendix A). This area was completely overgrown with emergent plants and was difficult to navigate with a rowboat. We did find two small water chestnut plants in this area, which were pulled.

Figure 2. Northeastern Section of Zone 6, with extensive emergent growth

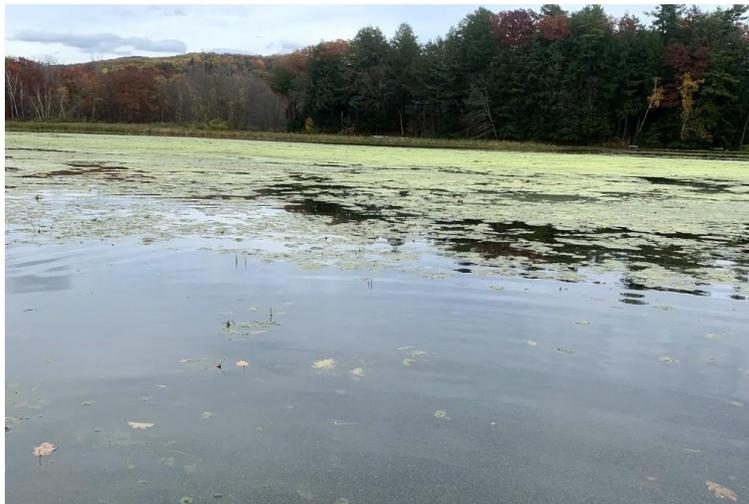
The remainder of the northeastern section has a lot of plant and algae growth, specifically filamentous algae, watermeal (*Wolffia* sp.), and sporadic emergent plant growth (Figure 3). The emergent growth extended to the southeast part of Zone 6 and into parts of Zone 5 (Figure 4).

Figure 3. Zone 6 extensive plant and algae growth.

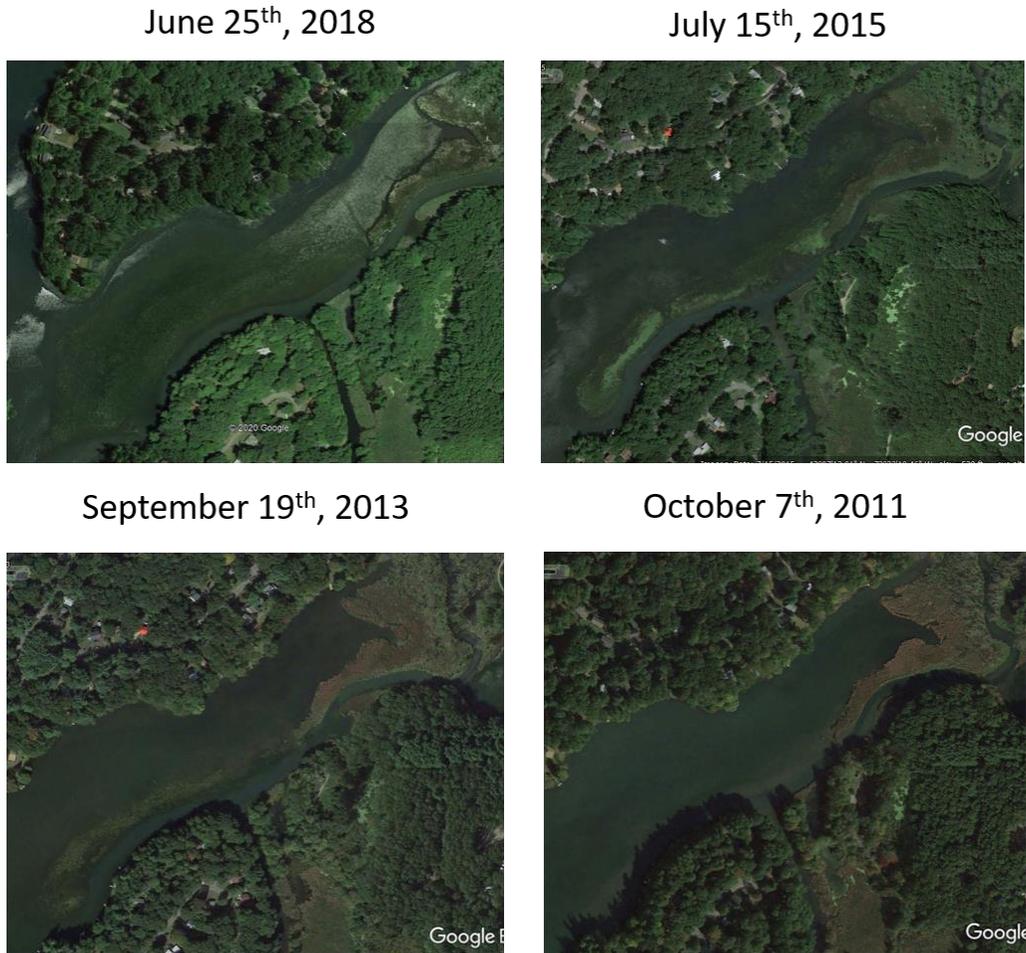
The hydro raking of the impacted area south of Lakeview Road and the harvesting in Zone 6 should allow for lake access and recreation. It is important to realize that one of the underlying reasons that the cattail and emergent plants became so abundant was due to the shallow nature of this area, presumably exacerbated by nutrient inputs by the Roeliff-Jansen Kill and local non-point source pollution (runoff, onsite wastewater, unsustainable lawn practices). Looking at the historical Google imagery (Figure 5), the shallow nature of this zone has been evident since 2015. Shallow

lakes that have such an extreme watershed load (200:1 watershed to lake ratio) are going to be subject to increased sedimentation and decreased depths over time. The summer drawdown gave the TSPOA a unique look into the future of the northeastern arm if proper management action is not taken.

Figure 5. Historical imagery of the northeastern section of Robinson Pond
